HUD CAPITAL NEEDS ASSESSMENT

Peabody
1875 Dorchester Avenue
Dorchester, Massachusetts 02124

AEI Project No. 463342
Site Inspection Date: July 26, 2022

Boston Housing Authority
52 Chauncy Street
Boston, Massachusetts 02111

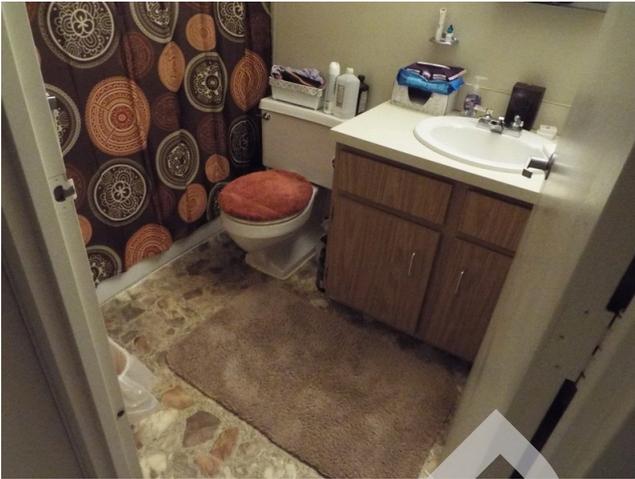
13. Flooring condition - 1-bed-1-bath - unit 205 - bathroom (Non-Critical Repair)

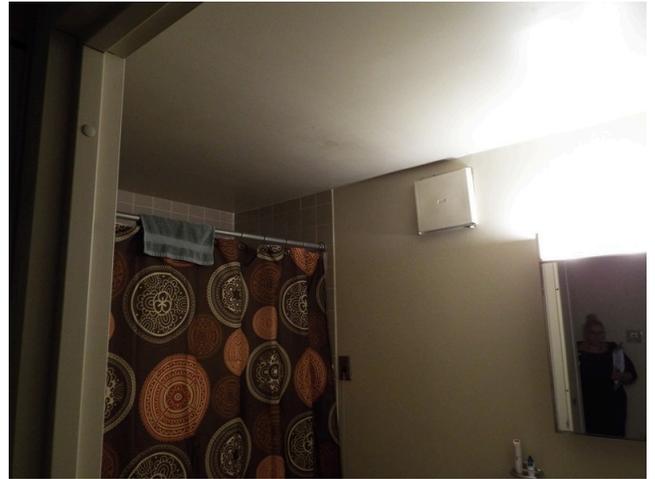
14. Fan not working - 1-bed-1-bath - unit 205 (Non-Critical Repair)

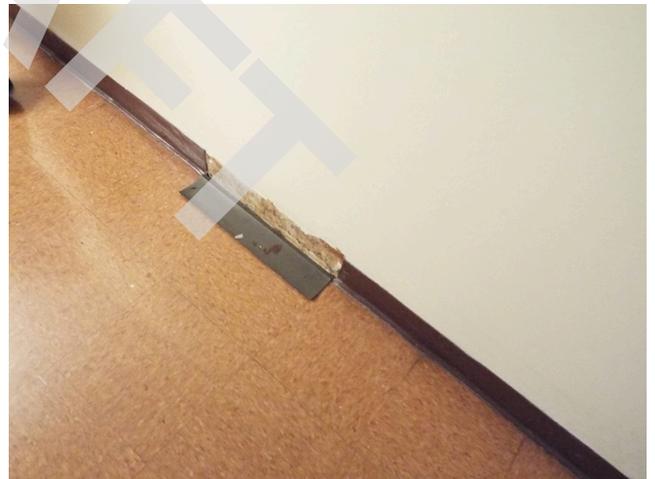
20. Wall base condition - 1-bed-1-bath - unit 205
(Non-Critical Repair)

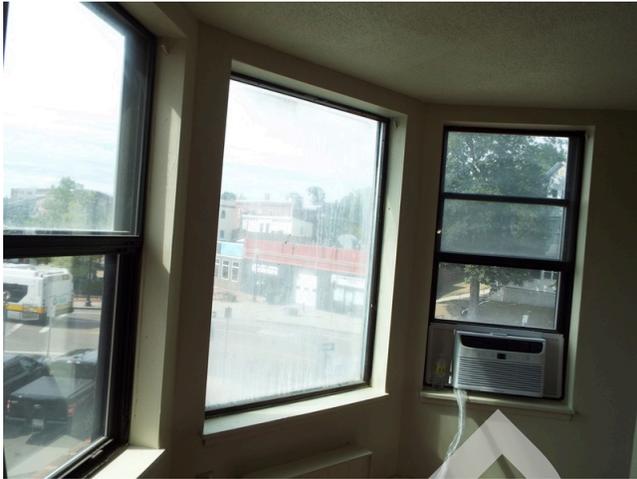
61. Window condensation - 1-bed-1-bath - unit 221
(Non-Critical Repair)

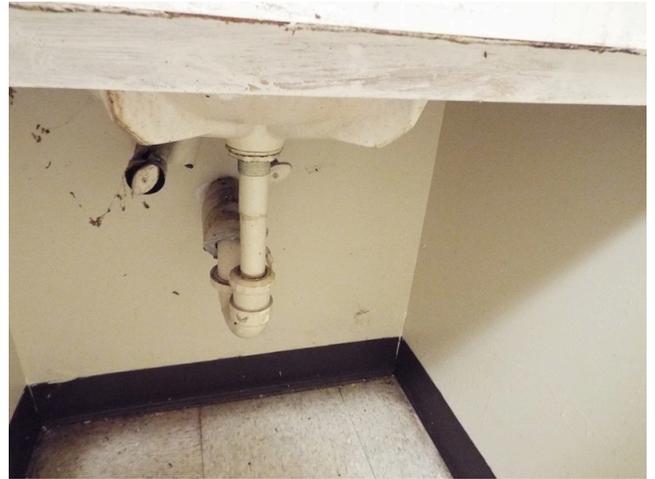
86. Bathroom sink lacks pipe protection - UFAS - unit 213 (Critical Repair)

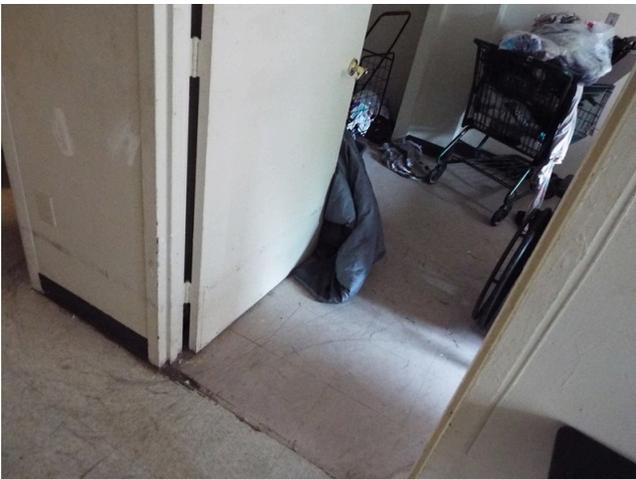
91. Doors lack lever hardware - UFAS - unit 213
(Critical Repair)

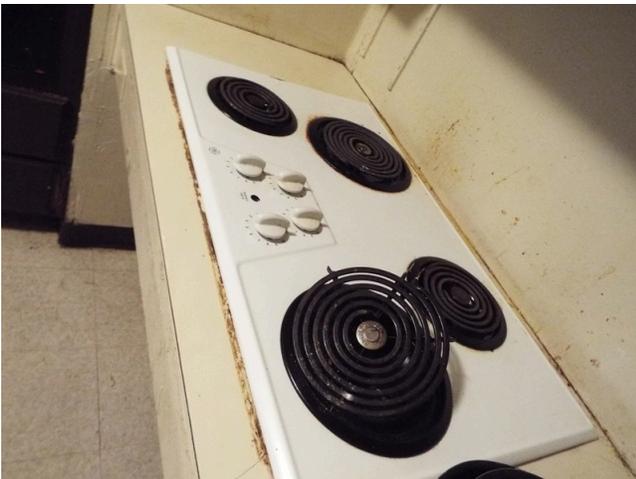
95. Range condition - 1-bed-1-bath - UFAS - unit 213 (Critical Repair)

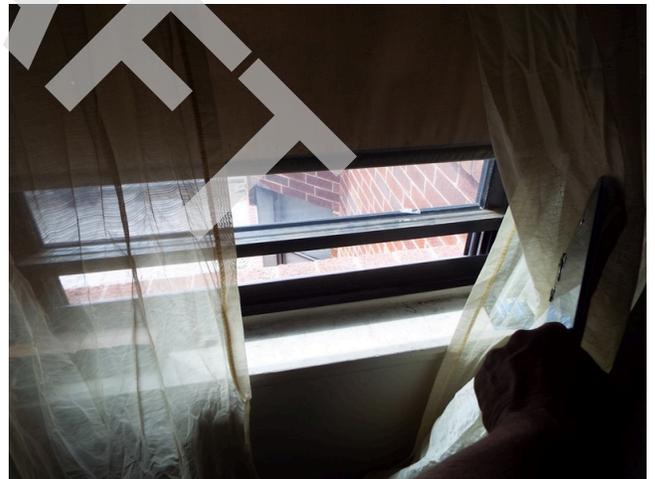
136. Window lacks screen - 1-bed-1-bath - UFAS
- unit 311 (Non-Critical Repair)

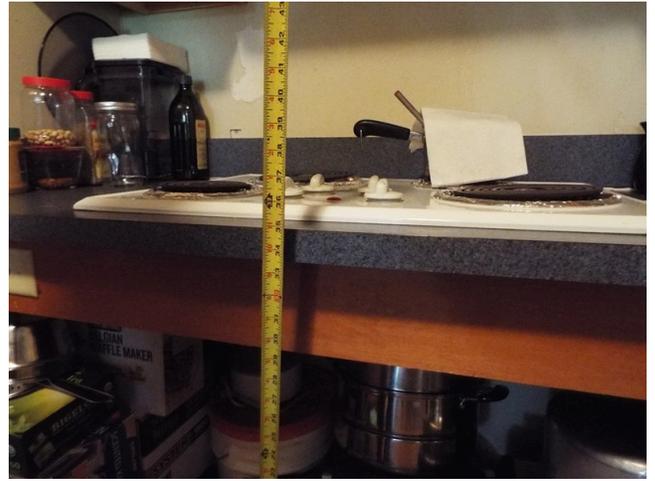
146. Kitchen stovetop counter exceeds 34 inches - UFAS - unit 313 (Critical Repair)

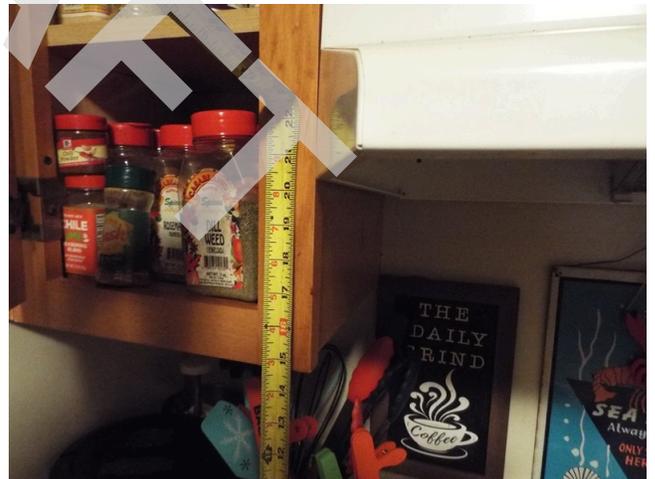
216. Kitchen cabinet lacks 48 inch shelf - UFAS - unit 413 (Critical Repair)

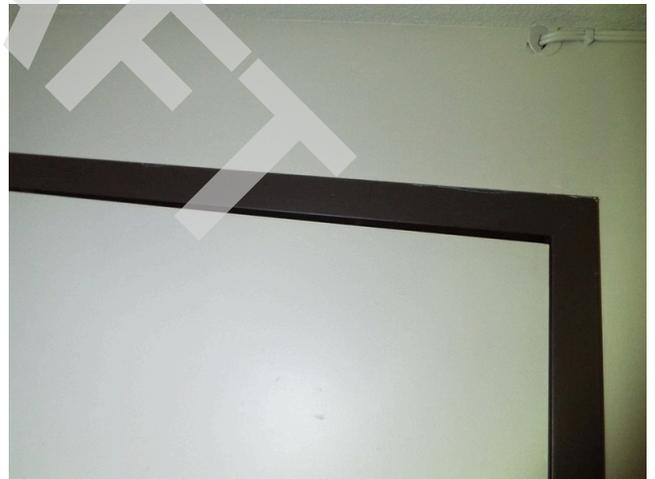
252. Entry door misalignment - 1-bed-1-bath - UFAS - unit 413 (Non-Critical Repair)

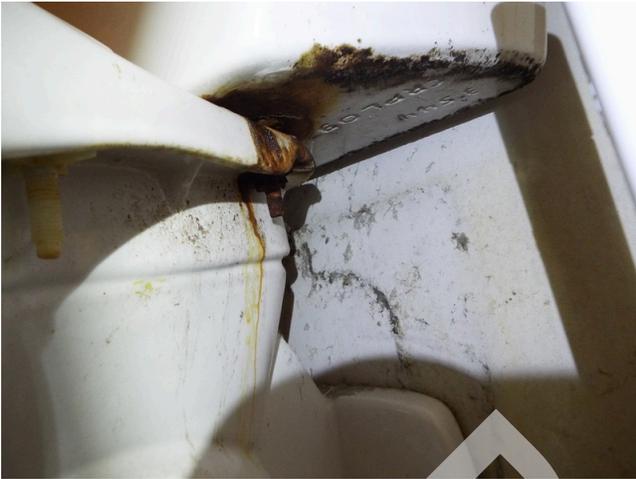
269. Toilet leak reported - 1-bed-1-bath - unit 504

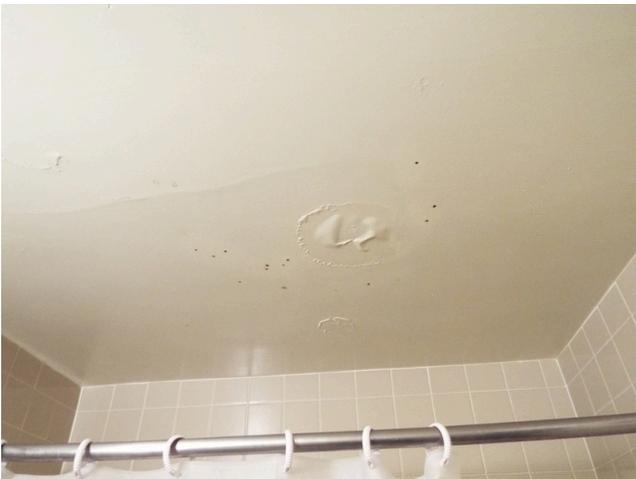
271. Ceiling condition - 1-bed-1-bath - unit 504
(Non-Critical Repair)

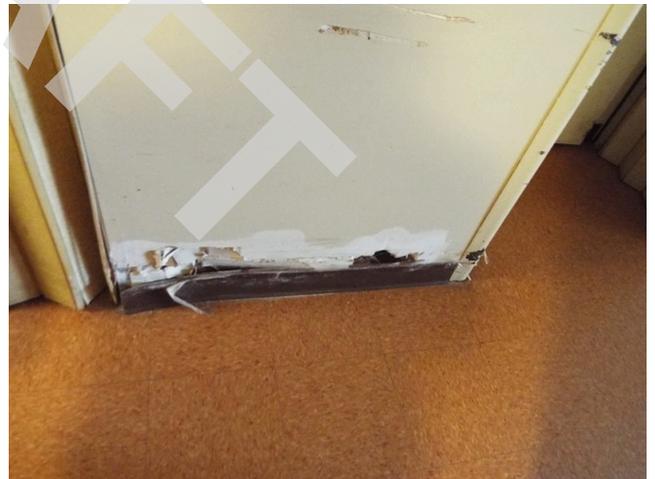
304. Wall base condition - 1-bed-1-bath - UFAS - unit 513 (Non-Critical Repair)

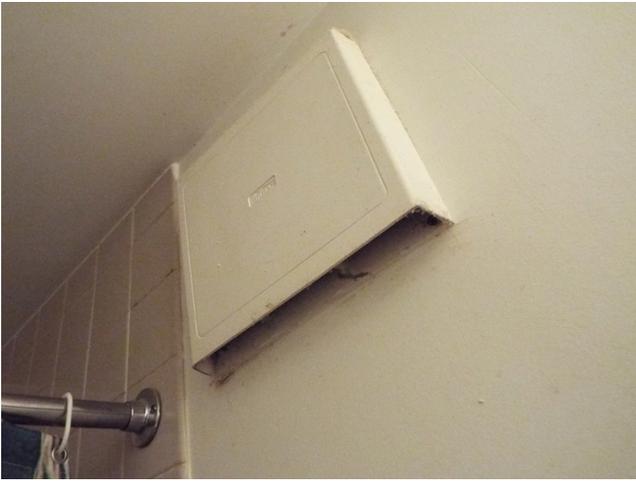
331. Bathroom fan condition - 1-bed-1-bath - unit 514 (Non-Critical Repair)

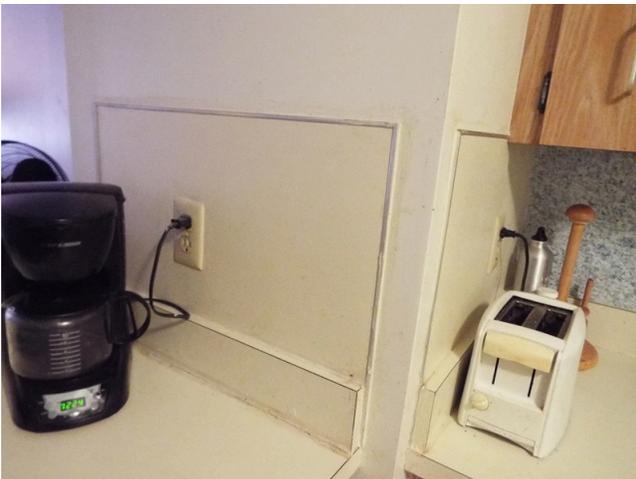
335. 1-bed-1-bath - unit 514 - kitchen lacks GFCI receptacle (Critical Repair)

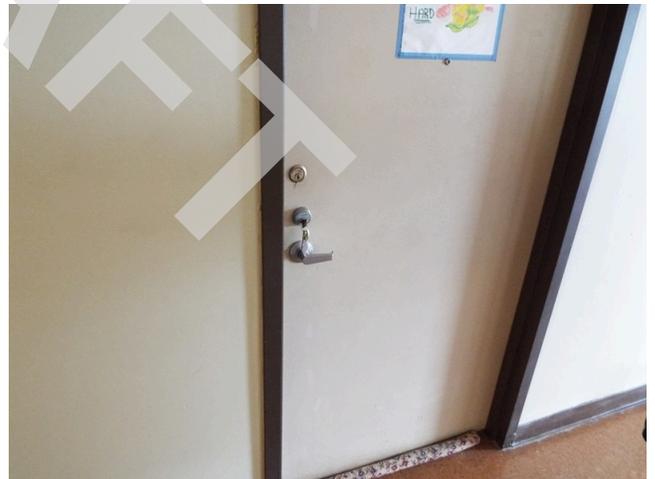
336. Entry door closer condition - 1-bed-1-bath - unit 514 (Non-Critical Repair)

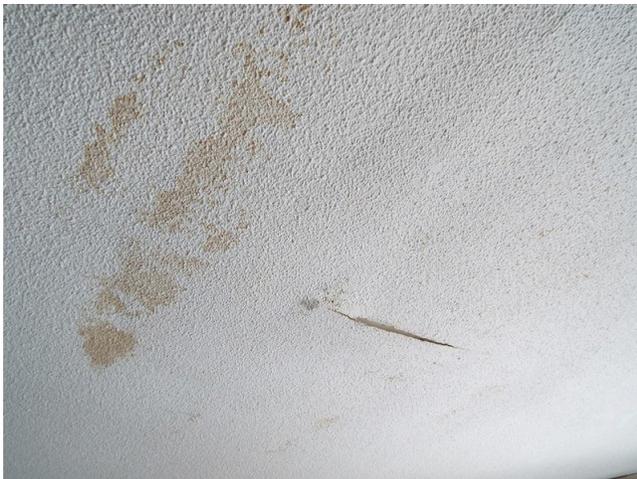
339. Ceiling condition - 1-bed-1-bath - unit 606
(Non-Critical Repair)

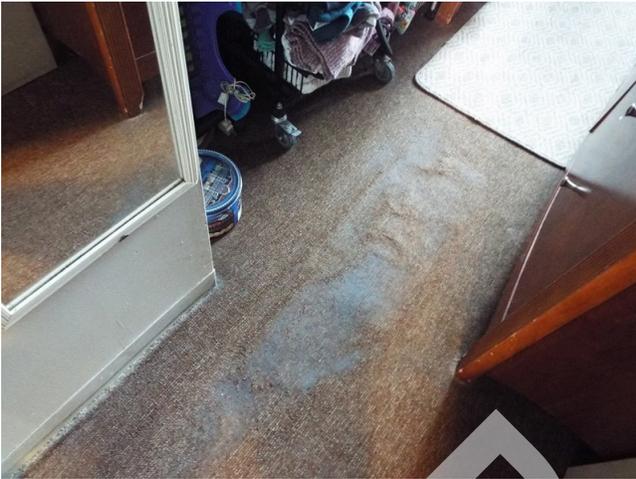
349. Flooring condition - 1-bed-1-bath - unit 606
(Non-Critical repair)

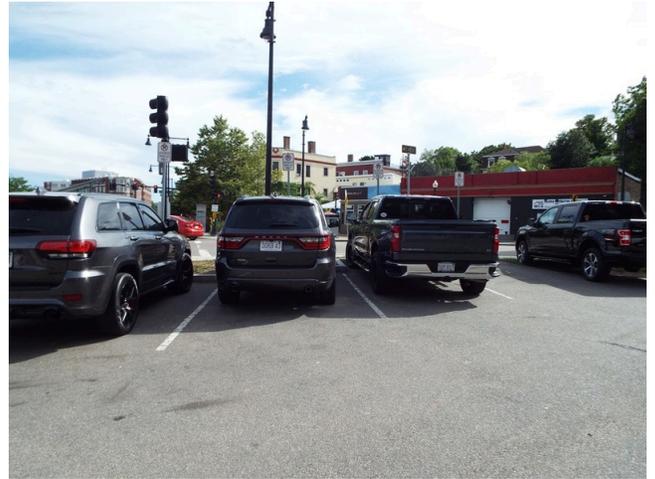
10. Pavement and striping condition

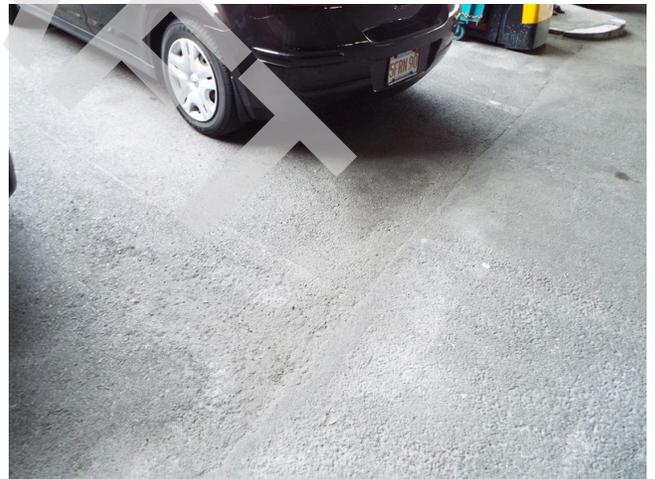
12. Parking garage pavement condition

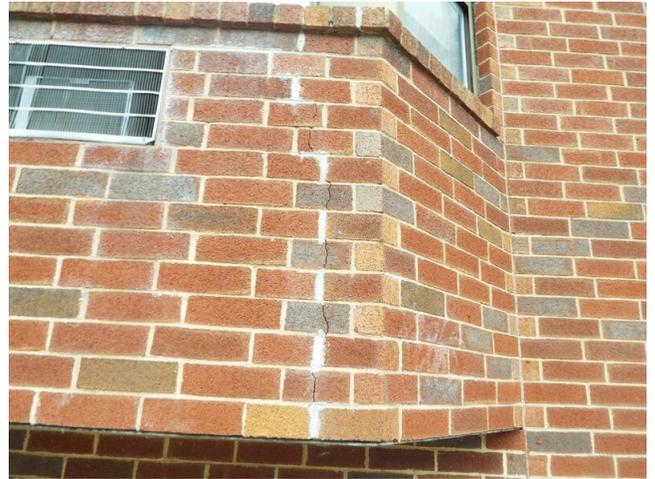
38. Masonry crack (Non-Critical Repair)

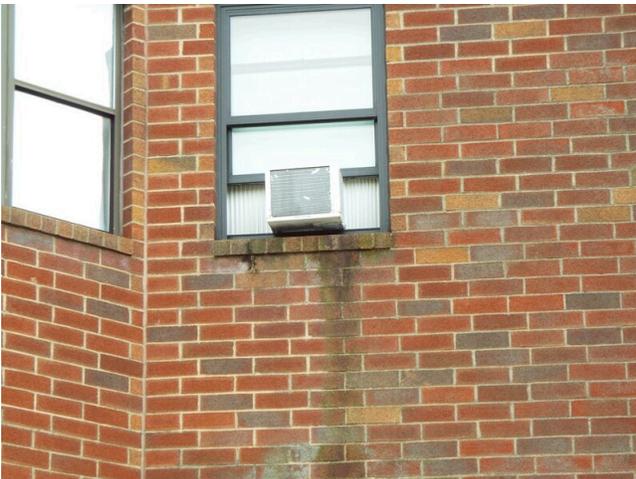
39. Masonry staining (Non-Critical repair)

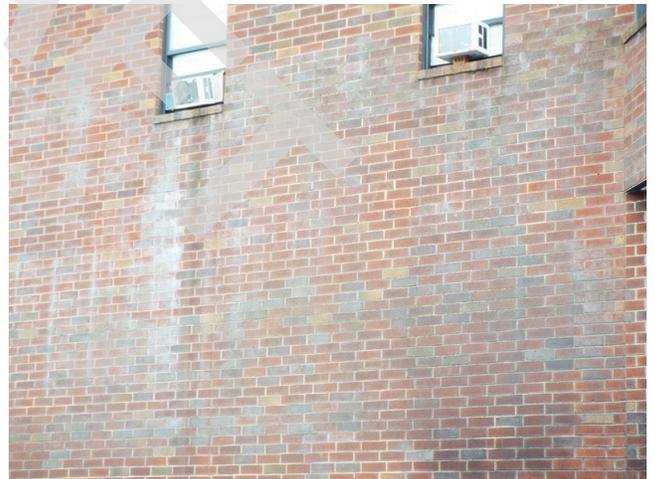
40. Masonry staining (Non-Critical repair)

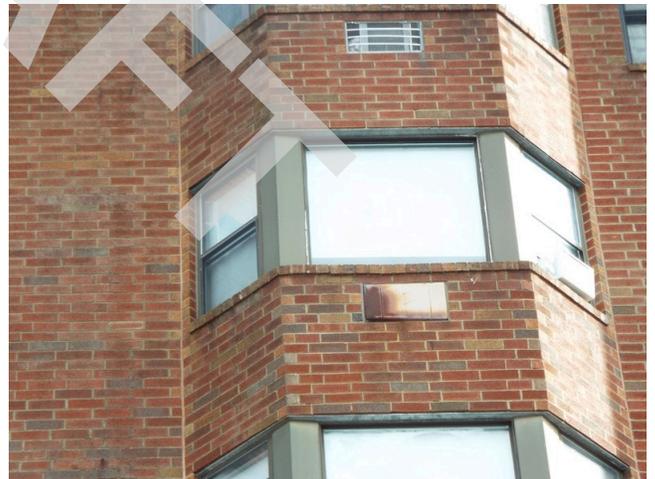
44. Thru wall panel condition (Non-Critical Repair)

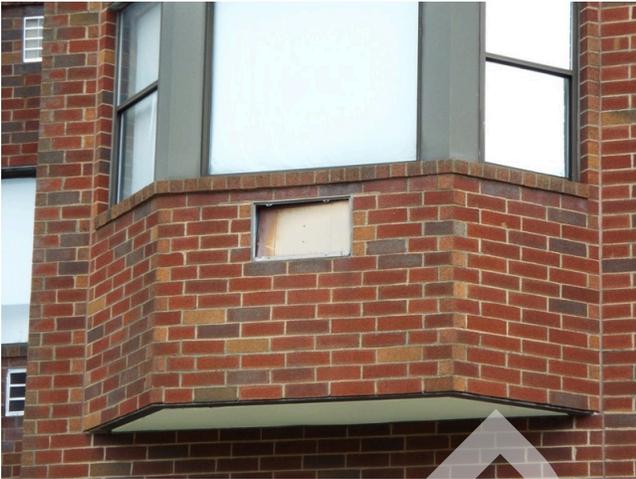
45. Thru wall panel condition (Non-Critical Repair)

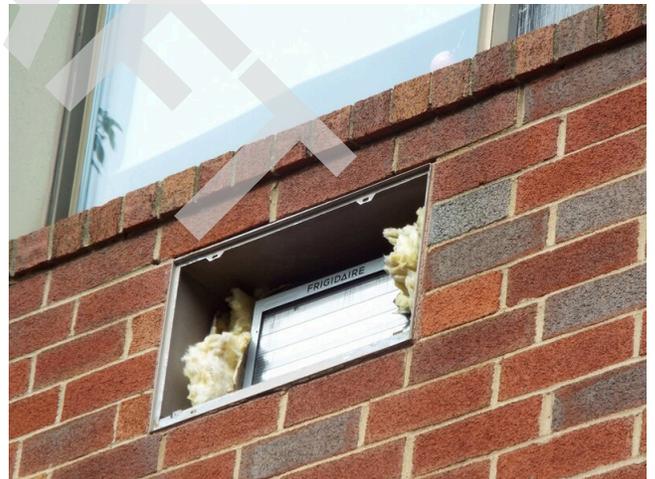
56. Thru wall HVAC unit installation (Non-Critical Repair)

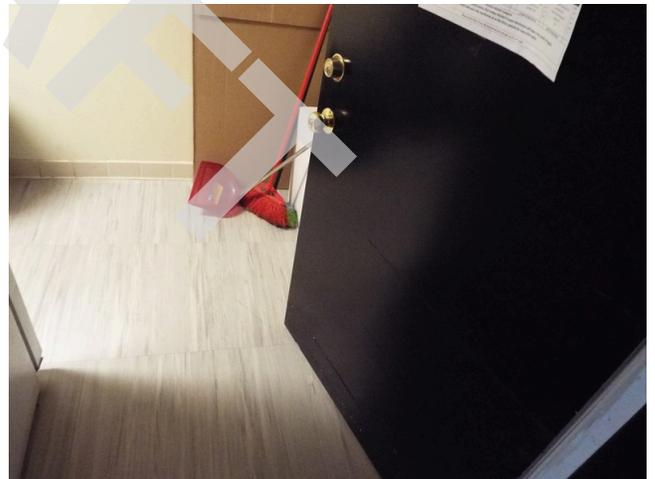
108. Common area - kitchen, knob hardware
(Critical Repair)

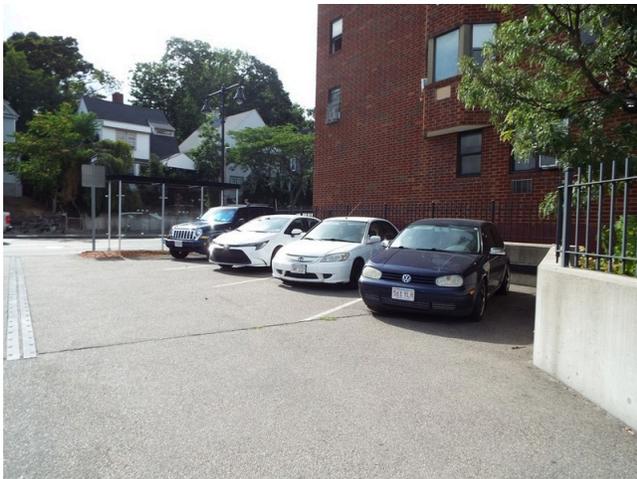
251. Pavement condition - surface parking
