## HUD CAPITAL NEEDS ASSESSMENT

Commonwealth Elderly  
35 Fidelis Way  
Boston, Massachusetts 02135

AEI Project No. 463345  
Site Inspection Date: July 20 and 21, 2022

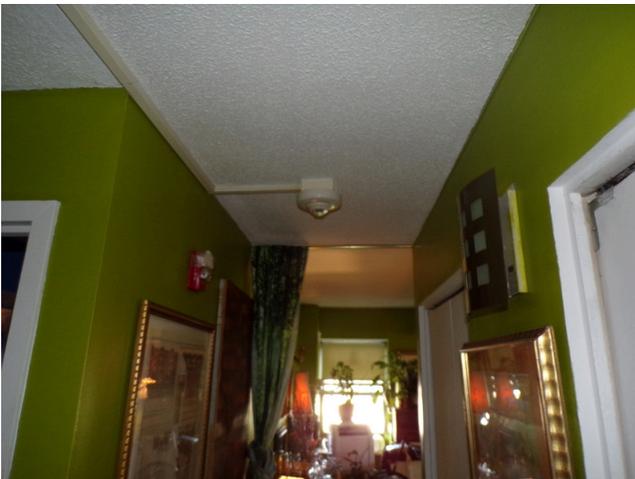
2. Apartment building 1 - Apartment 166 - 1-bed/  
1-bath - intercom (Non-Critical Repair)

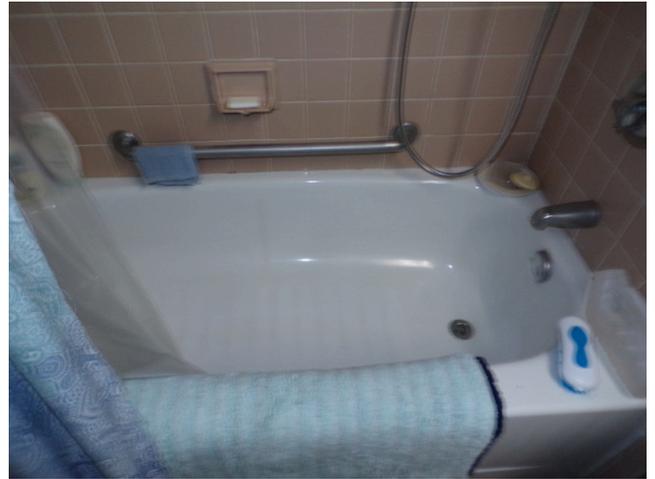
9. Apartment building 1 - Apartment 166 - 1-bed/  
1-bath - bathroom vent fan missing (Non-Critical  
Repair)

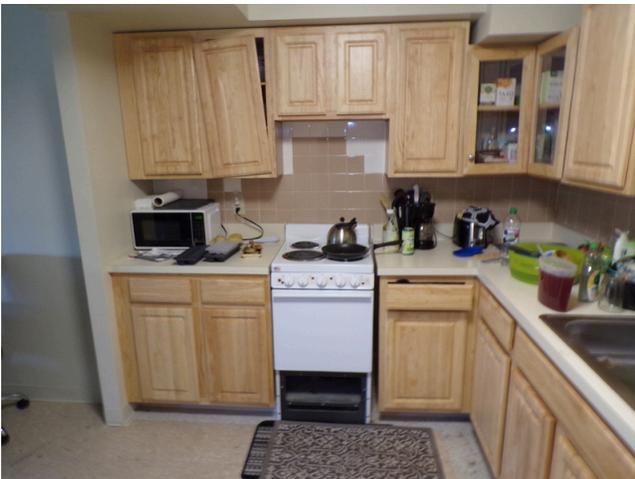
38. Apartment building 1 - Apartment 154 - 1-bed/  
1-bath - intercom (Non-Critical Repair)

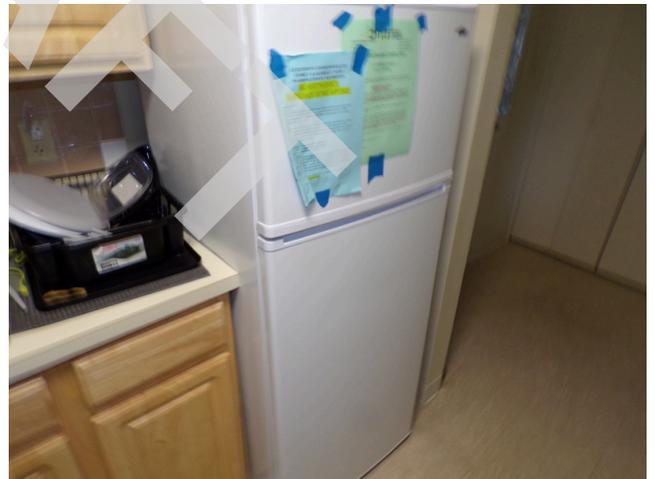
39. Apartment building 1 - Apartment 154 - 1-bed/  
1-bath - kitchen cabinet door damaged (Non-Critical  
Repair)

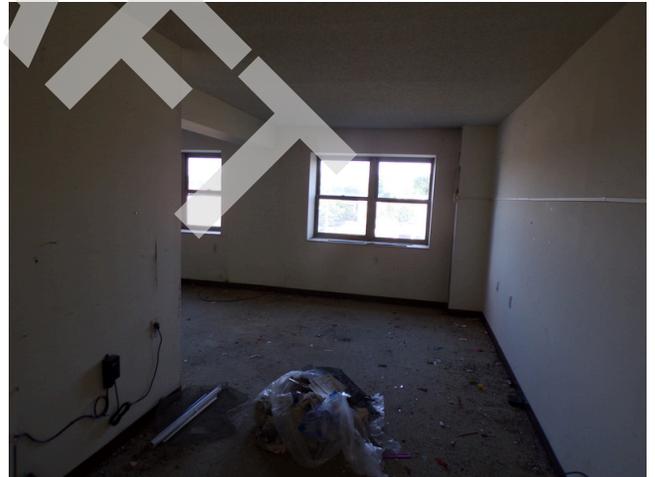
43. Apartment building 1 - Apartment 145 - 2-bed/  
1-bath - kitchen (Non-Critical Repair)

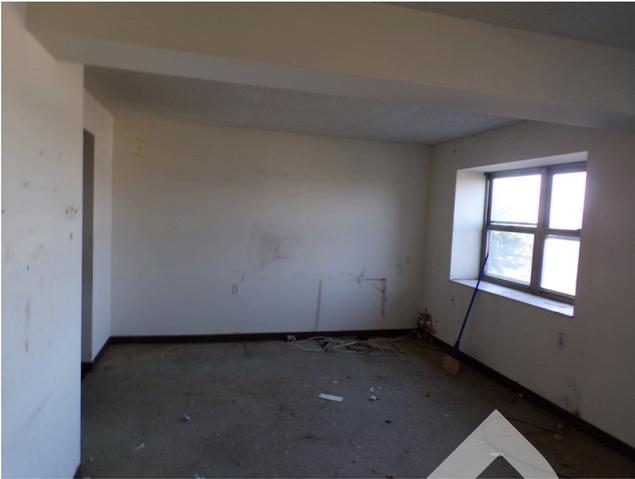
44. Apartment building 1 - Apartment 145 - 2-bed/  
1-bath - living room area (Non-Critical Repair)

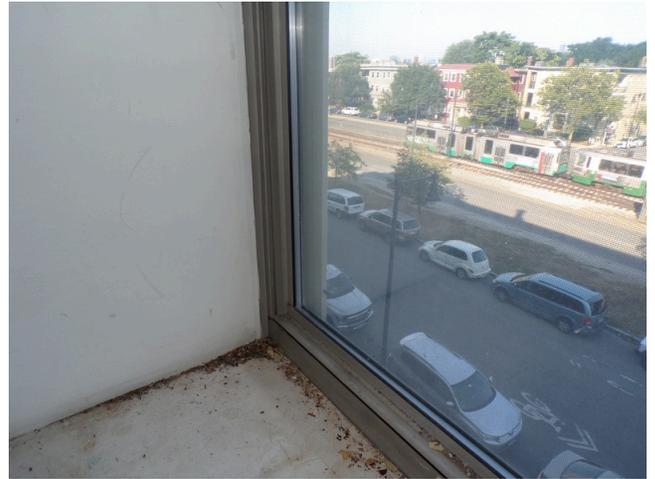
45. Apartment building 1 - Apartment 145 - 2-bed/  
1-bath - living room area (Non-Critical Repair)

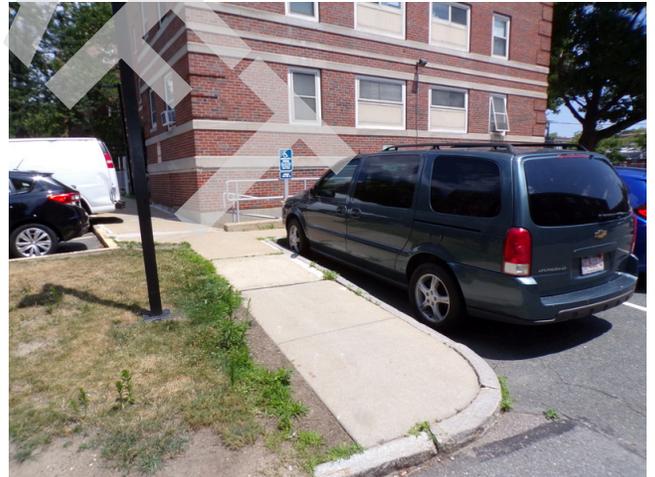
16. Apartment building 1 parking lot handicap parking missing curb cutout (Critical Repair)

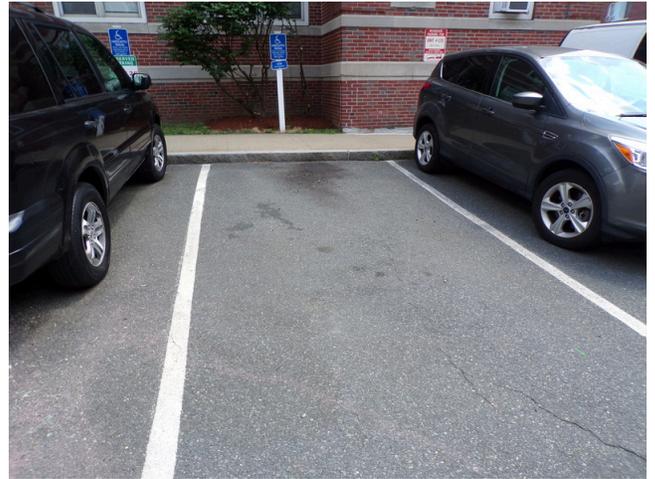
18. Apartment building 1 handicap parking no pavement markings or access aisle (Critical Repair)

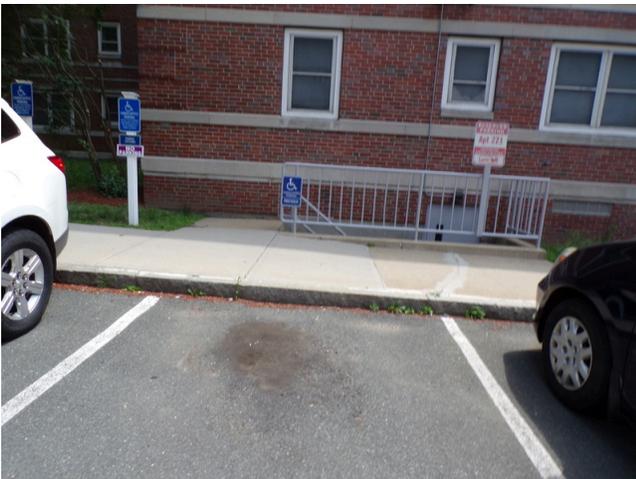
19. Apartment building 1 handicap parking signage less than 60 inches above ground (Critical Repair)

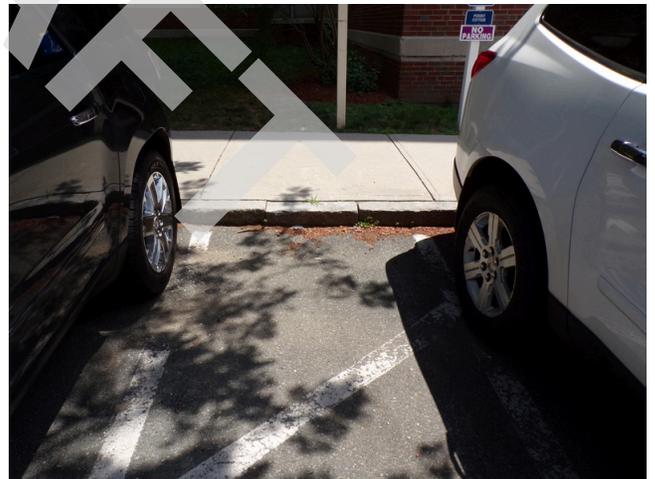
28. Apartment building 1 handicap parking missing curb cutout (Critical Repair)

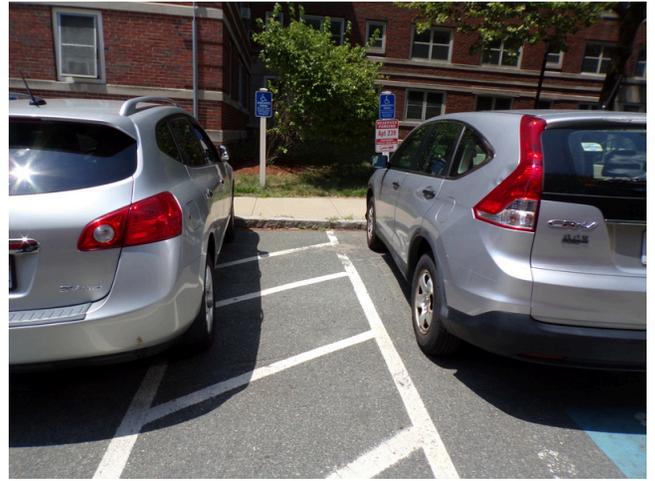
30. Apartment building 1 handicap parking signage and missing curb cutout (Critical Repair)

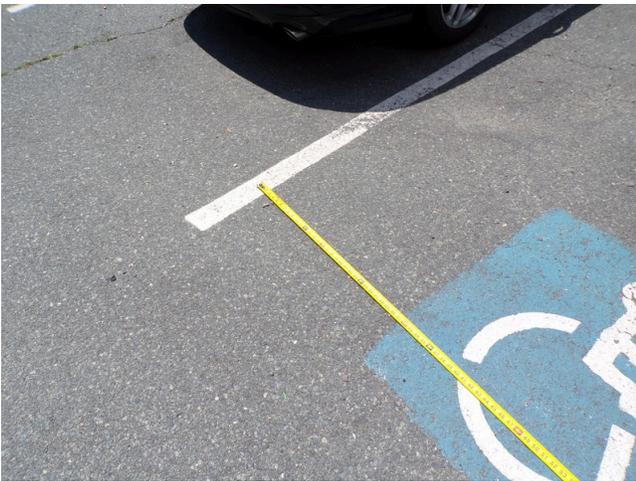
31. Apartment building 1 handicap parking seal coat asphalt (Non-Critical Repair)

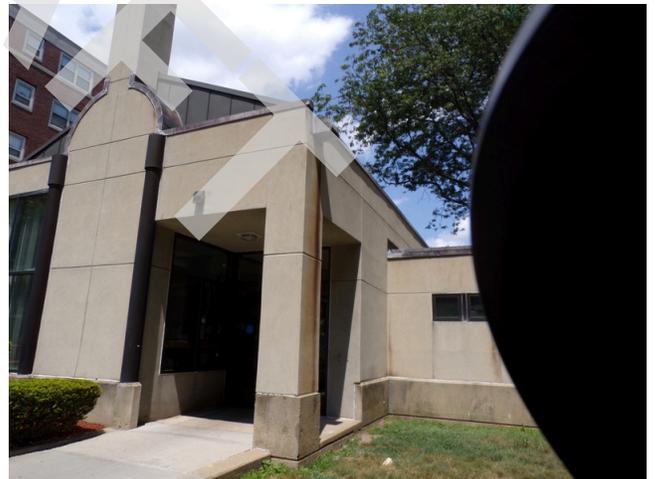
35. Apartment buildings 1 and 2 main ingress/egress sidewalks trip hazard (Critical Repair)

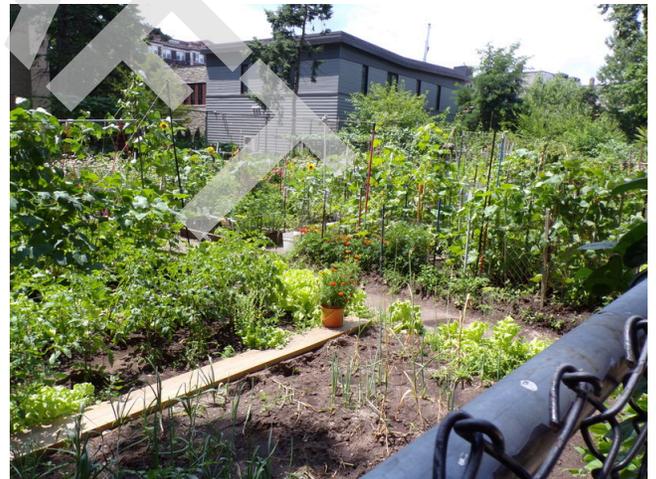
39. Apartment building 2 bare ground (Non-Critical Repair)

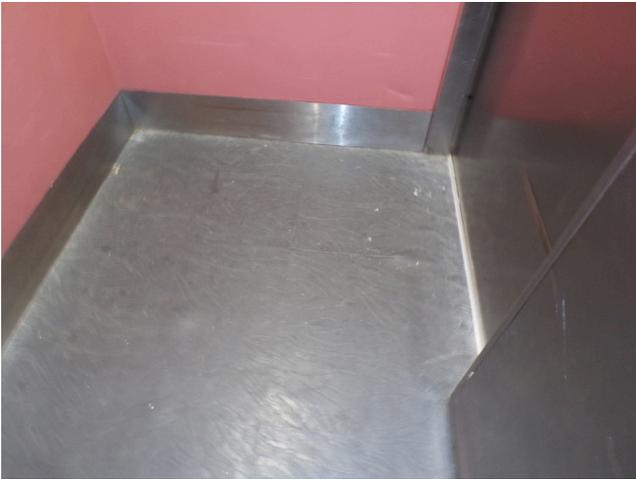
51. Apartment building 1 elevator cab floor (Non-Critical Repair)

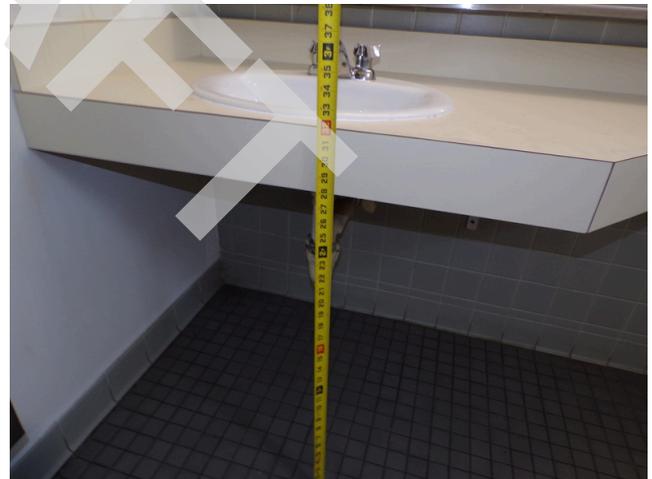
71. Apartment buildings 1 and 2 women's public restroom restroom sink missing scald and abrasion protection (Critical Repair)

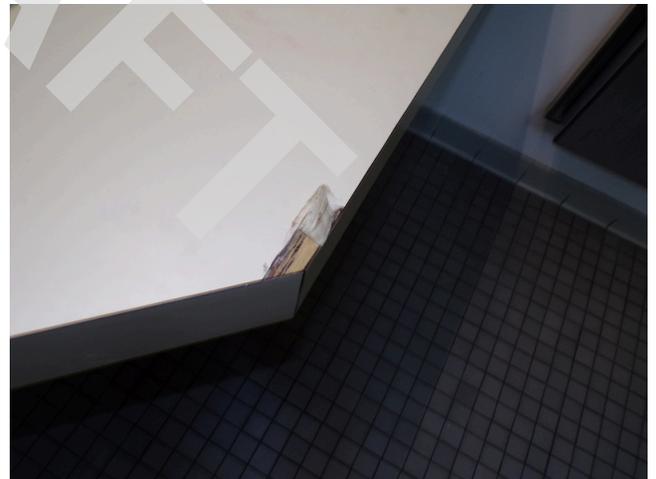
83. Apartment buildings 1 and 2 men's public restroom sink hardware (Critical Repair)

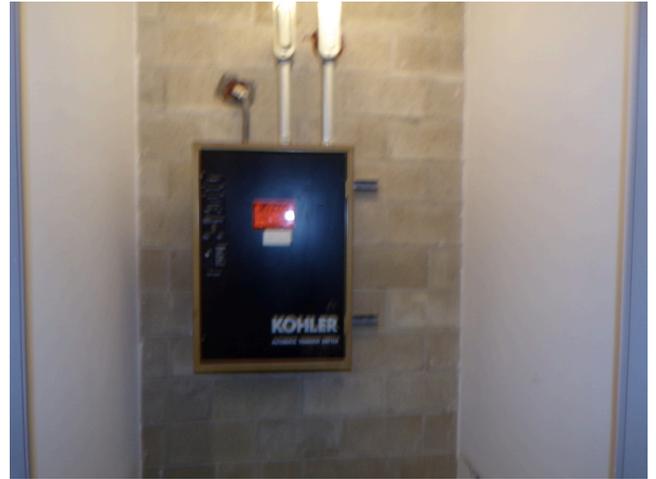
109. Apartment buildings 1 and 2 inoperable fire sprinkler system generator (Critical Repair)
