## HUD CAPITAL NEEDS ASSESSMENT

Commonwealth Family  
35 Fidelis Way  
Brighton, Massachusetts 02135

AEI Project No. 463346  
Site Inspection Date: July 20 and 21, 2022

Boston Housing Authority  
52 Chauncy Street  
Boston, Massachusetts 02111

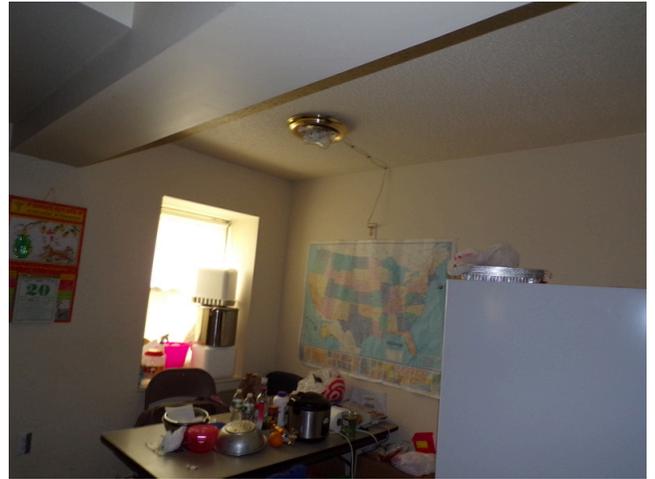
5. Building 4 - unit 414 - 3-bed/2-bath - TH - UFAS - living room missing light (Non-Critical Repair)

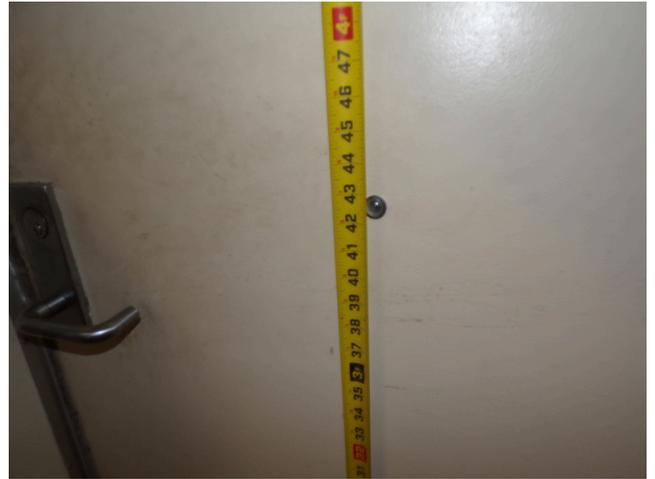
29. Building 4 - unit 414 - 3-bed/2-bath - TH - UFAS  
- lower thermostat (Critical Repair)

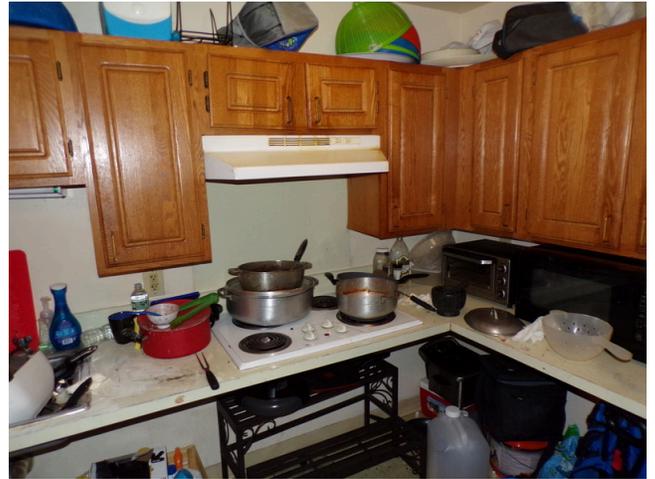
34. Building 4 - unit 412 - 3-bed/1.5-bath - UFAS - kitchen range hood missing front end controls (Critical Repair)

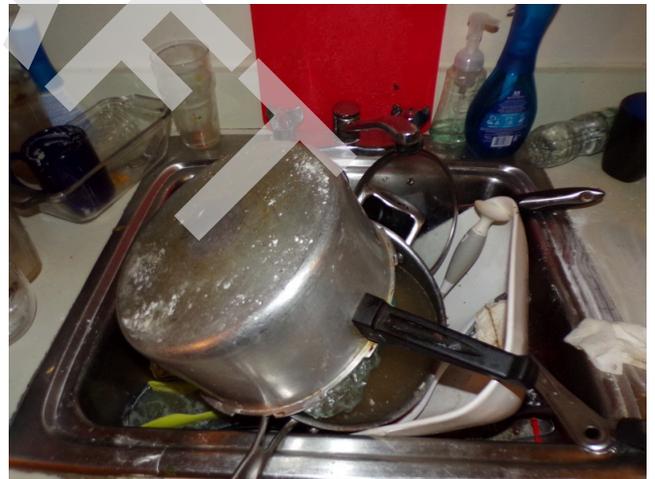
36. Building 4 - unit 412 - 3-bed/1.5-bath - UFAS - kitchen sink hardware missing lever handles (Critical Repair)

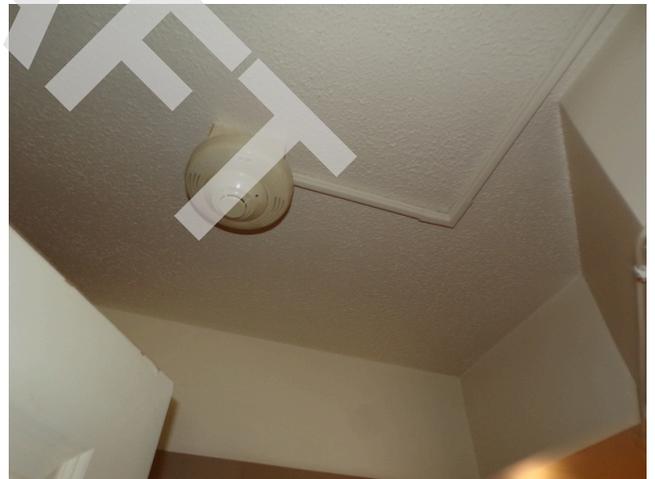
59. Building 4 - unit 418 - 3-bed/1.5-bath - TH - bedroom ceiling damage (Non-Critical Repair)

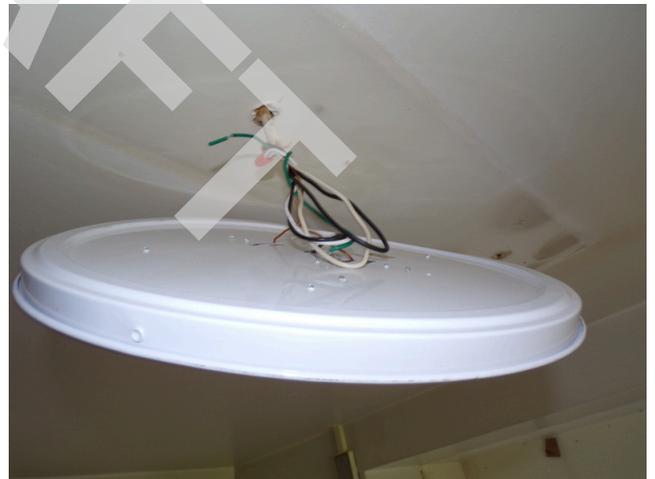
91. Building 4 - unit 451 - 2-bed/1-bath - missing light (Non-Critical Repair)

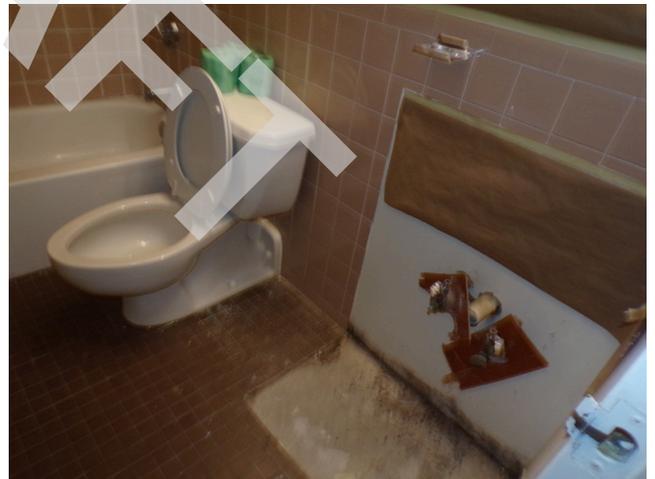
96. Building 4 - unit 444 - 2-bed/1-bath - bathroom missing vanity (Non-Critical Repair)

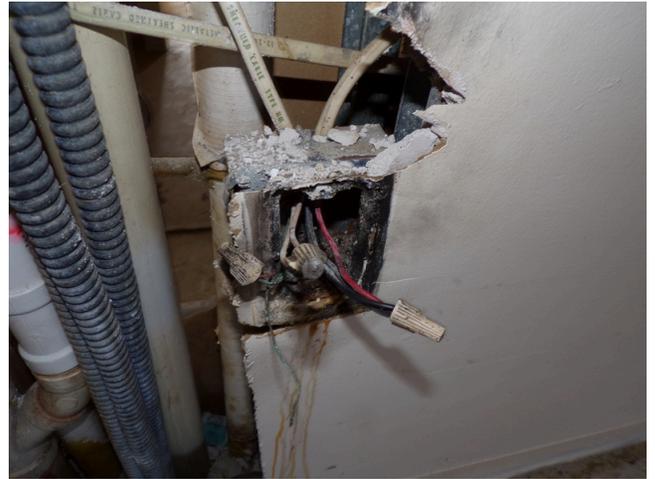
97. Building 4 - unit 444 - 2-bed/1-bath - hole in wall (Non-Critical Repair)

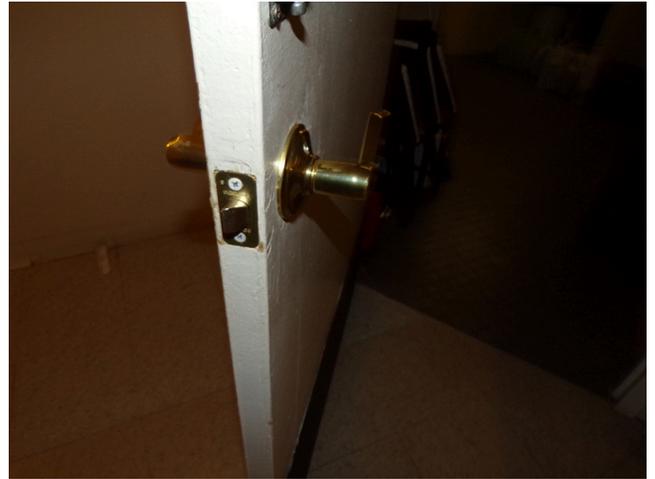
125. Building 4 - unit 415 - 3-bed/2-bath - TH - UFAS - bathroom peeling paint (Non-Critical Repair)

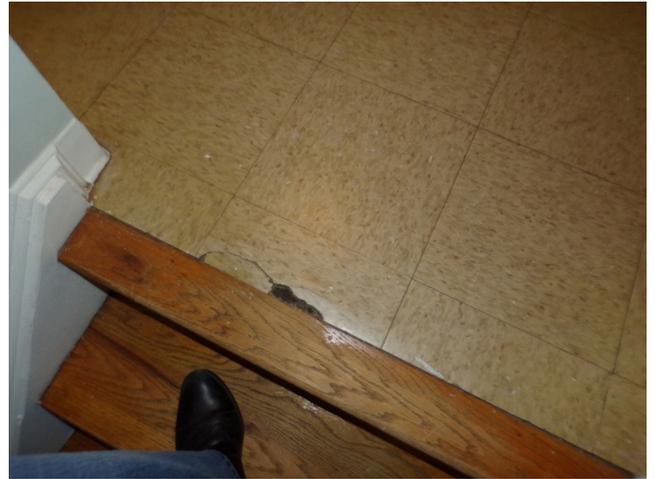
166. Building 4 - unit 416 - 3-bed/1.5-bath - TH - vinyl tile damage by stairs (Non-Critical Repair)

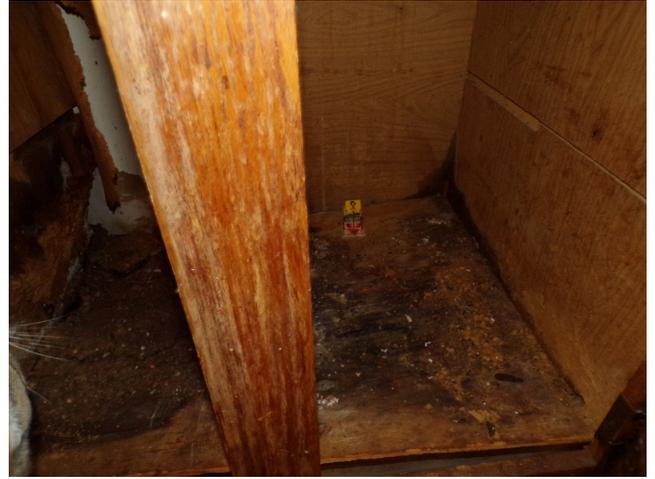
177. Building 5 - unit 533 - 1-bed/1-bath - kitchen cabinets replacement (Non-Critical Repair)

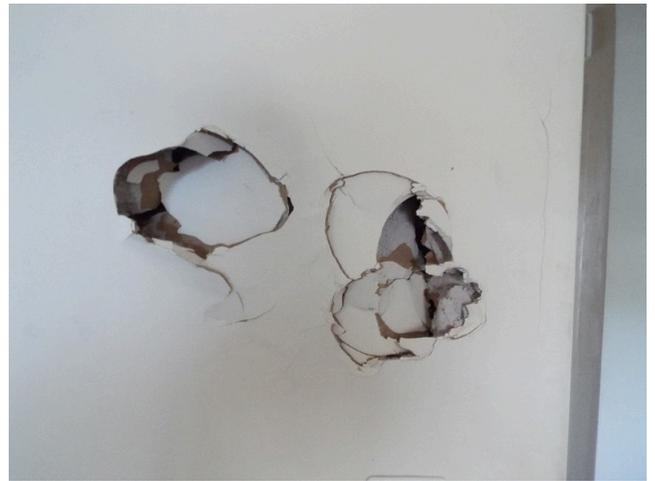
257. Building 11 - unit 1110 - 2-bed/1-bath - TH - kitchen wall damage (Non-Critical Repair)

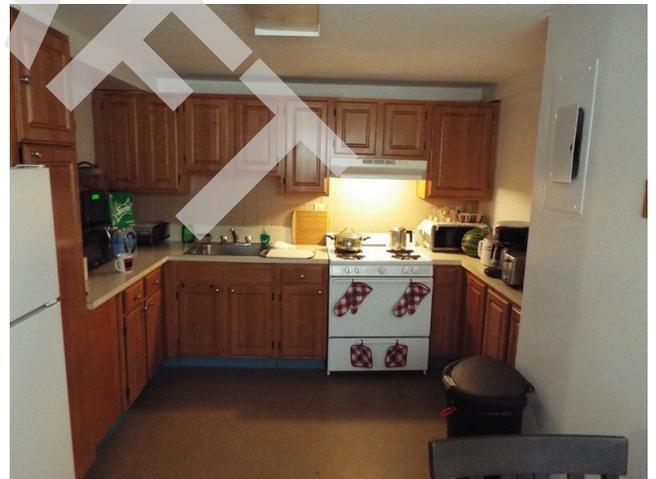
271. Building 12 - unit 1220 - 4-bed/2-bath - TH - kitchen missing GFCI (Critical Repair)

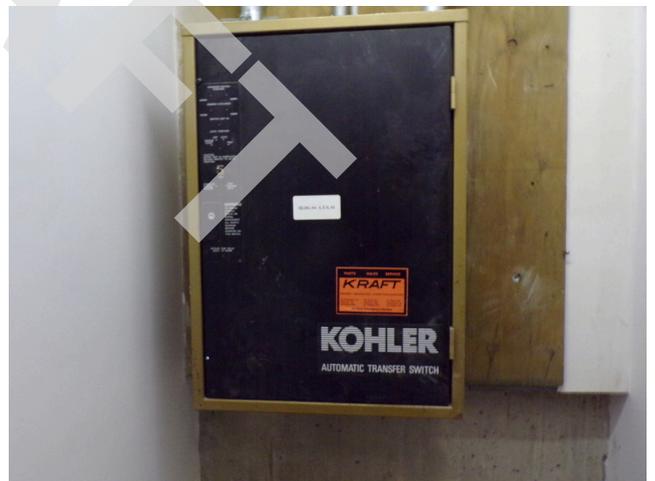
143. Building 4 - fire pump emergency generator not operational (Critical Repair)

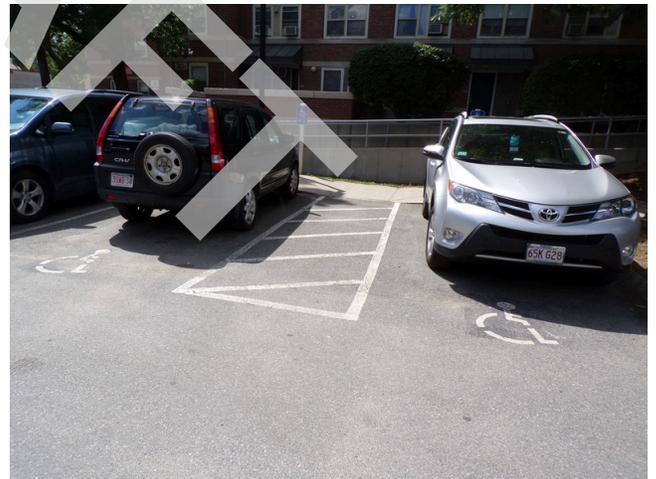
287. Building 7 - parking lot (Non-Critical Repair)

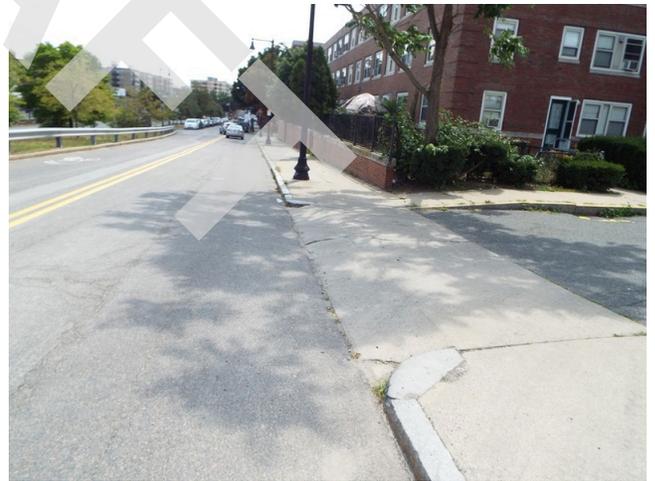
435. Building 11 - fence damage (Non-Critical Repair)

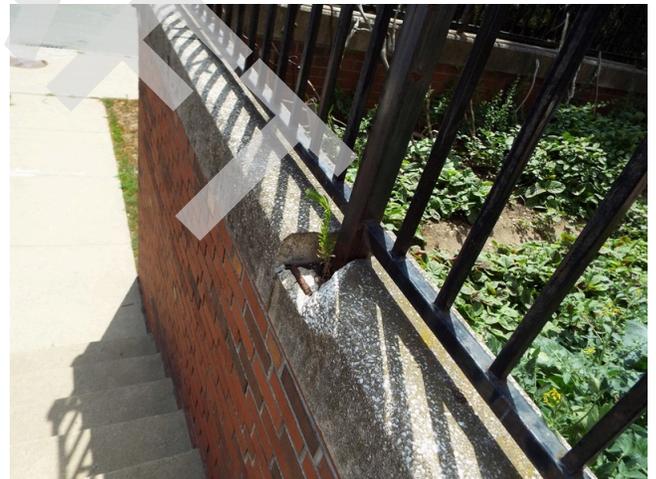
439. Building 11 - fence damage (Non-Critical Repair)
