HUD CAPITAL NEEDS ASSESSMENT

ML King
280 Martin Luther King Boulevard
Boston, Massachusetts 02119

AEI Project No. 463348
Site Inspection Date: June 28, 2022

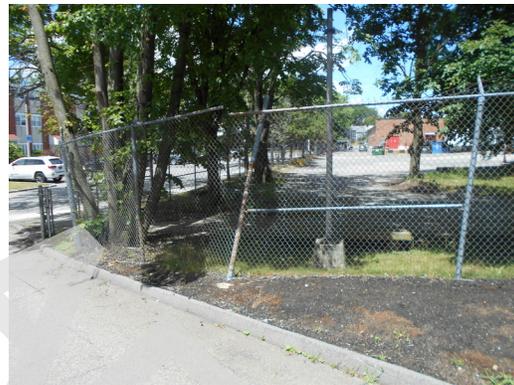
Chain link fencing, damaged (Non-Critical Repair)

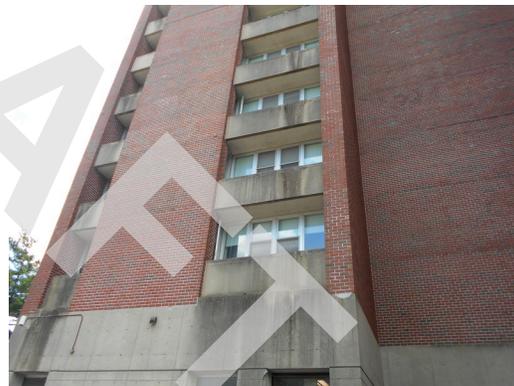
Rear façade, dirt buildup (Non-Critical Repair)

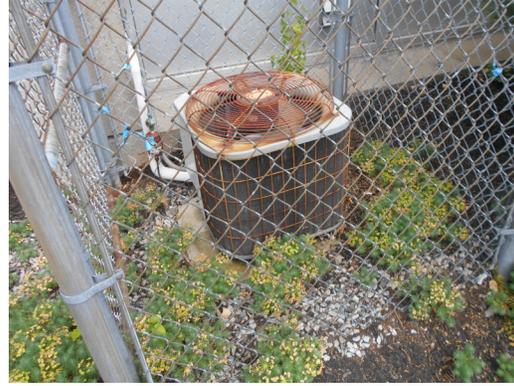
A/C unit, deteriorated (Non-Critical Repair)

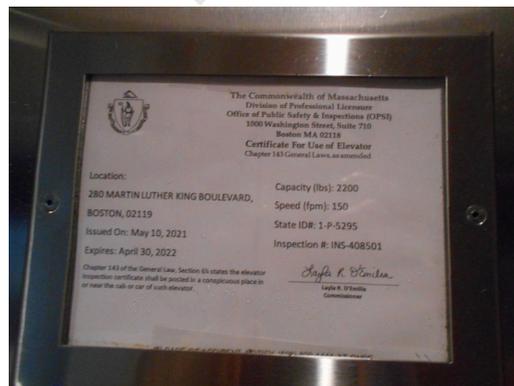
Building elevator 2 inspection, expired 4/30/2022 (Critical Repair)

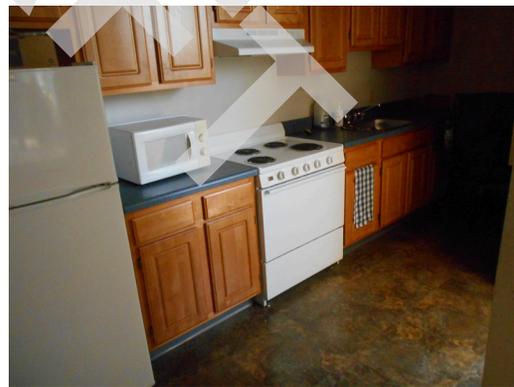
Community room kitchen, no roll under sink
(Critical Repair)

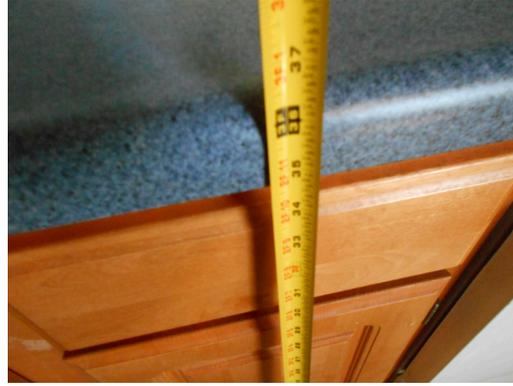
Community room kitchen cabinets, 36" AFF
(Critical Repair)

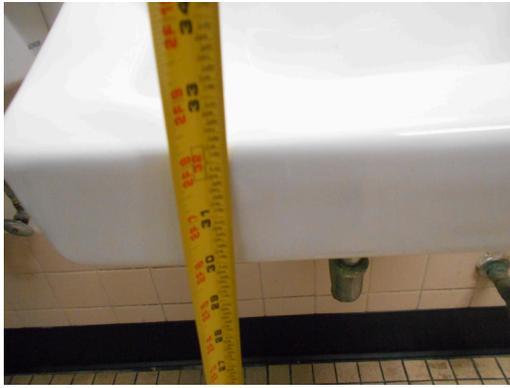
Men's public restroom, sink height, 34"

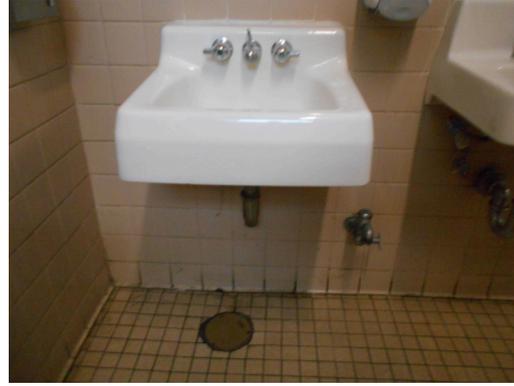
Women's public restroom, sink, no scald abrasion protection (Critical Repair)

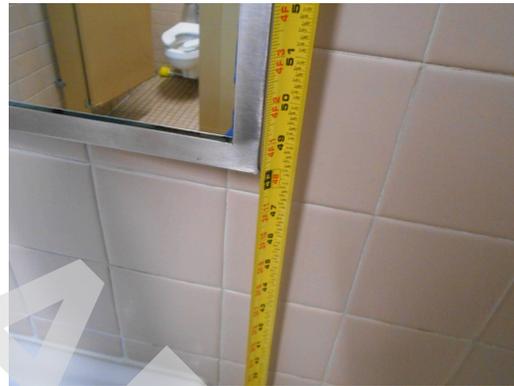
Women's public restroom, mirror height 48" AFF (Critical Repair)

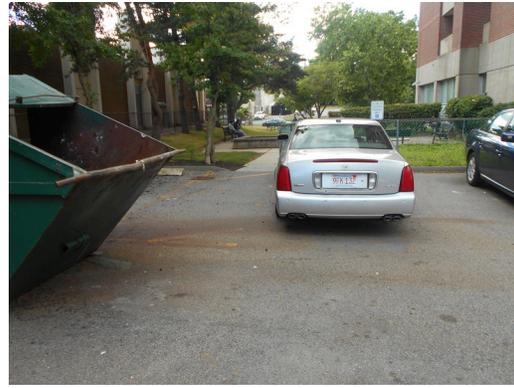
Handicap parking space, faded lines
(Non-Critical Repair)

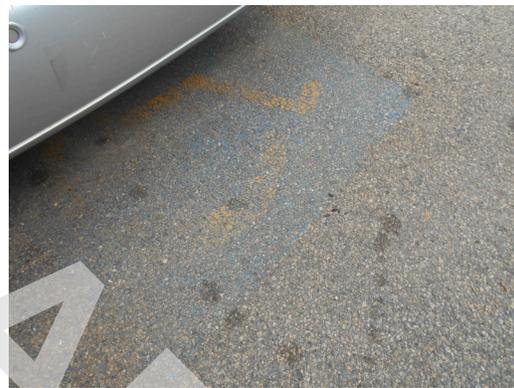
Handicap parking space, faded lines
(Non-Critical Repair)

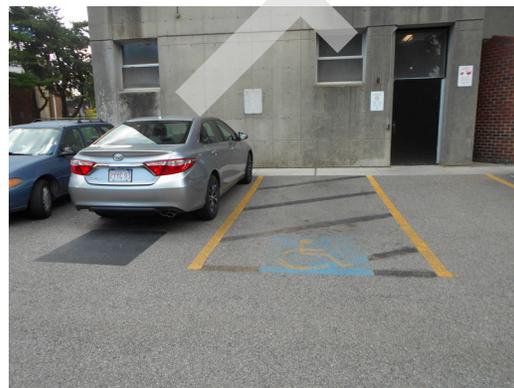
Handicap parking space marking in access
aisle by removed handicap parking space
(Critical Repair)

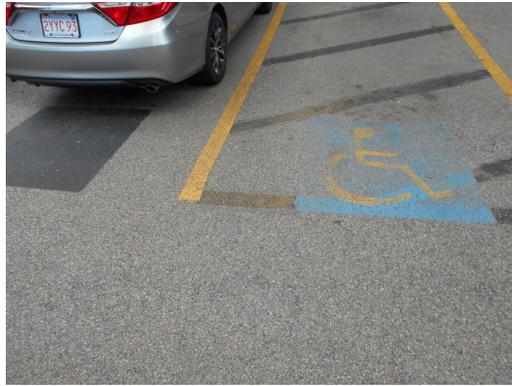
Handicap parking space marking in access aisle by removed handicap parking space (Critical Repair)

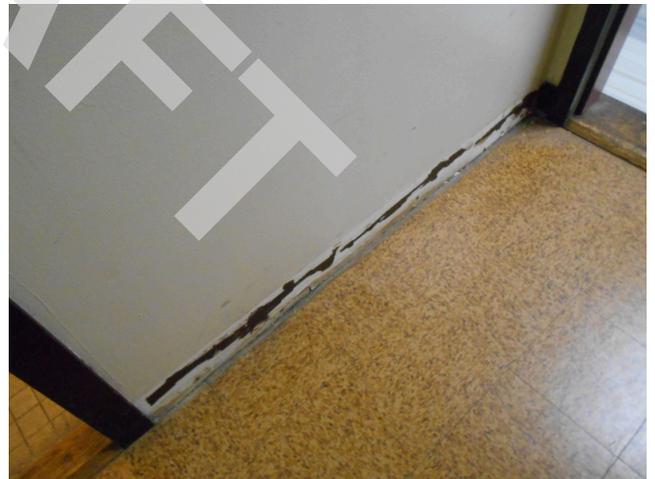
4. 0br/1ba, Unit 7 - Hallway, damaged wall (Non-Critical Repair)

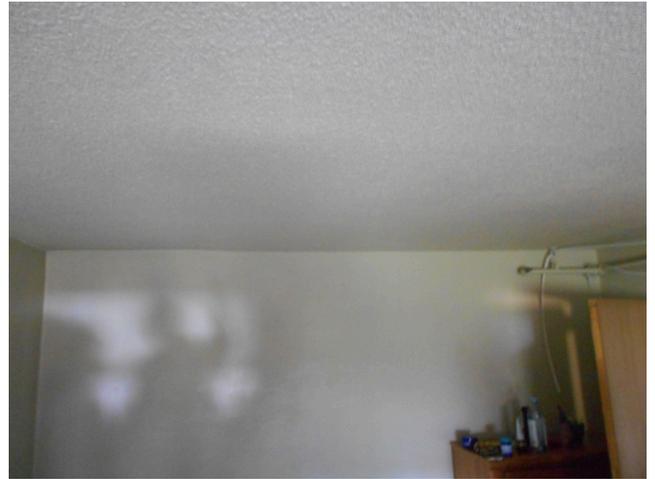
26. 1br/1ba, Unit 25 - Bedroom ceiling, no smoke detector (Critical Repair)

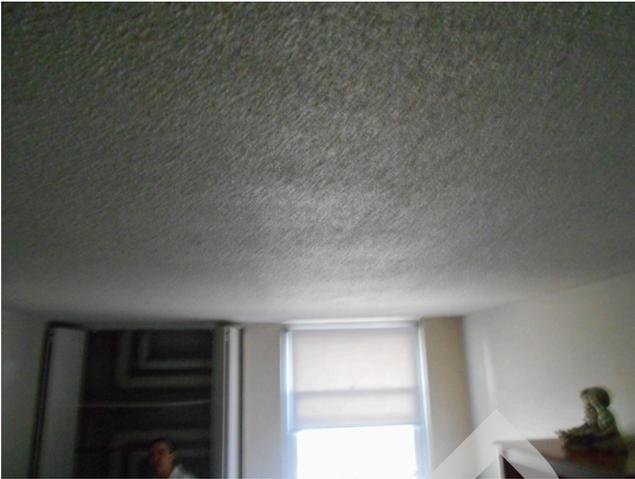
29. 1br/1ba, Unit 25 - Bedroom ceiling, no smoke detector (Critical Repair)

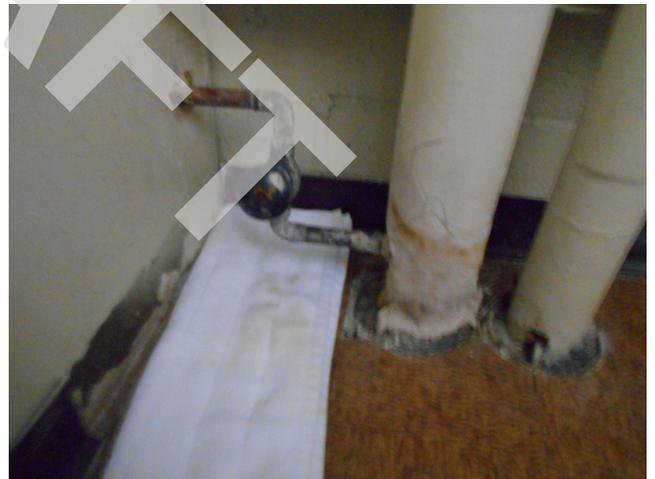
32. 1br/1ba, Unit 25 - Bedroom pipes, occasional leaking (Non-Critical Repair)

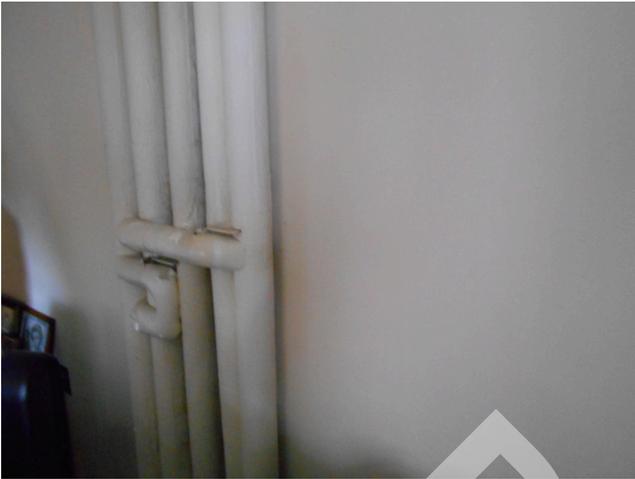
33. 1br/1ba, Unit 25 - Bedroom pipes, occasional leaking (Non-Critical Repair)

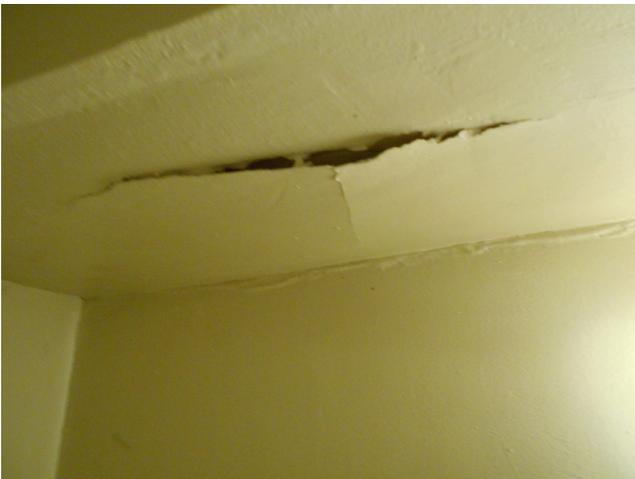
47. 1br/1ba, Unit 28 - Bathroom, damaged ceiling
(Non-Critical Repair)

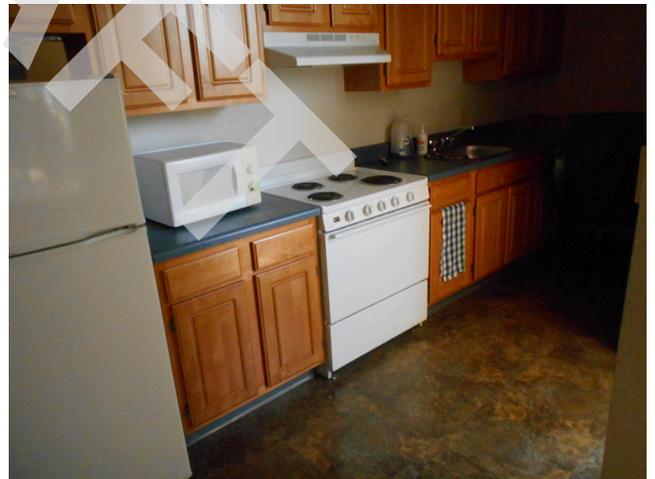
20. Community room kitchen, no roll under sink
(Critical Repair)

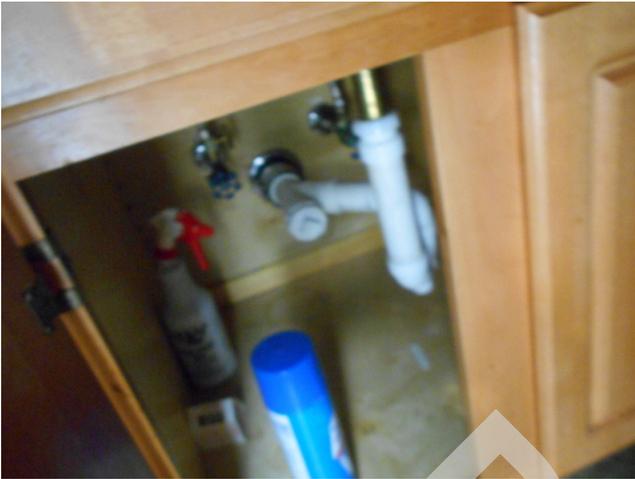
21. Community room kitchen, no roll under sink
(Critical Repair)

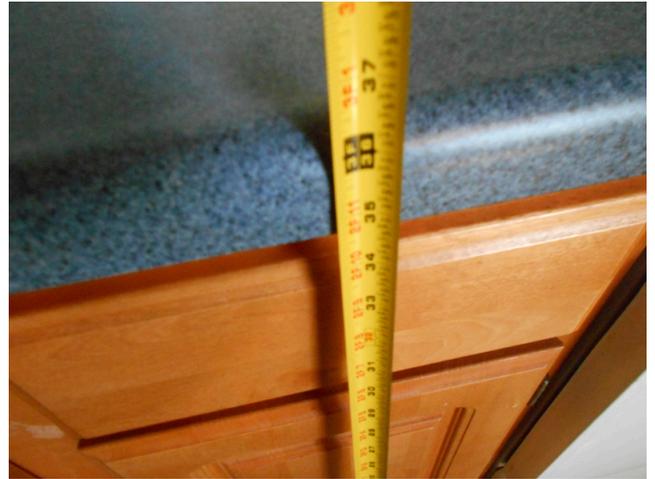
22. Community room kitchen cabinets, 36" AFF
(Critical Repair)

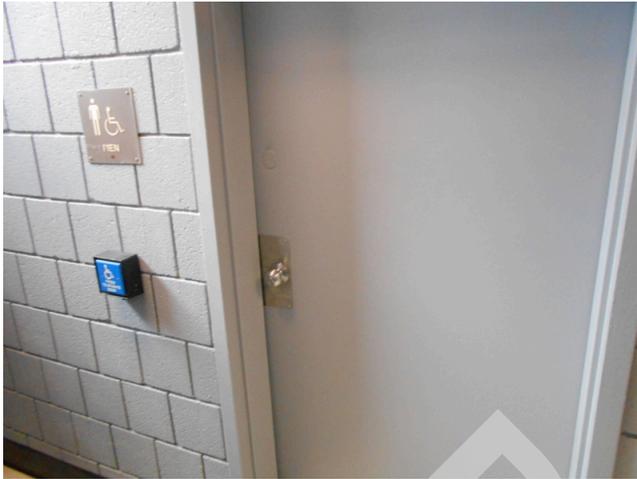
57. Public restrooms, knob hardware (Critical Repair)

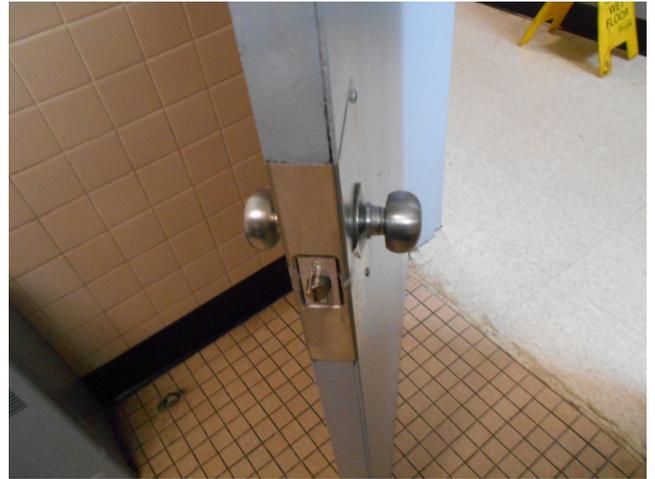
58. Public restrooms, knob hardware (Critical Repair)

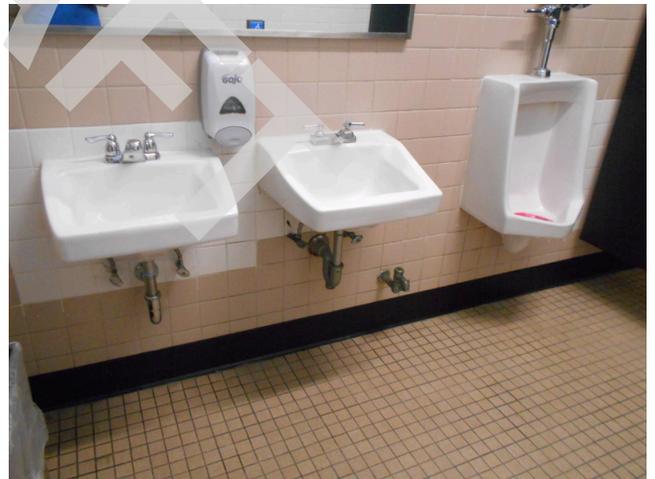
60. Men's public restroom, no scald abrasion protection at sinks (Critical Repair)

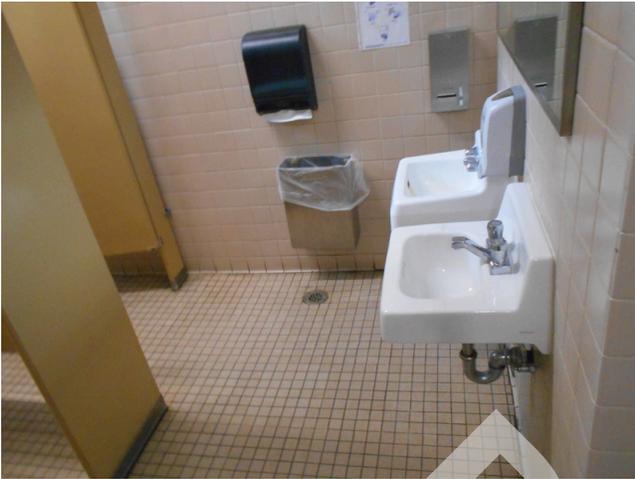
73. Women's public restroom, sink, no scald abrasion protection (Critical Repair)

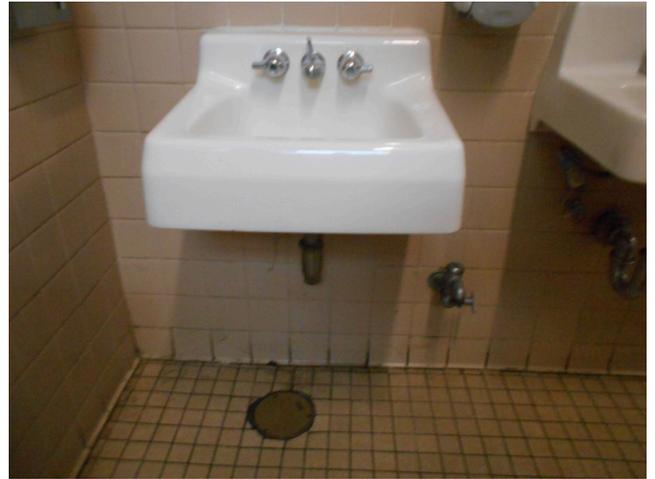
74. Women's public restroom, sink, no scald abrasion protection (Critical Repair)

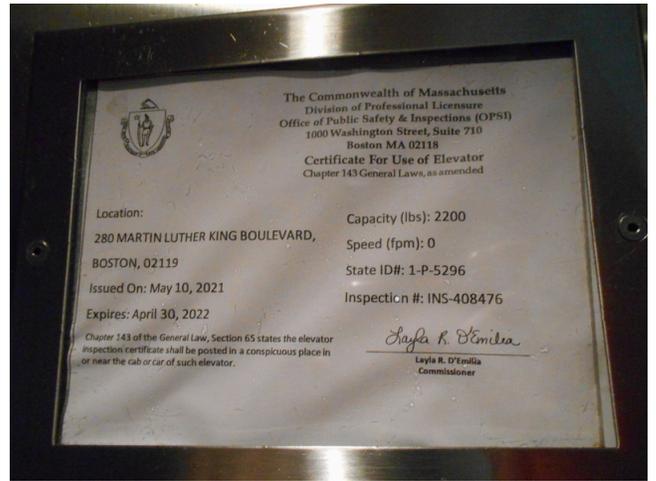
90. Building elevator 1 inspection, expired 4/30/2022 (Critical Repair)

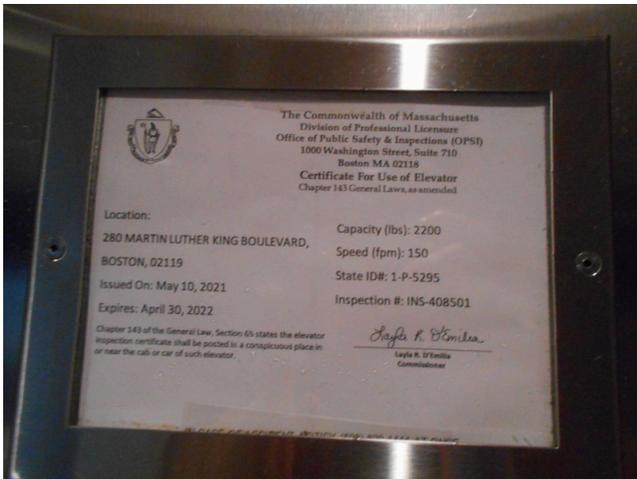
91. Building elevator 2 inspection, expired 4/30/2022 (Critical Repair)

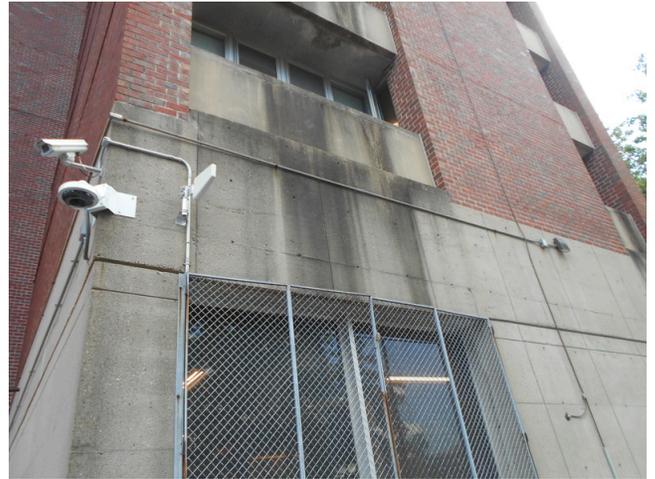
130. Rear façade, dirt buildup (Non-Critical Repair)

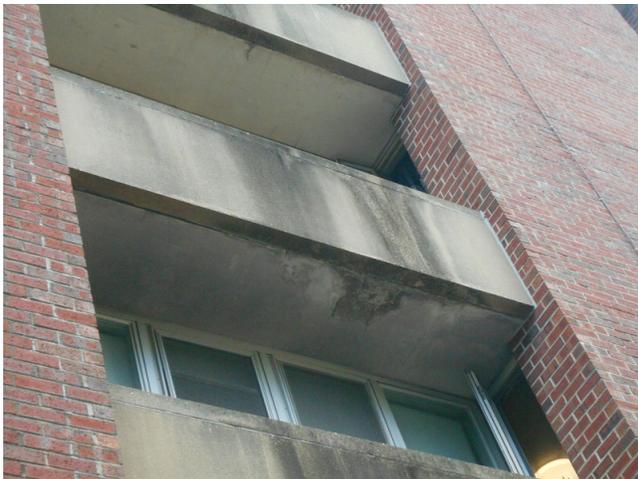
131. Rear façade, dirt buildup (Non-Critical Repair)

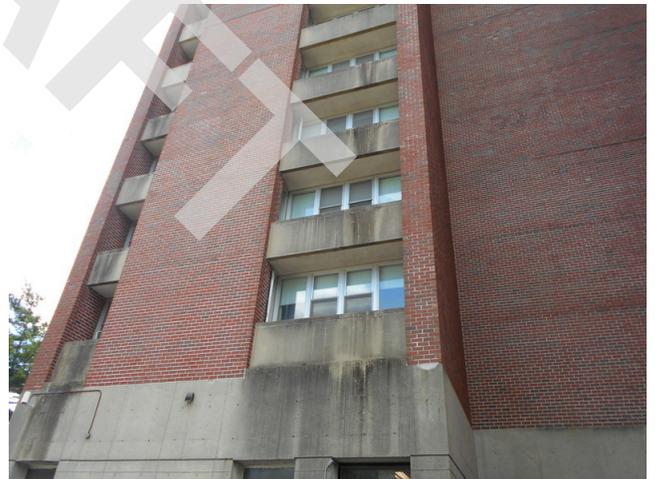
132. Rear façade, dirt buildup (Non-Critical Repair)

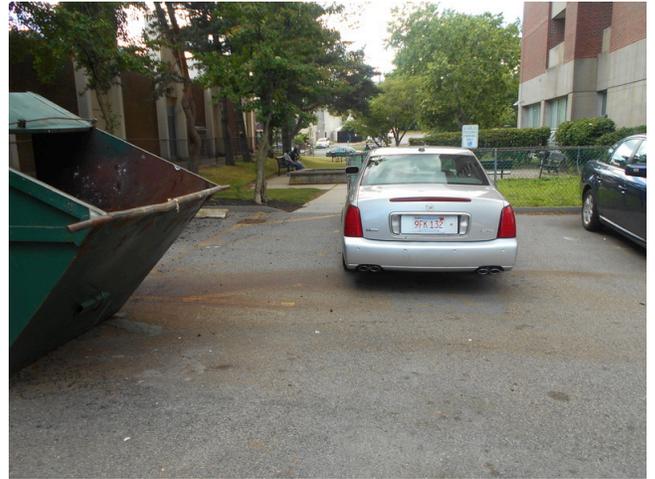
134. Handicap parking space, faded lines (Non-Critical Repair)

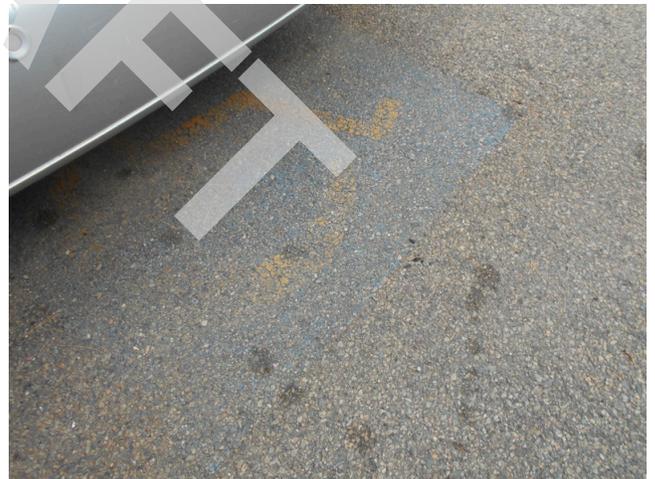
136. Handicap parking space, faded lines (Non-Critical Repair)

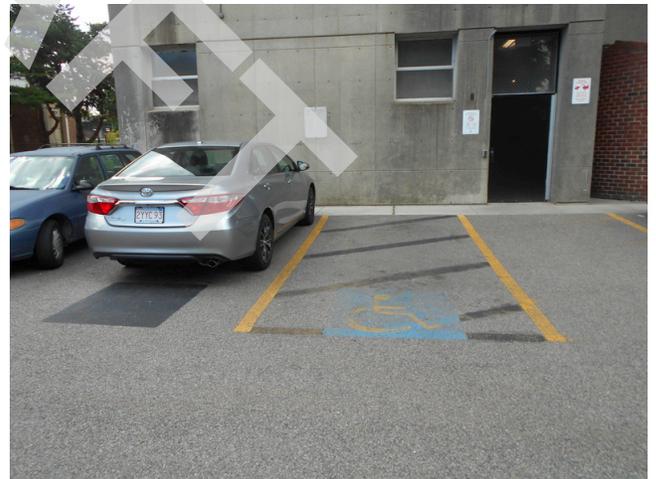
140. Handicap parking space marking in access aisle by removed handicap parking space (Critical Repair)

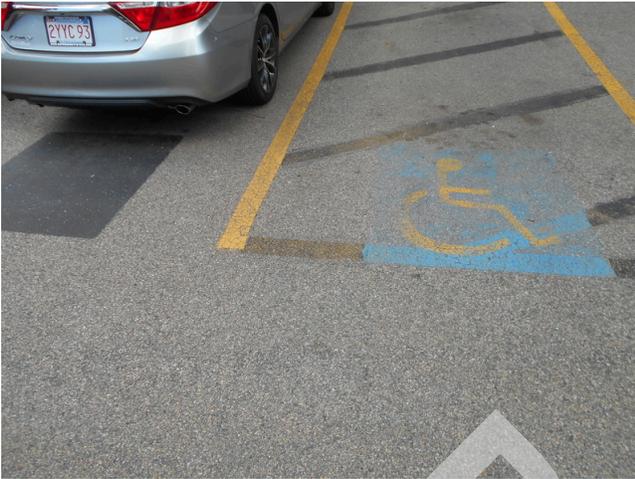
141. Handicap parking space marking in access aisle by removed handicap parking space (Critical Repair)

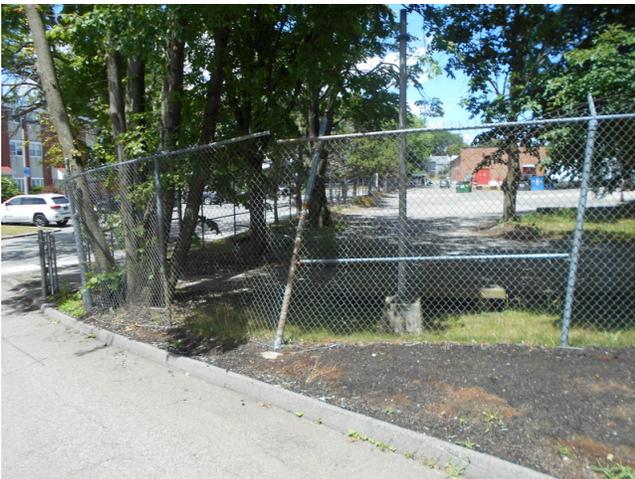
143. Chain link fencing, damaged (Non-Critical Repair)

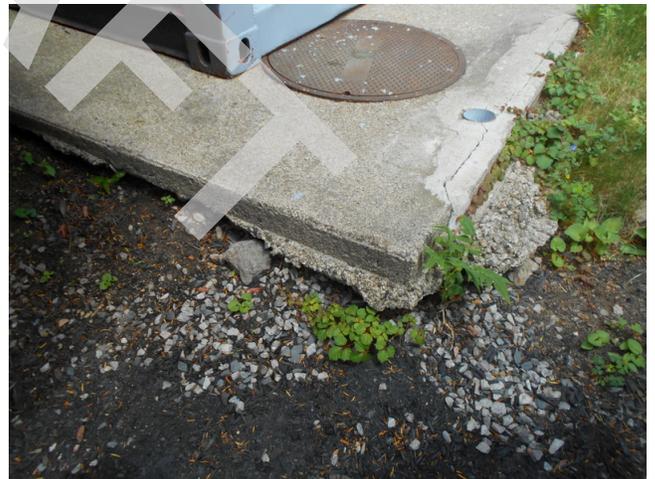
144. Concrete sidewalk along western side of building, erosion under sidewalk (Non-Critical Repair)

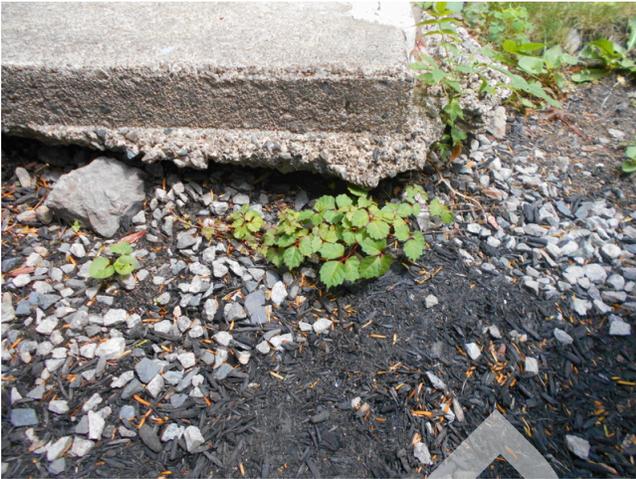
145. Concrete sidewalk along western side of building, erosion under sidewalk (Non-Critical Repair)
