HUD RAD CAPITAL NEEDS ASSESSMENT

Property Identification: Joseph Malone Apartments 11 Gordon Avenue Hyde Park, Massachusetts 02136

AEI Project No. 463343 Site Inspection Date: June 27, 2022 Prepared For: Boston Housing Authority 52 Chauncy Street Boston, Massachusetts 02111

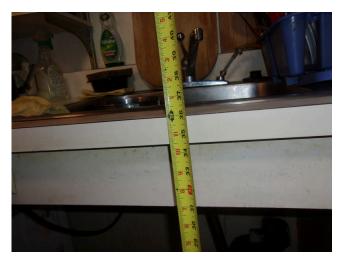
2. Unit 5A 1 Bedroom / 1 Bathroom H/C Kitchen Sink Measurement From Finished Floor, too high (Critical Repair)

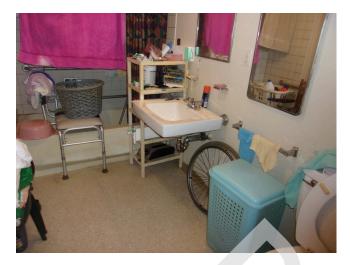
5. Unit 5A 1 Bedroom / 1 Bathroom H/C Bathroom, missing s/a wrap (Critical Repair)

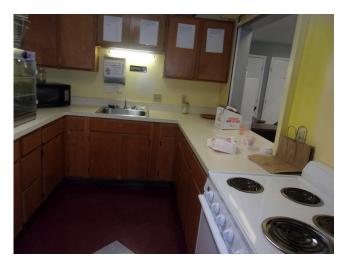
14. Community Kitchen, not UFAS compliant (Critical Repair)

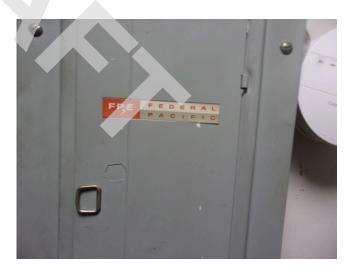
28. Federal Pacific Electrical Panel (Critical Repair)

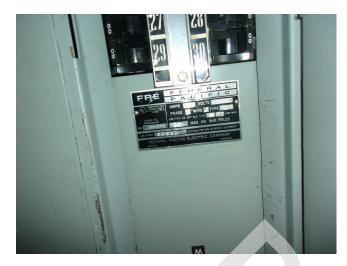
29. Federal Pacific Electrical Panel (Critical Repair)

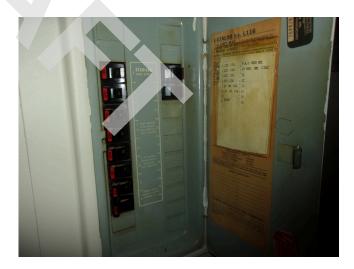
32. Federal Pacific Electrical Panel (Critical Repair)

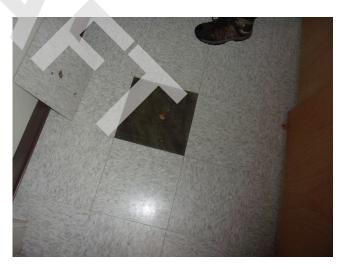
48. Dwelling Unit Old Vinyl Flooring (Non-Critical Repair)

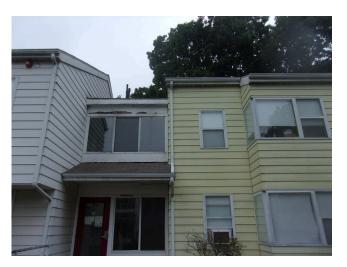
54. Damaged Fascia (Non-Critical Repair)

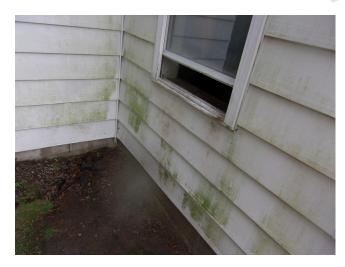
55. Mildew Siding

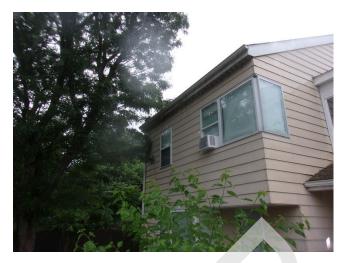
57. Tree In Contact With Building (Non-Critical Repair)

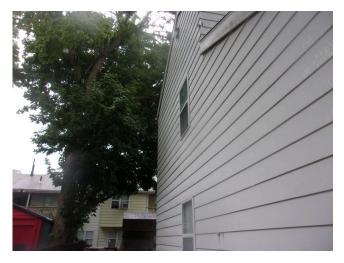
58. Tree In Contact With Building (Non-Critical Repair)

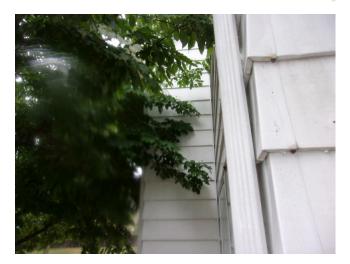
59. Tree In Contact With Building (Non-Critical Repair)

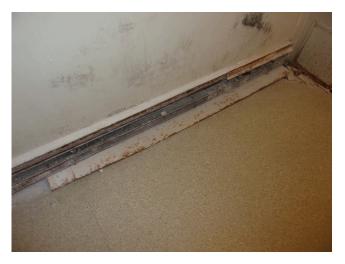
```
74. Damaged Baseboard Heater
```

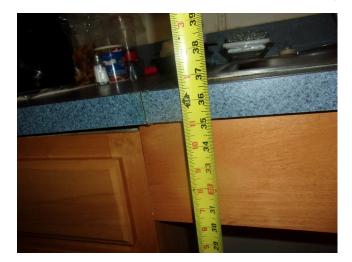
75. Kitchen Countertop Mounted Above the 34" Maximum From Finished Floor In The Designated Handicapped Unit

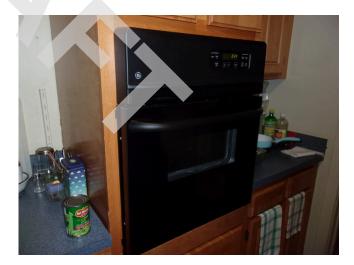
76. Handicapped Accessible Unit; Stove Controls Out Of Reach Range

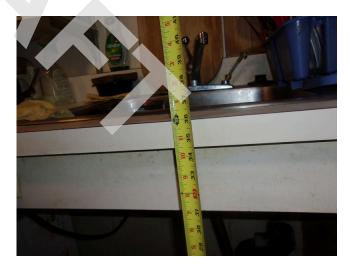
80. Kitchen Countertop Mounted Above the 34" Maximum From Finished Floor In The Designated Handicapped Unit
