HUD CAPITAL NEEDS ASSESSMENT

Peabody
1875 Dorchester Avenue
Dorchester, Massachusetts 02124

AEI Project No. 463342
Site Inspection Date: July 26, 2022

Boston Housing Authority
52 Chauncy Street
Boston, Massachusetts 02111

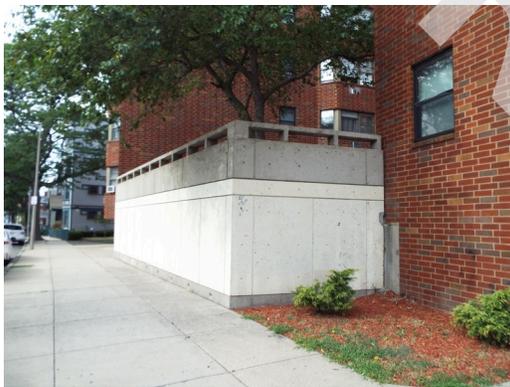
Retaining wall

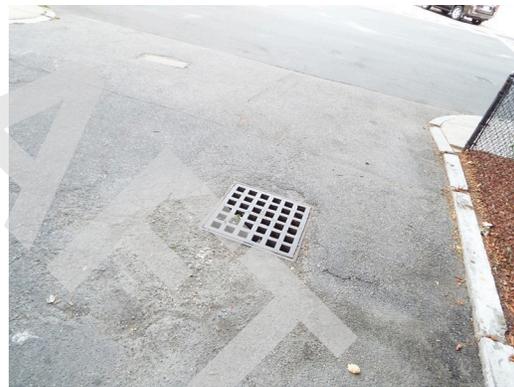
Surface drain

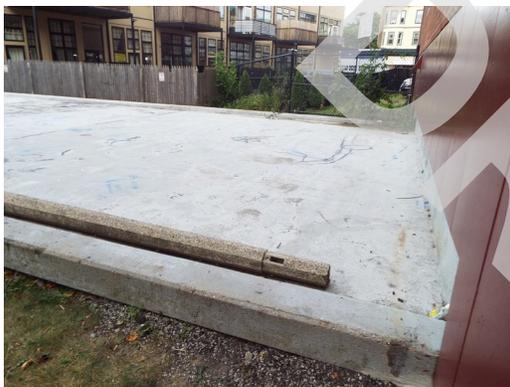
Public transit subway enclosure

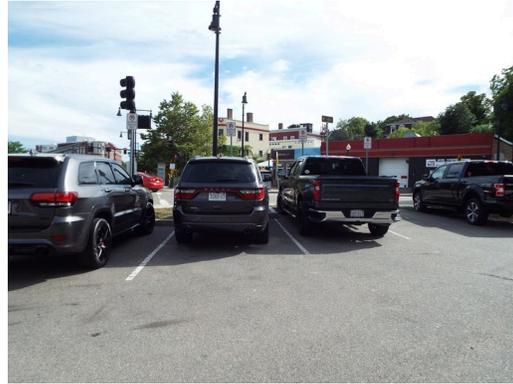
Pavement and striping condition

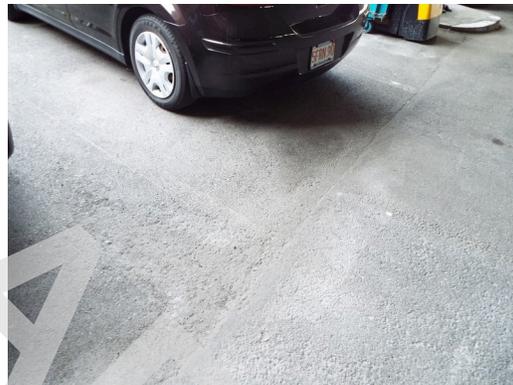
Parking garage pavement condition

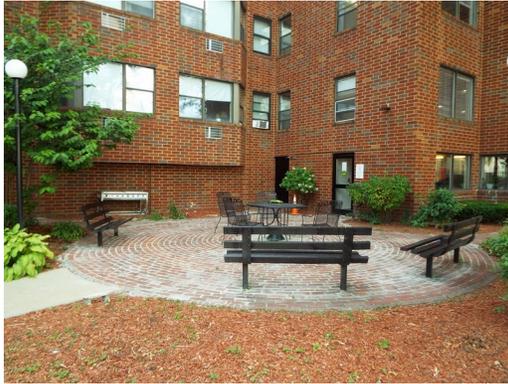
Brick pavers

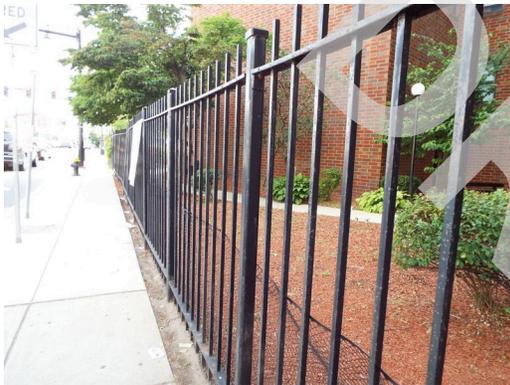
Metal fencing

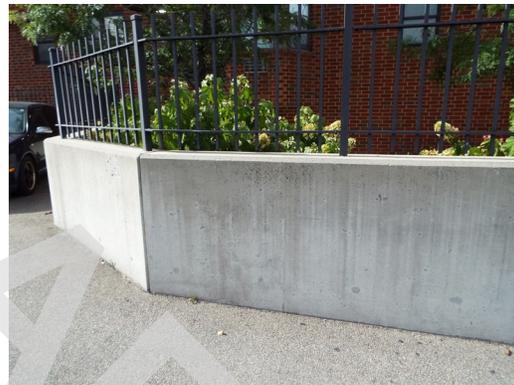
Site wall

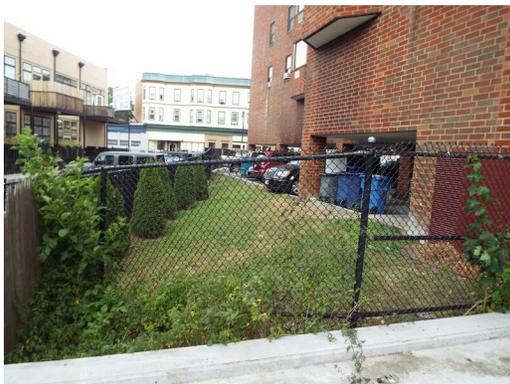
Chain link fencing

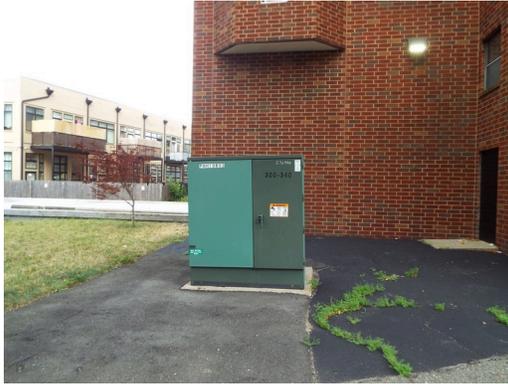
Transformer

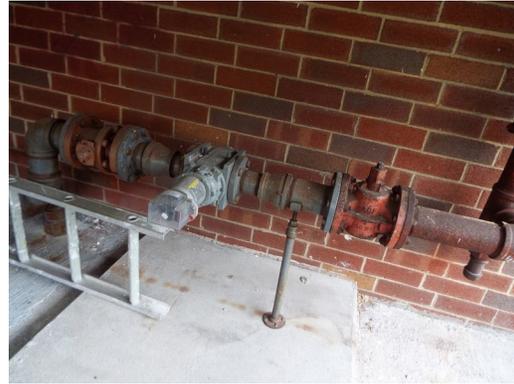
Gas meter

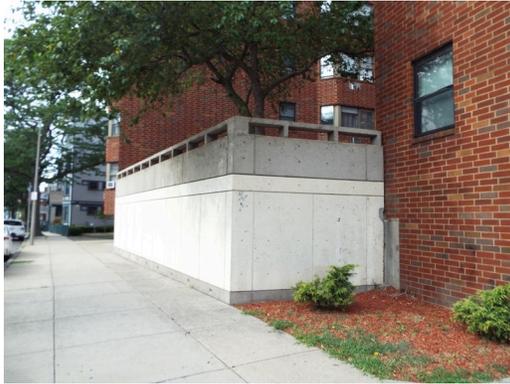
Retaining wall

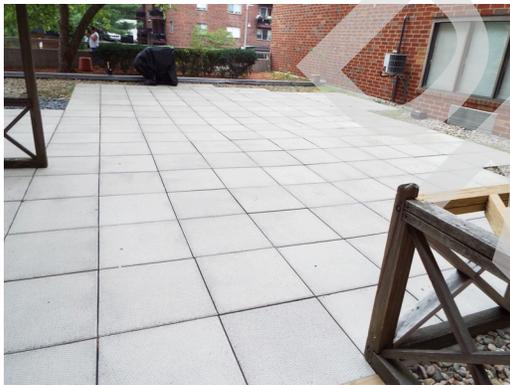
Raised terrace

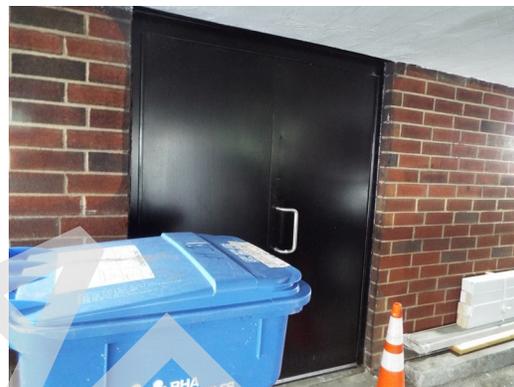
Service doors

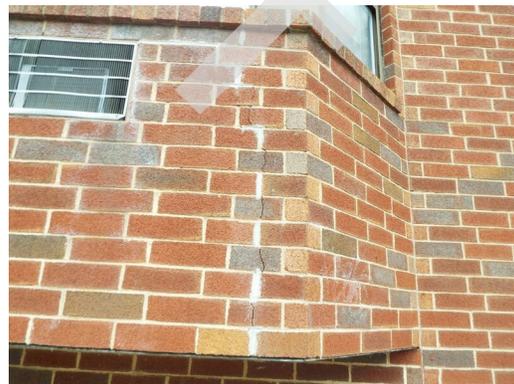
Minor vertical joint cracking was observed at a window bay located on Talbot Avenue. Repair is required. (Non-Critical Repair)

Masonry crack (Non-Critical Repair)

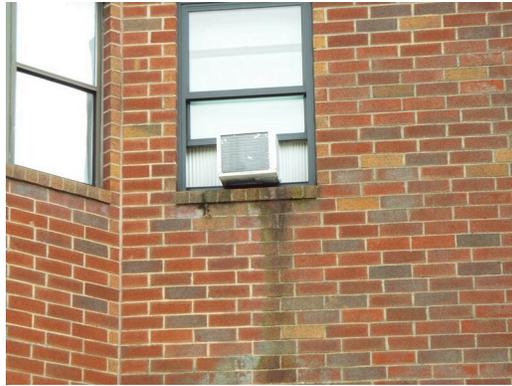
Staining was observed on the building exterior, primarily due to condensate and deterioration at thru wall and window air conditioners. Pressure washing is recommended. (Non-Critical Repair)

Masonry staining (Non-Critical repair)

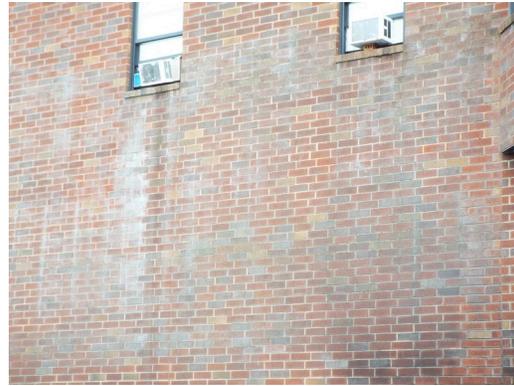
Masonry staining (Non-Critical repair)

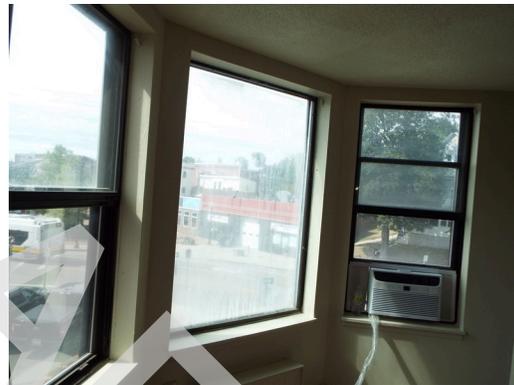
Condensation was observed at several windows scattered throughout the building. The condensation occurs due to failure of the insulating glazing perimeter seal. According to the site contact, approximately 10% of the windows are currently affected. Replacement of insulating glass at affected units is recommended. (Non-Critical Repair)

Window condensation - 1-bed-1-bath - unit 221 (Non-Critical Repair)

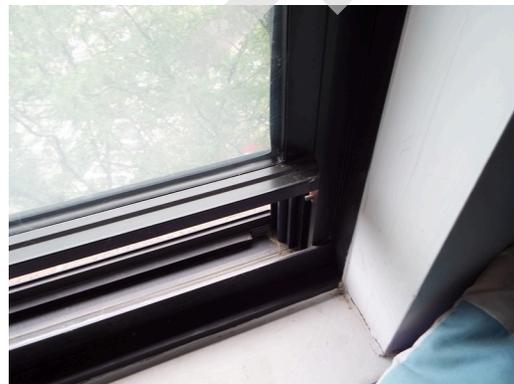
Residents reported difficulty with window opening operation at units 205, 422, 514 and generally throughout the building. This appears to be due to failure of sash counterbalances. An allowance for repair is recommended. (Non-Critical Repair)

Window operation condition - 1-bed-1-bath - unit 514 (Non-Critical Repair)

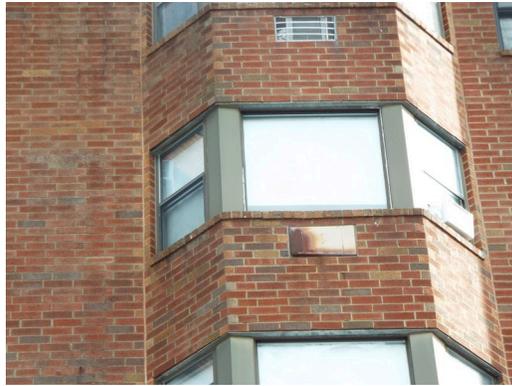
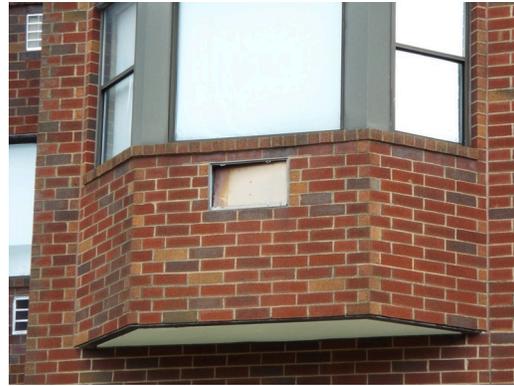
Gaps and deterioration were observed at thru-wall air conditioner opening panels, scattered throughout the exterior elevations. Panel replacement and gap sealing is recommended. (Non-Critical Repair)

Thru wall panel condition (Non-Critical Repair) Thru wall panel condition (Non-Critical Repair)

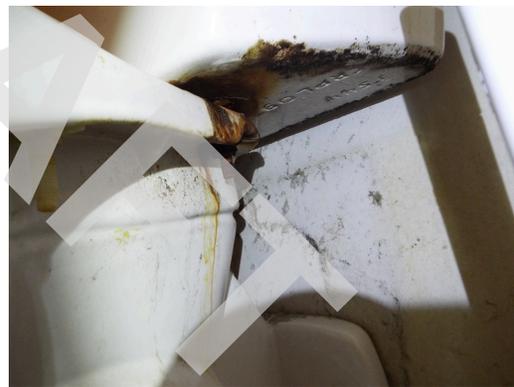
A leaking toilet was reported at unit 504. Repair is required. However, the work can be performed as a part of the property routine maintenance program. No costs are included in the Tables.

Toilet leak reported - 1-bed-1-bath - unit 504

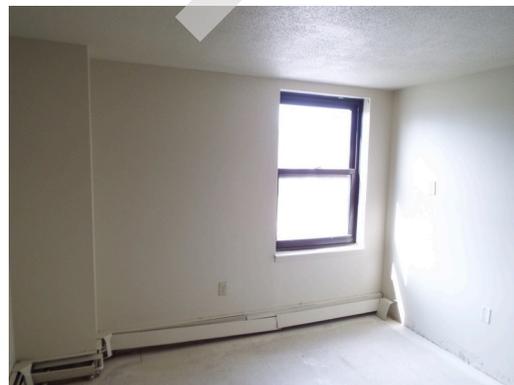
AEI observed damaged and loose baseboard heaters covers scattered throughout the property. An allowance for replacement is recommended. (Non-Critical Repair)

Baseboard heater cover condition -
1-bed-1-bath - unit 221 (Non-Critical Repair)

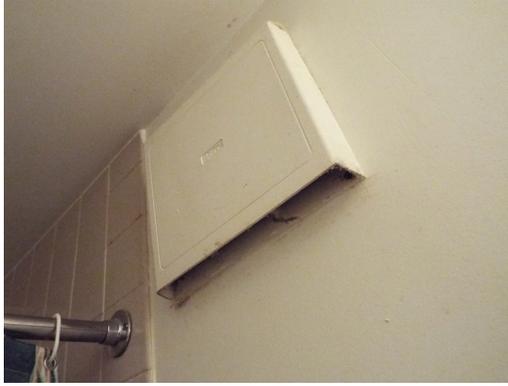
Non-functional and noisy bathroom fans were reported at units 205 and 514. Repairs are recommended. (Non-Critical Repair)

Bathroom fan condition - 1-bed-1-bath - unit 514 (Non-Critical Repair)

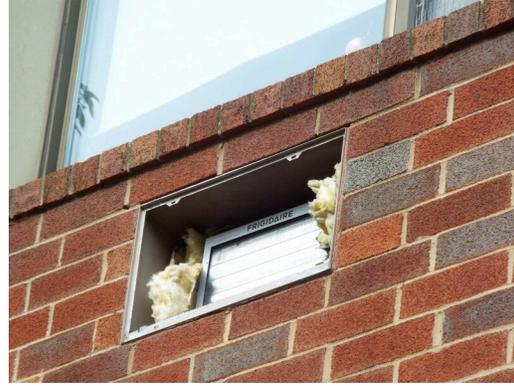
AEI observed gaps at a thru-wall air conditioner located on the Talbot Avenue elevation. Repair is required. (Non-Critical Repair)

Thru wall HVAC unit installation (Non-Critical Repair)

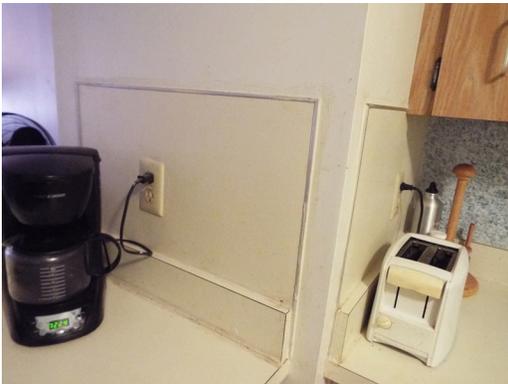
1-bed-1-bath - unit 514 - kitchen lacks GFCI receptacle (Critical Repair)

The kitchen located at unit 514 lacks a GFCI receptacles. Installation of a GFCI receptacle is required. (Critical Repair)

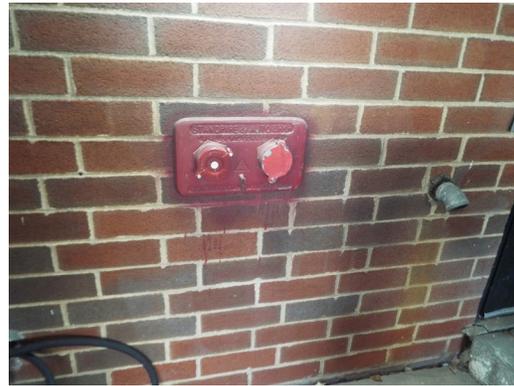
Fire alarm control panel

According to the fire alarm inspection report, dated 3/9/2022, smoke detector deficiencies exist, including lack of access to devices in units 89, 105, 432, 433, 464, and 465. A heat detector in unit 37 was painted. Corrective action is required. (Critical Repair)

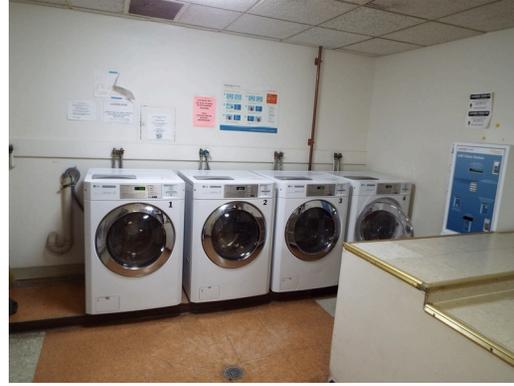
Common area - kitchen, not UFAS compliant
(Critical Repair)

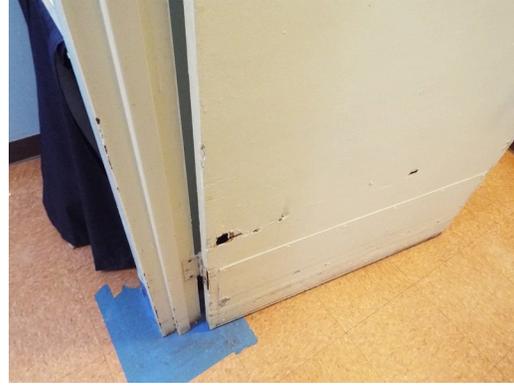
Wall base condition - 1-bed-1-bath - unit 205
(Non-Critical Repair)

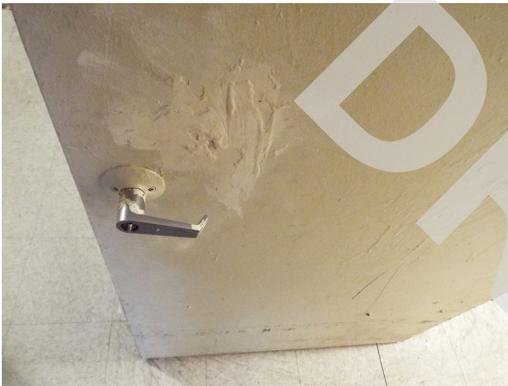
Door condition - 1-bed-1-bath - UFAS - unit
211 (Non-Critical Repair)

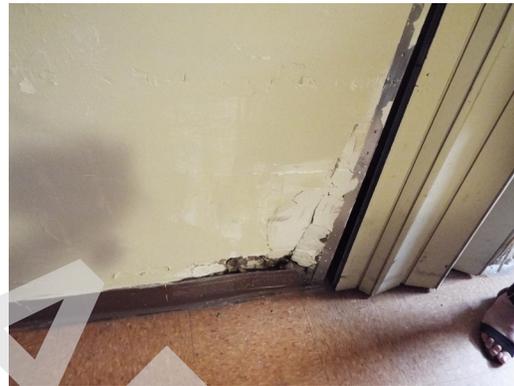
Door condition - 1-bed-1-bath - UFAS - unit
213 (Non-Critical Repair)

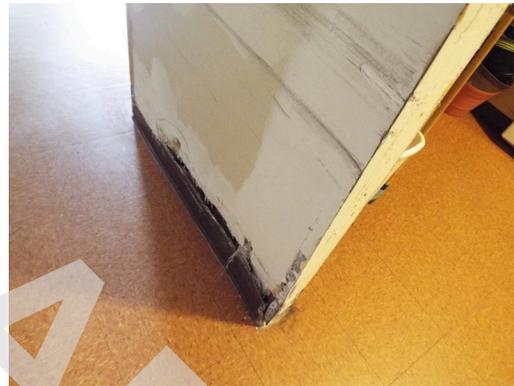
Wall base condition - 1-bed-1-bath - UFAS -
unit 513 (Non-Critical Repair)

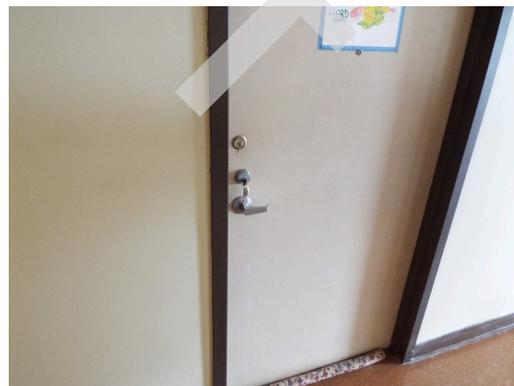
Entry door closer condition - 1-bed-1-bath -
unit 514 (Non-Critical Repair)

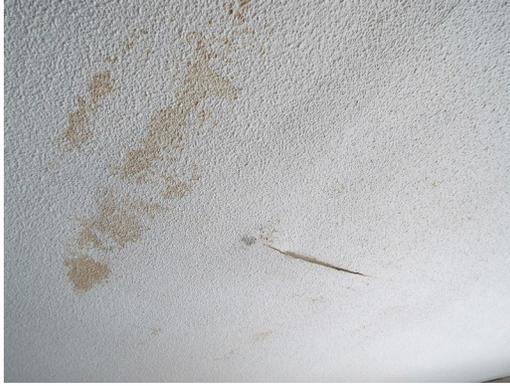
Ceiling condition - 1-bed-1-bath - unit 606
(Non-Critical Repair)

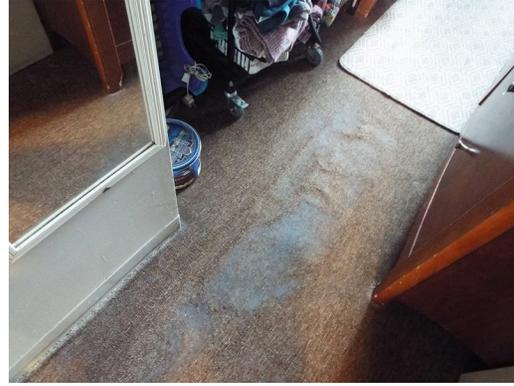
Flooring condition - 1-bed-1-bath - unit 606
(Non-Critical repair)

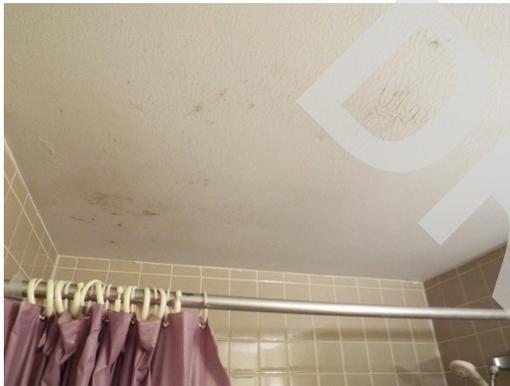
Bathroom ceiling condition - 2-bed-1-bath -
unit 509 (Non-Critical Repair)

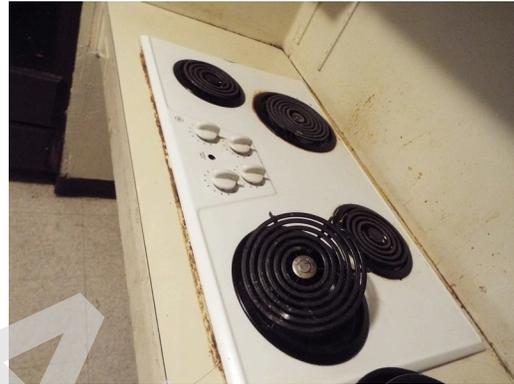
Range condition - 1-bed-1-bath - UFAS - unit 213 (Critical Repair)

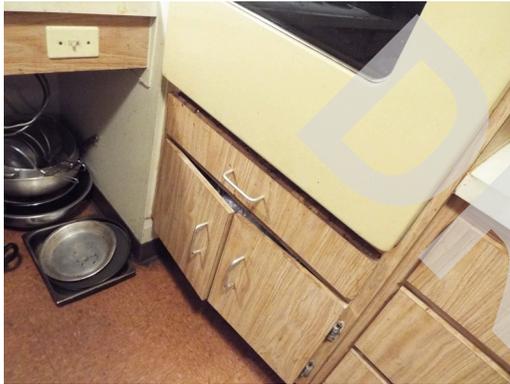
Kitchen cabinet condition - 1-bed-1-bath - UFAS - unit 311 (Non-Critical Repair)

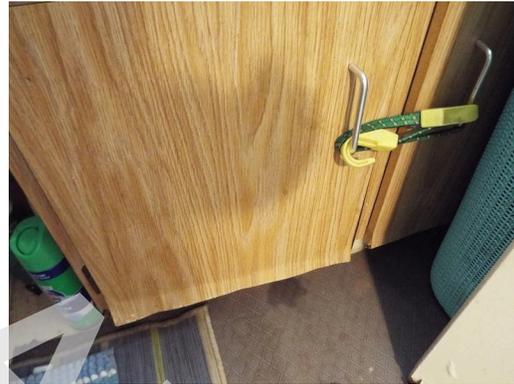
Vanity cabinet condition - 1-bed-1-bath - unit 606 (Non-Critical Repair)

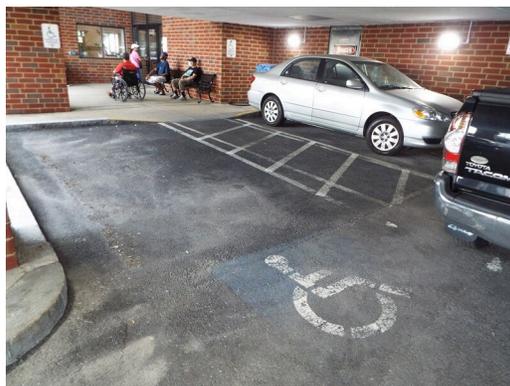
- The property lacks a designated van accessible parking space and van sign (Critical Repair).

Accessible parking lacks van space and signage (Critical Repair)

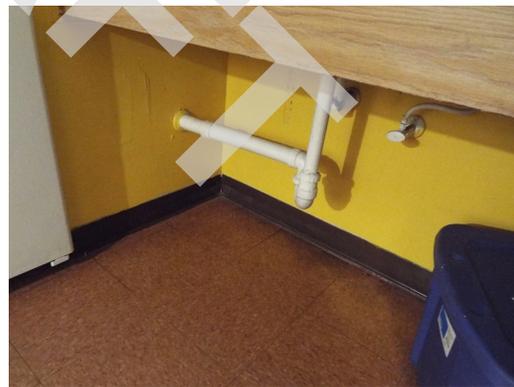
Kitchen sink lacks pipe protection - UFAS - unit 211 (Critical Repair)

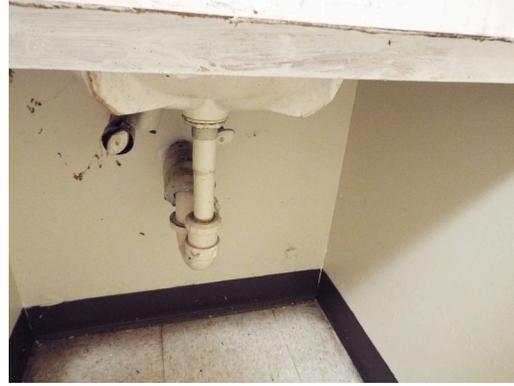
Bathroom sink lacks pipe protection - UFAS -
unit 213 (Critical Repair)

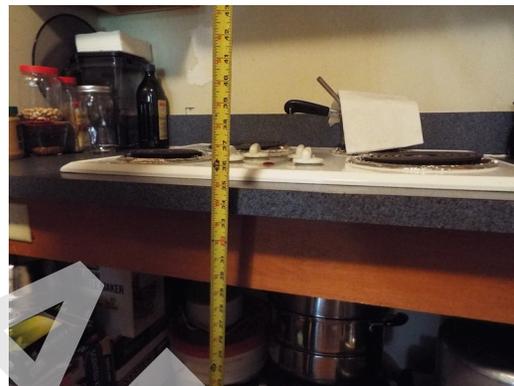
7.	Accessible Kitchens: Are the countertops and sinks lowered from 36" to approximately 34"?		✓		Kitchen countertops were observed to be 36 inch height at sinks and cooktops

Kitchen stovetop counter exceeds 34 inches -
UFAS - unit 313 (Critical Repair)

- Several of the designated handicapped dwelling unit doors lack lever hardware. Installation of lever hardware is required. (Critical Repair)
- The designated handicapped dwelling unit kitchen countertops were observed to be 36 inch height at sinks and cooktops. Countertops must be lowered to 34 inches to comply with UFAS requirements. (Critical Repair)
- The designated handicapped dwelling unit cabinet storage mounted at max 48" AFF for at least one shelf. (Critical Repair)

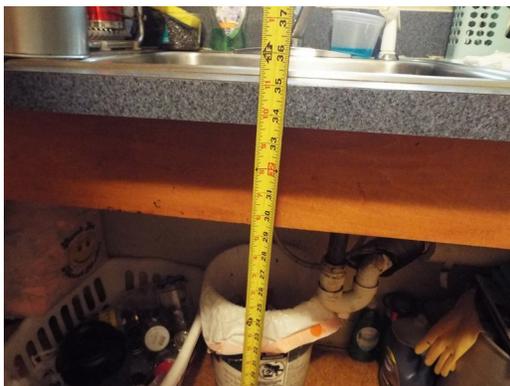
Kitchen sink counter exceeds 34 inches -
UFAS - unit 313 (Critical Repair)

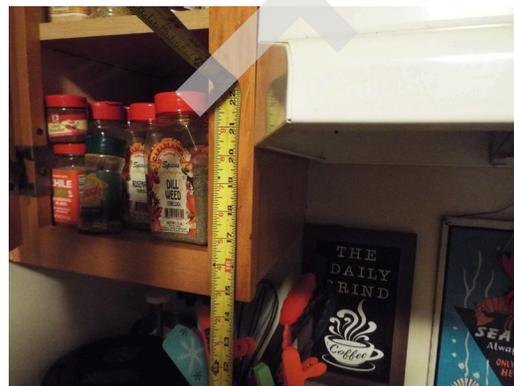
Kitchen cabinet lacks 48 inch shelf - UFAS -
unit 413 (Critical Repair)

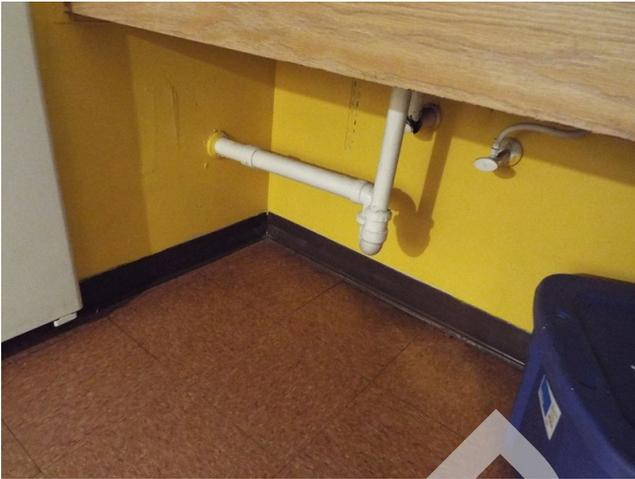
25. Kitchen sink lacks pipe protection - UFAS - unit 211 (Critical Repair)

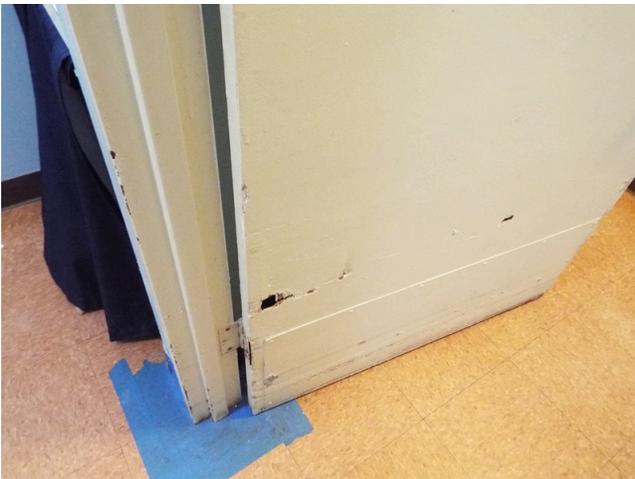
27. Door condition - 1-bed-1-bath - UFAS - unit 211 (Non-Critical Repair)

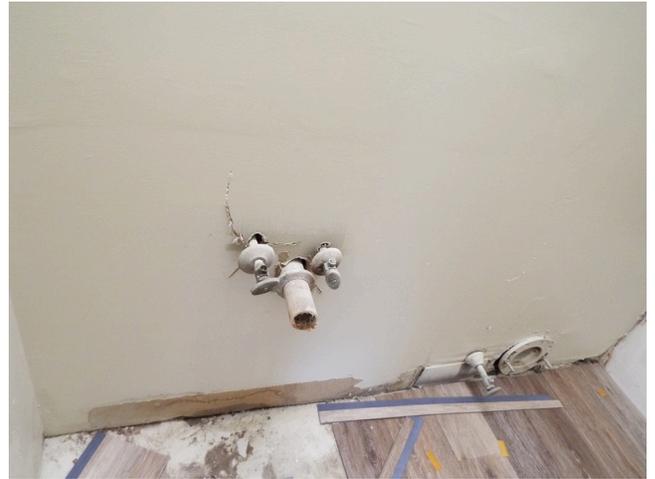
53. Baseboard heater cover condition - 1-bed-1-bath
- unit 221 (Non-Critical Repair)

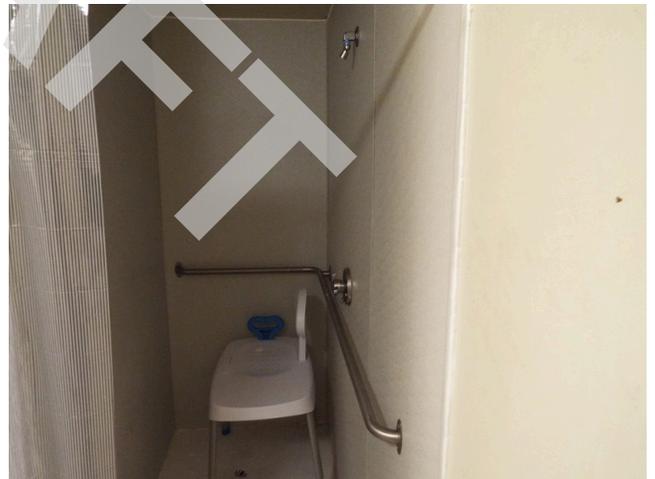
87. UFAS - unit 213 - roll in shower

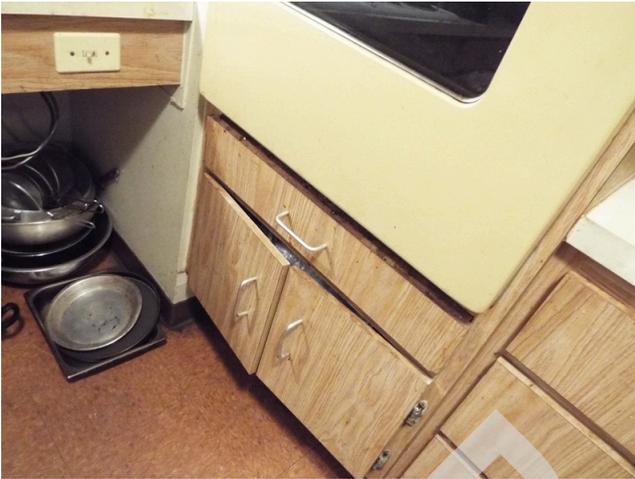
121. Kitchen cabinet condition - 1-bed-1-bath - UFAS - unit 311 (Non-Critical Repair)

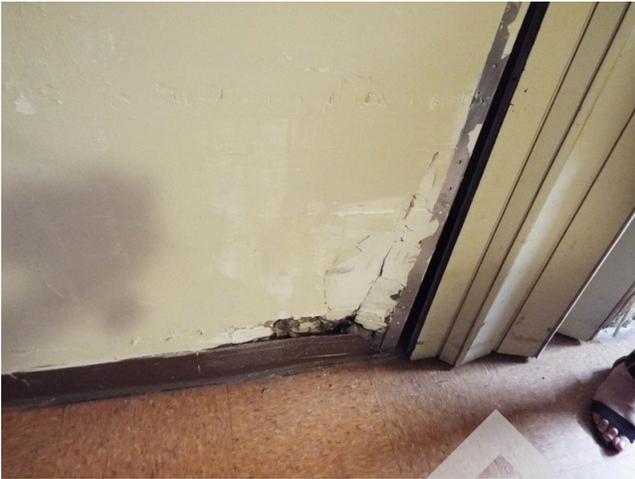
125. Door condition - 1-bed-1-bath - UFAS - unit 311 (Non-Critical Repair)

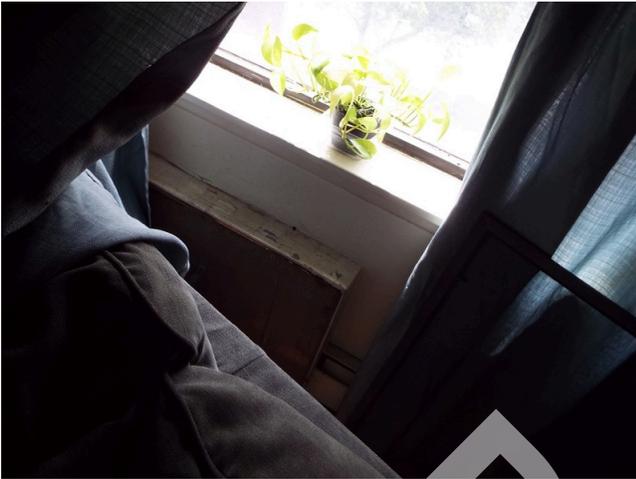
136. Window lacks screen - 1-bed-1-bath - UFAS
- unit 311 (Non-Critical Repair)

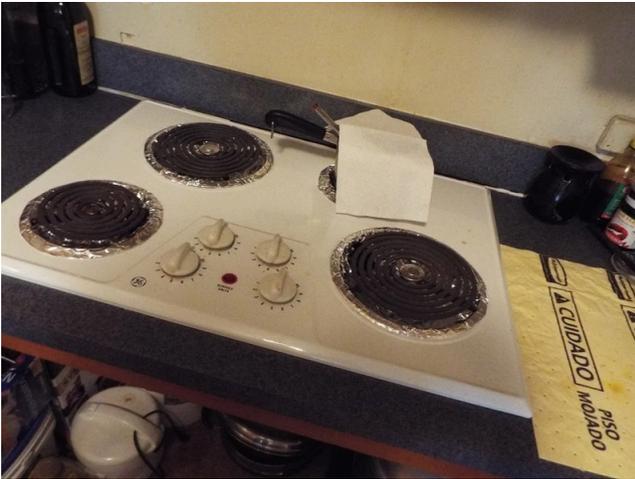
146. Kitchen stovetop counter exceeds 34 inches - UFAS - unit 313 (Critical Repair)

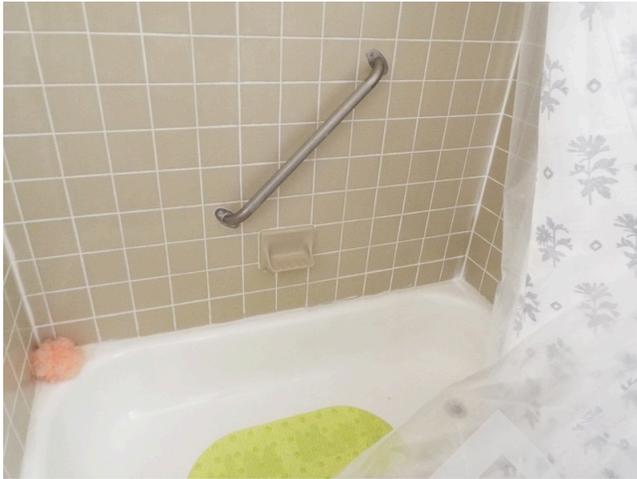
204. Emergency call device - 1-bed-1-bath - unit

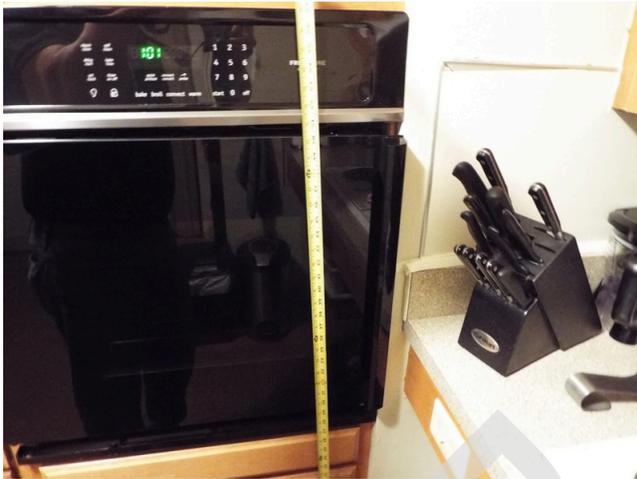
216. Kitchen cabinet lacks 48 inch shelf - UFAS - unit 413 (Critical Repair)

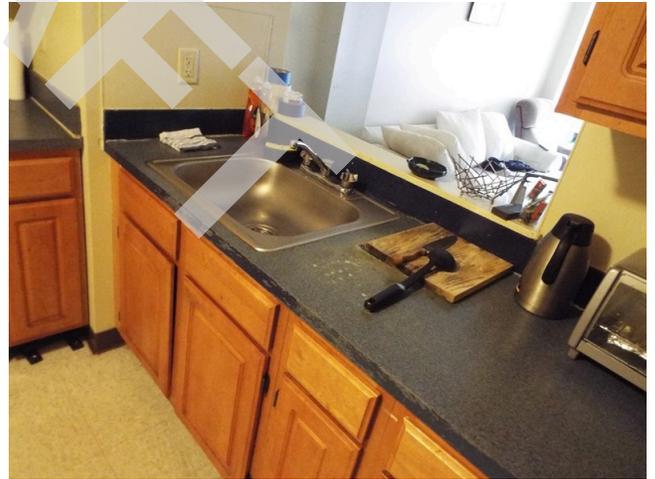
268. 1-bed-1-bath - unit 504 - kitchen cabinets

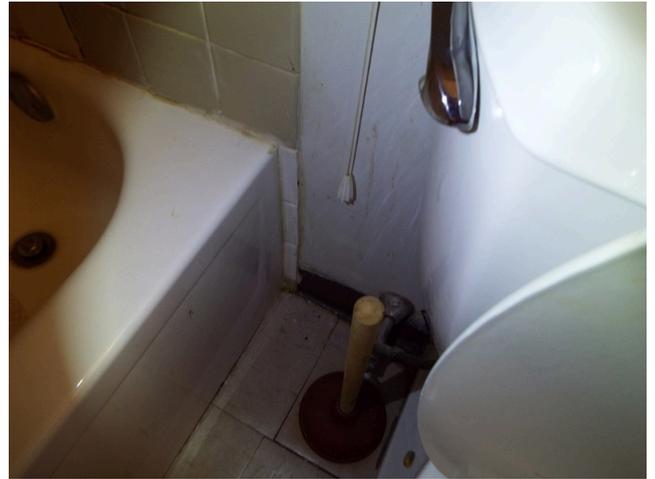
282. Wall condition - 1-bed-1-bath - unit 505 bathroom (Non-Critical Repair)

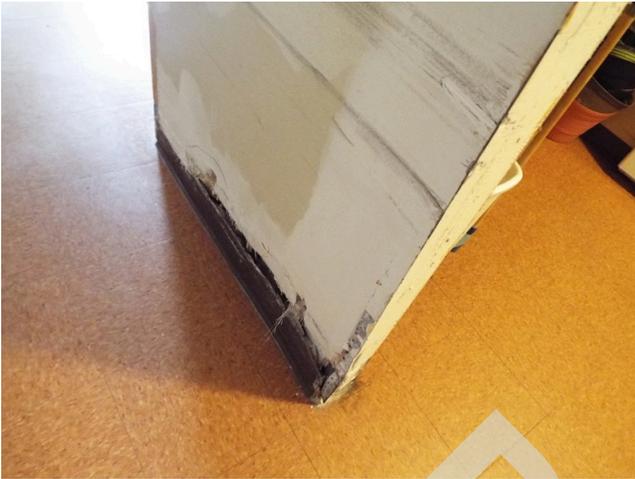
304. Wall base condition - 1-bed-1-bath - UFAS - unit 513 (Non-Critical Repair)

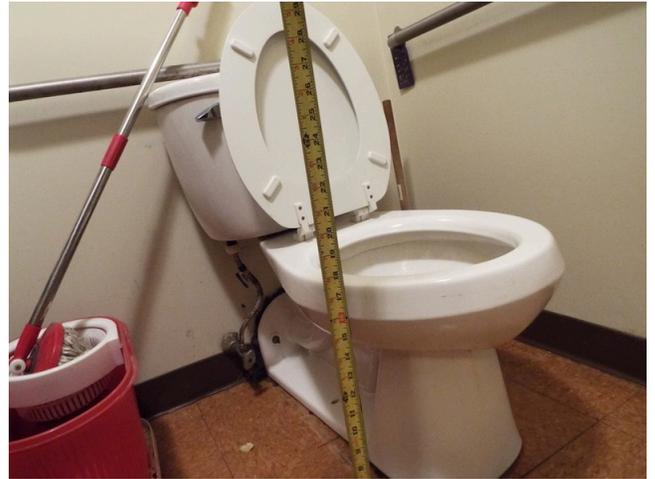
309. 1-bed-1-bath- UFAS - unit 513 - emergency call device (Non-Critical Repair)

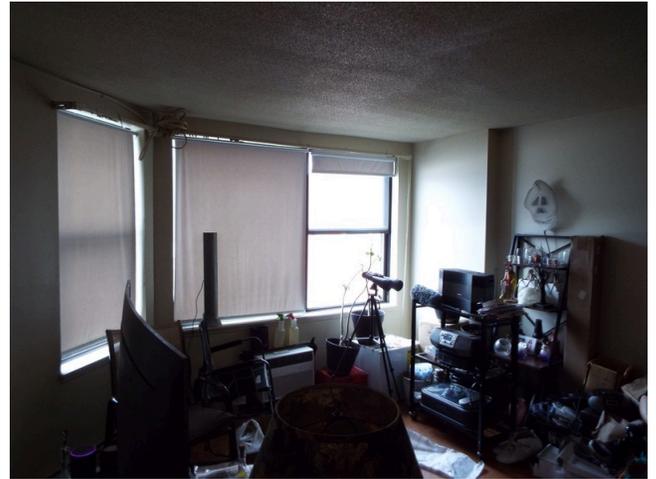
321. Wall condition - 1-bed-1-bath - UFAS - unit 513
(Non-Critical Repair)

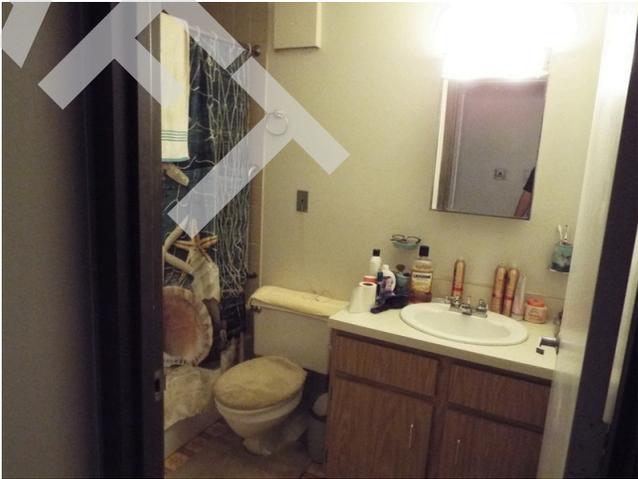
327. Window operation condition - 1-bed-1-bath - unit 514 (Non-Critical Repair)

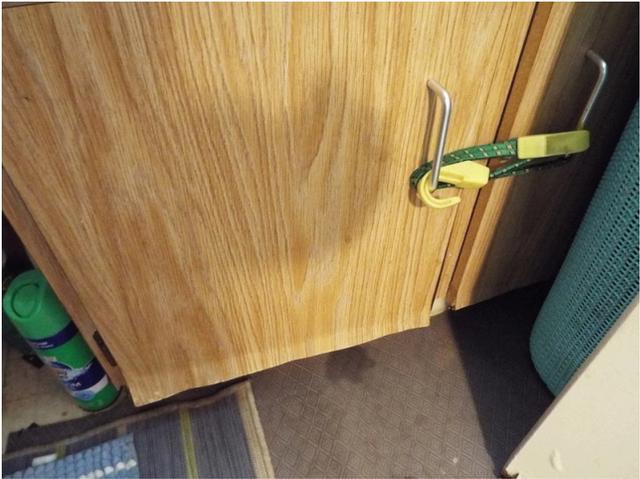
346. Vanity cabinet condition - 1-bed-1-bath - unit 606 (Non-Critical Repair)

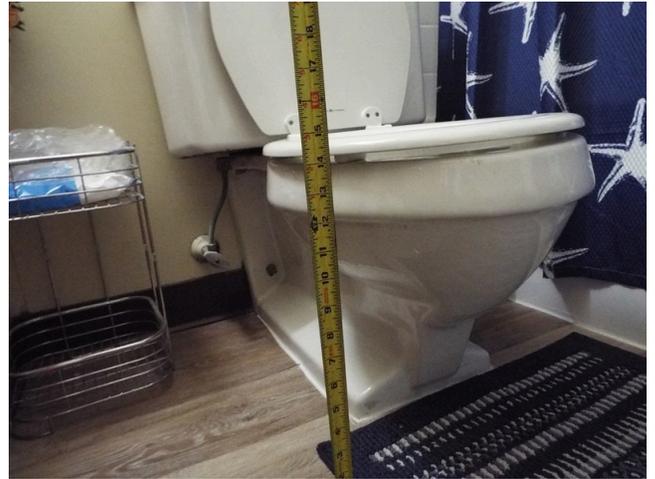
381. 1-bed-1-bath - unit 612 - tub shower (newer)

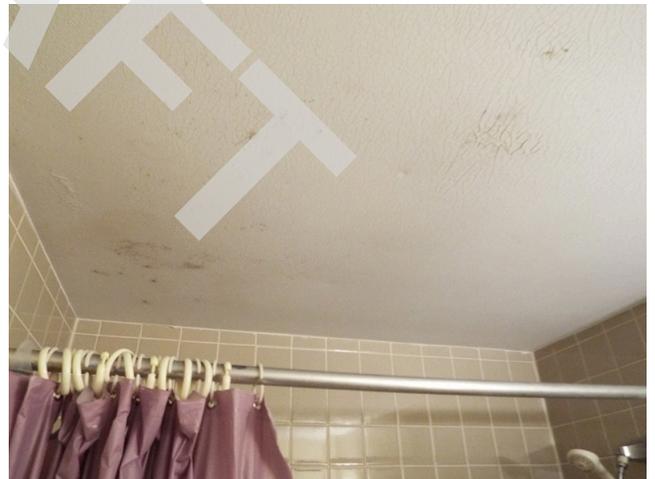
411. 2-bed-1-bath - unit 509 - tub shower (older)

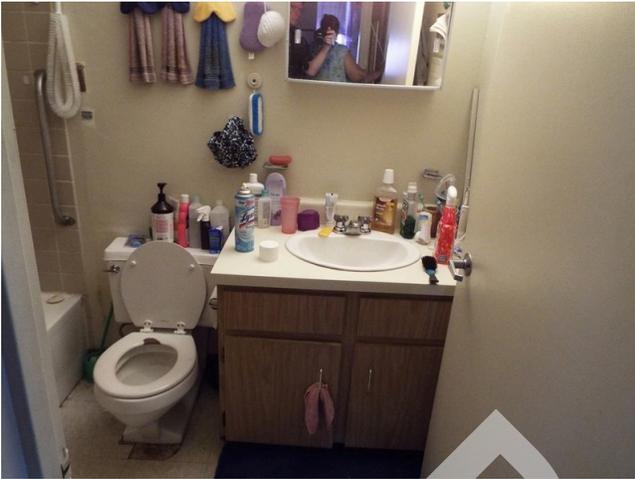
412. Bathroom ceiling condition - 2-bed-1-bath - unit 509 (Non-Critical Repair)

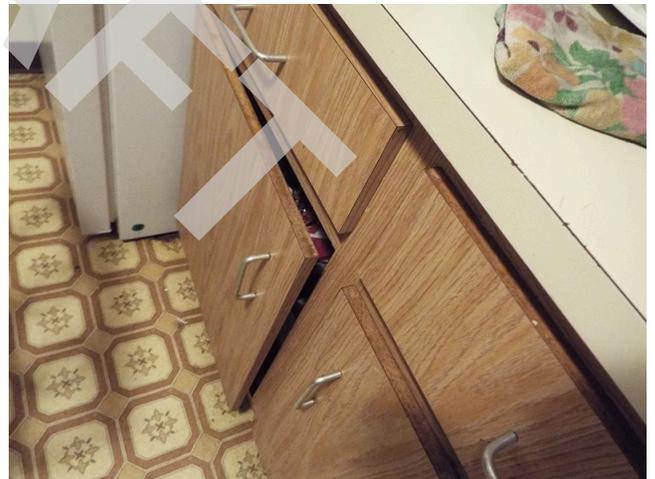
419. Kitchen cabinet condition - 2-bed-1-bath - unit 509 (Non-Critical Repair)

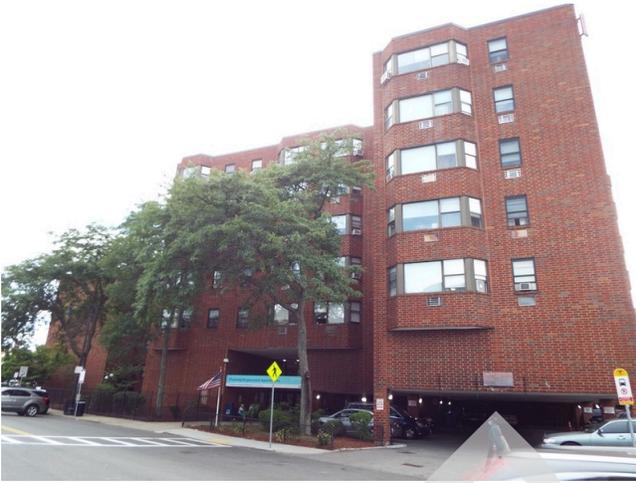
1. Topography

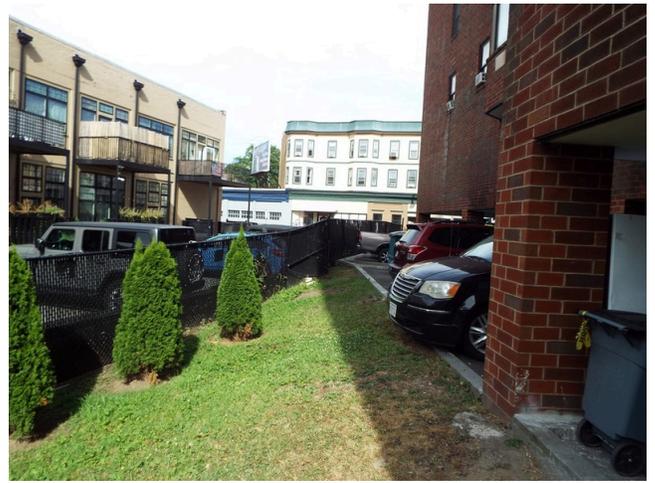
2. Topography

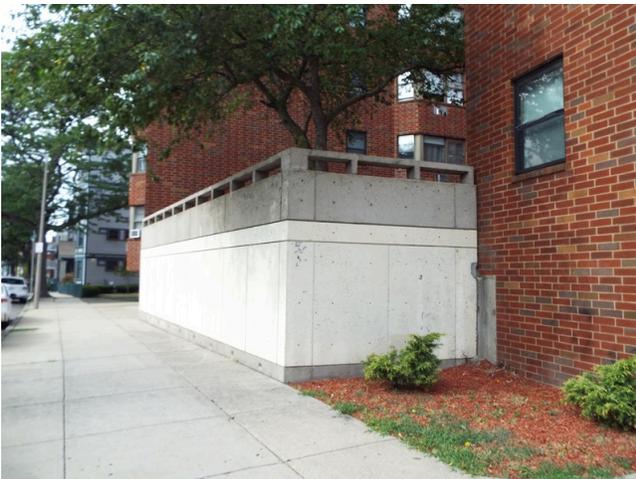
3. Retaining wall

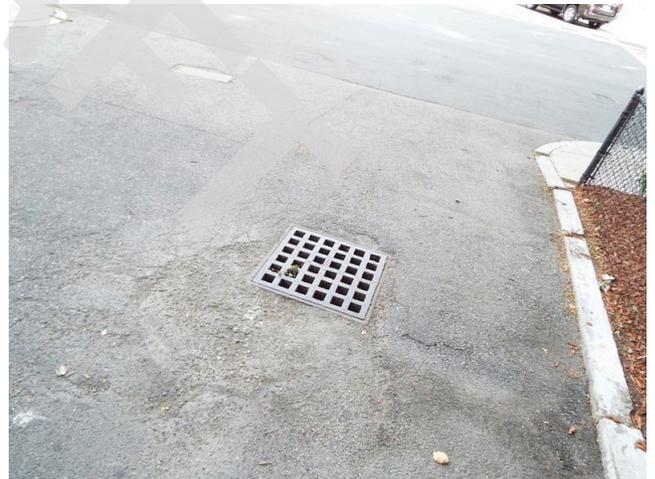
4. Surface drain

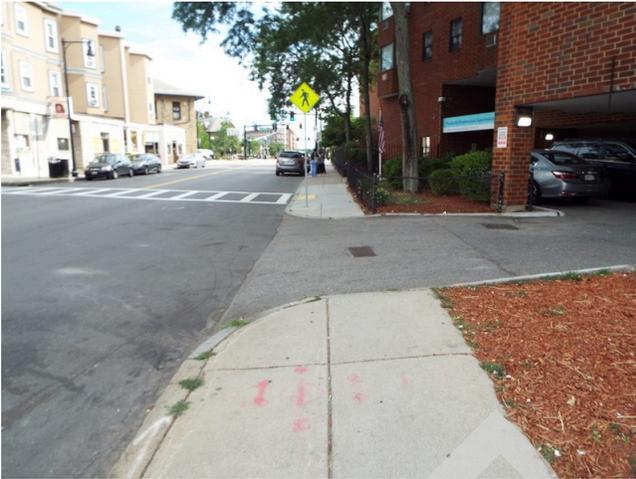
5. Property entrance - parking garage

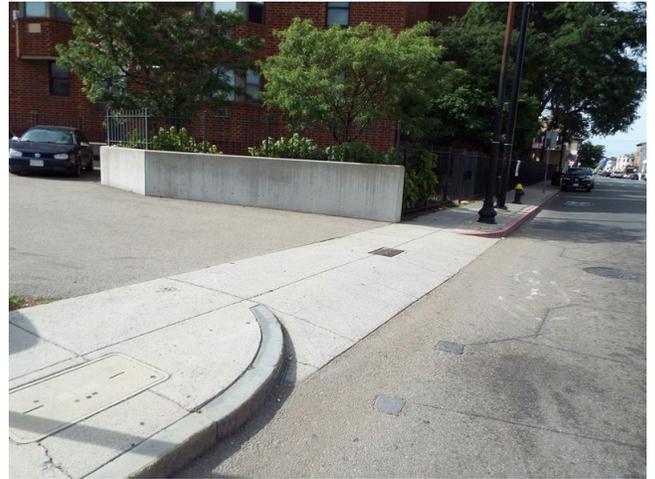
6. Property entrance - surface parking

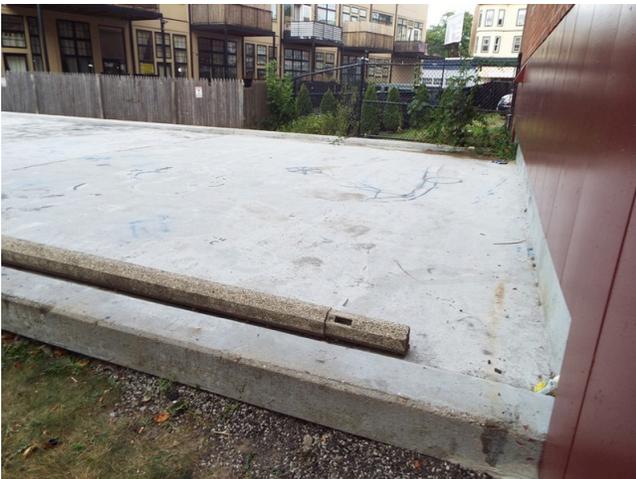
7. Public transit subway enclosure

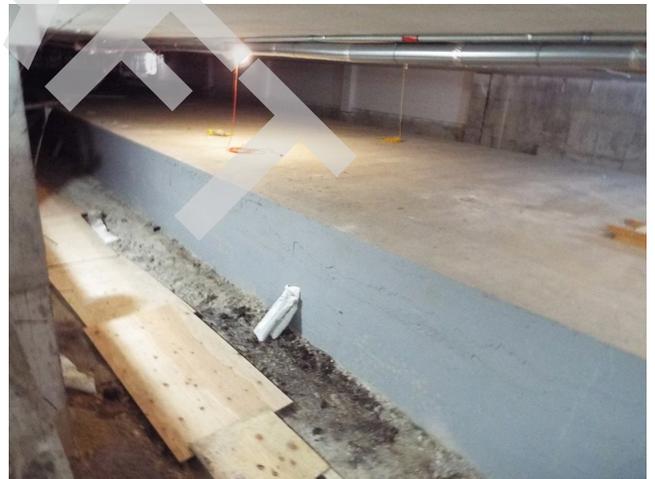
8. Public transit subway enclosure

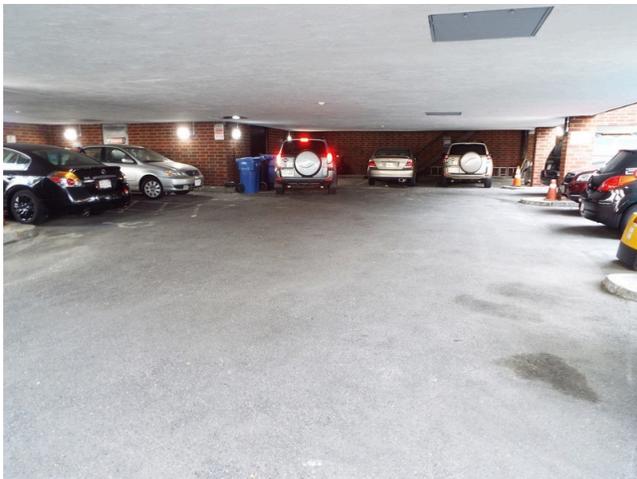
11. Parking - garage

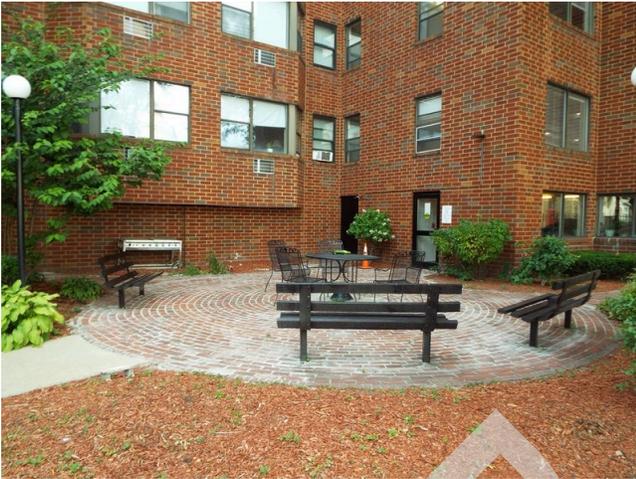
13. Brick pavers

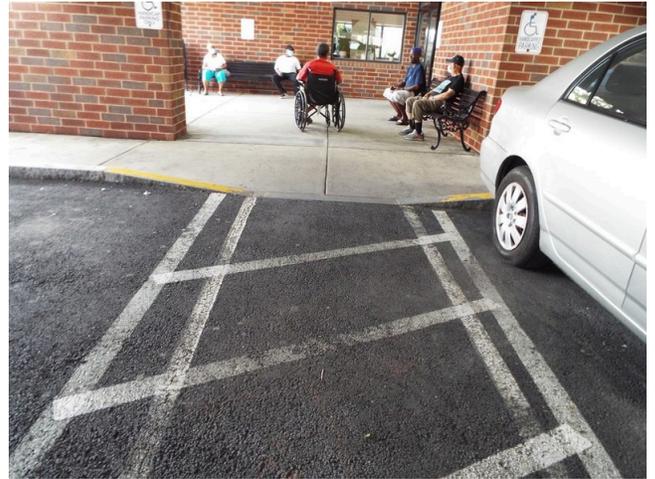
14. Main entry walkway

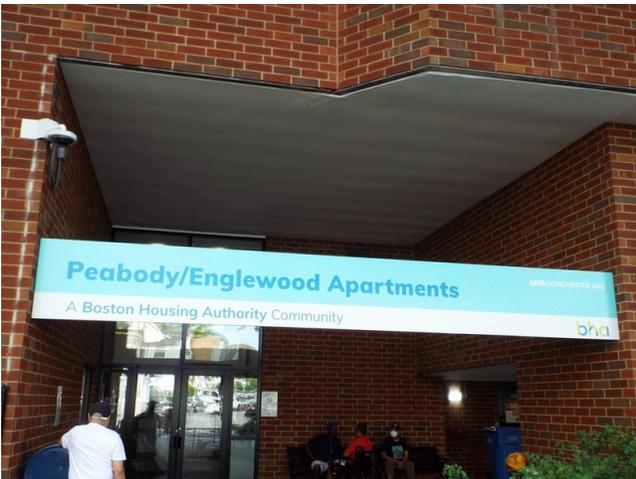
15. Property signage

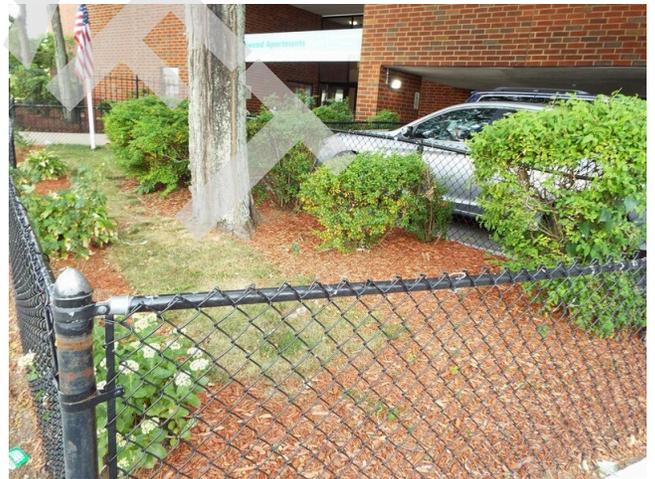
16. Landscaping

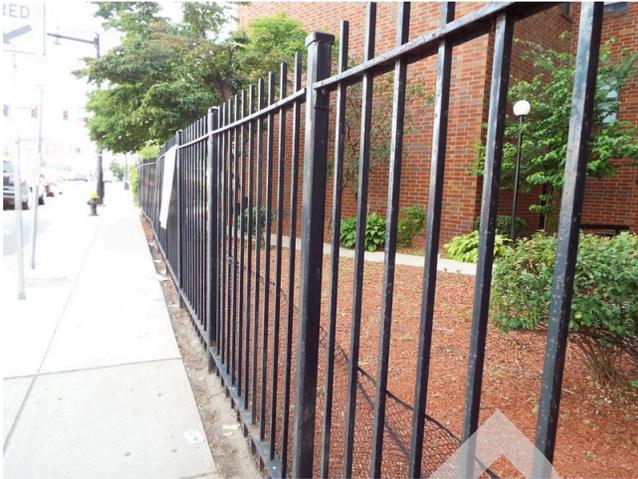
17. Metal fencing

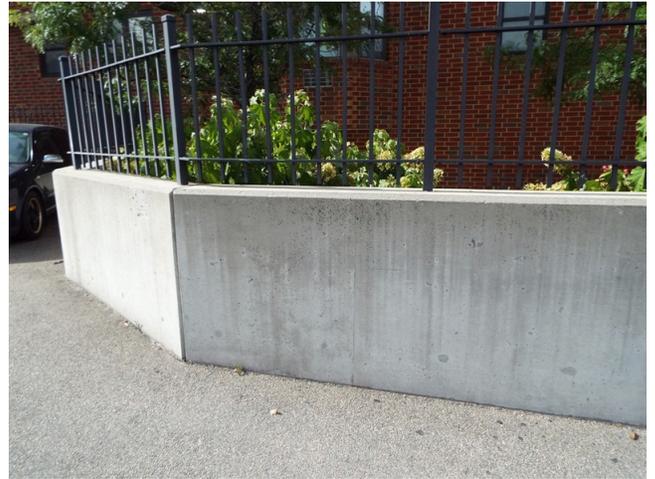
18. Site wall

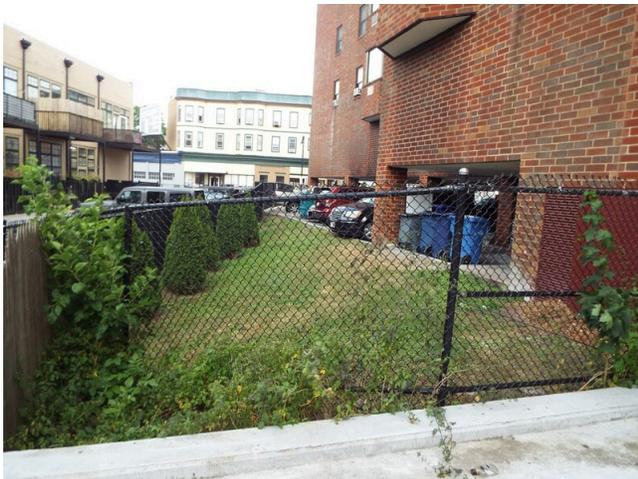
19. Chain link fencing

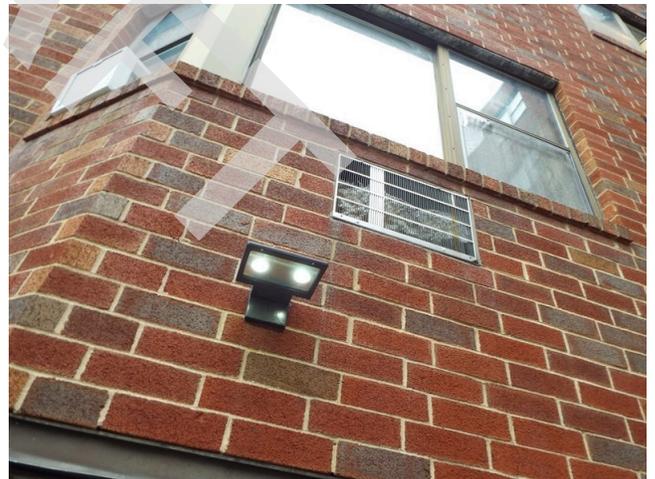
20. Building mounted lighting

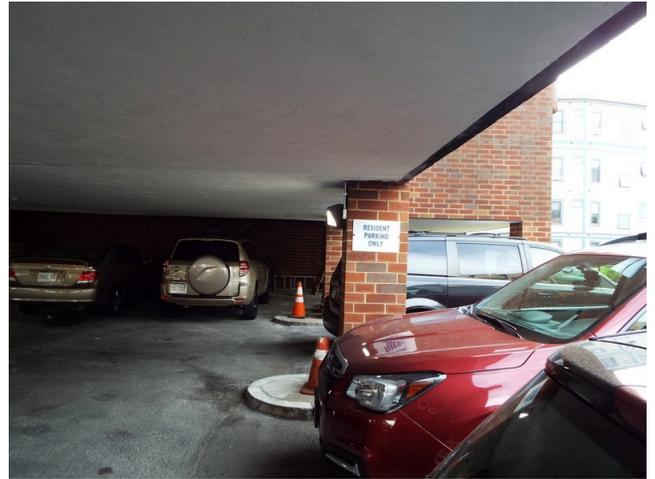
22. Parking - garage
