HUD CAPITAL NEEDS ASSESSMENT

Peabody
1875 Dorchester Avenue
Dorchester, Massachusetts 02124

AEI Project No. 463342
Site Inspection Date: July 26, 2022

Boston Housing Authority
52 Chauncy Street
Boston, Massachusetts 02111

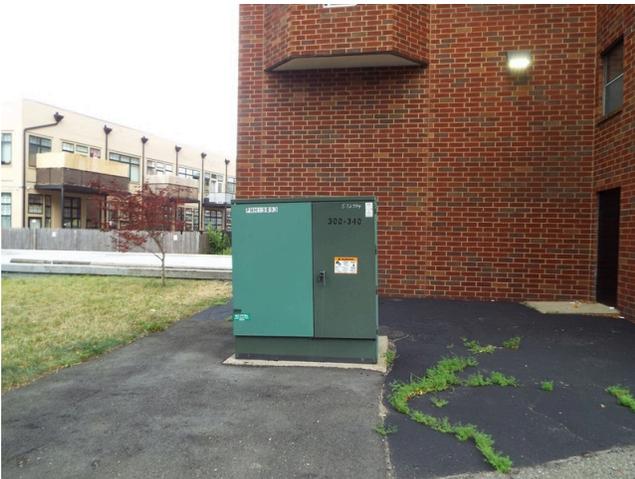
23. Transformer

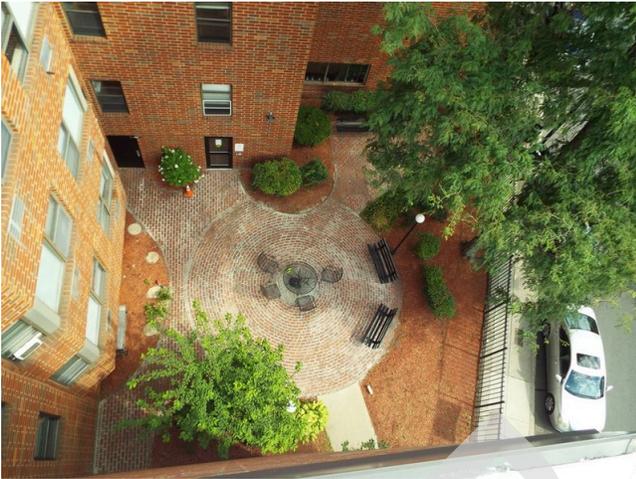
25. Common area patio

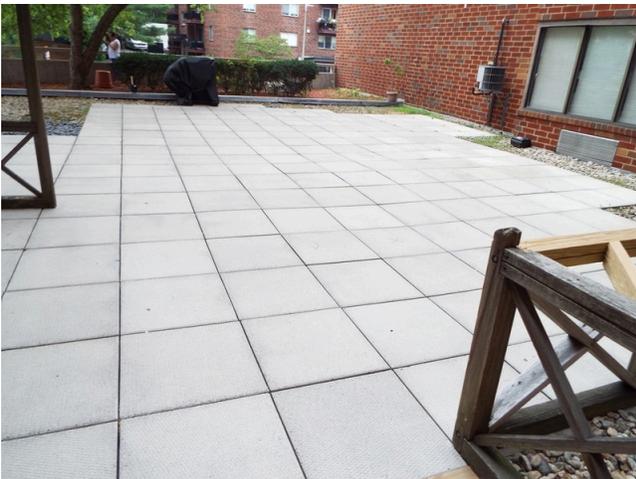
27. Raised terrace

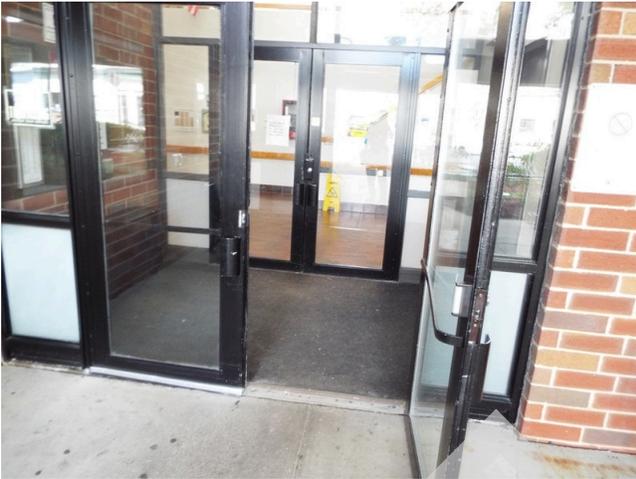
29. Main entry

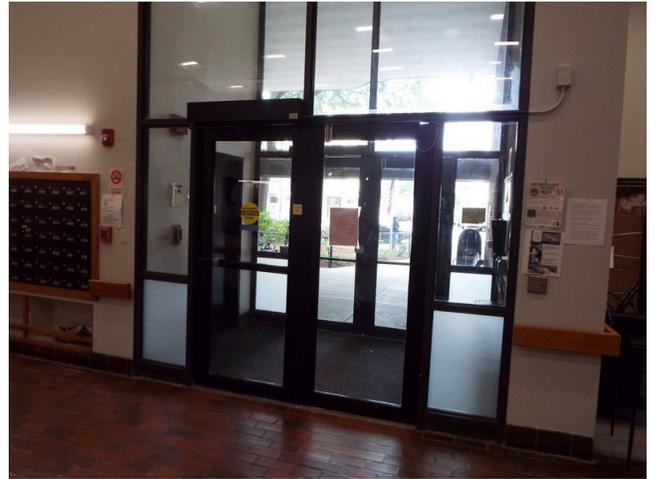
30. Storefront system

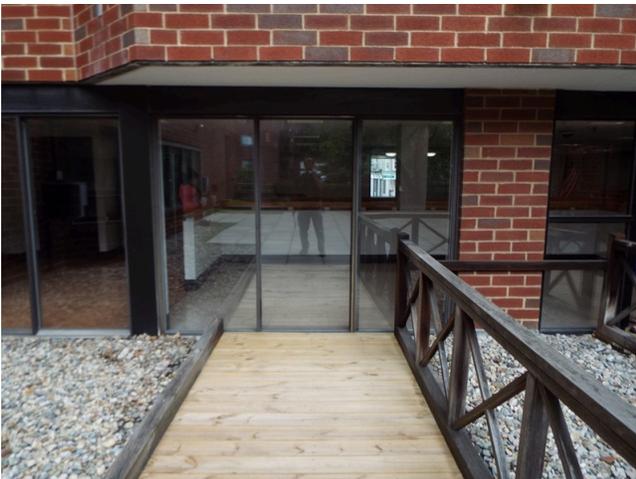
31. Sliding glass door

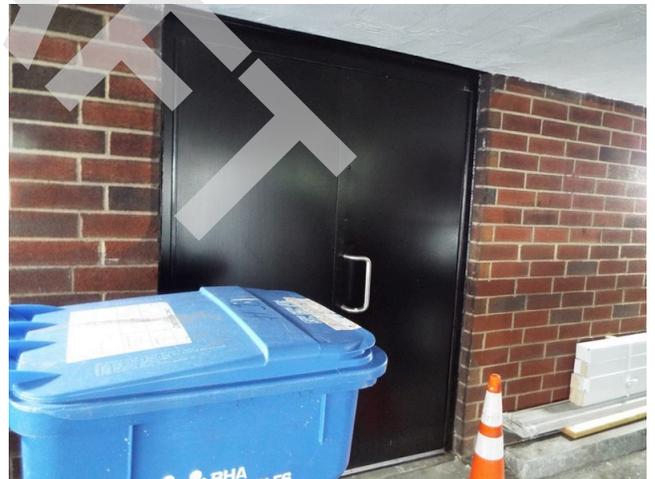
32. Service doors

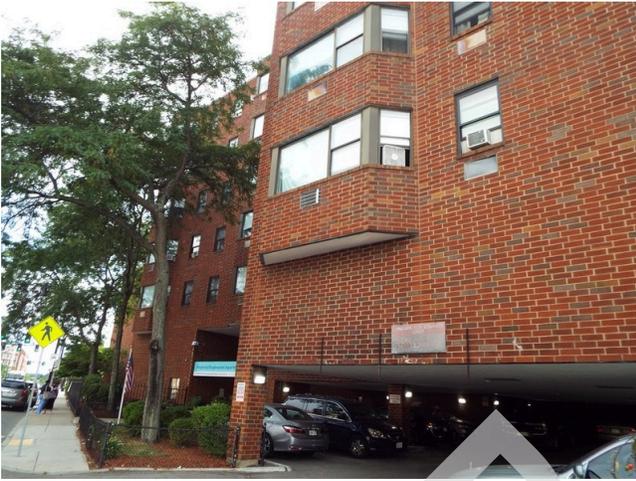
33. Elevation - Dorchester Avenue

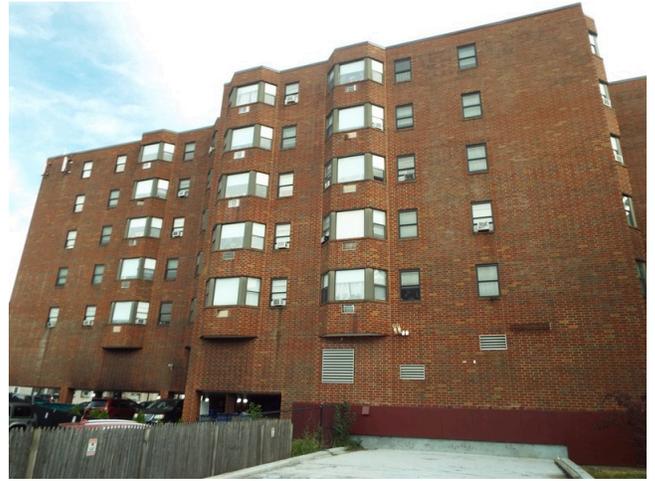
34. Elevation - side

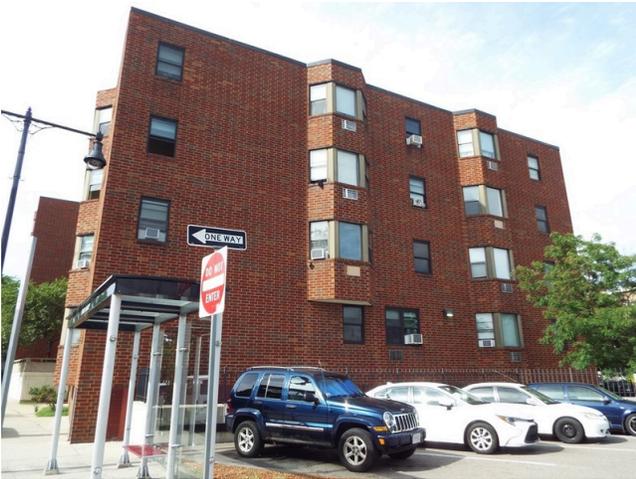
35. Elevation - side

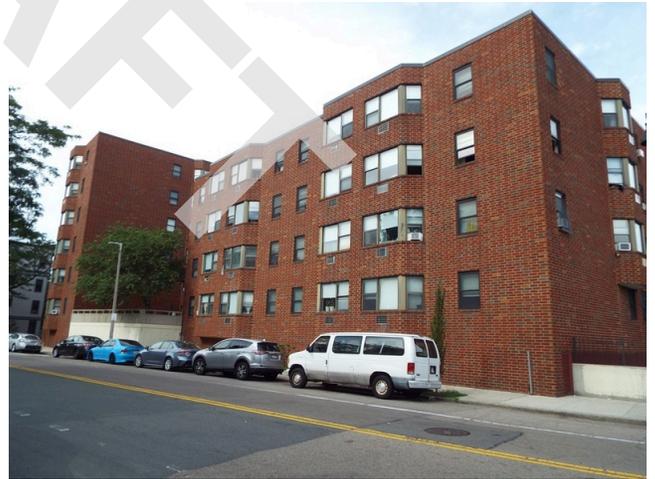
36. Elevation - Talbot Avenue

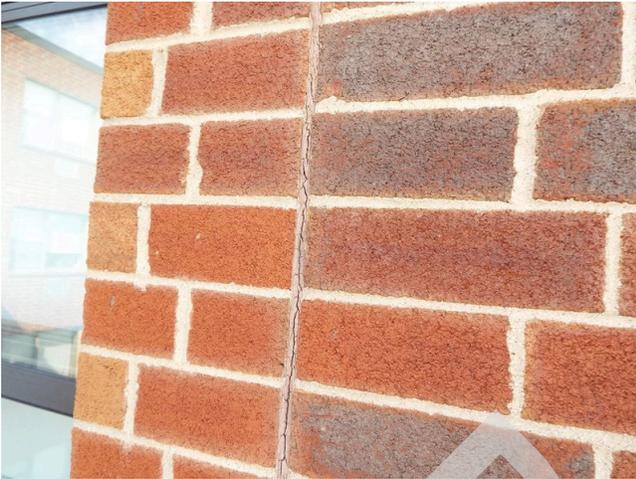
37. Masonry condition

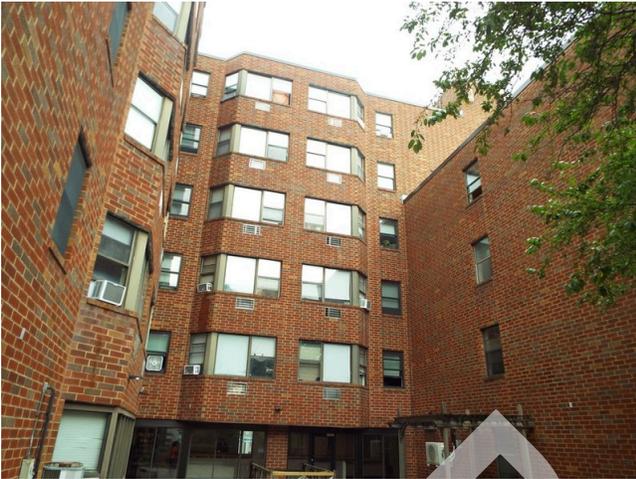
41. Typical windows

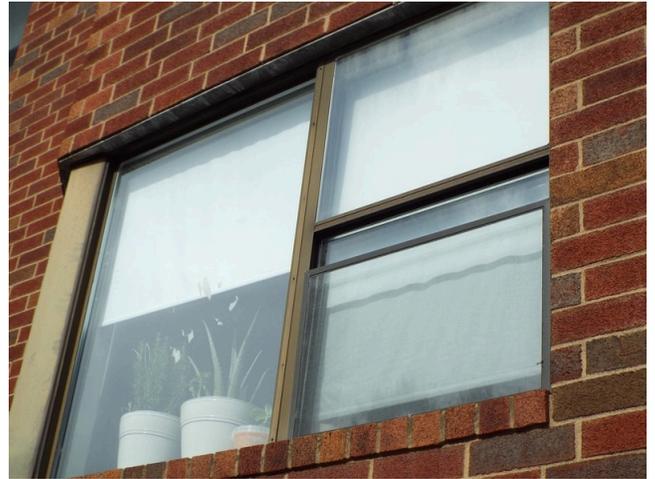
42. Typical window

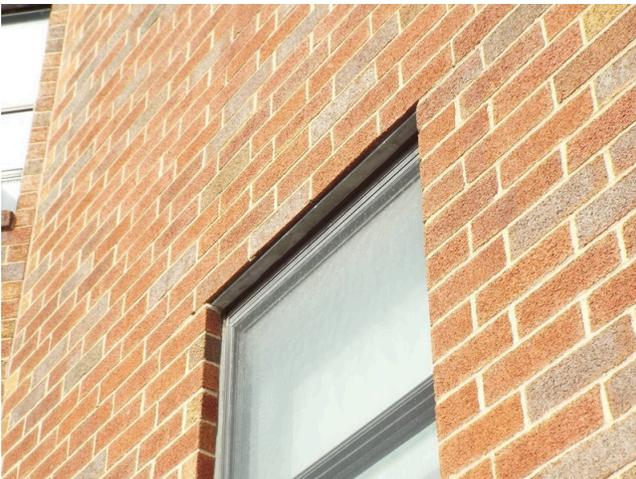
43. Typical window frame

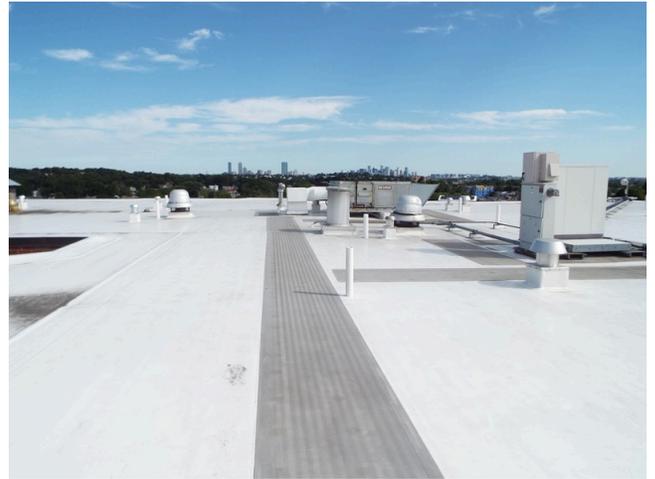
46. Roof overview

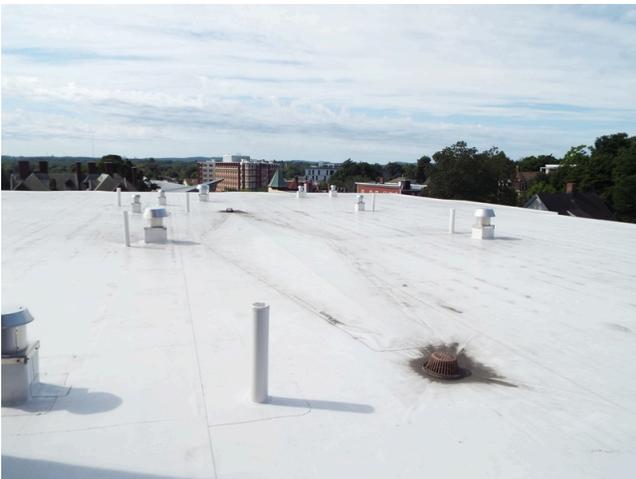
47. Roofing

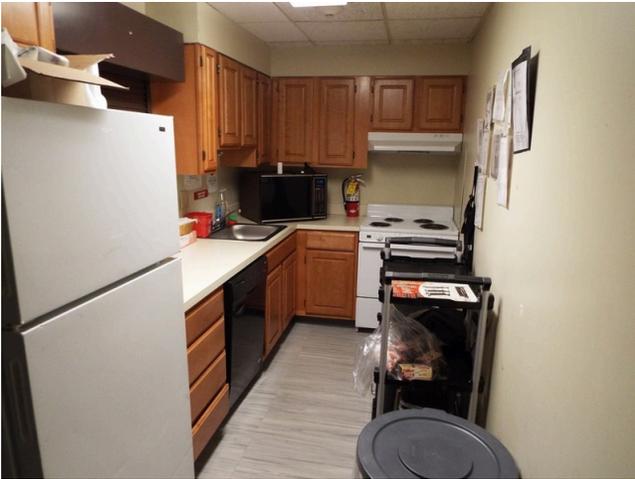
75. Common area - kitchen, not UFAS compliant
(Critical Repair)

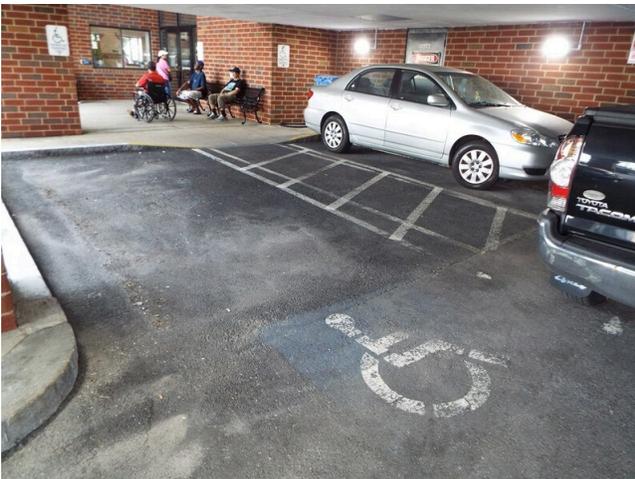
79. Accessible parking lacks van space and signage
(Critical Repair)

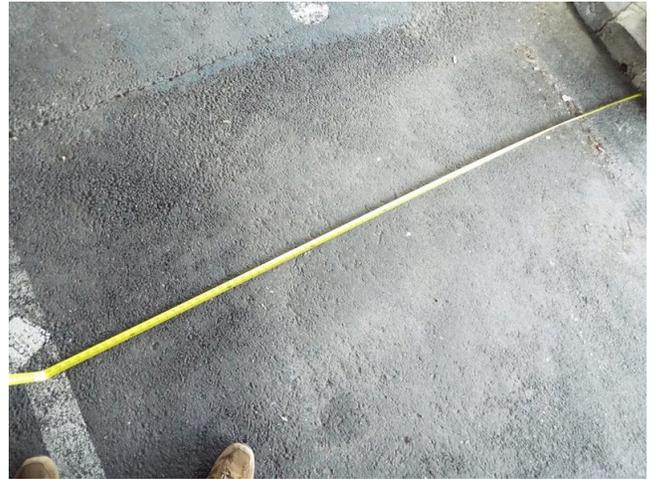
89. Accessible parking

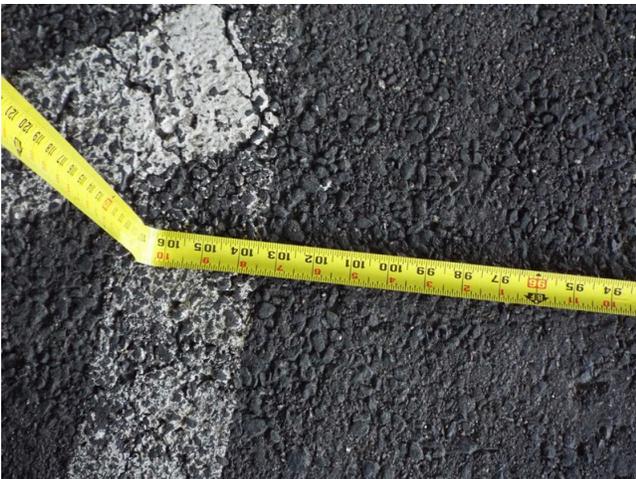
90. Accessible parking

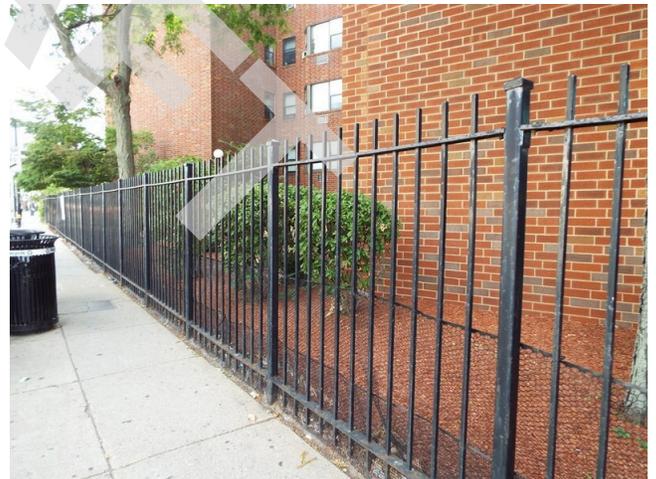
252. Fencing

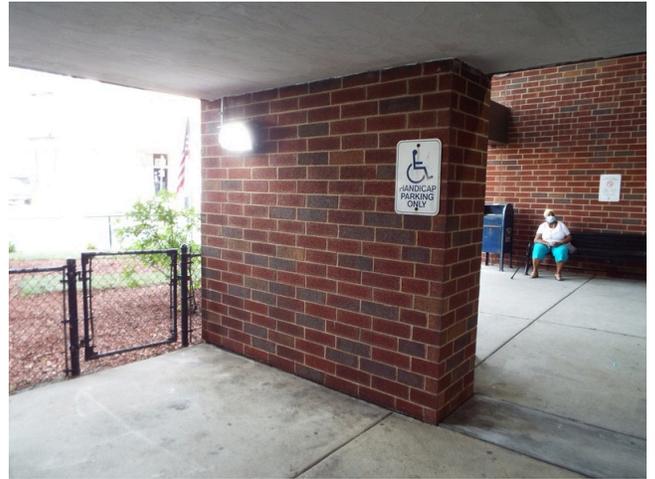
254. Concrete entry pad

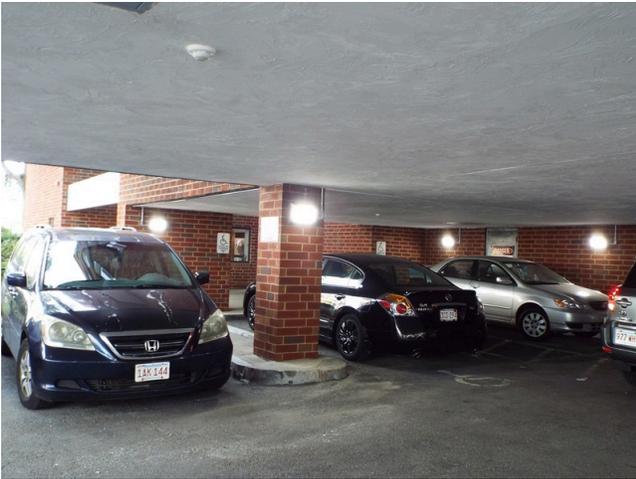
255. Parking garage lighting

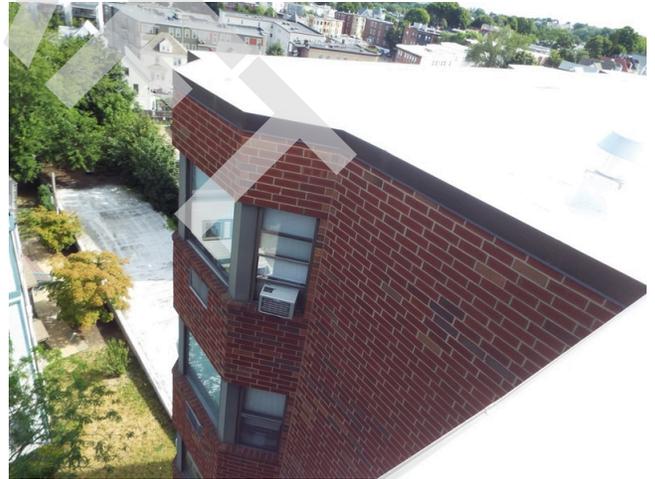
256. Flashing
