## HUD CAPITAL NEEDS ASSESSMENT

Commonwealth Elderly  
35 Fidelis Way  
Boston, Massachusetts 02135

AEI Project No. 463345  
Site Inspection Date: July 20 and 21, 2022

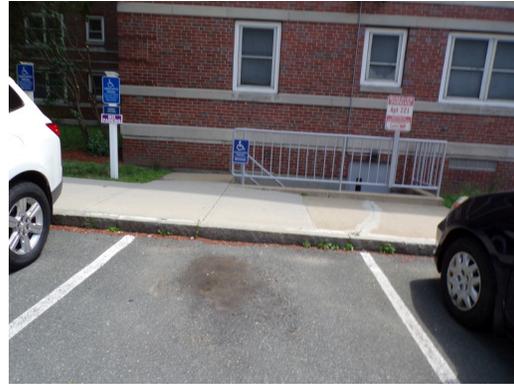
Apartment building 1 handicap parking signage less than 60 inches above ground (Critical Repair)

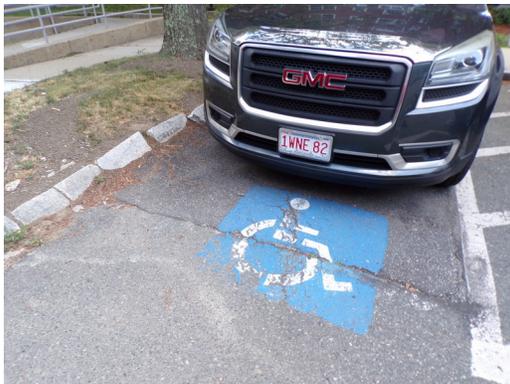
Apartment building 1 handicap parking seal coat asphalt (Non-Critical Repair)

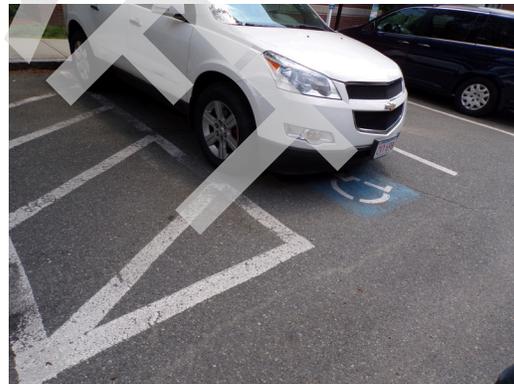
Apartment building 1 handicap parking seal coat asphalt (Non-Critical Repair)

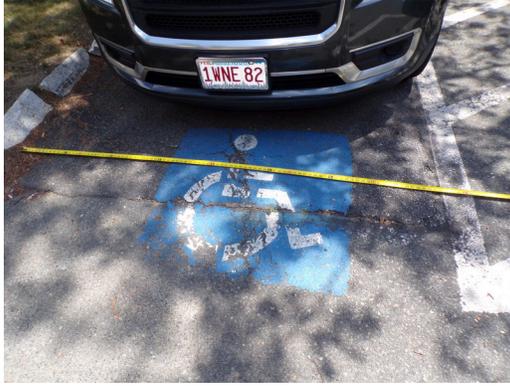
Apartment building 1 handicap parking seal coat asphalt (Non-Critical Repair)

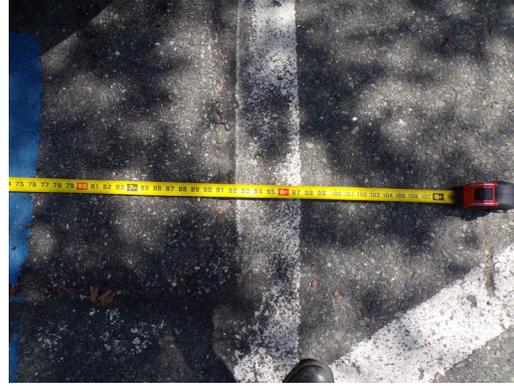
Apartment building 1 handicap parking seal coat asphalt (Non-Critical Repair)

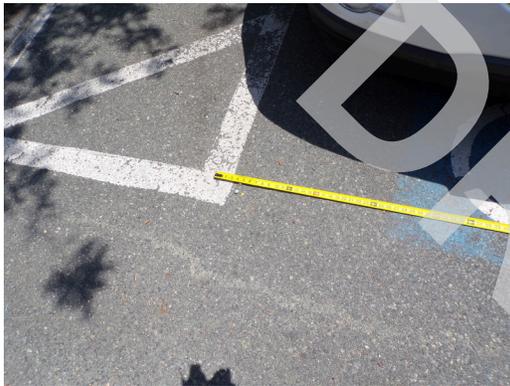
Apartment building 1 handicap parking seal coat asphalt (Non-Critical Repair)

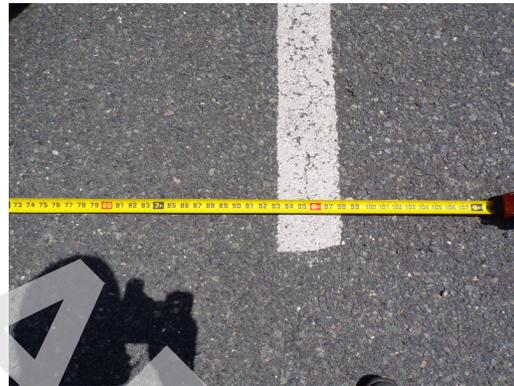
Apartment building 1 handicap parking seal coat asphalt (Non-Critical Repair)

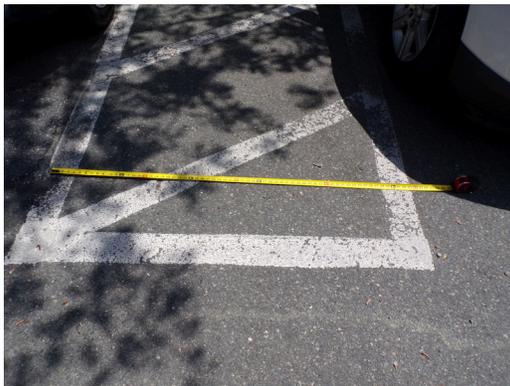
Apartment building 1 handicap parking seal coat asphalt (Non-Critical Repair)

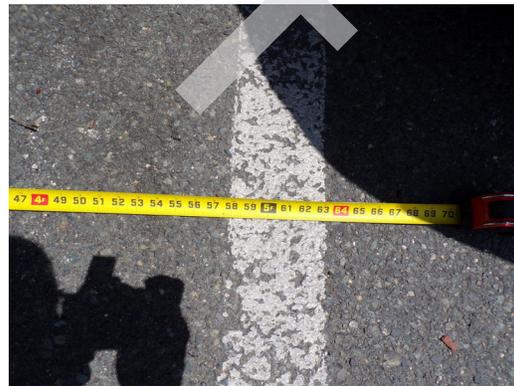
Apartment building 1 handicap parking seal coat asphalt (Non-Critical Repair)

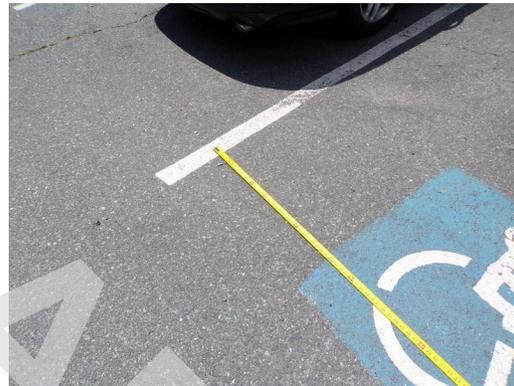
Apartment building 1 handicap parking seal coat asphalt (Non-Critical Repair)

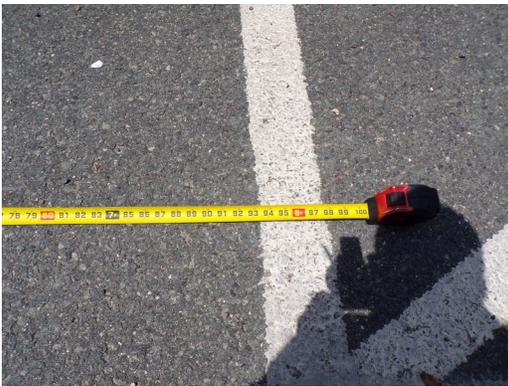
Apartment building 1 handicap parking seal coat asphalt (Non-Critical Repair)

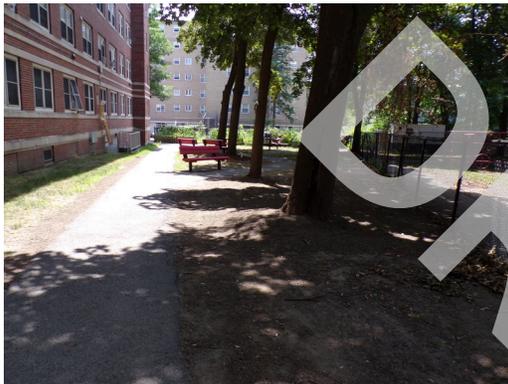
Apartment building 2 park area bare ground  
(Non-Critical Repair)

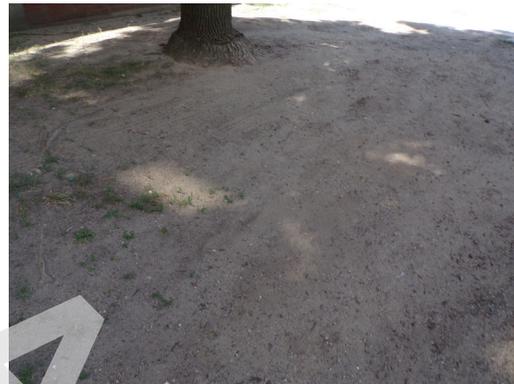
Apartment building 2 bare ground  
(Non-Critical Repair)

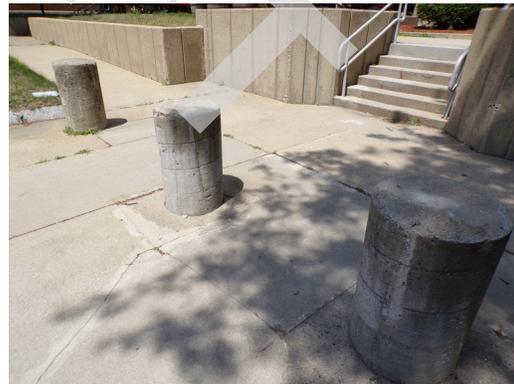
Apartment buildings 1 and 2 main ingress/egress sidewalks trip hazard (Critical Repair)

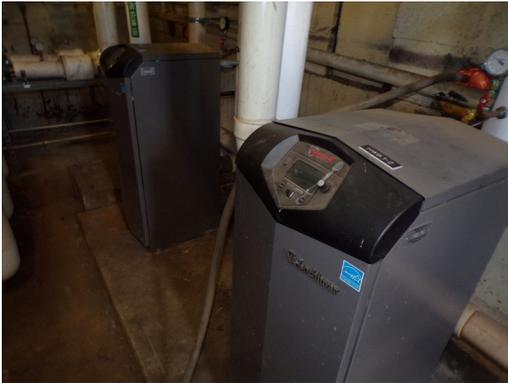
Apartment building 1 hot water boilers

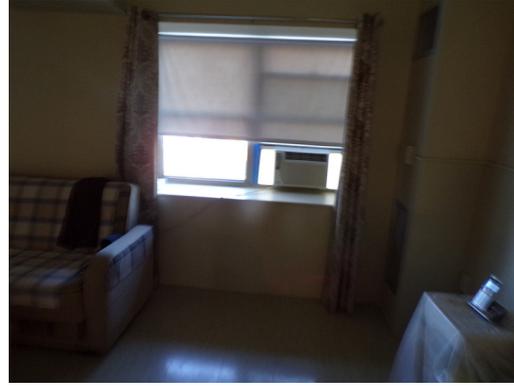
Apartment building 1 - Apartment 135 - 2-bed/1-bath - UFAS unit - window mounted air conditioner

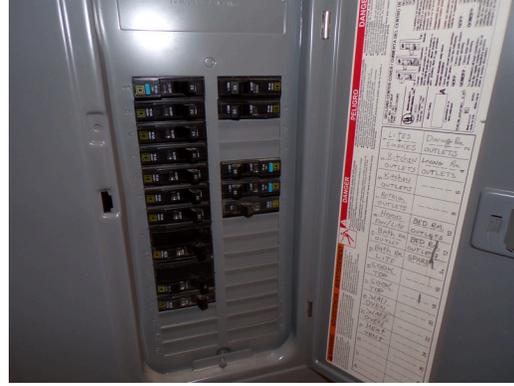
Apartment building 1 - Apartment 125 -  
2-bed/1-bath - UFAS unit - circuit breaker box

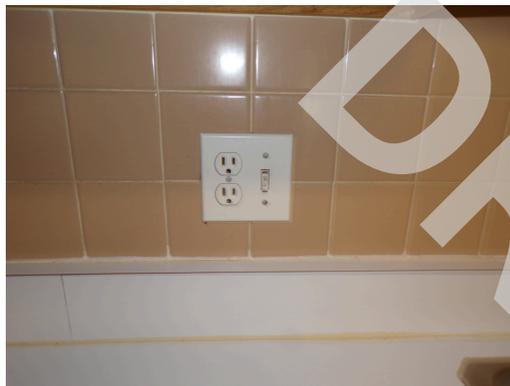
Apartment buildings 1 and 2 community room  
kitchen missing GFCI (Critical Repair)

- The common area kitchen was observed without a GFCI by the kitchen sink (Critical Repair)

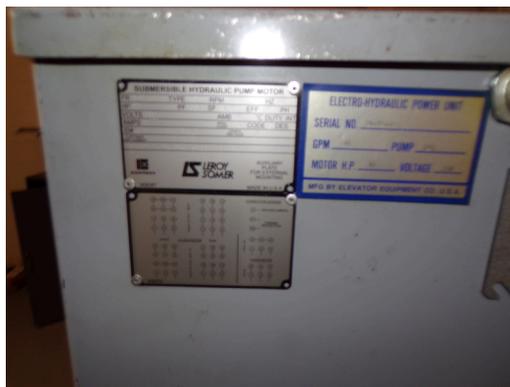
Apartment building 2 elevator information

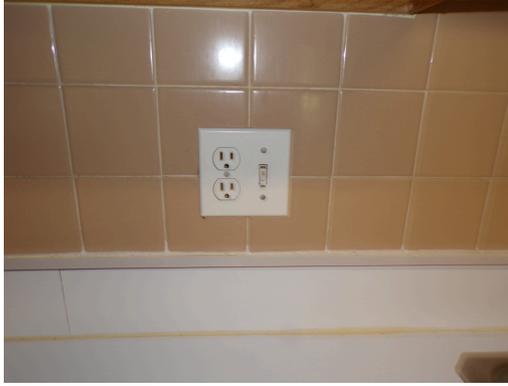
Apartment buildings 1 and 2 community room kitchen missing GFCI (Critical Repair)

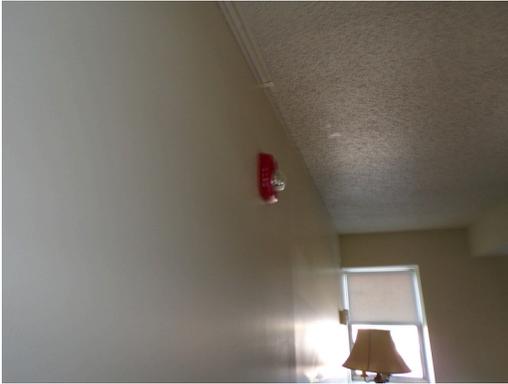
Apartment building 1 - Apartment 154 -  
1-bed/1-bath - fire alarm strobe light

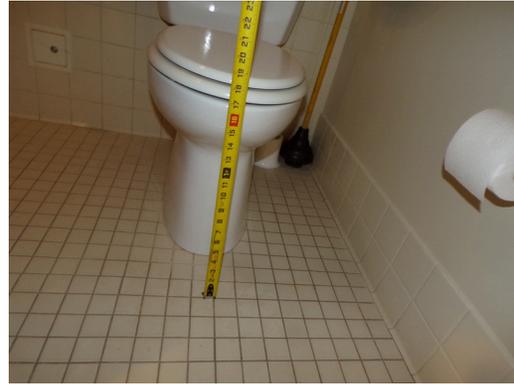
Apartment building 1 - Apartment 135 -  
2-bed/1-bath - UFAS unit - bathroom toilet

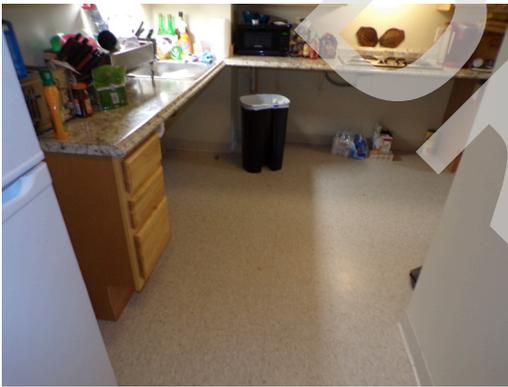
Apartment building 1 - Apartment 125 -  
2-bed/1-bath - UFAS unit - kitchen vinyl floor

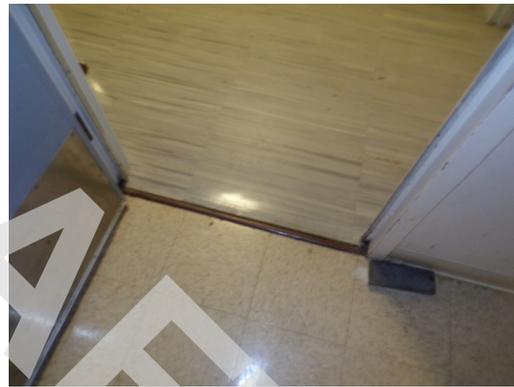
Apartment building 1 - Apartment 111 -  
1-bed/1-bath - UFAS unit - main ingress/  
egress threshold

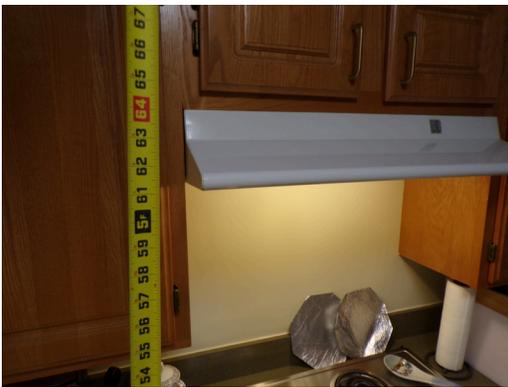
Apartment building 1 - Apartment 135 -  
2-bed/1-bath - UFAS unit - Range hood not  
front end controls and upper cabinets over 48  
inches (Critical Repair)

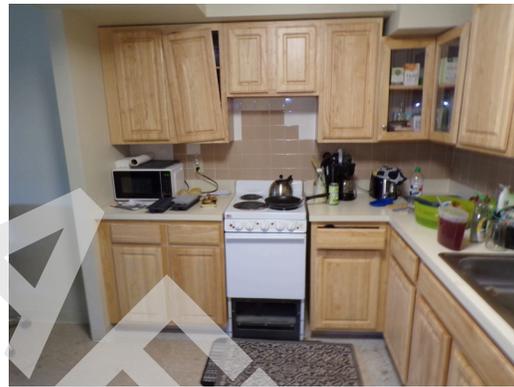
Apartment building 1 - Apartment 154 -  
1-bed/1-bath - kitchen cabinet door damaged  
(Non-Critical Repair)

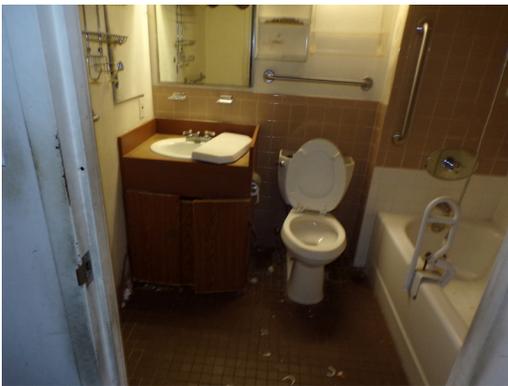
Apartment building 1 - Apartment 145 -  
2-bed/1-bath - bathroom (Non-Critical Repair)

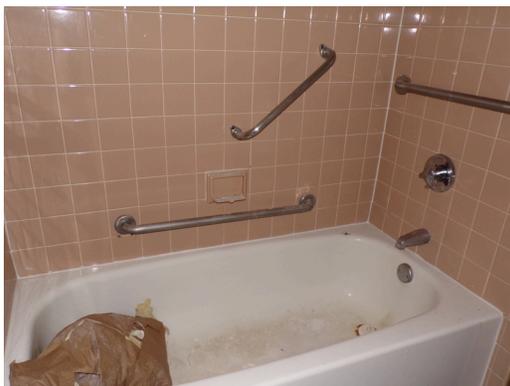
Apartment building 2 - Apartment 245 -  
2-bed/1-bath - bathtub hardware (Non-Critical  
Repair)

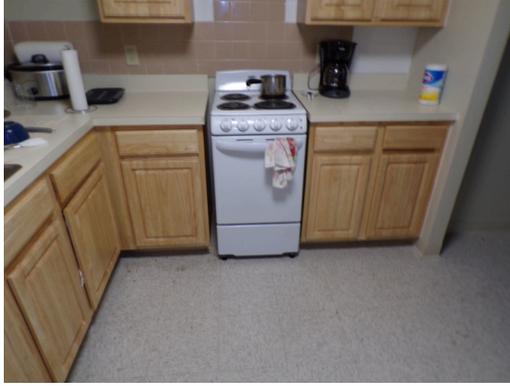
Apartment building 2 - Apartment 213 -  
1-bed/1-bath - kitchen

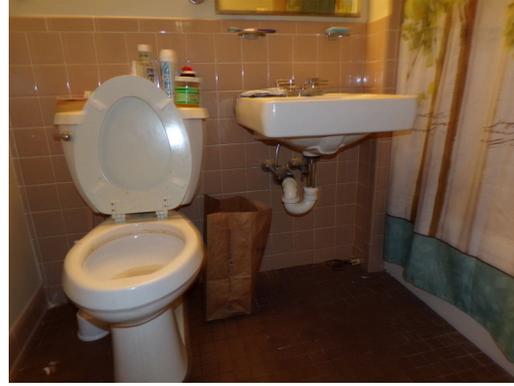
Apartment building 2 - Apartment 213 -  
1-bed/1-bath - bathroom

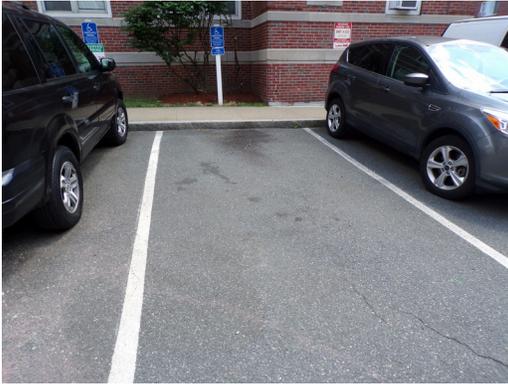
- The property has four (4) accessible parking spaces without proper signage and curb cutouts. The Accessible signage is also located below 60 inches (Critical Repair).

Apartment building 1 handicap parking no pavement markings or access aisle (Critical Repair)

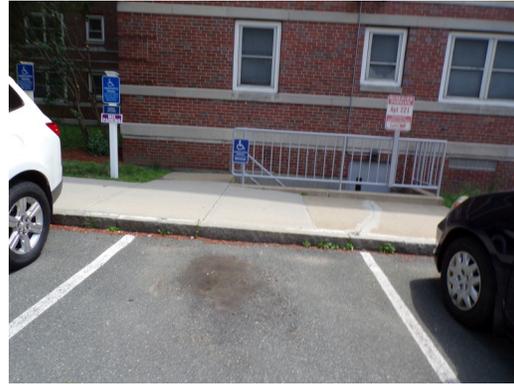
Apartment building 1 handicap parking signage less than 60 inches above ground (Critical Repair)

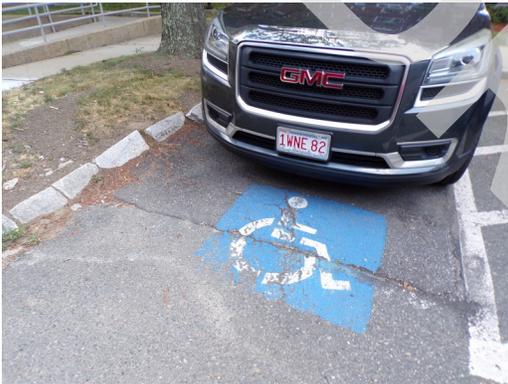
Apartment building 1 handicap parking seal coat asphalt (Non-Critical Repair)

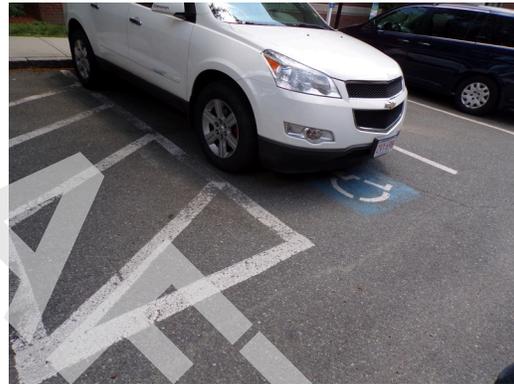
Apartment building 1 handicap parking seal coat asphalt (Non-Critical Repair)

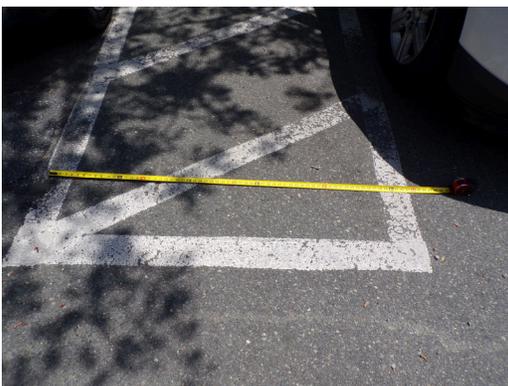
Apartment building 1 handicap parking seal coat asphalt (Non-Critical Repair)

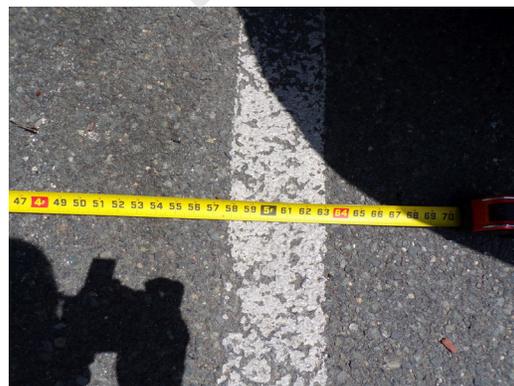
Apartment building 1 handicap parking seal coat asphalt (Non-Critical Repair)

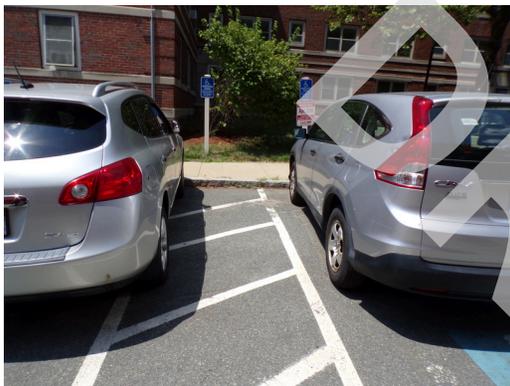
Apartment building 1 handicap parking signage and missing curb cutout (Critical Repair)

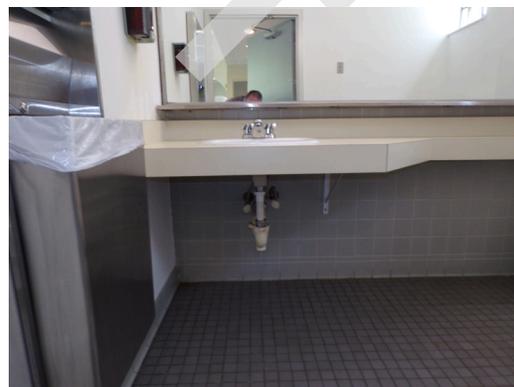
9.	Are exposed pipes under sink sufficiently insulated against contact?		✓		The women's restroom sink was observed without scald and abrasion protection (Critical Repair)
<b>Pools</b>

Apartment buildings 1 and 2 women's public restroom restroom sink missing scald and abrasion protection (Critical Repair)

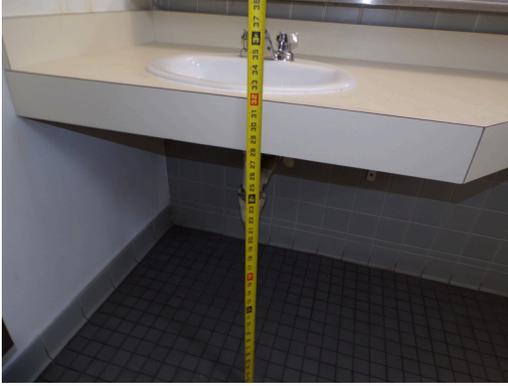
6.	Are grab bars provided in toilet stalls?	✓			
7.	Are sinks provided with clearance for a wheelchair to roll under?	✓			
8.	Are sink handles operable with one hand without grasping, pinching or twisting?		✓		Both the men's and women's public restrooms were observed with sink hardware involving twisting the knobs to operate the sink (Critical Repair)

Apartment buildings 1 and 2 women's public restroom sink hardware (Critical Repair)

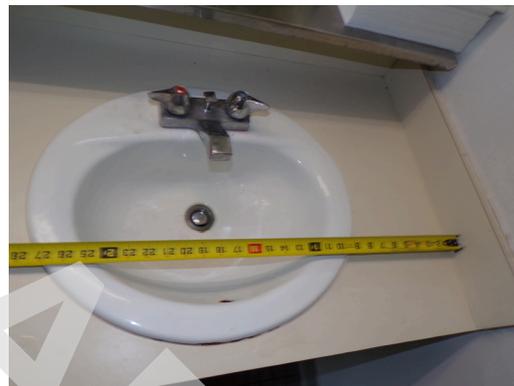
Apartment buildings 1 and 2 men's public restroom sink hardware (Critical Repair)

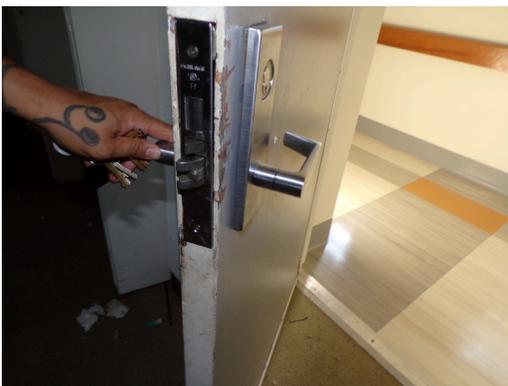
Apartment building 1 - Apartment 145 - 2-bed/1-bath - main ingress/egress door hardware and door condition (Non-Critical Repair)

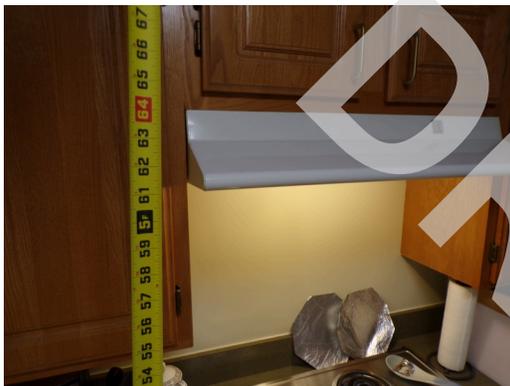
Apartment building 1 - Apartment 135 -  
2-bed/1-bath - UFAS unit - Range hood not  
front end controls and upper cabinets over 48  
inches (Critical Repair)

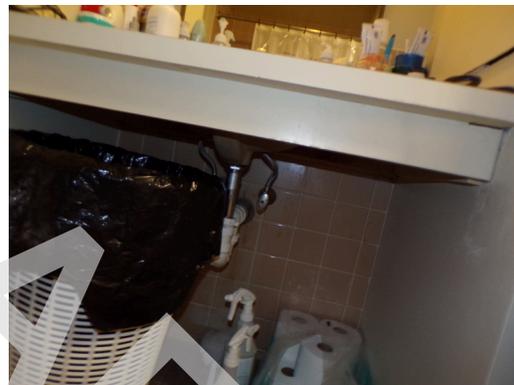
- The bathrooms in UFAS units 111 and 114 were missing rear grab bars for the toilets (Critical Repair).
- The designated UFAS dwelling units were observed without scald and abrasion protection in select units in bathrooms and kitchens (Critical Repair).

Apartment building 1 - Apartment 114 - 2-bed/1-bath - UFAS unit - bathroom sink missing scald and abrasion protection (Critical Repair)

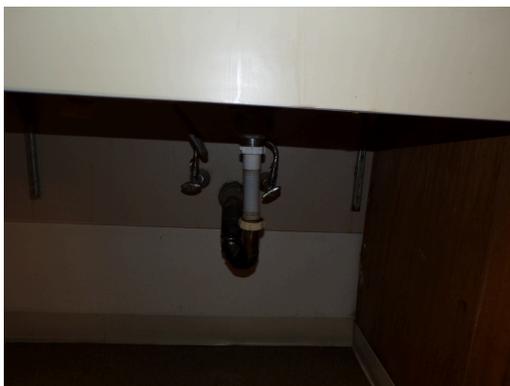
Apartment building 1 - Apartment 111 - 1-bed/1-bath - UFAS unit - kitchen sink missing scald and abrasion protection (Critical Repair)

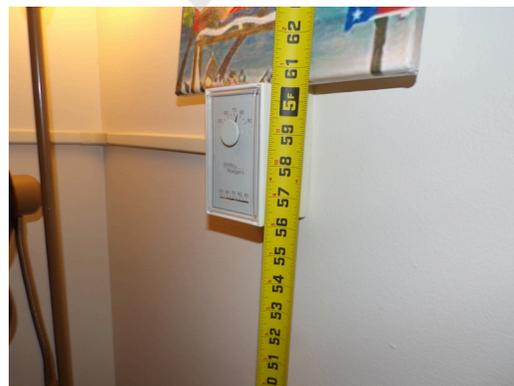
Apartment building 1 - Apartment 111 - 1-bed/1-bath - UFAS unit - heat control thermostat over 48 inches (Critical Repair)

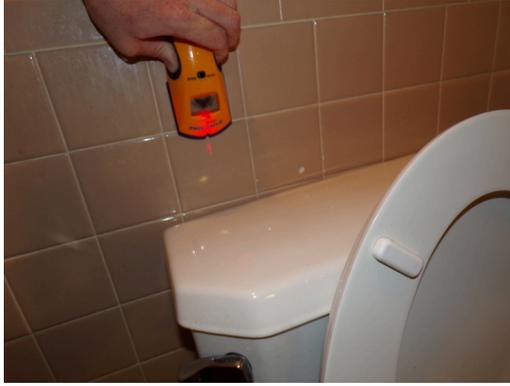
Apartment building 1 - Apartment 111 - 1-bed/1-bath - UFAS unit - bathroom missing rear grab bar (Critical Repair)

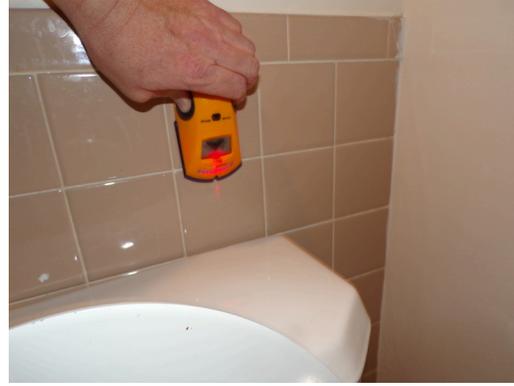
Apartment building 1 - Apartment 111 - 1-bed/1-bath - UFAS unit - bathroom missing rear grab bar (Critical Repair)

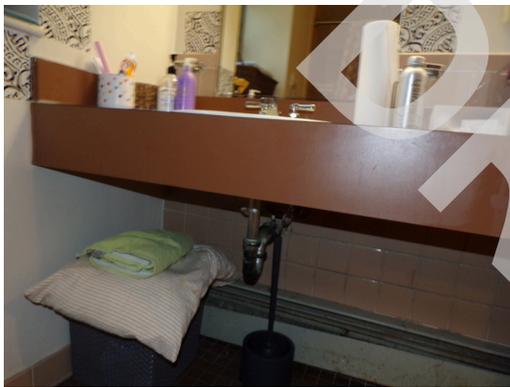
Apartment building 2 - Apartment 212 - 1-bed/1-bath - UFAS unit - bathroom sink missing scald and abrasion protection (Critical Repair)

Common area bath accessories (towel bars, grab bars, toilet stalls, etc.)	Install Scald and Abrasion Sink Wrap (Critical Repair)	Women's public restroom, and UFAS HDCP units	Repair	19	Each	\$ 80.00	\$ 1,520.00	The designated handicapped unit sinks and the common area women's restroom sinks were observed without scald and abrasion protection at the roll under sink. In order to comply with the Uniformed Federal Accessibility Standards (UFAS), the installation of scald and abrasion protection is required.
Common area bath accessories (towel bars, grab bars, toilet stalls, etc.)	Install Compliant Grab Bars (Critical Repair)	Dwelling units 111 and 114	Repair	2	Each	\$ 250.00	\$ 500.00	The bathroom in units 111 and 114 were observed missing rear grab bars behind the toilet. In order to comply with the Uniformed Federal Accessibility Standards (UFAS), the installation of compliant grab bars is required.

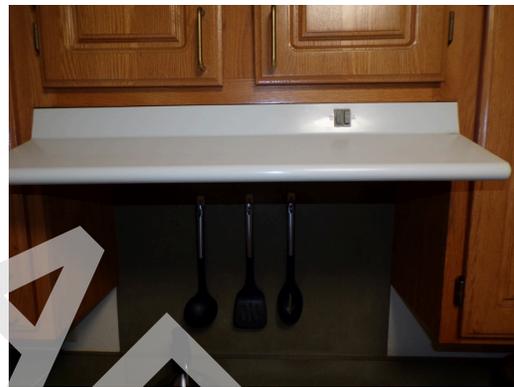
Apartment building 2 - Apartment 214 - 2-bed/1-bath - UFAS unit - Range hood missing front end controls and over 48 inches (Critical Repair)

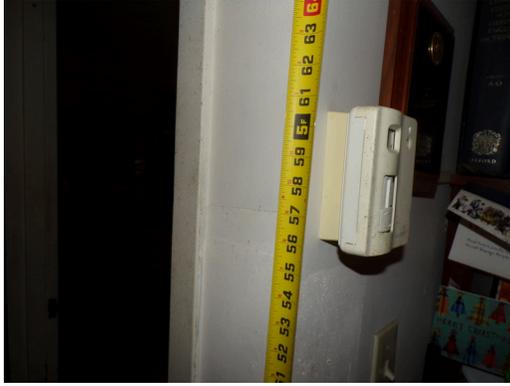
Apartment building 2 - Apartment 211 -  
1-bed/1-bath - heat control thermostat

Dwelling/common area thermostat	Lower Thermostats (Critical Repair)	Select UFAS dwelling units	Repair	2	Each	\$ 125.00	\$ 250.00	Select thermostats in the UFAS dwelling units were measured over 48 inches above the finished floor (AFF). In order to comply with the Uniformed Federal Accessibility Standards (UFAS), lowering the thermostats to maximum height of 48-inches AFF is required.
Faucets & valves	Public Restroom Faucet Hardware (Critical Repair)	Public men's and women's restroom	Repair	2	Each	\$ 125.00	\$ 250.00	AEI observed the faucet hardware in the public men's and women's restroom without levered faucet hardware. Installing levered faucet hardware is required.
<b>CRITICAL REPAIRS (LIFE SAFETY)</b>								
Concrete	Correct Concrete Sidewalk Trip Hazards (Critical Repair)	Throughout site	Repair	4	Each	\$ 750.00	\$ 3,000.00	Select sections throughout property of concrete sidewalk were observed with abrupt elevation changes, resulting in tripping hazards. In order to prevent injury to a resident, repair of trip hazards is required.

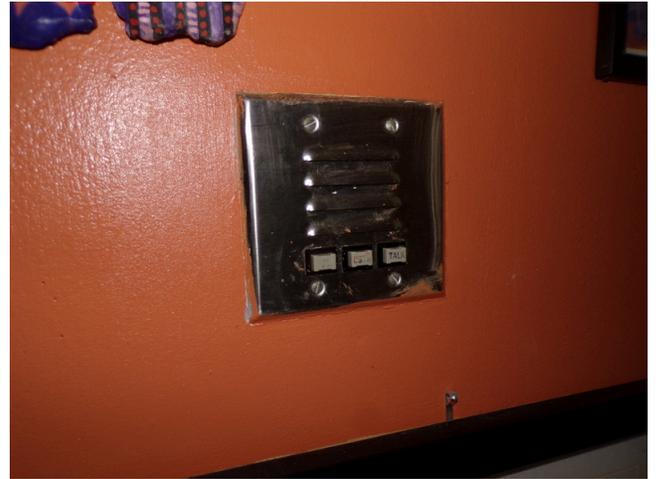
2. Apartment building 1 - Apartment 166 - 1-bed/  
1-bath - intercom (Non-Critical Repair)

Drywall	Repair Damaged Drywall (Non-Critical Repair)	Men's public restroom	Repair	1	Each	\$ 300.00	\$ 300.00	The drywall in the men's public restroom was observed damaged. In order to prevent further damage, the repair of the drywall is recommended.
Earthwork, swales, drainways, erosion controls	Bare ground (Non-Critical Repair)	Throughout site	Repair	3	Each	\$ 500.00	\$ 1,500.00	Areas of bare ground were observed throughout the property. In order to prevent further erosion and to improve the condition of the property, reseeding of the areas of bare ground is recommended.
Bath/kitchen vent/exhaust fans	Bathroom Ventilation (Non-Critical Repair)	Unit 166	Repair	1	Each	\$ 125.00	\$ 125.00	AEI observed the bathroom ventilation fan missing in dwelling unit 166. Replacing the bathroom ventilation fan is recommended.
Tenant buzzer / intercom /secured entry system	Intercom System (Non-Critical Repair)	Apartment buildings	Level 1 Alteration	116	Each	\$ 300.00	\$ 34,800.00	AEI observed the intercom system throughout the building past the estimated useful life (EUL). Replacing the intercom system is recommended.

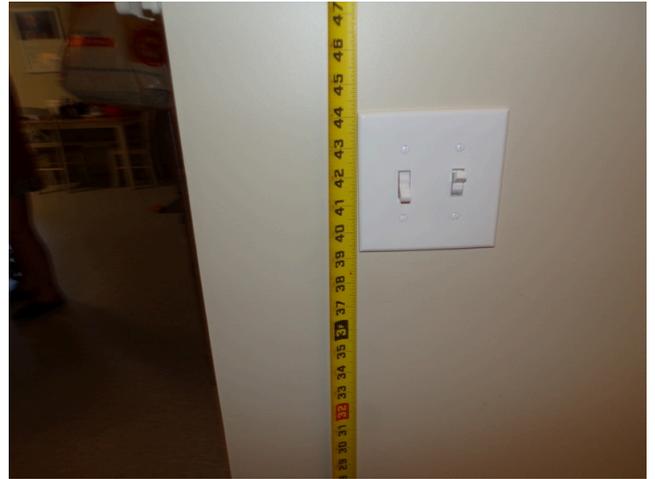
77. Apartment building 1 - Apartment 125 - 2-bed/  
1-bath - UFAS unit - heat thermostat

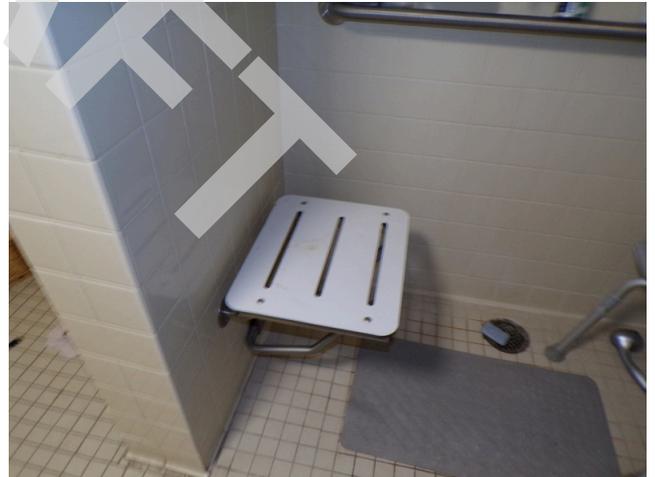
79. Apartment building 1 - Apartment 125 - 2-bed/  
1-bath - UFAS unit - roll-in shower

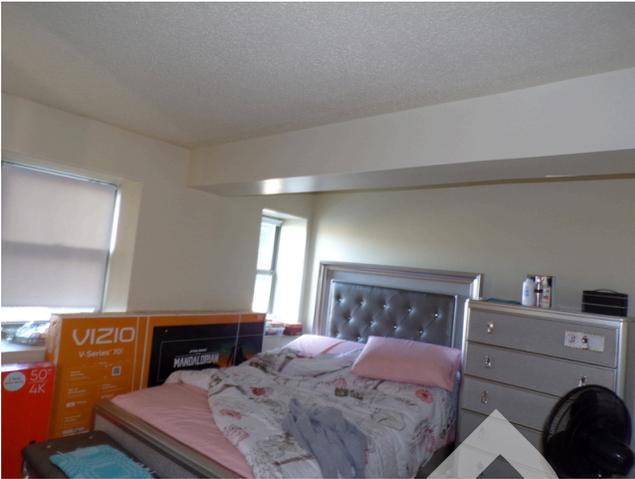
80. Apartment building 1 - Apartment 125 - 2-bed/  
1-bath - UFAS unit - roll-in shower bench

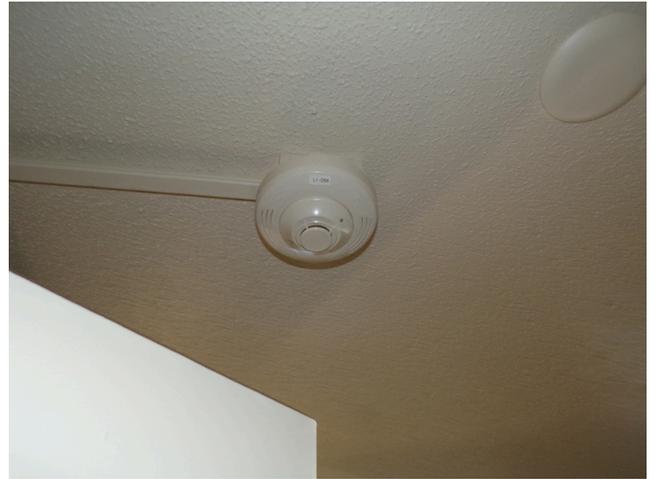
81. Apartment building 1 - Apartment 125 - 2-bed/  
1-bath - UFAS unit - bedroom

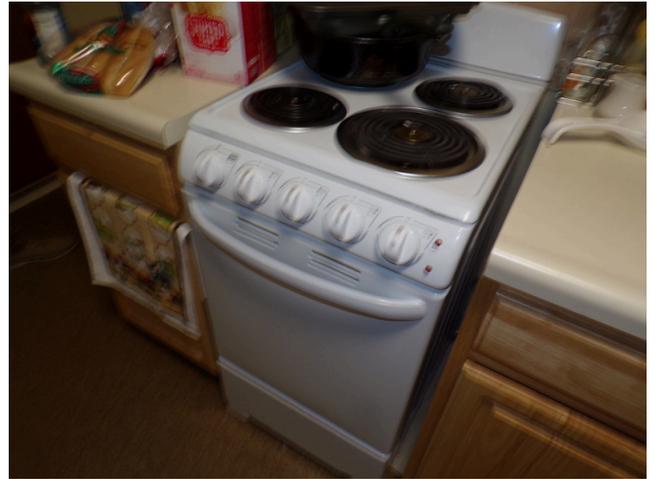
85. Apartment building 1 - Apartment 118 - 1-bed/  
1-bath - kitchen

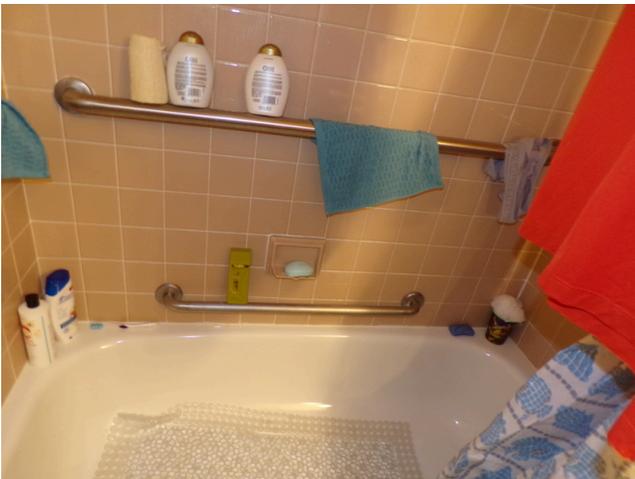
90. Apartment building 1 - Apartment 118 - 1-bed/  
1-bath - bathroom

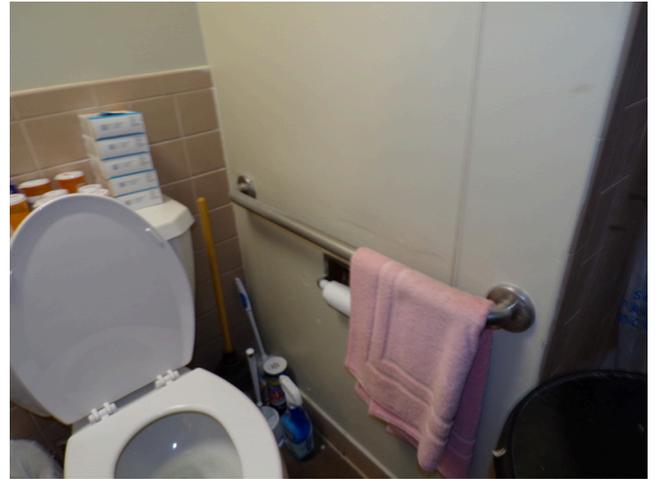
101. Apartment building 1 - Apartment 114 - 2-bed/  
1-bath - UFAS unit - bathroom

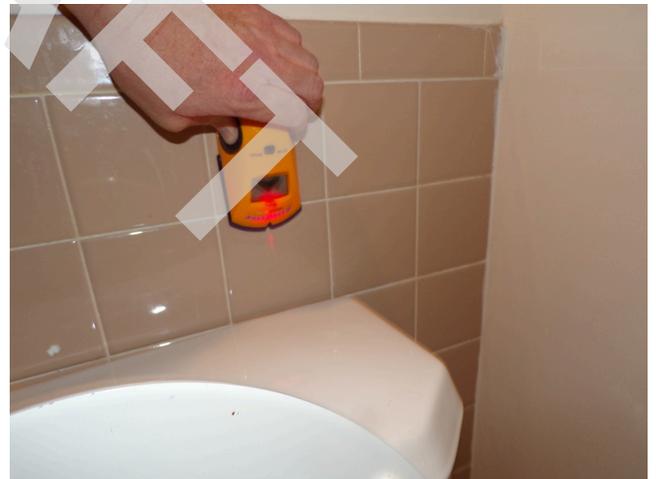
115. Apartment building 1 - Apartment 111 - 1-bed/  
1-bath - UFAS unit - bathroom missing rear grab bar  
(Critical Repair)

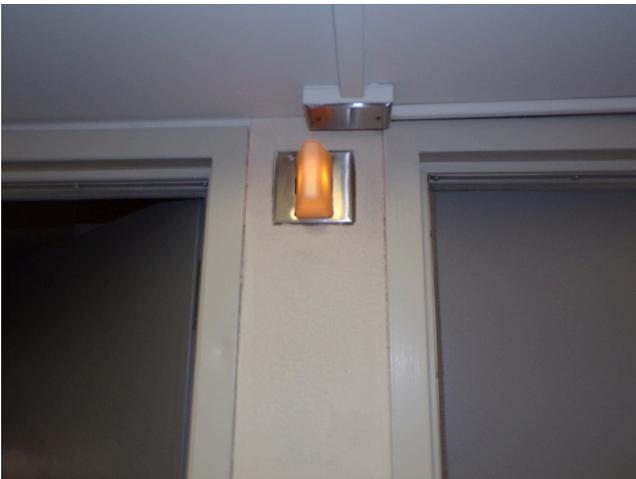
138. Apartment building 2 - Apartment 265 - 2-bed/  
1-bath - emergency call

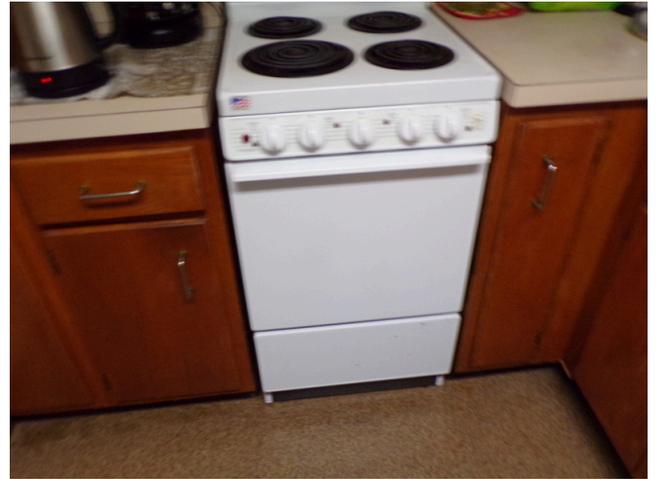
141. Apartment building 2 - Apartment 258 - 1-bed/  
1-bath - kitchen

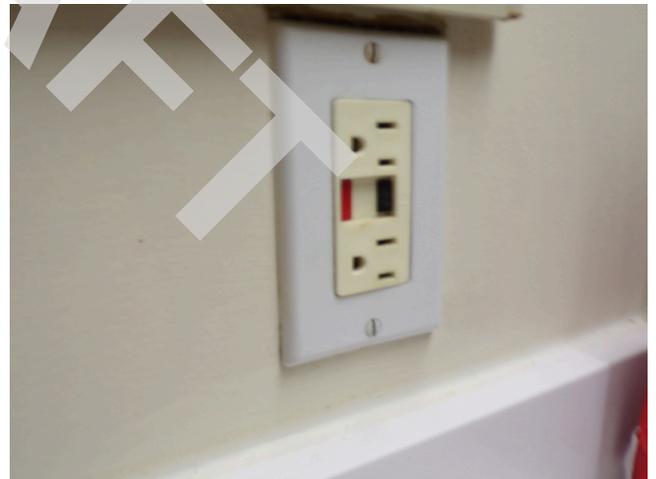
143. Apartment building 2 - Apartment 258 - 1-bed/  
1-bath - bathroom

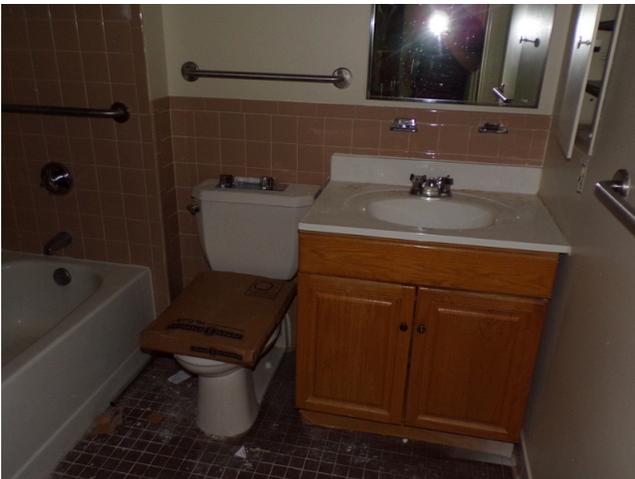
154. Apartment building 2 - Apartment 245 - 2-bed/  
1-bath - bathtub hardware (Non-Critical Repair)

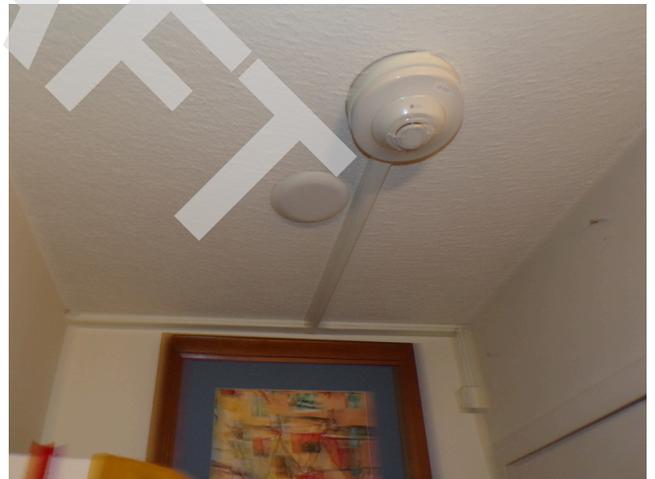
155. Apartment building 2 - Apartment 245 - 2-bed/  
1-bath - bathroom

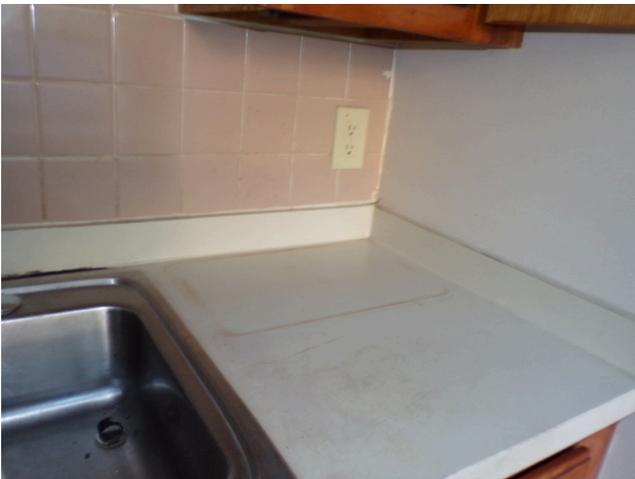
162. Apartment building 2 - Apartment 230 - 1-bed/  
1-bath - kitchen

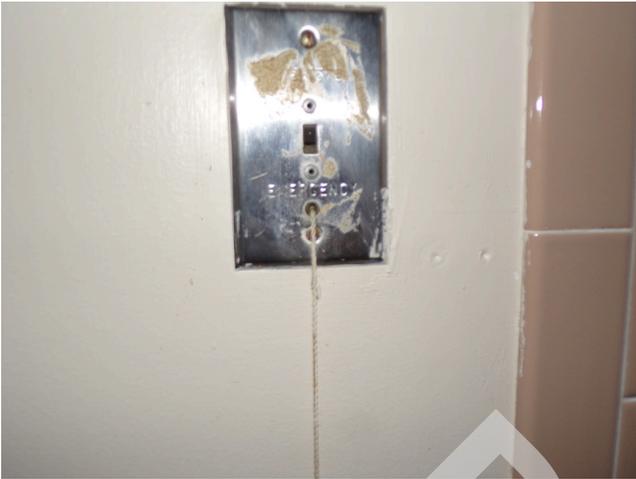
164. Apartment building 2 - Apartment 230 - 1-bed/  
1-bath - bathroom vanity

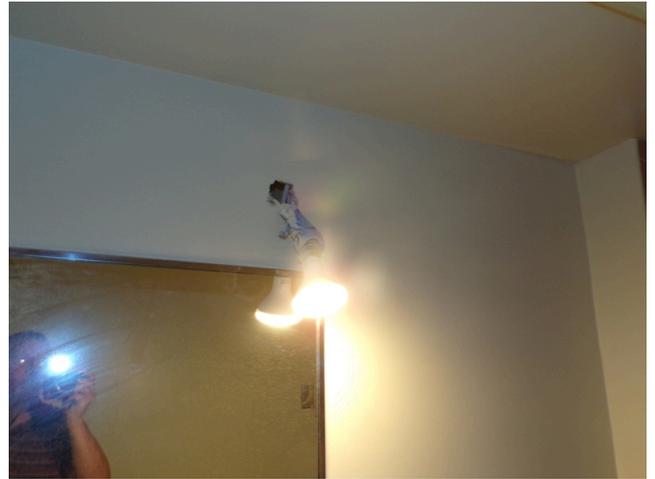
181. Apartment building 2 - Apartment 217 - 1-bed/  
1-bath - bathroom light (Non-Critical Repair)

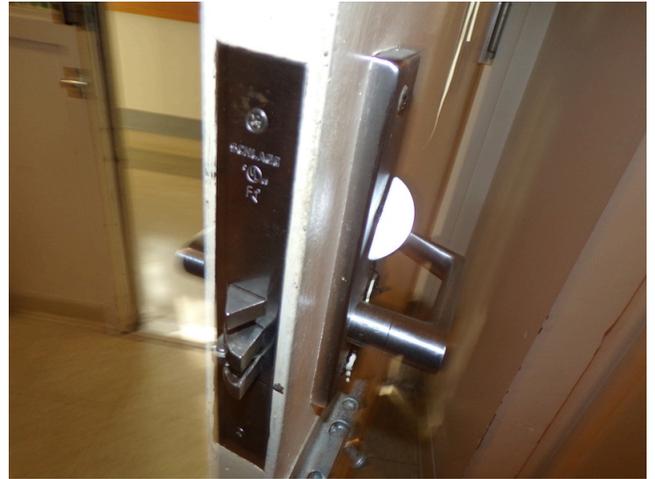
185. Apartment building 2 - Apartment 214 - 2-bed/  
1-bath - UFAS unit - main ingress/egress door  
damage (Non-Critical Repair)

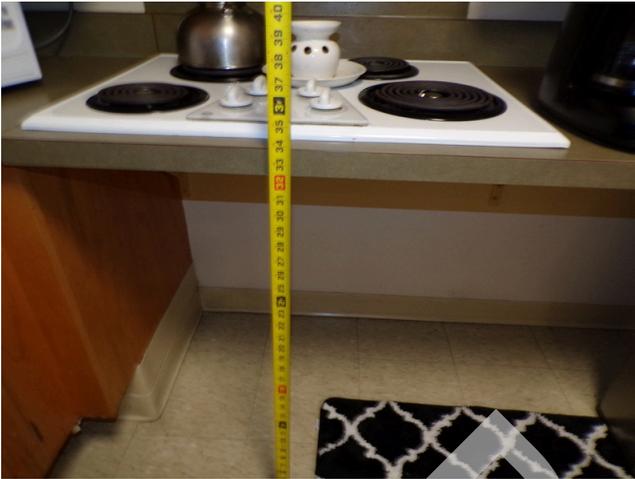
188. Apartment building 2 - Apartment 214 - 2-bed/  
1-bath - UFAS unit - Range hood missing front end  
controls and over 48 inches (Critical Repair)

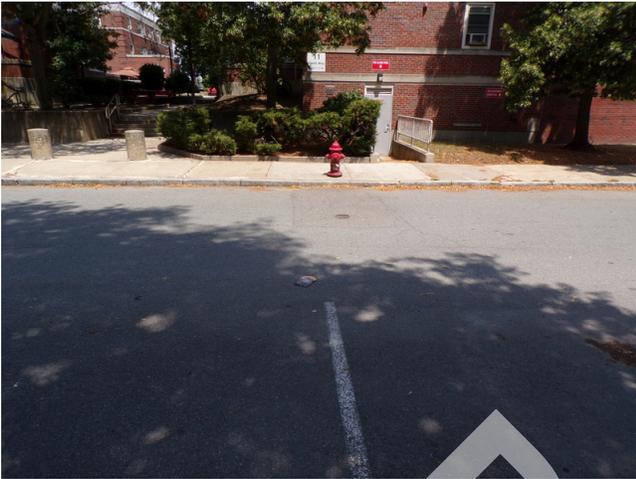
5. Fire hydrant

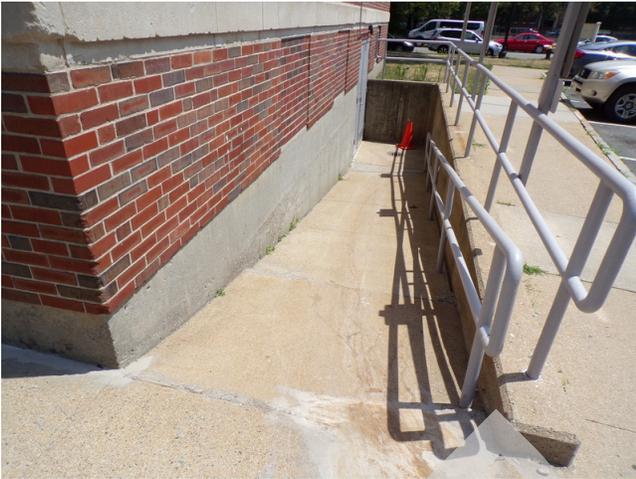
17. Apartment Building 1 basement ramp ingress/egress

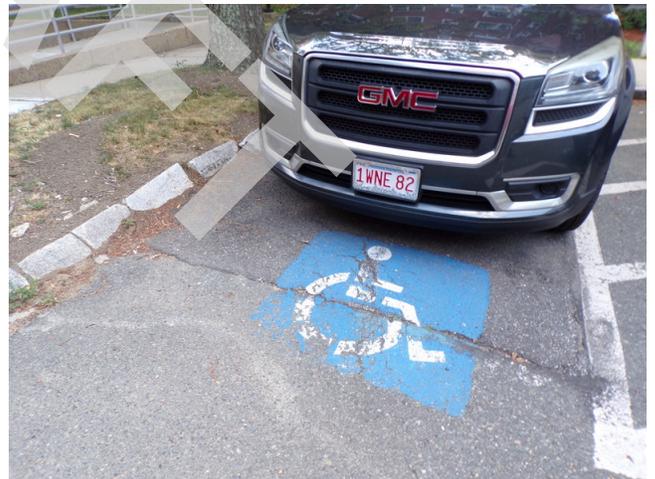
20. Apartment building 1 handicap parking seal coat asphalt (Non-Critical Repair)

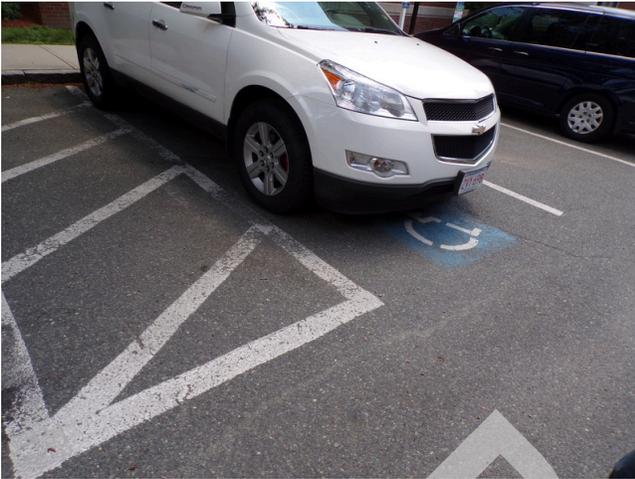
21. Apartment building 1 handicap parking seal coat asphalt (Non-Critical Repair)

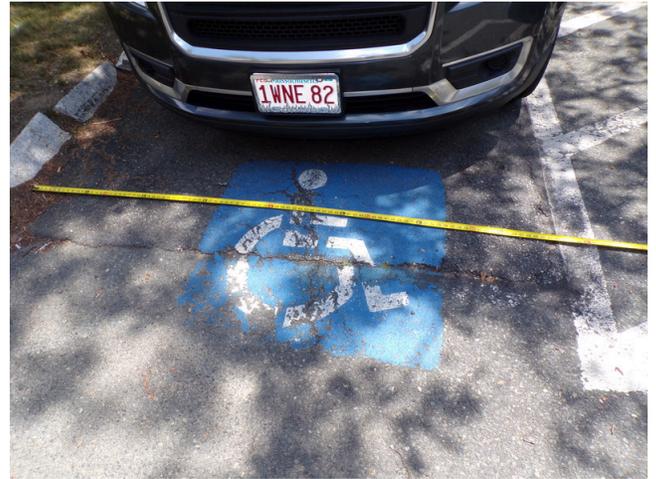
22. Apartment building 1 handicap parking seal coat asphalt (Non-Critical Repair)

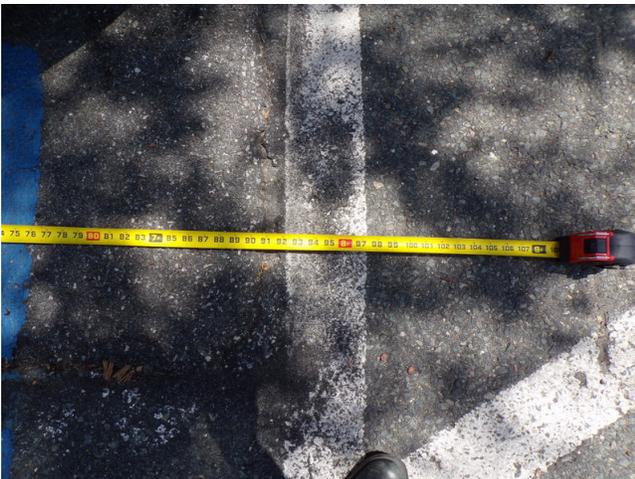
23. Apartment building 1 handicap parking seal coat asphalt (Non-Critical Repair)

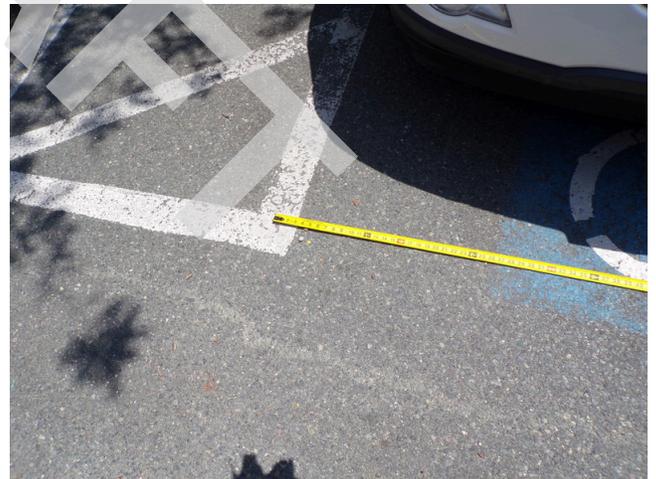
24. Apartment building 1 handicap parking seal coat asphalt (Non-Critical Repair)

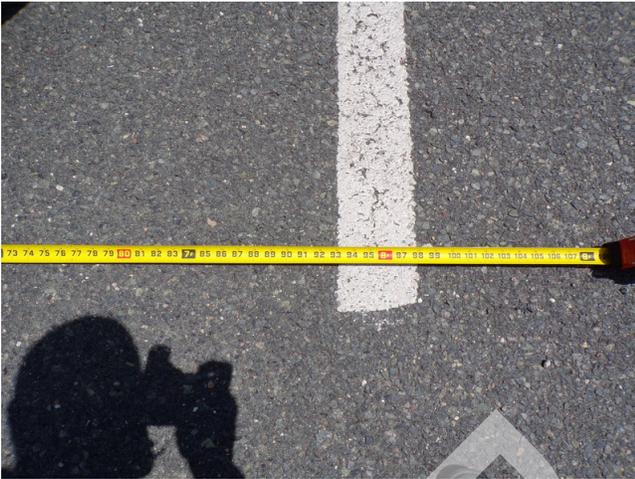
25. Apartment building 1 handicap parking seal coat asphalt (Non-Critical Repair)

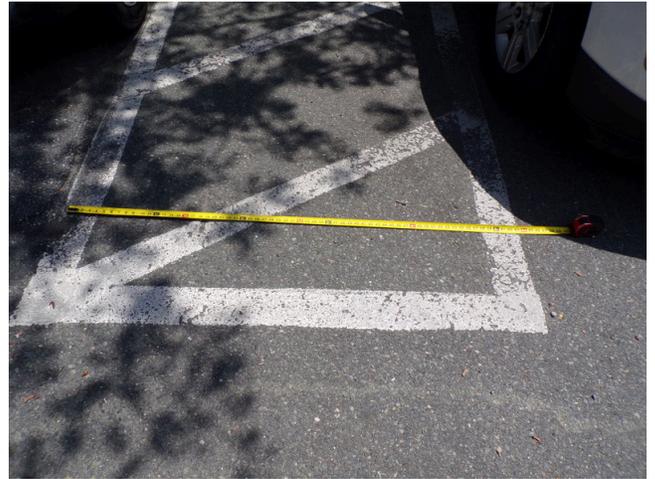
26. Apartment building 1 handicap parking seal coat asphalt (Non-Critical Repair)

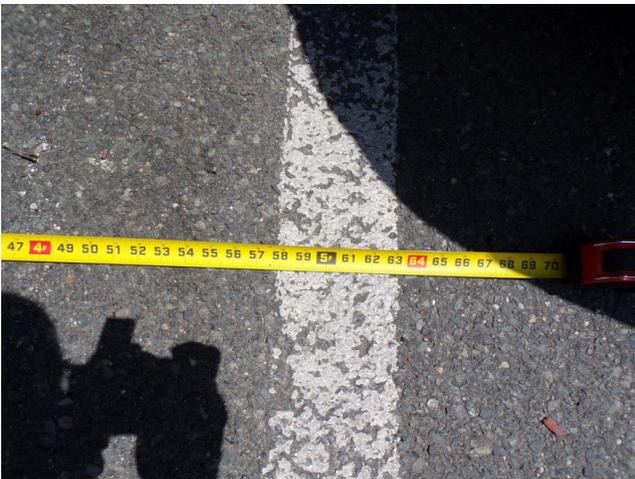
27. Apartment building 1 handicap parking seal coat asphalt (Non-Critical Repair)

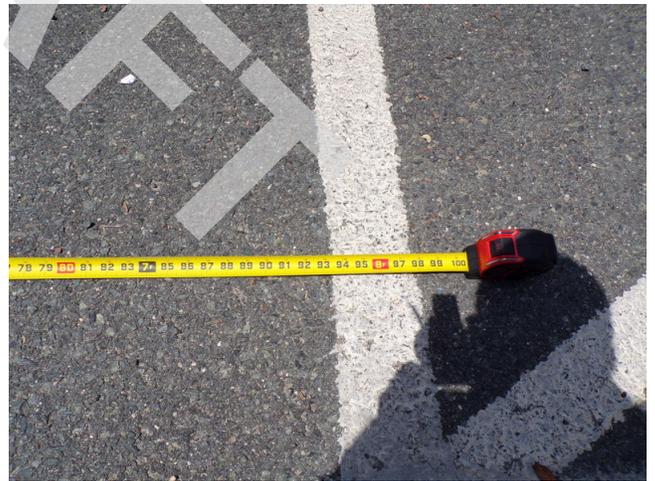
32. Apartment building 1 handicap parking seal coat asphalt (Non-Critical Repair)

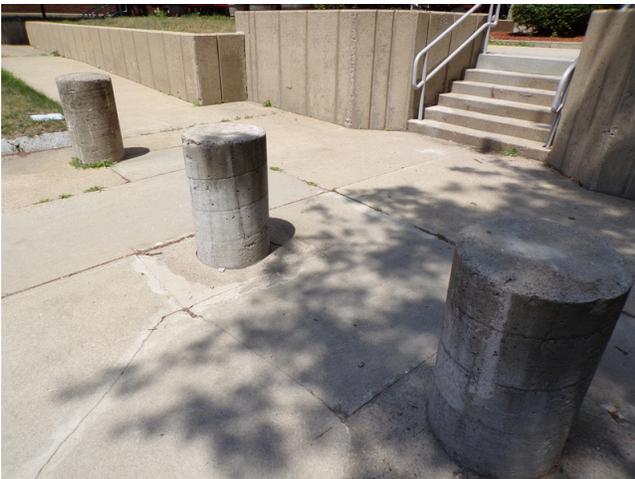
35. Apartment buildings 1 and 2 main ingress/egress sidewalks trip hazard (Critical Repair)

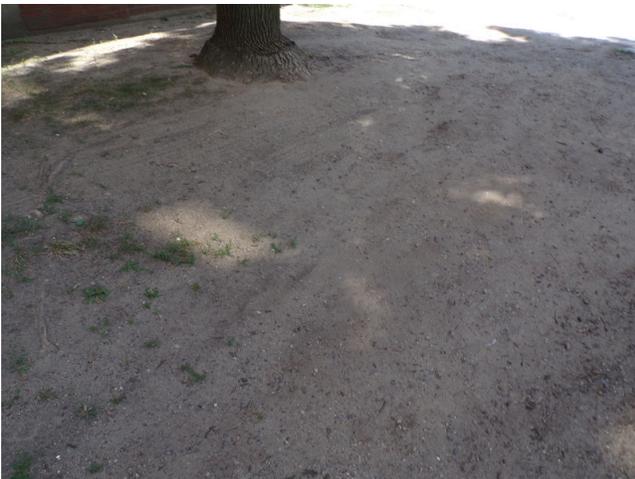
39. Apartment building 2 bare ground (Non-Critical Repair)
