## HUD CAPITAL NEEDS ASSESSMENT

Commonwealth Elderly  
35 Fidelis Way  
Boston, Massachusetts 02135

AEI Project No. 463345  
Site Inspection Date: July 20 and 21, 2022

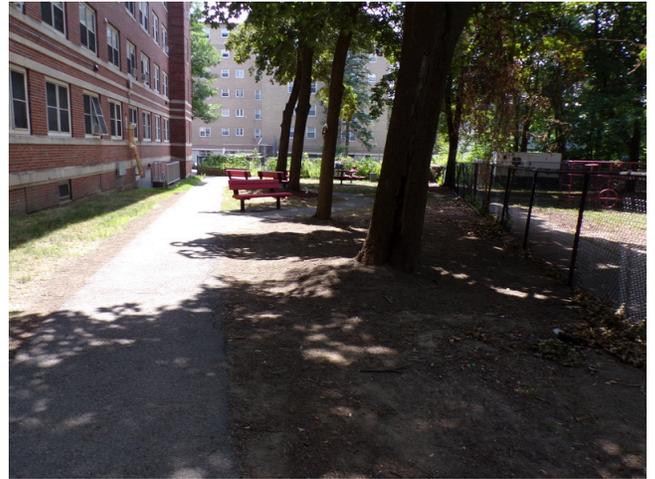
42. Apartment building 2 park area bare ground  
(Non-Critical Repair)

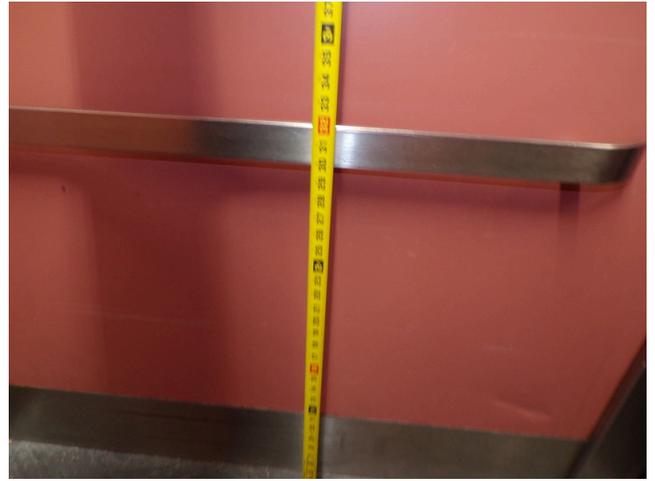
51. Apartment building 1 elevator cab floor (Non-Critical Repair)

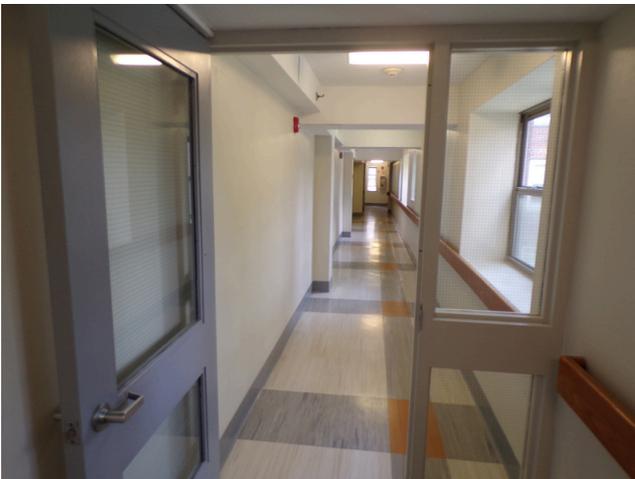
54. Apartment building 1 common area hallway fire extinguisher

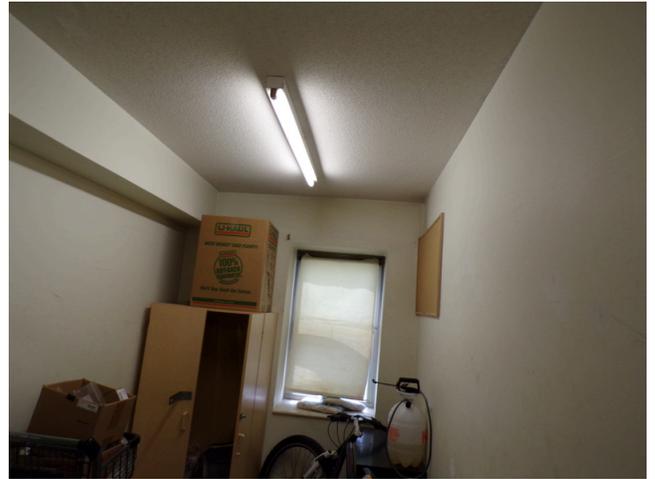
57. Apartment building 1 common area BHA (Boston Housing Authority) storage area

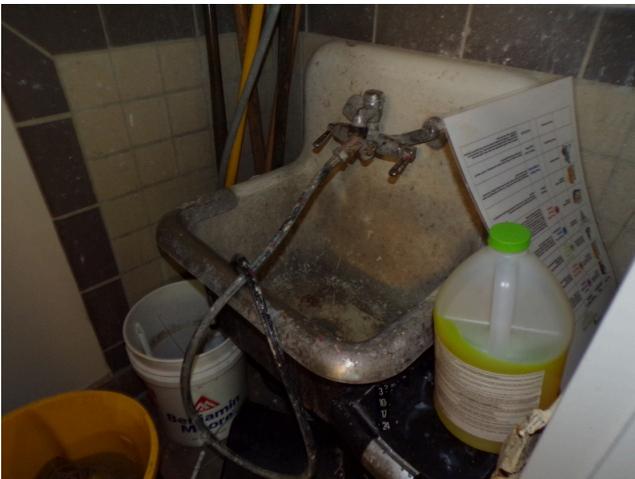
58. Apartment building 1 common area BHA (Boston Housing Authority) storage area

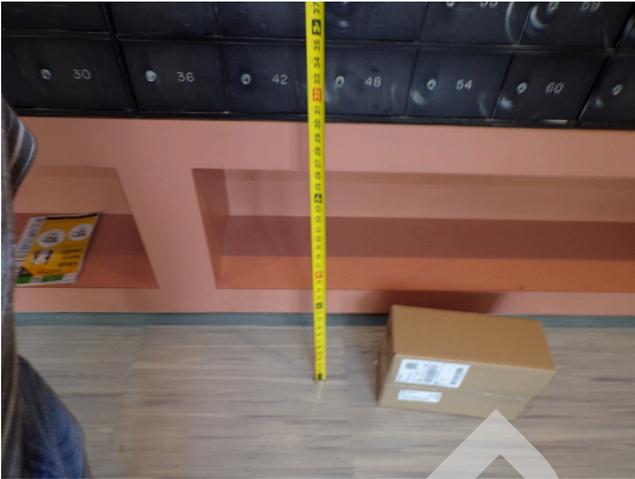
60. Apartment buildings 1 and 2 mailboxes

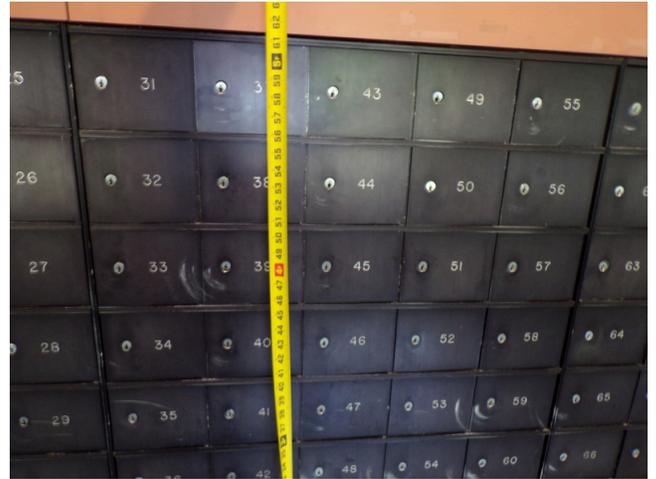
61. Apartment buildings 1 and 2 mailboxes

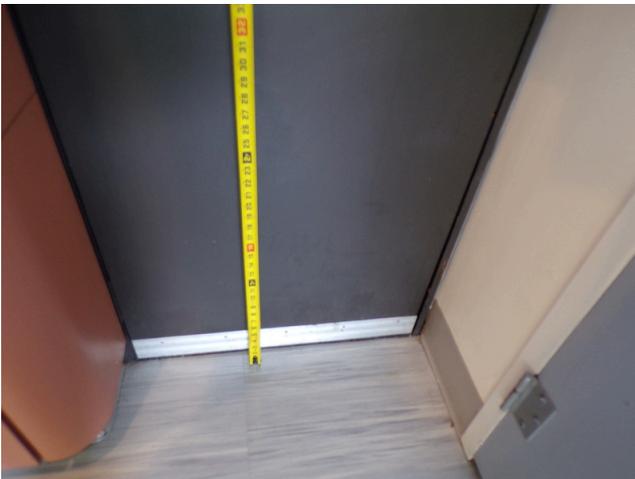
62. Apartment buildings 1 and 2 mailboxes

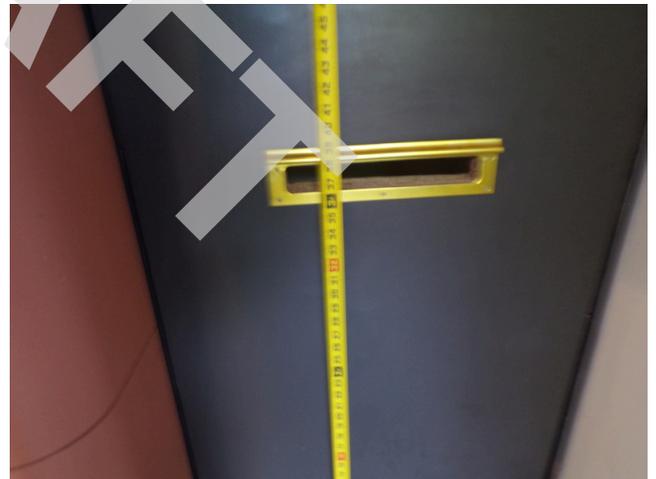
63. Apartment buildings 1 and 2 rent drop box

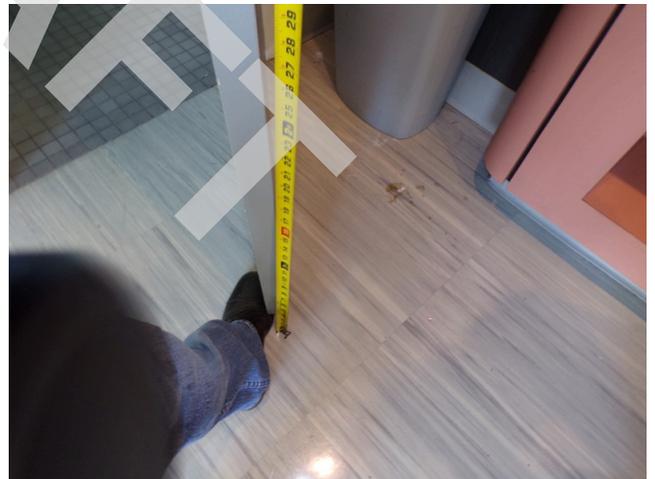
67. Apartment buildings 1 and 2 women's public restroom door hardware

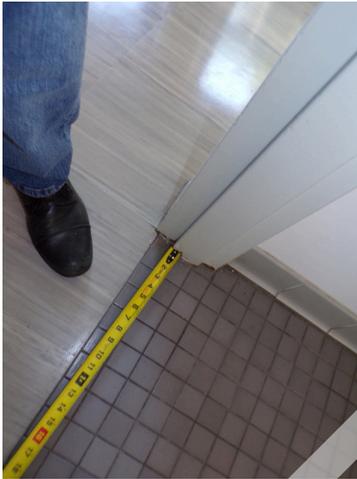
68. Apartment buildings 1 and 2 women's public restroom main ingress/egress door hardware

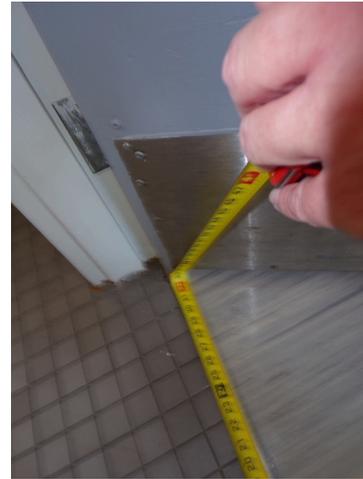
69. Apartment buildings 1 and 2 women's public restroom doorway floorspace

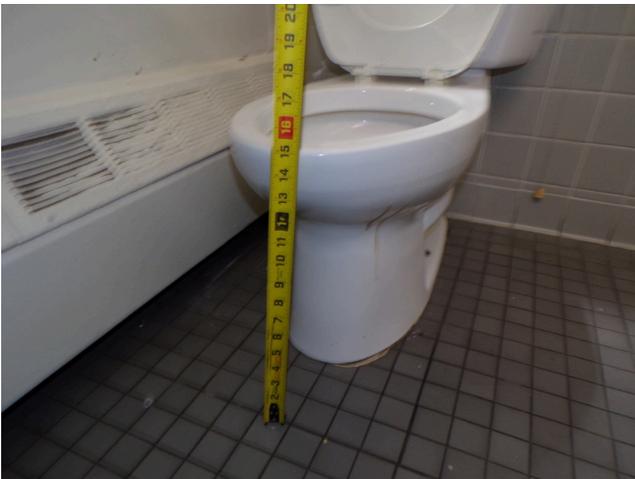
74. Apartment buildings 1 and 2 women's public restroom toilet

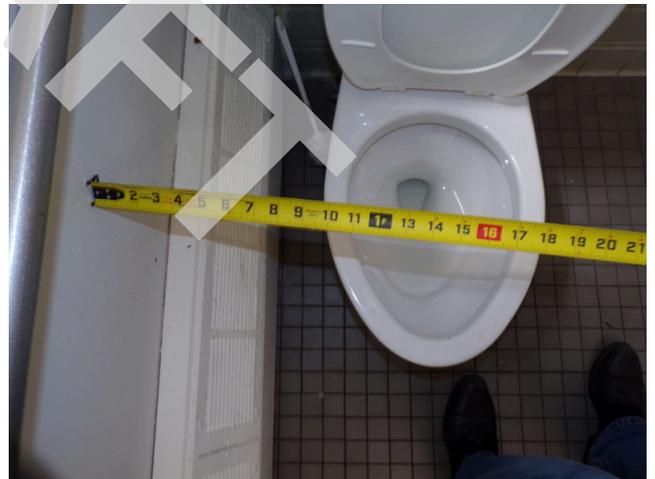
75. Apartment buildings 1 and 2 women's public restroom toilet

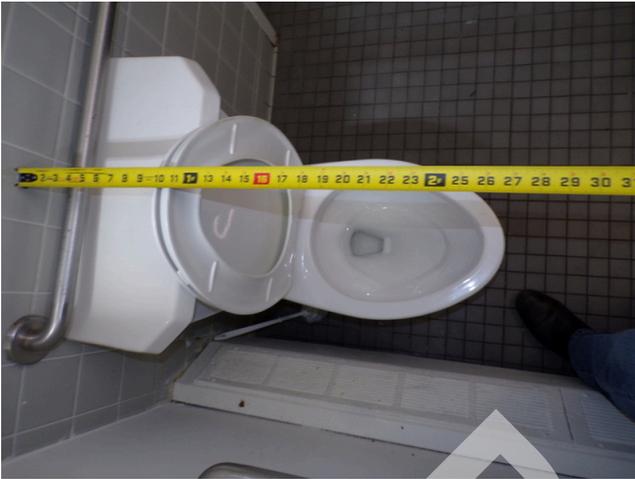
76. Apartment buildings 1 and 2 women's public restroom toilet

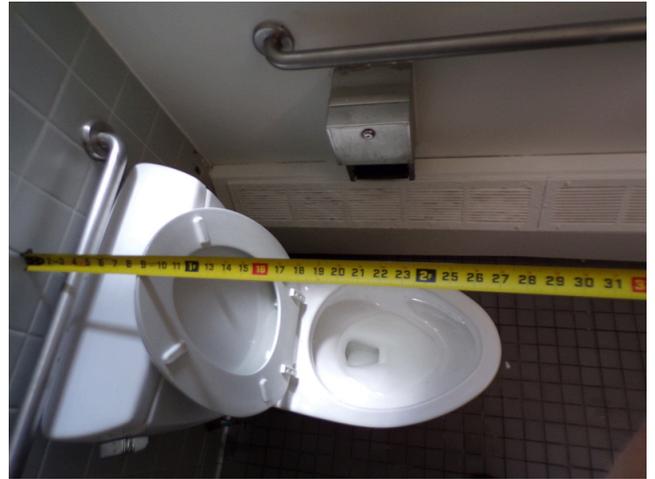
85. Apartment buildings 1 and 2 men's public restroom toilet

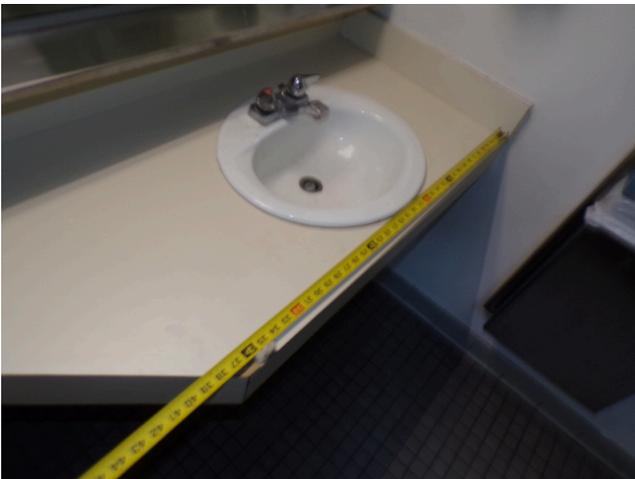
86. Apartment buildings 1 and 2 men's public restroom toilet

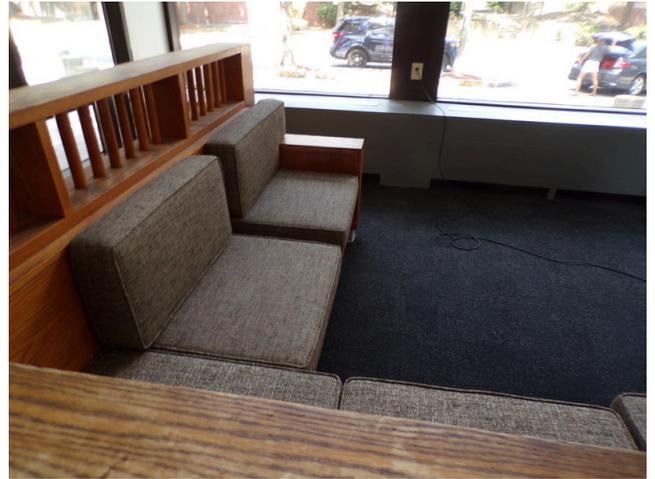
89. Apartment buildings 1 and 2 common area radiator

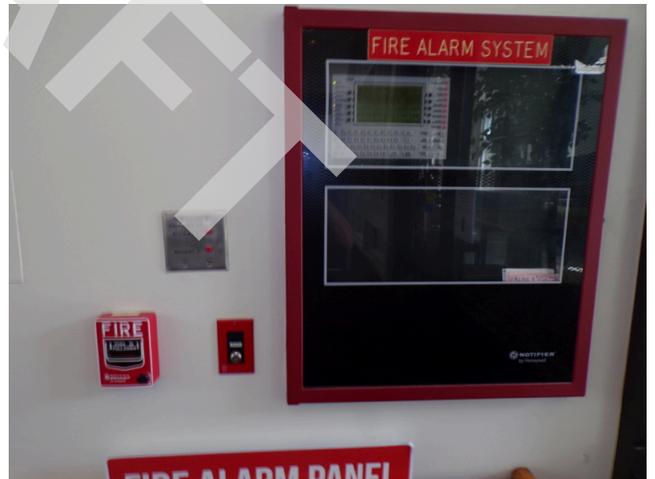
91. Apartment buildings 1 and 2 interior sedentary stairs

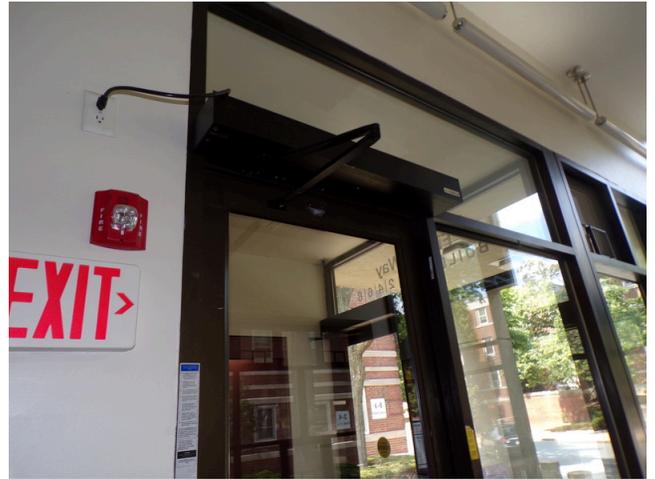
93. Apartment buildings 1 and 2 main ingress/egress doorway

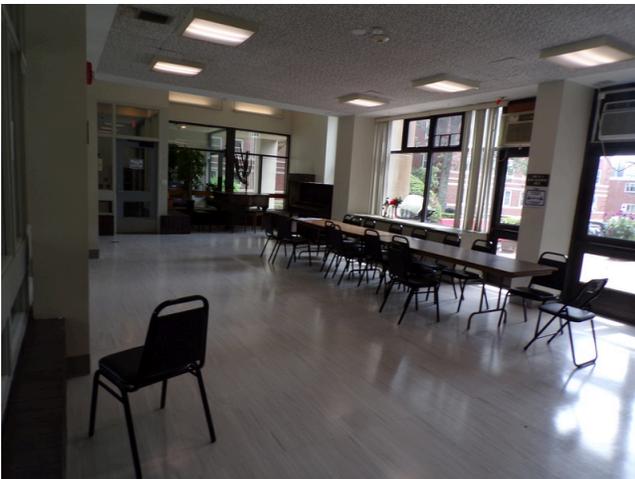
94. Apartment buildings 1 and 2 main ingress/egress doorway

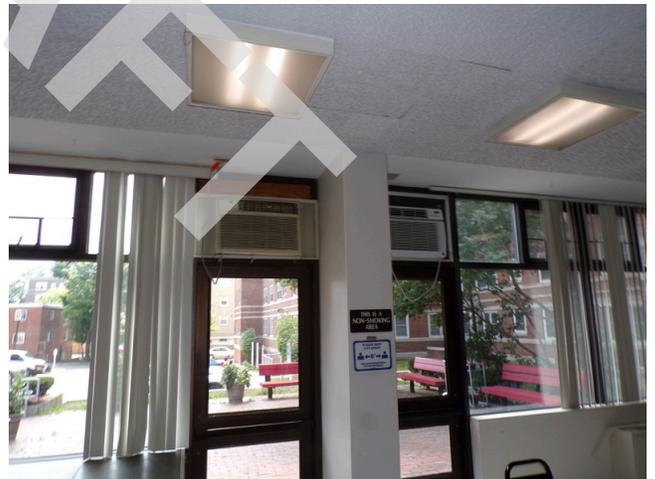
96. Apartment buildings 1 and 2 community room air conditioning window mounted units

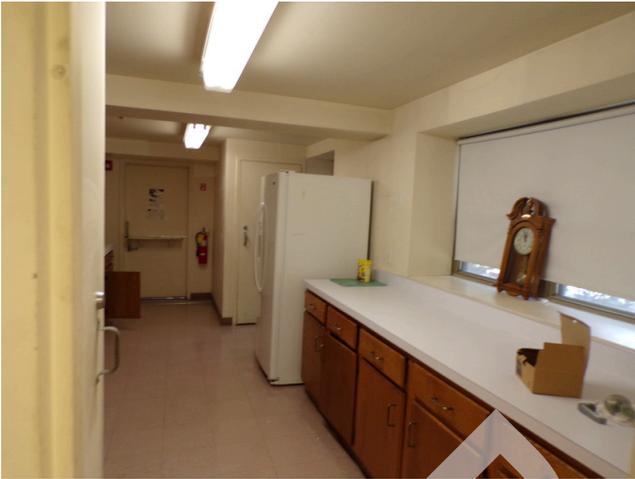
97. Apartment buildings 1 and 2 community room kitchen

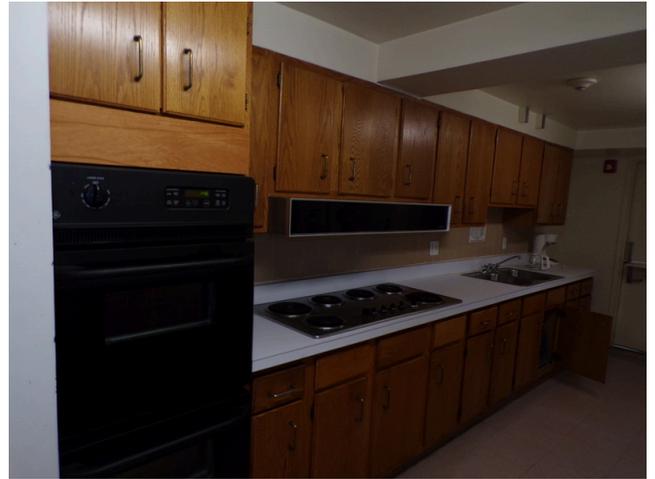
98. Apartment buildings 1 and 2 community room kitchen range and oven

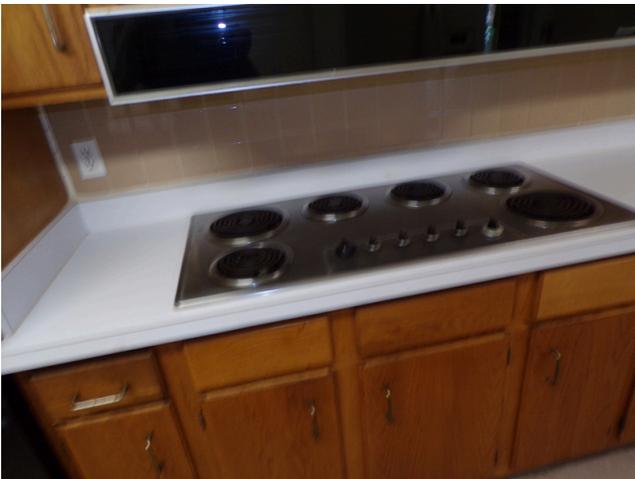
99. Apartment buildings 1 and 2 community room range

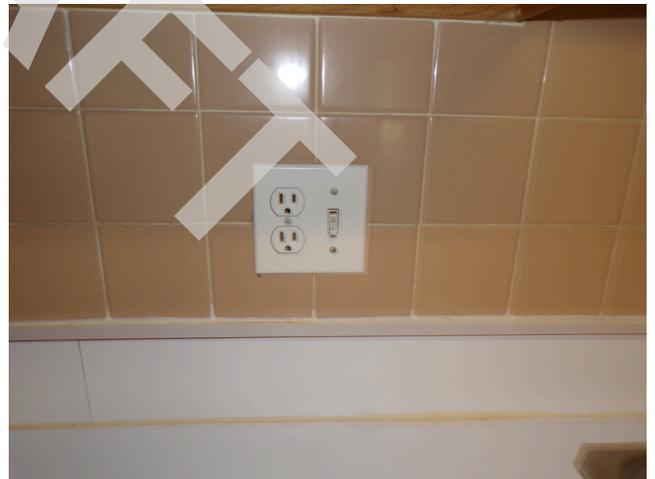
100. Apartment buildings 1 and 2 community room kitchen missing GFCI (Critical Repair)

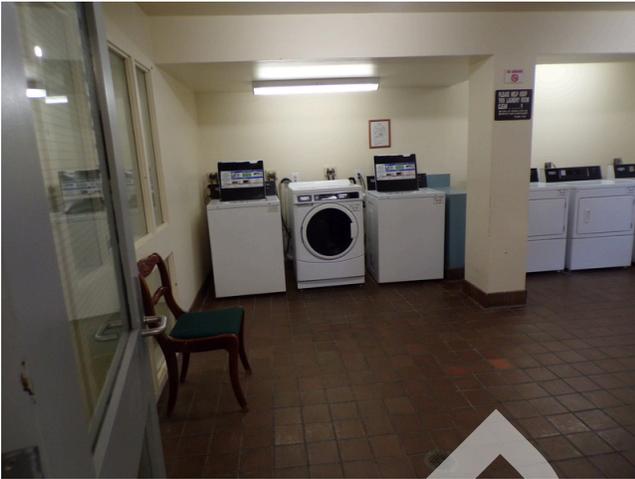
101. Apartment building 2 laundry room

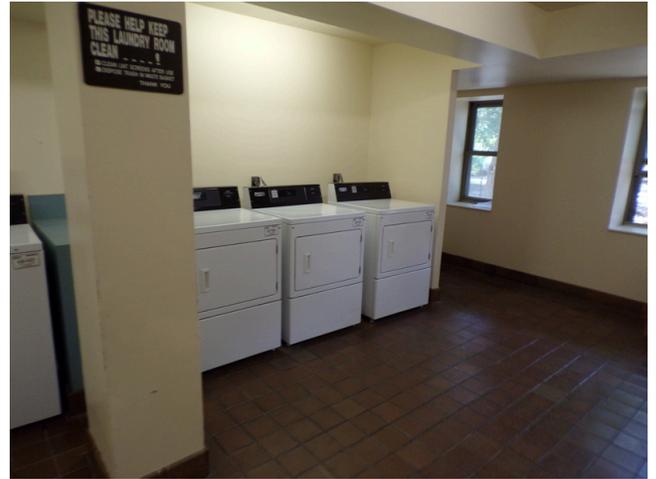
102. Apartment building 2 laundry room

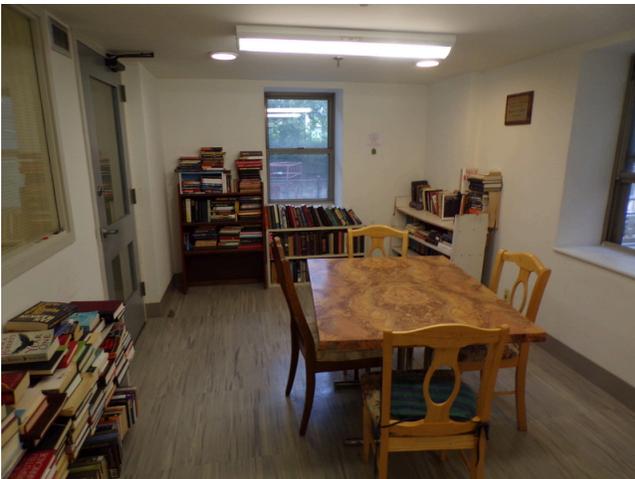
103. Apartment building 2 library

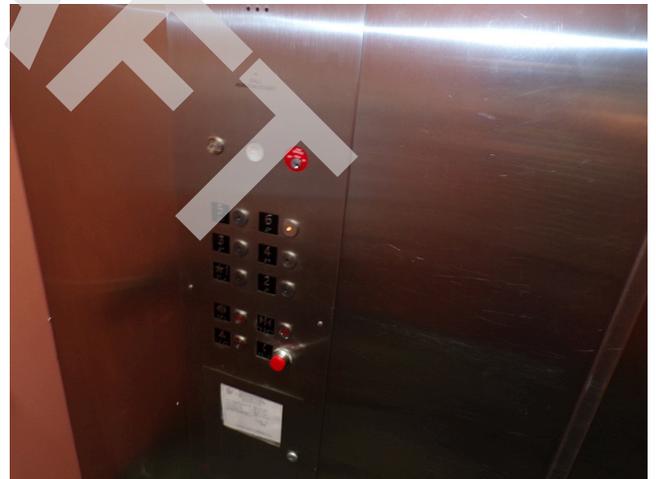
104. Apartment building 2 elevator cab control buttons

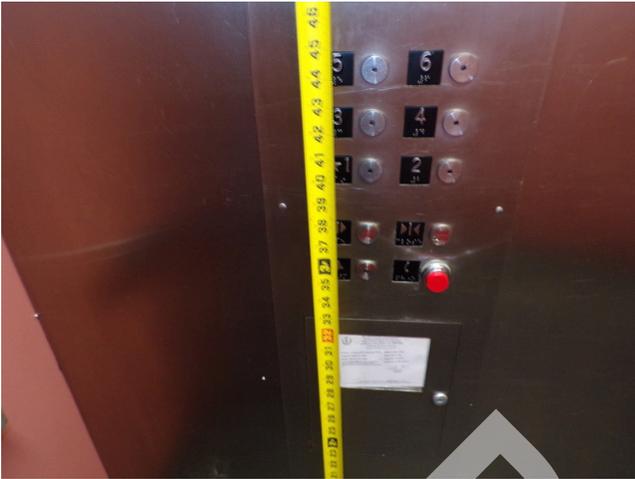
105. Apartment building 2 elevator cab control buttons

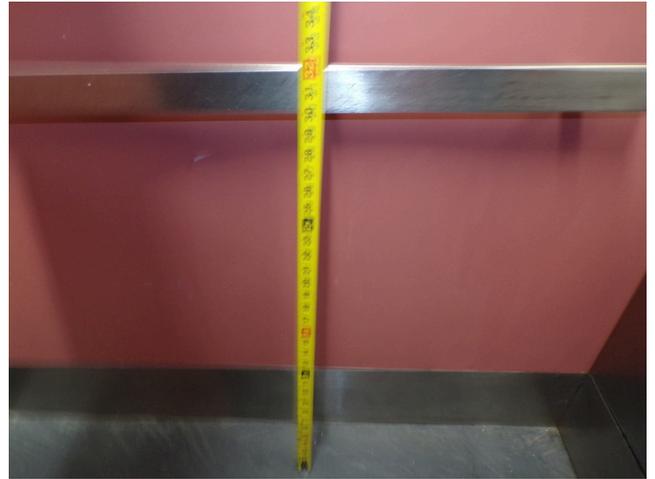
106. Apartment building 2 elevator cab support bar

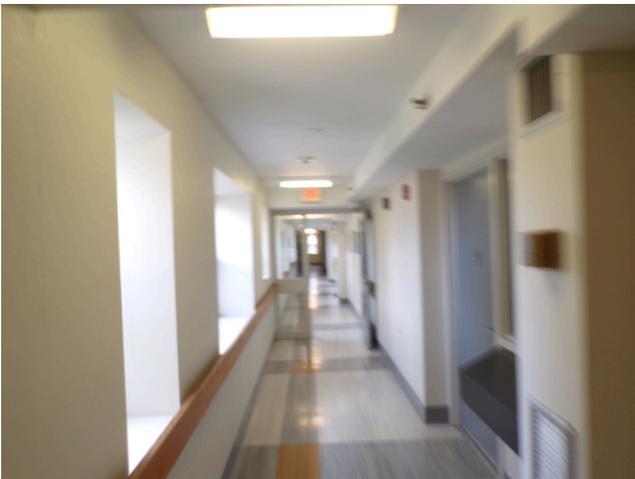
107. Apartment building 2 typical common hallway

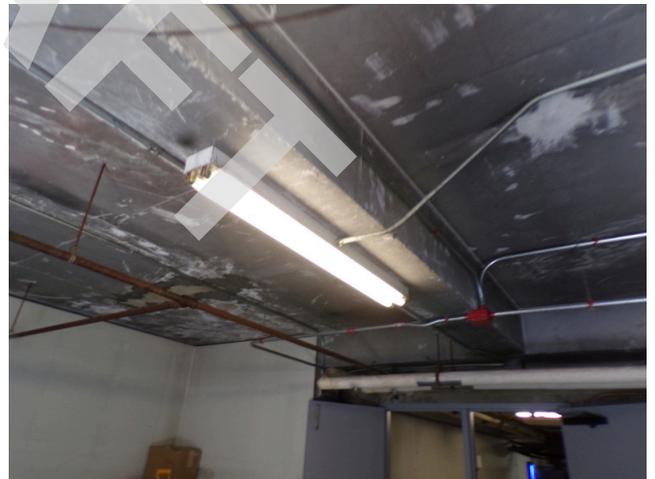
108. Apartment building 2 basement light fixture

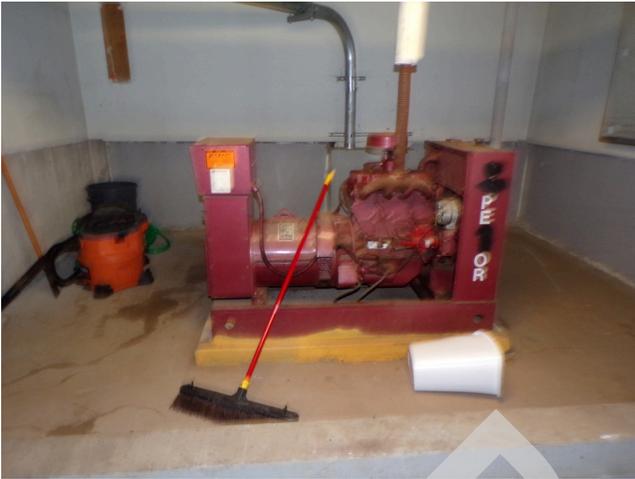
109. Apartment buildings 1 and 2 inoperable fire sprinkler system generator (Critical Repair)

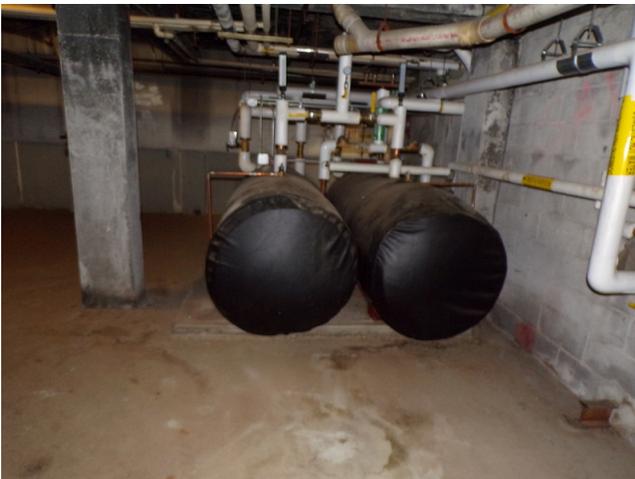
111. Apartment building 2 hot water storage tanks

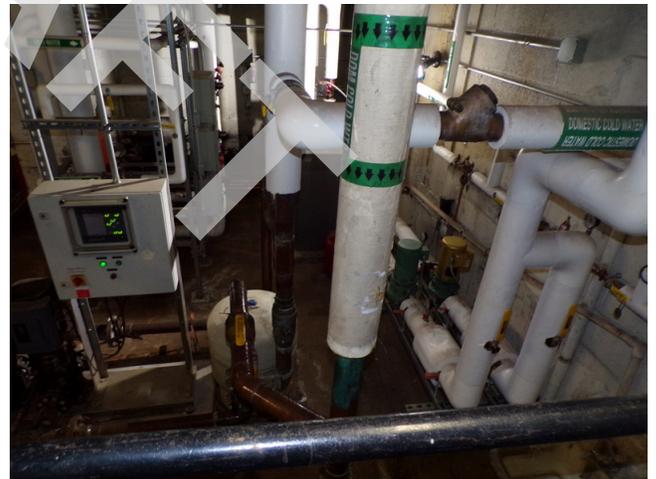
112. Apartment building 2 PVC pipes

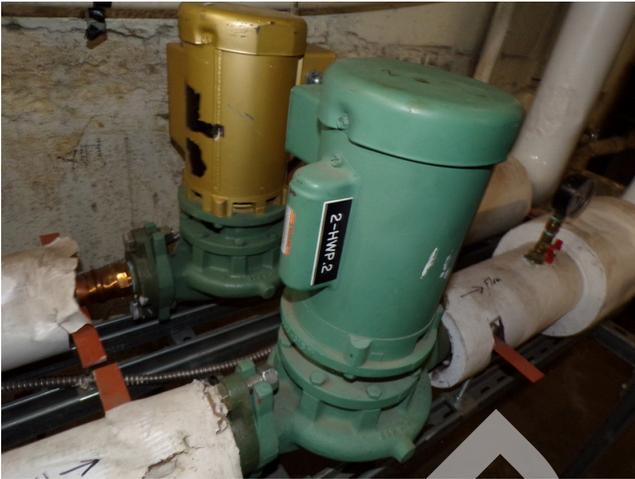
113. Apartment building 2 hot water circulation pumps

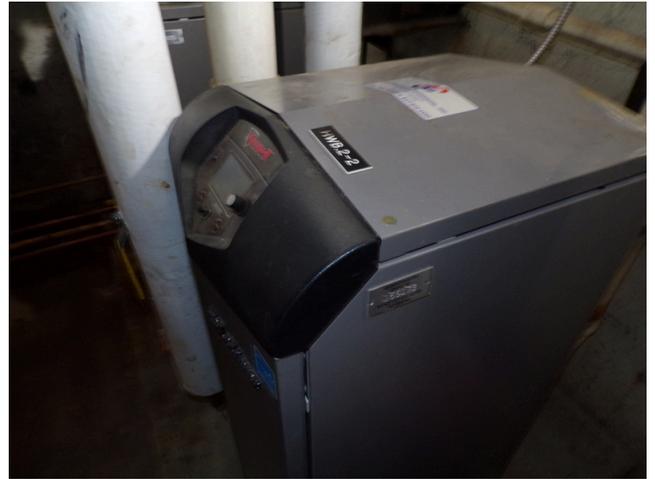
114. Apartment building 2 hot water heater boilers

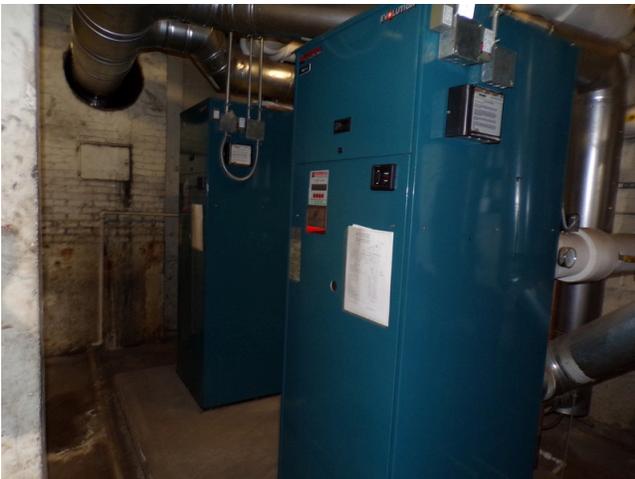
115. Apartment building 2 heating boilers

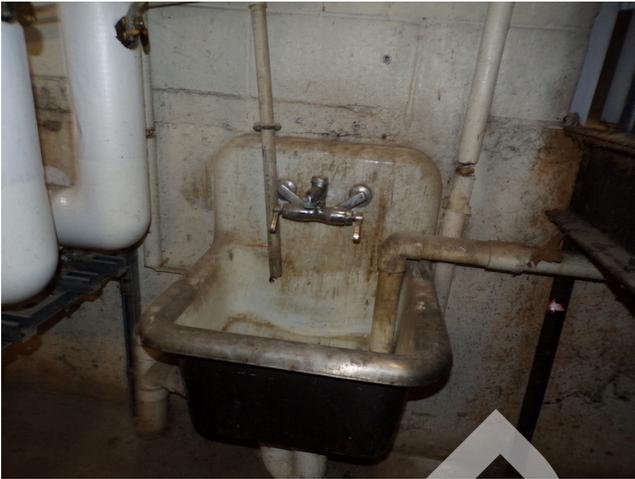
117. Apartment building 2 boiler room utility sink

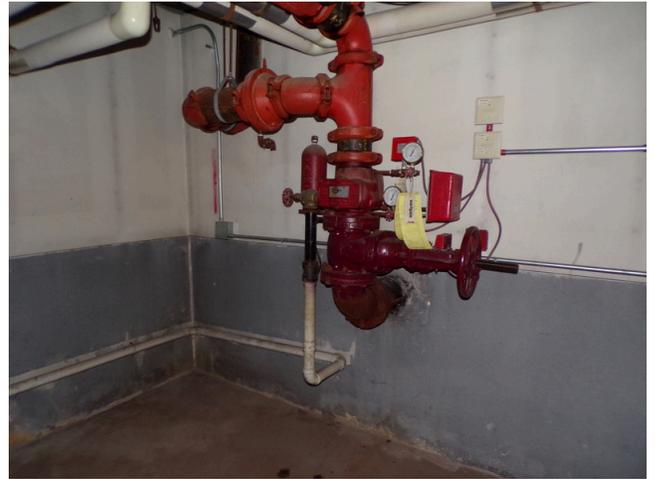
118. Apartment building 2 fire pump

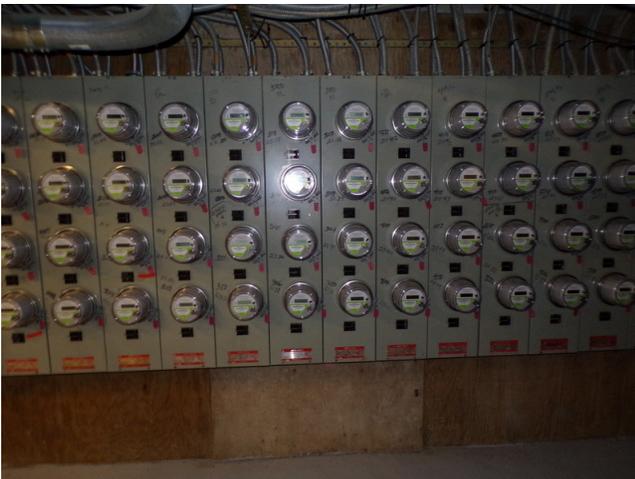
119. Apartment building 2 electrical meters

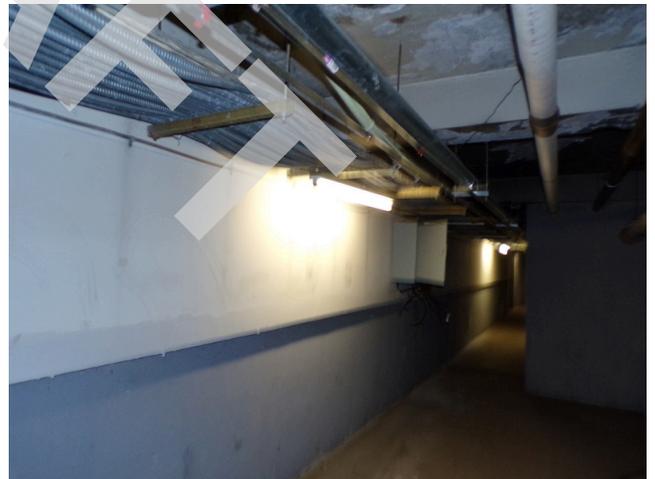
120. Apartment building 2 basement

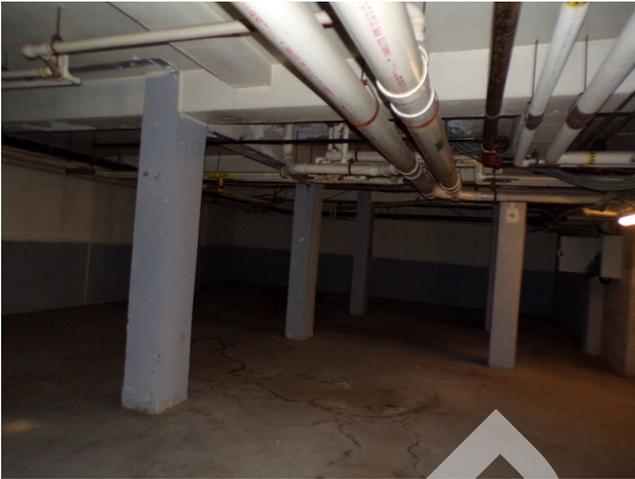
121. Apartment building 1 basement

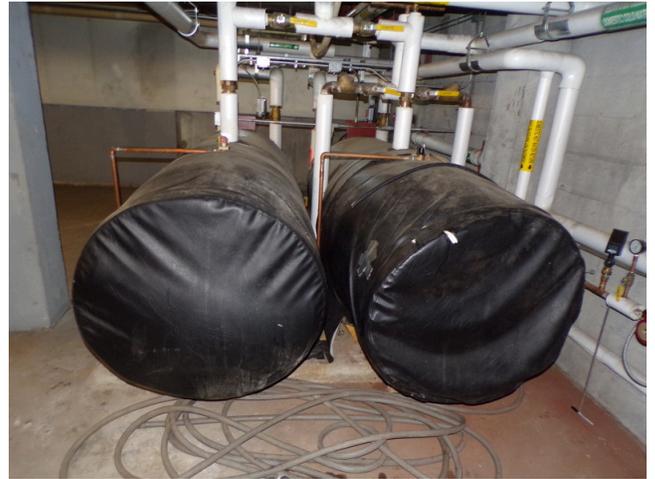
122. Apartment building 1 hot water storage tanks

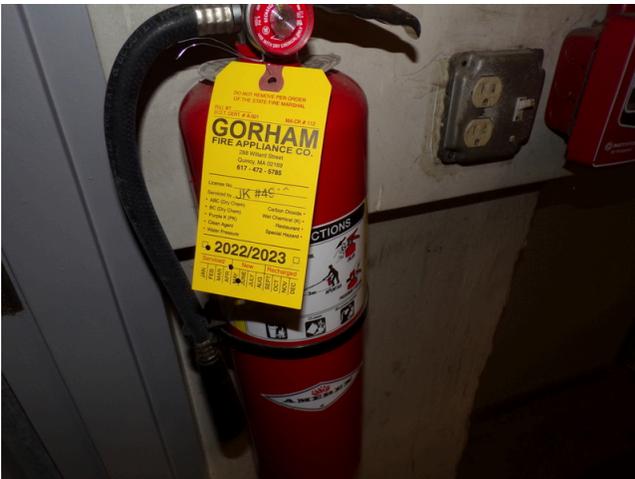
123. Apartment building 1 basement fire extinguisher

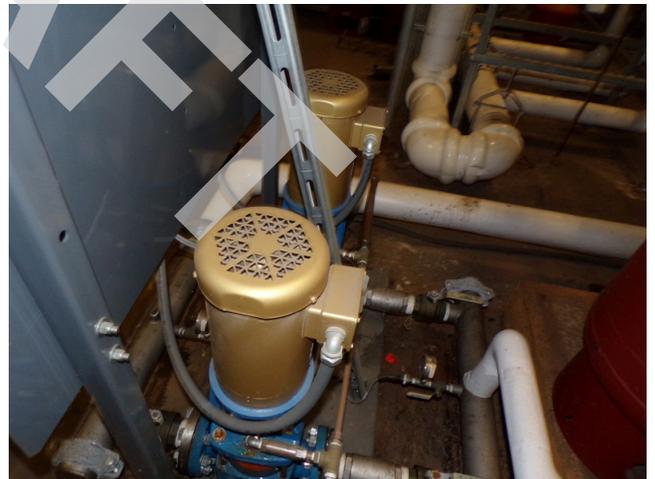
124. Apartment building 1 hot water circulation pumps

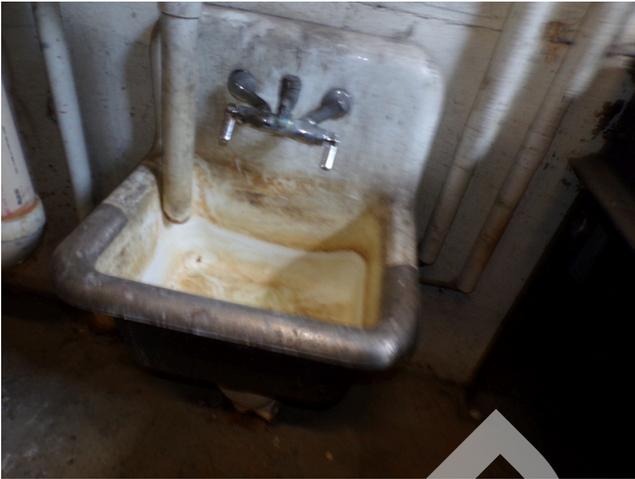
125. Apartment building 1 boiler room utility sink

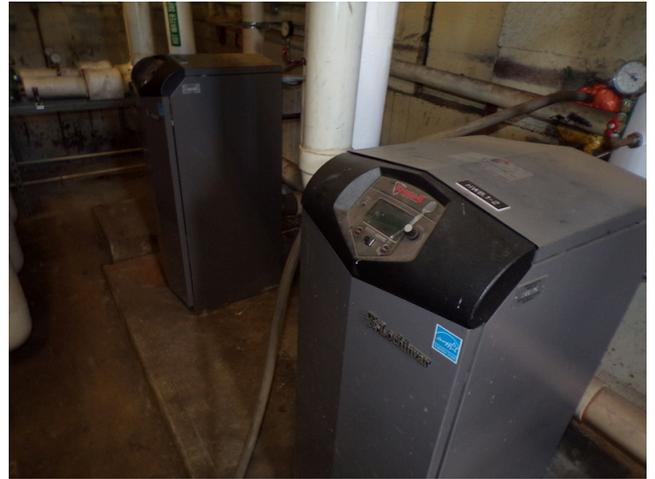
126. Apartment building 1 hot water boilers

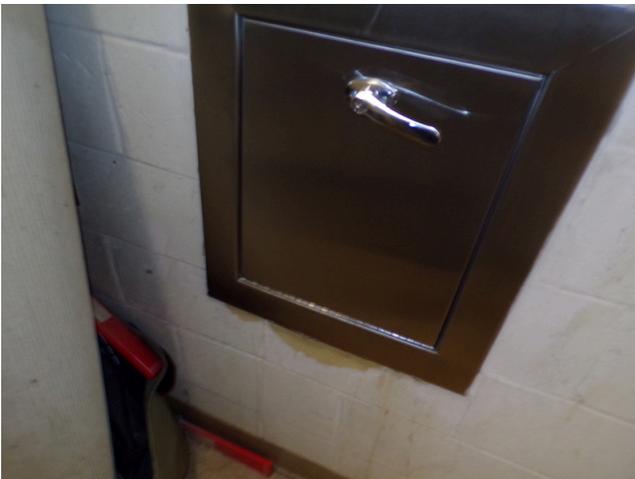
127. Apartment building 1 trash chute door 2nd floor

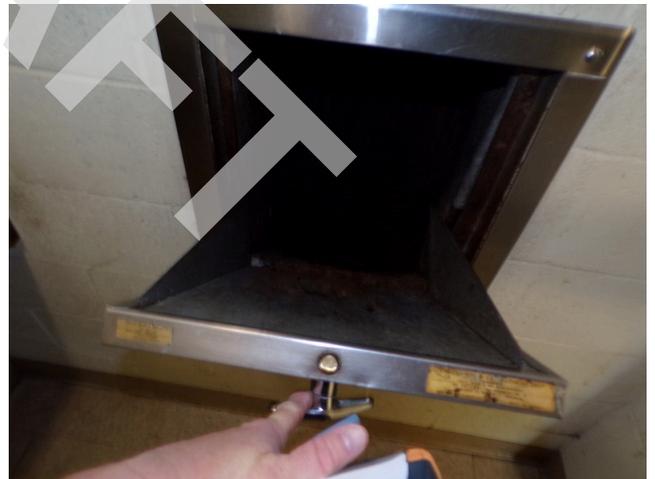
128. Apartment building 1 trash chute door 3rd floor

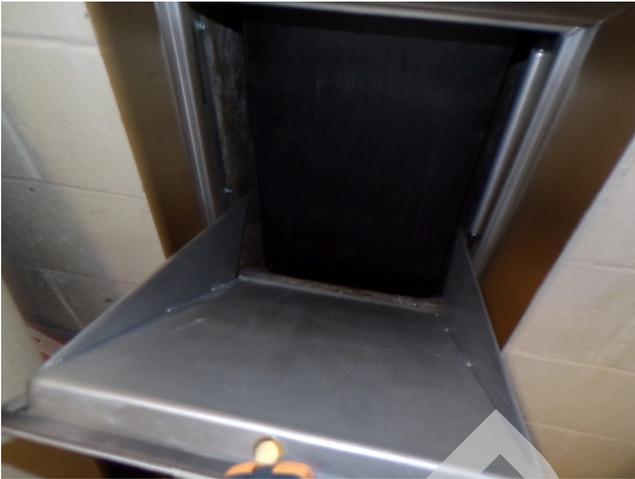
129. Apartment building 2 trash chute door 2nd floor

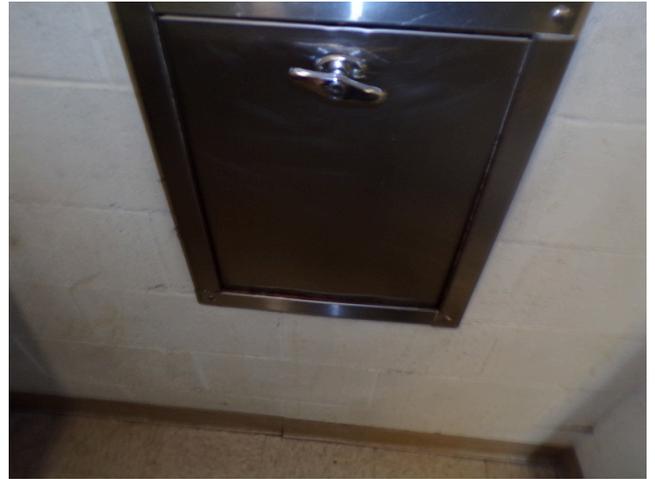
130. Apartment building 2 trash chute door 3rd floor

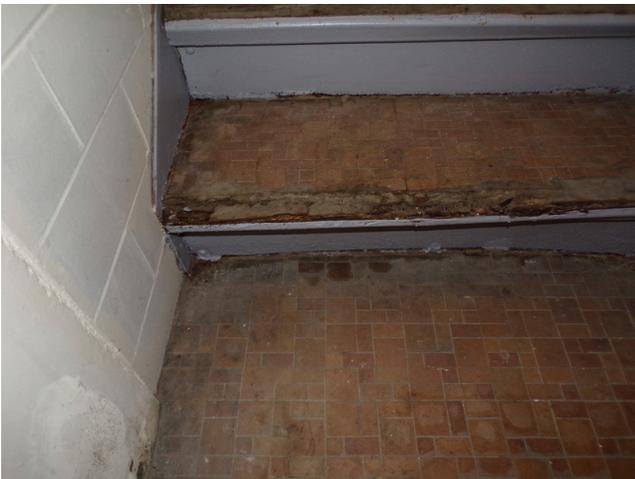
131. Apartment building 1 stairwell B 2nd floor stairs damage trip hazard (Critical Repair)

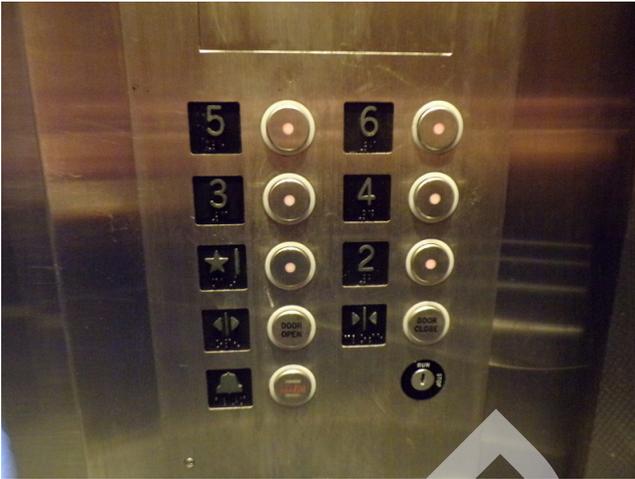
133. Apartment building 2 controls

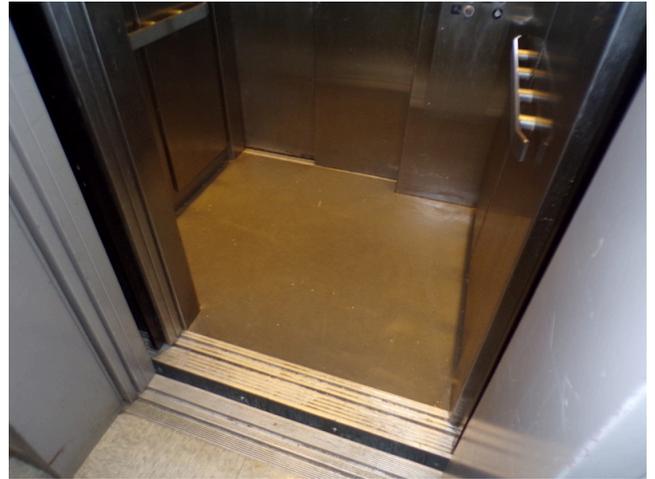
134. Apartment building 2 elevator cab size
