## HUD CAPITAL NEEDS ASSESSMENT

Commonwealth Family  
35 Fidelis Way  
Brighton, Massachusetts 02135

AEI Project No. 463346  
Site Inspection Date: July 20 and 21, 2022

Boston Housing Authority  
52 Chauncy Street  
Boston, Massachusetts 02111

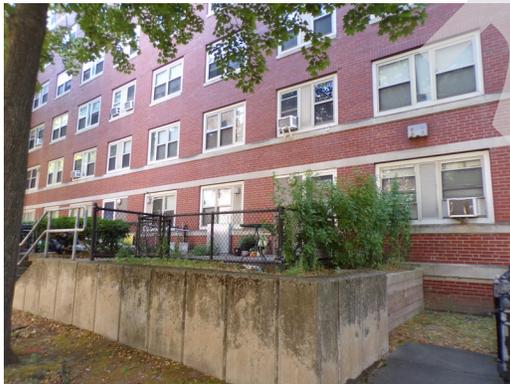
Building 4 - retention wall power washing  
(Non-Critical Repair)

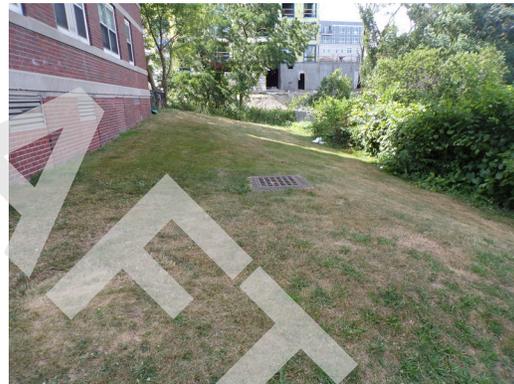
Building 7 - drainage

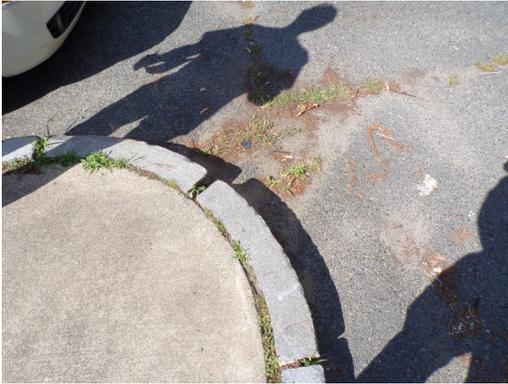
Building 4 - curb damage trip hazard (Critical Repair))

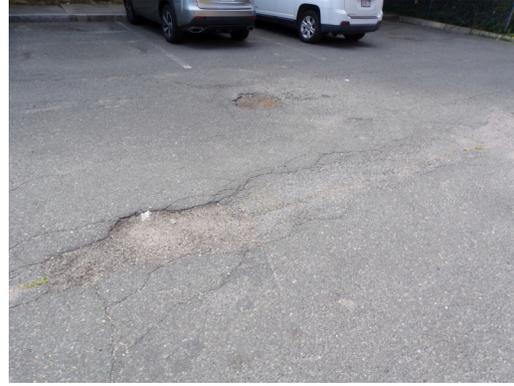
Building 4 - parking lot condition (Non-Critical Repair)

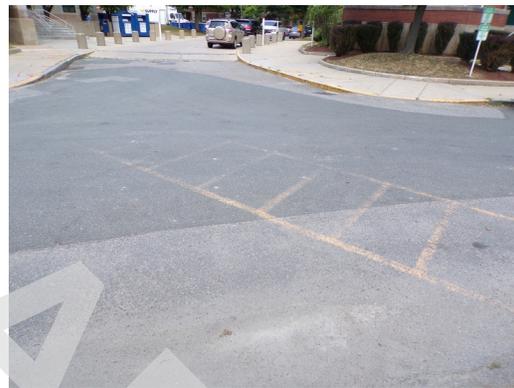
Building 5 - hash marks (Critical Repair)

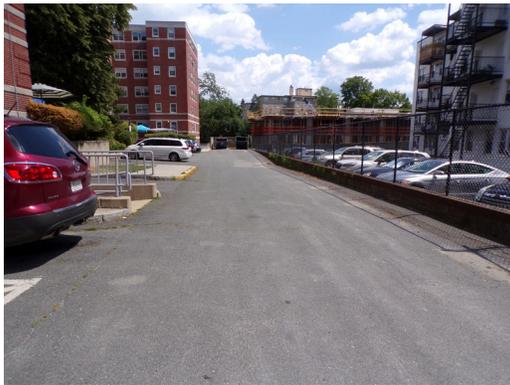
Building 5 - parking lot (Non-Critical Repair)

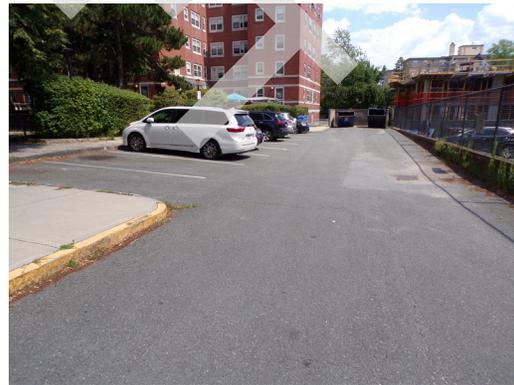
Building 5 - parking lot (Non-Critical Repair)

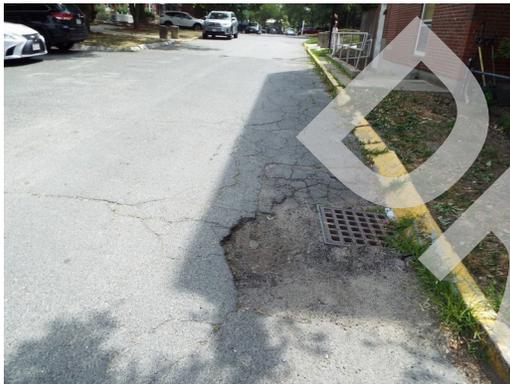
Building 8 - asphalt condition (Non-Critical Repair)

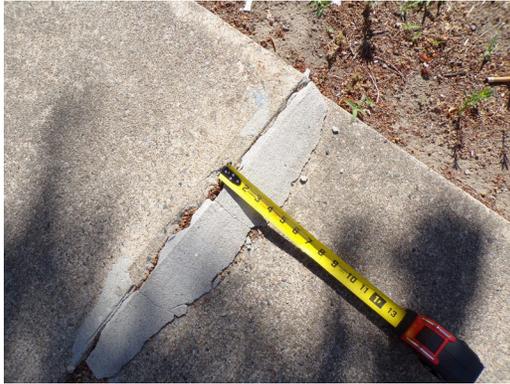
Building 4 - sidewalk trip hazard (Critical Repair)

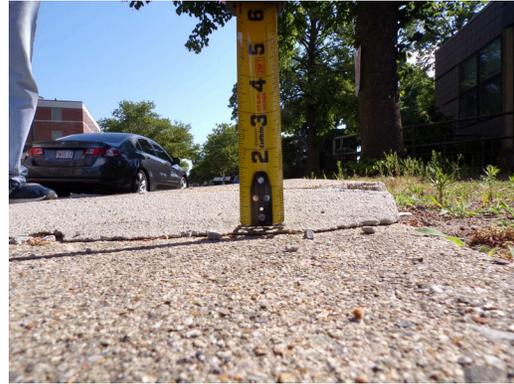
Building 4 - sidewalk trip hazard (Critical Repair)

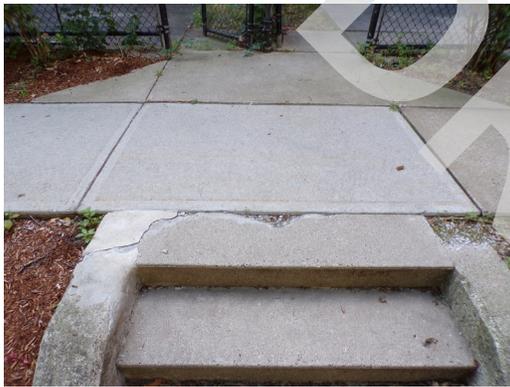
Building 4 - concrete trip hazard (Critical Repair)

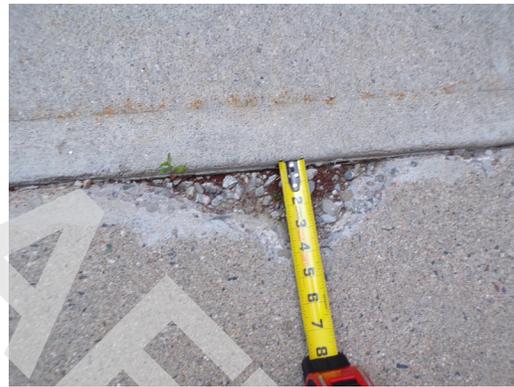
Building 4 - concrete trip hazard (Critical Repair)

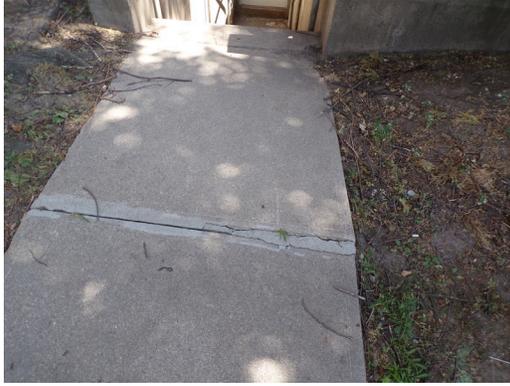
Building 5 - sidewalk trip hazard (Critical Repair)

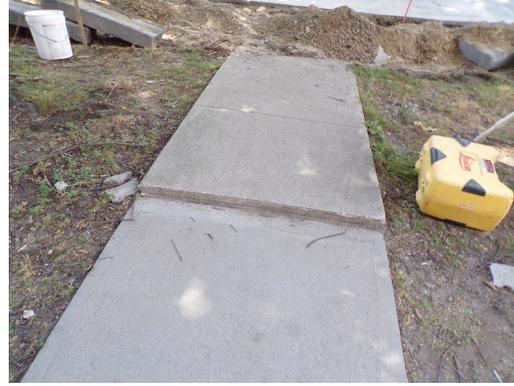
Building 5 - sidewalk trip hazard (Critical Repair)

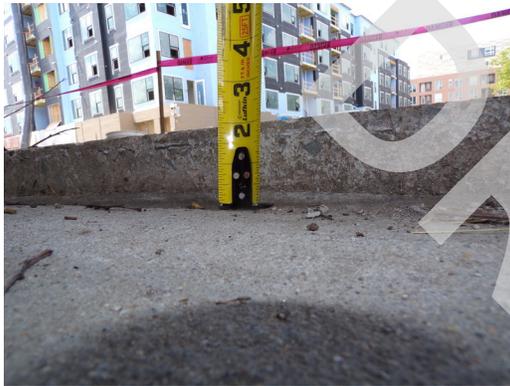
Building 5 - sidewalk trip hazard (Critical Repair)

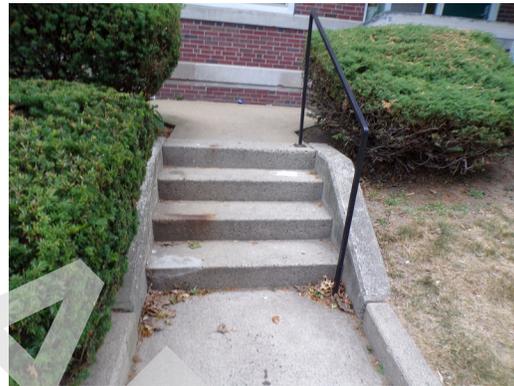
Building 7 - stairs missing railing (Critical Repair)

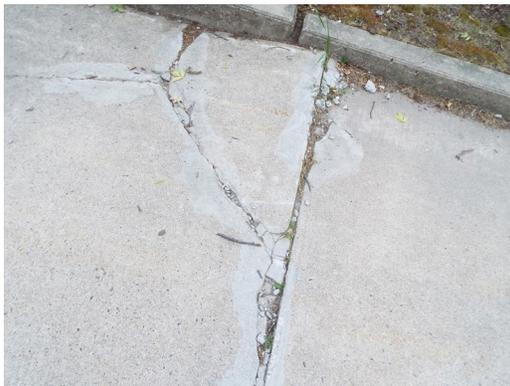
Building 8 - sidewalk trip hazard (Critical Repair)

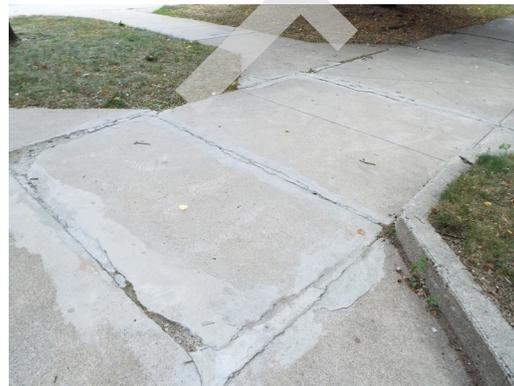
Building 8 - sidewalk trip hazard (Critical Repair)

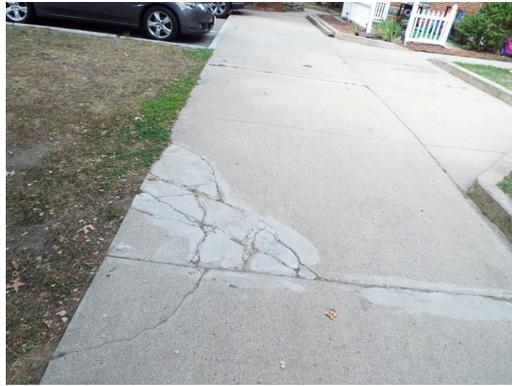
Building 9 - sidewalk trip hazard (Critical Repair)

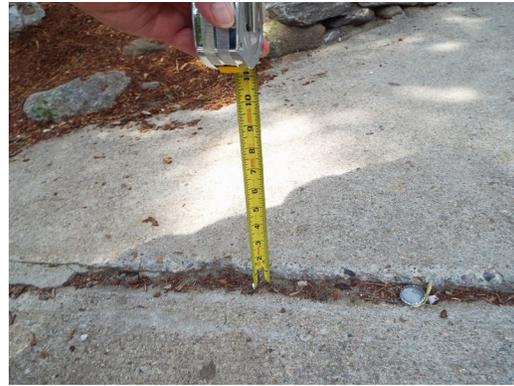
Building 9 - sidewalk trip hazard (Critical Repair)

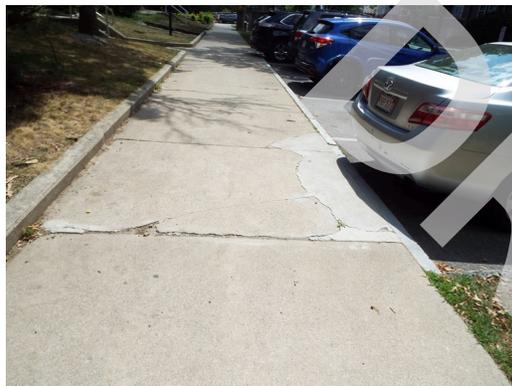
Building 9 - sidewalk trip hazard (Critical Repair)

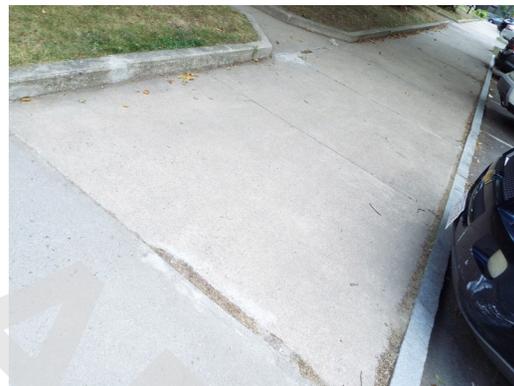
Building 9 - sidewalk trip hazard (Critical Repair)

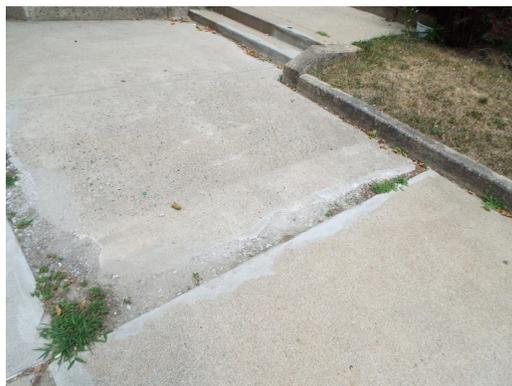
Building 9 - sidewalk trip hazard (Critical Repair)

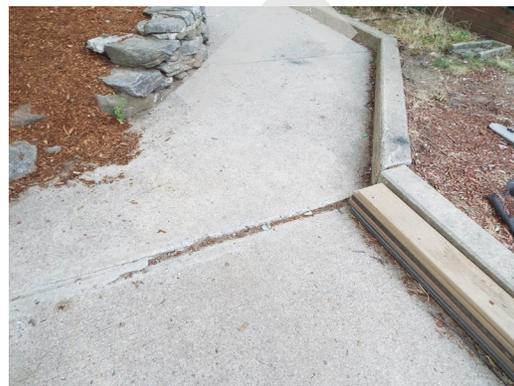
Building 9 - sidewalk trip hazard (Critical Repair)

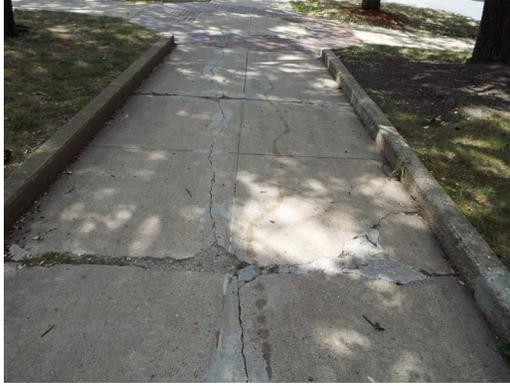
Building 9 - sidewalk trip hazard (Critical Repair)

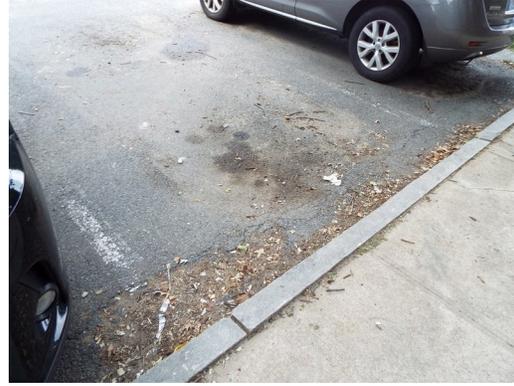
Building 9 - parking lot condition (Non-Critical Repair)

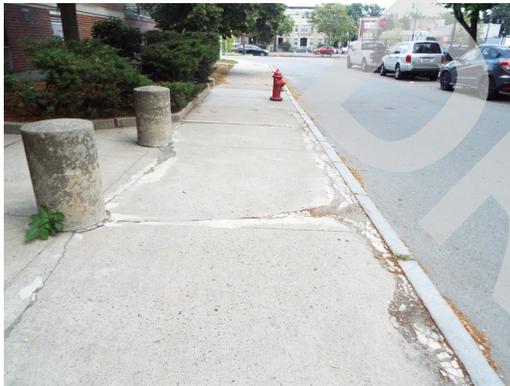
Building 10 - sidewalk trip hazard (Critical Repair)

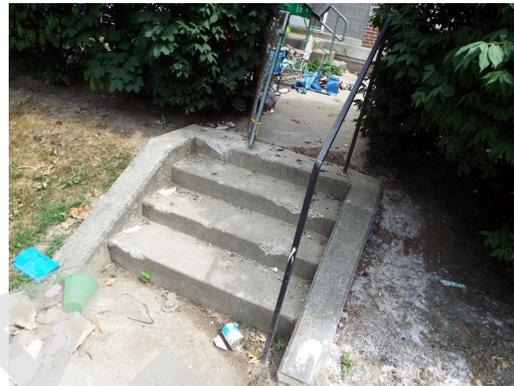
Building 10 - concrete stair damage (Critical Repair)

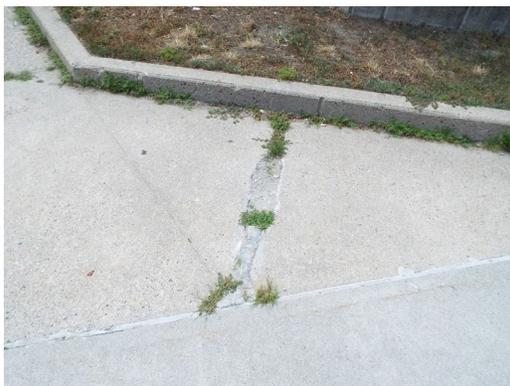
Building 10 - sidewalk trip hazard (Critical Repair)

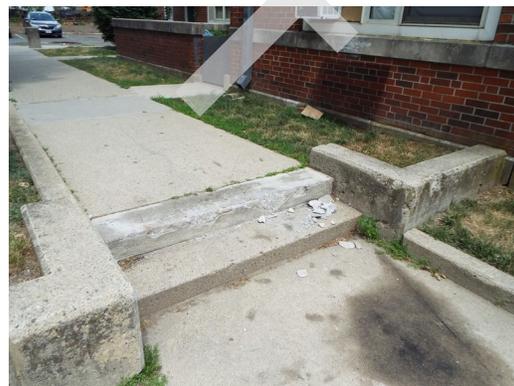
Building 10 and 11 - concrete step trip hazard (Critical Repair)

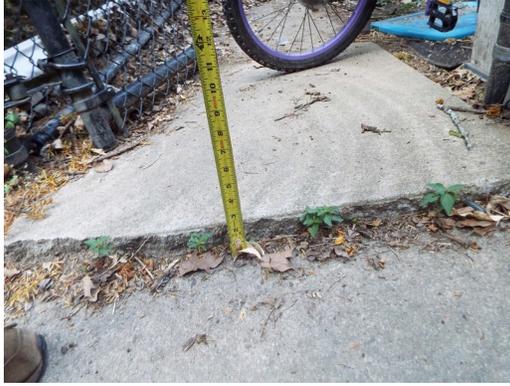
Building 12 - sidewalk trip hazard (Critical Repair)

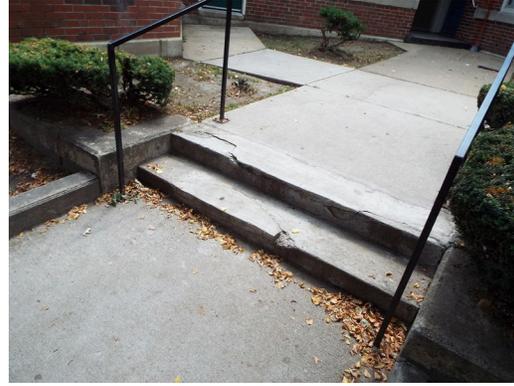
Building 12 - concrete steps trip hazard (Critical Repair)

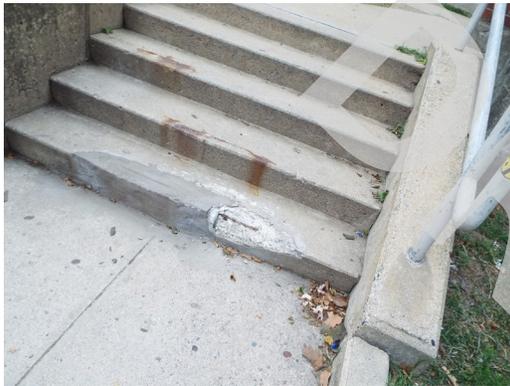
Building 12 - concrete steps trip hazard (Critical Repair)

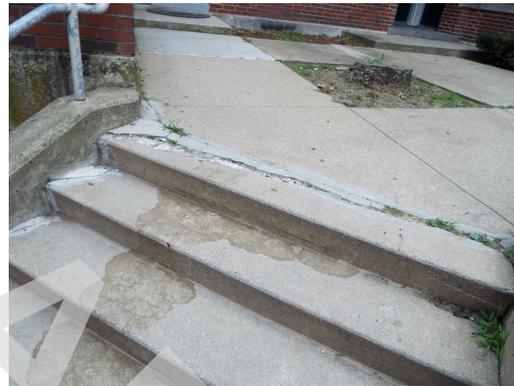
Building 12 - concrete stair trip hazard (Critical Repair)

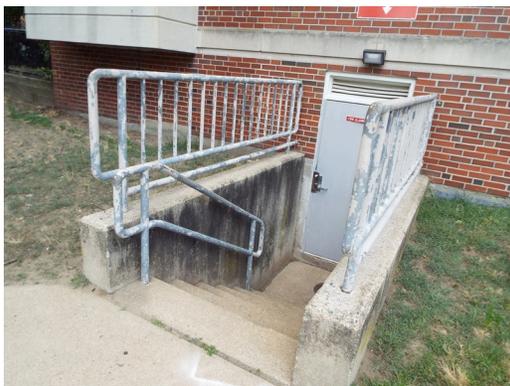
Building 12 - power wash concrete stairway (Non-Critical Repair)

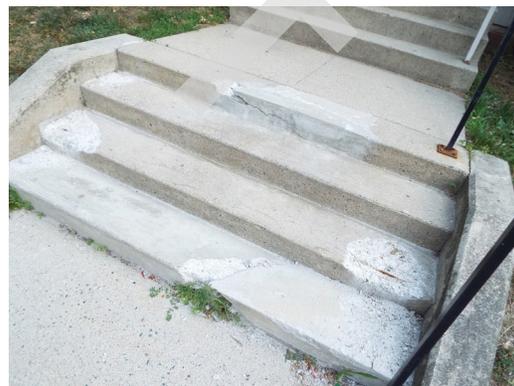
Building 13 - concrete stair trip hazard and missing railing (Critical Repair)

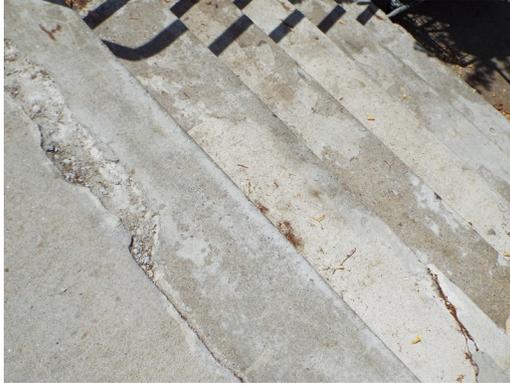
Building 13 - concrete stairs trip hazard  
(Critical Repair)

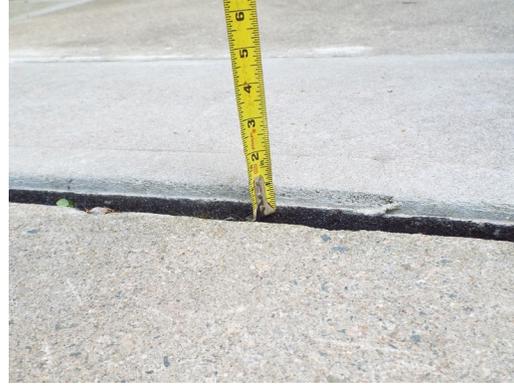
Building 13 - sidewalk trip hazard (Critical Repair)

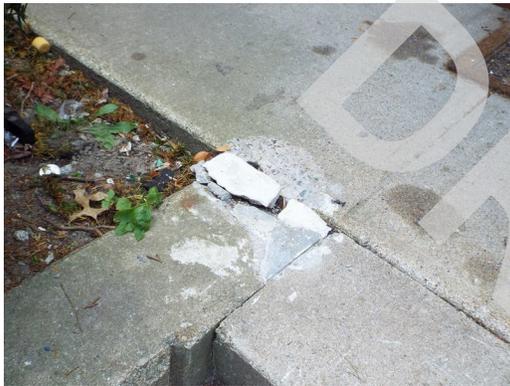
Building 13 - concrete stairs trip hazard  
(Critical Repair)

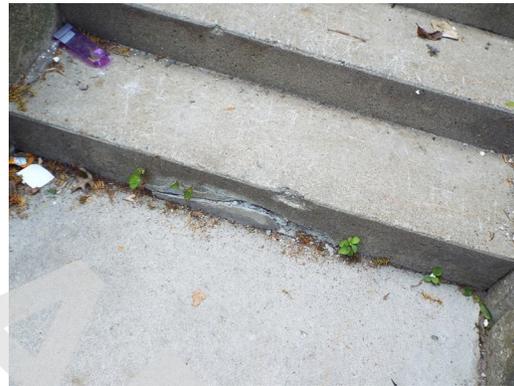
Building 13 - concrete stairs damaged (Critical Repair)

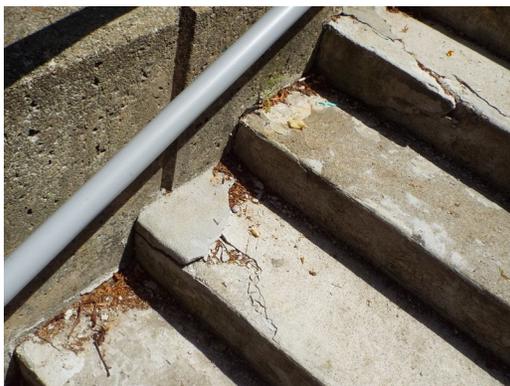
Building 13 - concrete stairs trip hazard  
(Critical Repair)

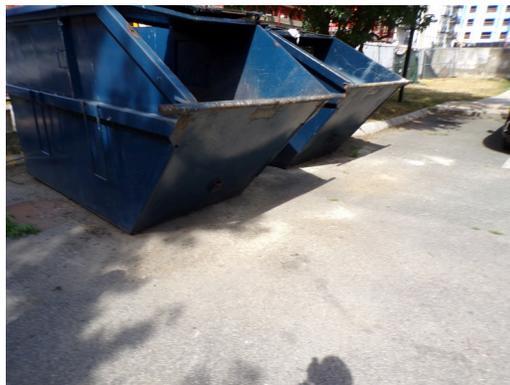
Building 4 - dumpsters missing concrete pad (Non-Critical Repair)

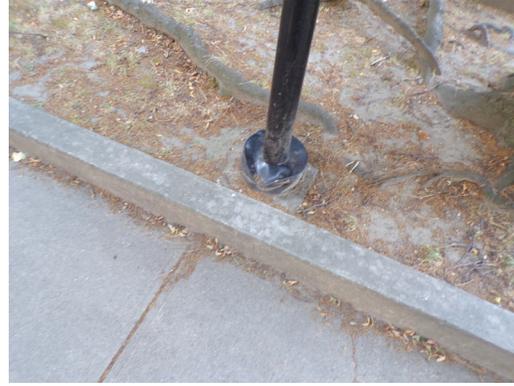
Building 4 - damaged pole light (Non-Critical Repair)

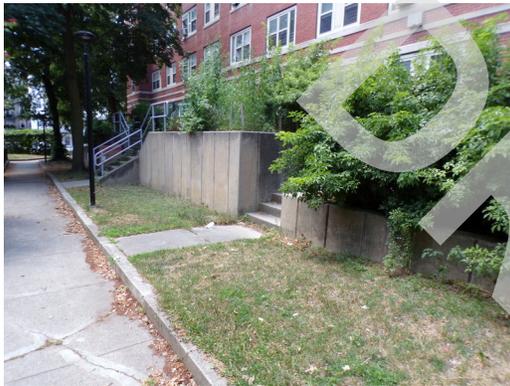
Building 5 - overgrown vegetation and retaining wall (Non-Critical Repair)

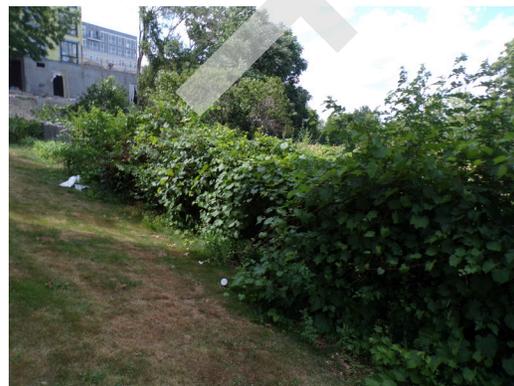
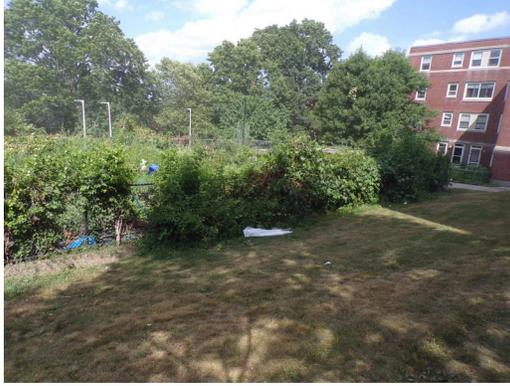
Building 7 - overgrown vegetation

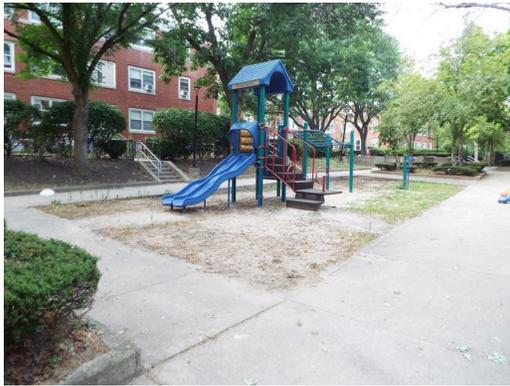
Building 8 - playground with bare ground  
(Non-Critical Repair)

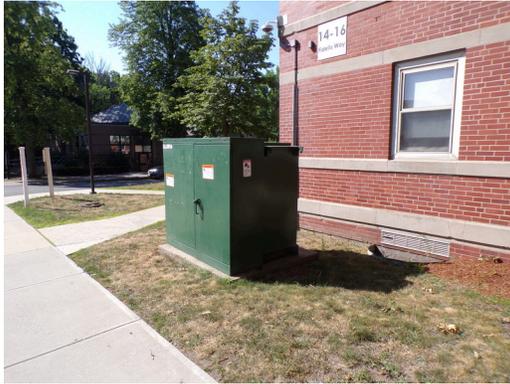
Pad mounted transformer

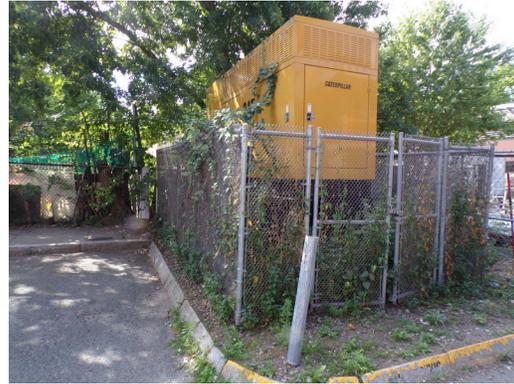
Building 4 - emergency generator

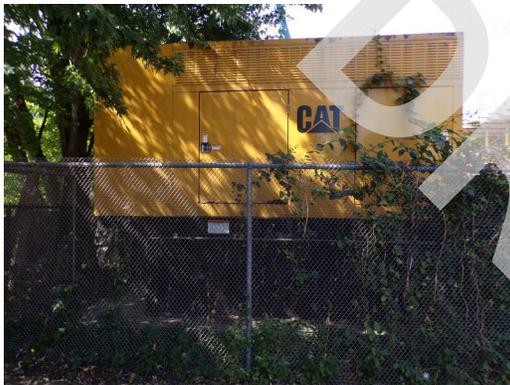
Building 4 - emergency generator

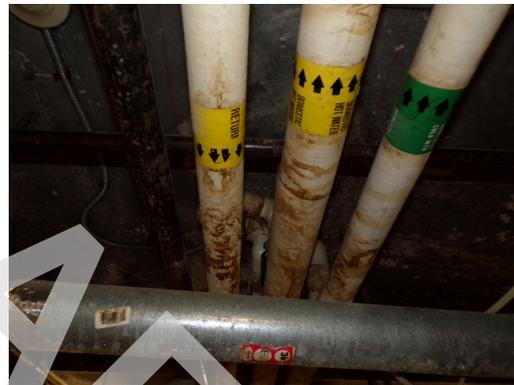
Building 4 - PVC pipes

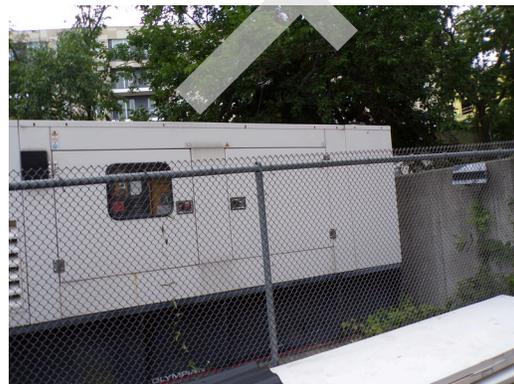
Building 7 - emergency generator

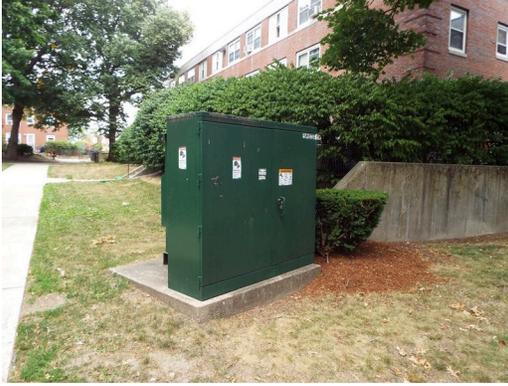
Building 10 - pad mounted transformer

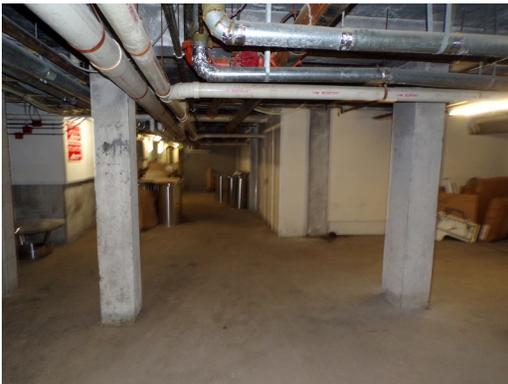
Building 4 - basement

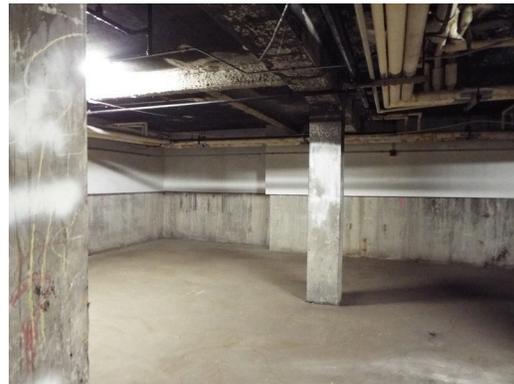
Building 9 - basement structure

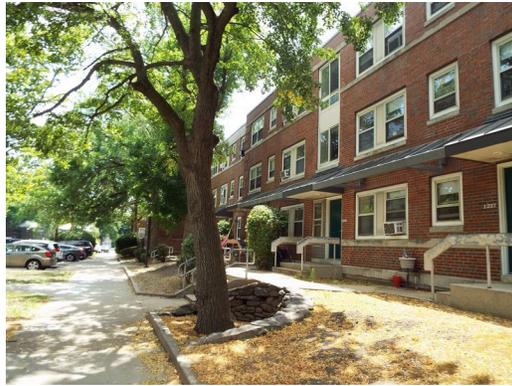
Building 12 - stone retaining wall and peeling paint on hand railings (Non-Critical Repair)

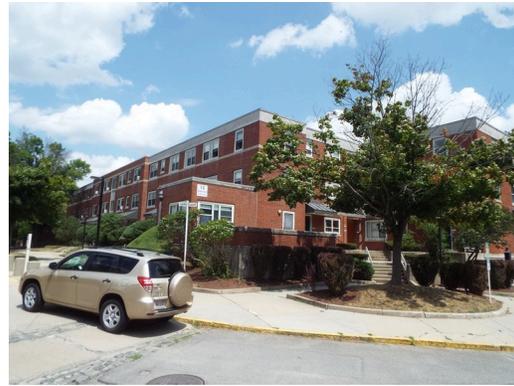
Building 13 - signage and façade

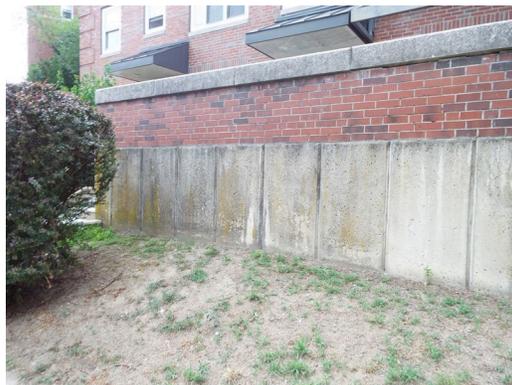
Building 8 - power wash foundation (Non-Critical Repair)

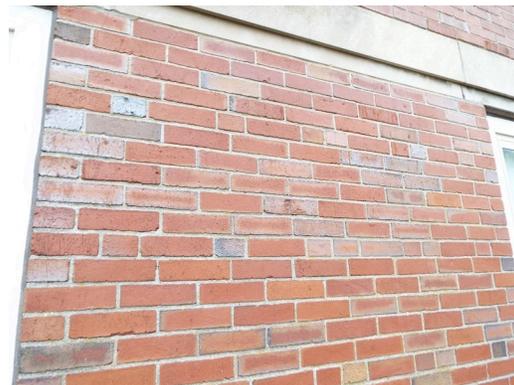
Building 8 - masonry condition

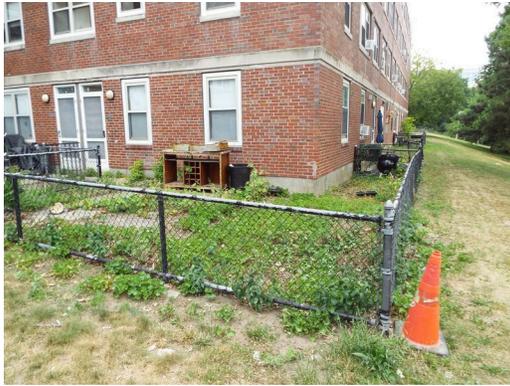
Building 8 - chain link fence

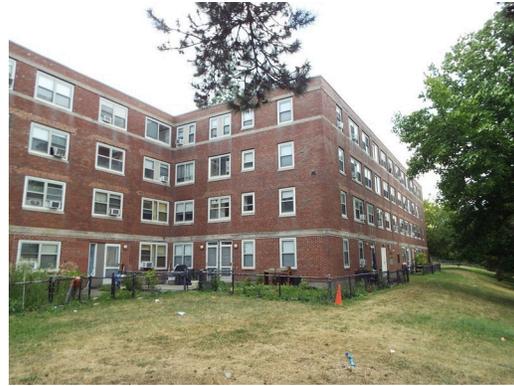
Building 8 - façade

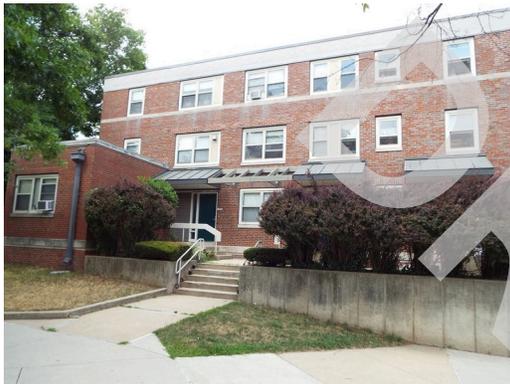
Building 8 - power wash retaining wall  
(Non-Critical Repair)

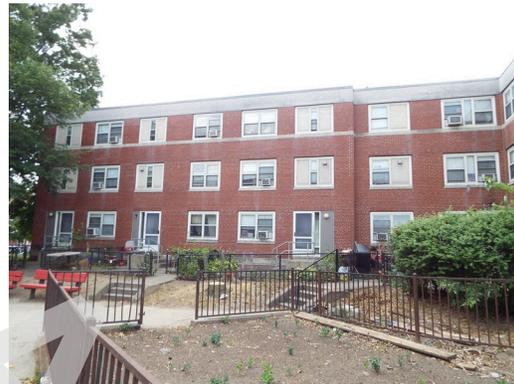
Building 9 - stairs missing railings (Critical Repair)

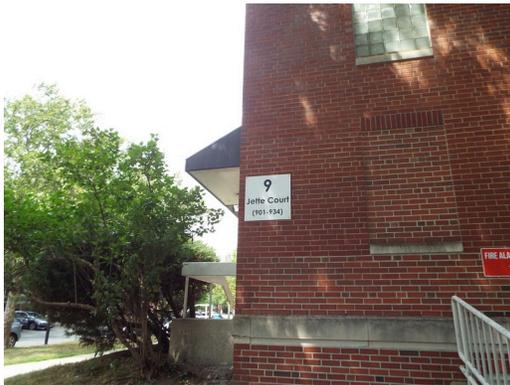
Building 9 - signage

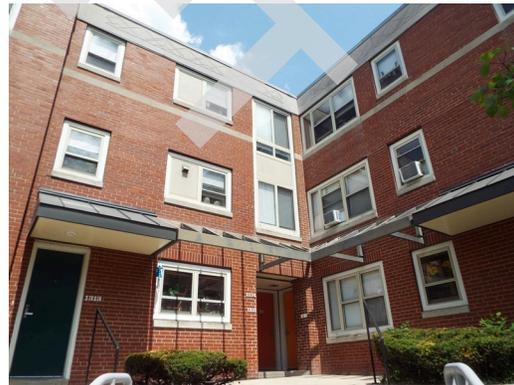
Building 13 - façade

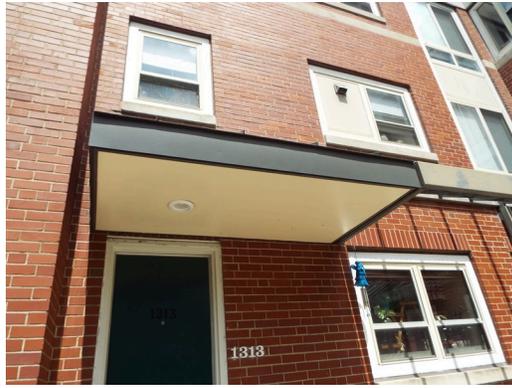
Building 13 - door overhang

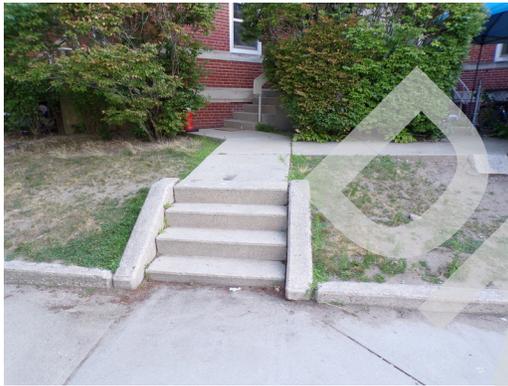
Building 4 - concrete stairs missing railing (Critical Repair)

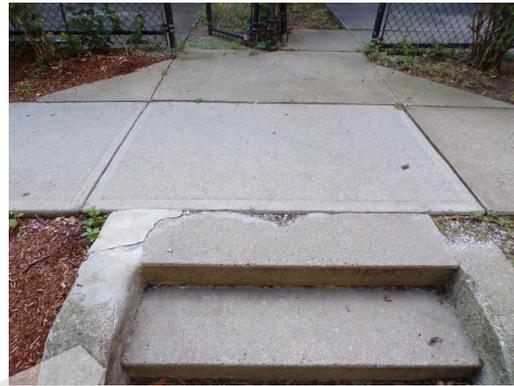
Building 4 - concrete trip hazard (Critical Repair)

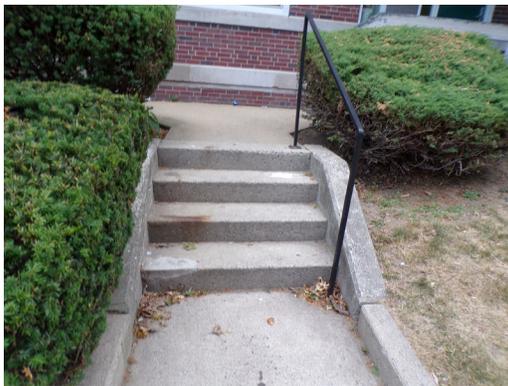
Building 7 - stairs missing railing (Critical Repair)

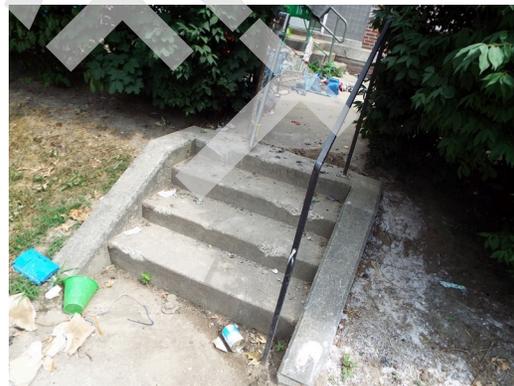
Building 10 - concrete stair damage (Critical Repair)

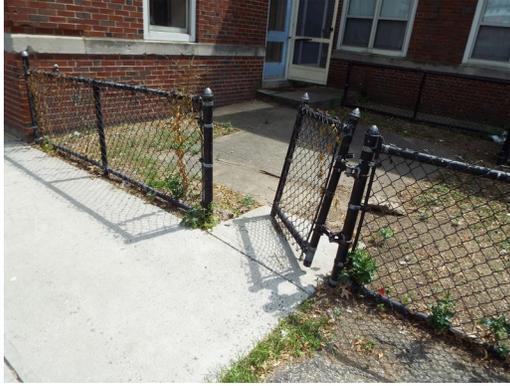
Building 10 - chain link fence damage  
(Non-Critical Repair)

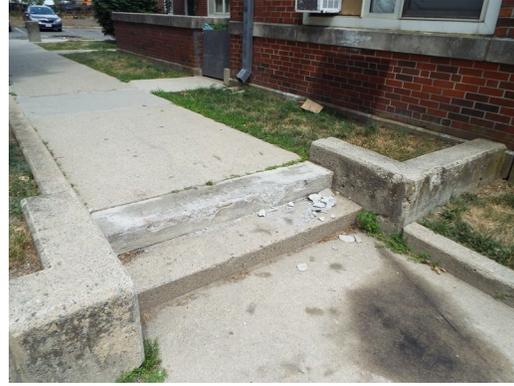
Building 10 and 11 - concrete step trip hazard  
(Critical Repair)

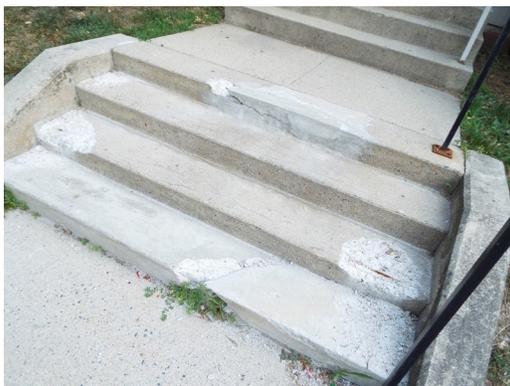
Building 13 - concrete stair trip hazard and  
missing railing (Critical Repair)

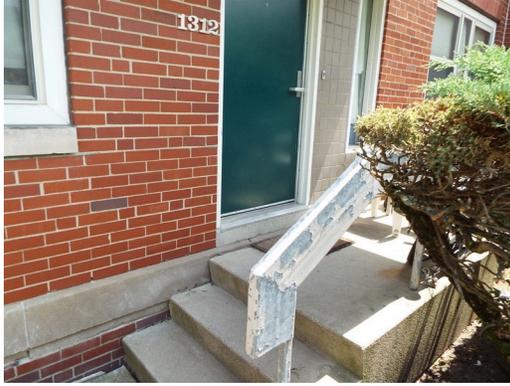
Building 13 - hand rail paint peeling  
(Non-Critical Repair)

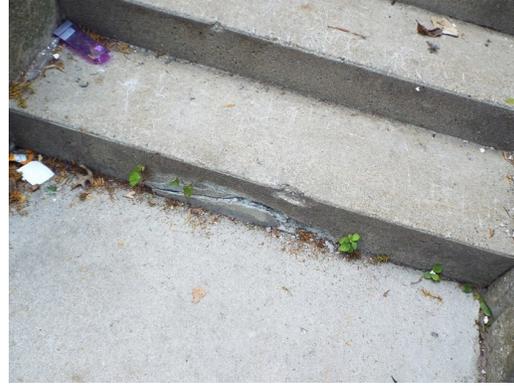
Building 13 - concrete stairs damaged (Critical Repair)

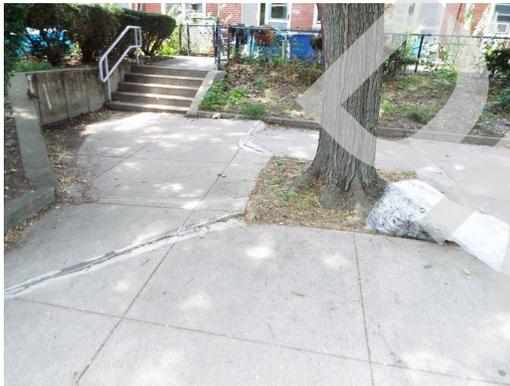
Building 13 - plaza area no ADA access  
(Critical Repair)

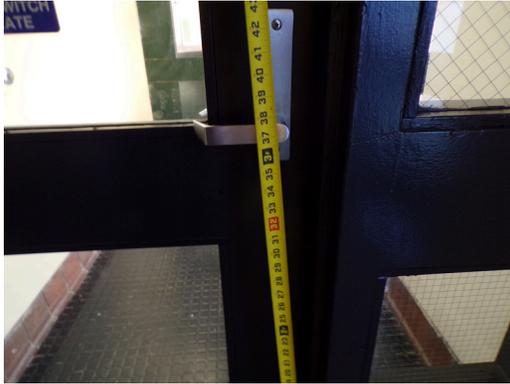
Building 4 - main ingress/ egress hardware

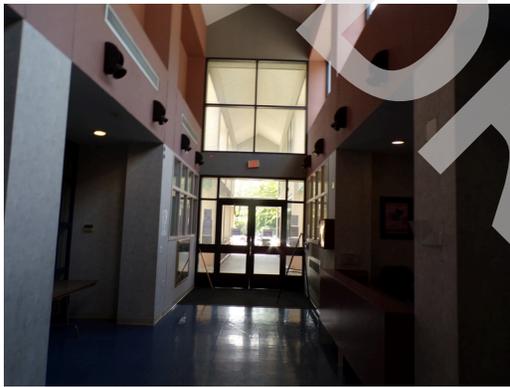
Community building - main ingress/egress

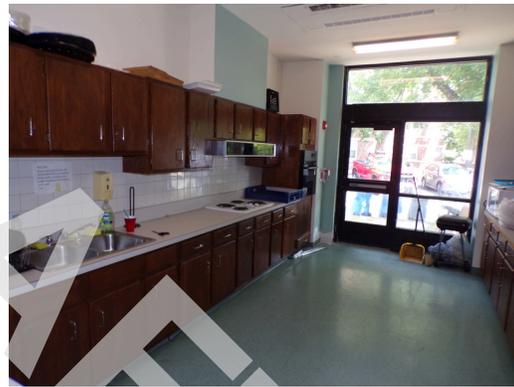
Community building - kitchen

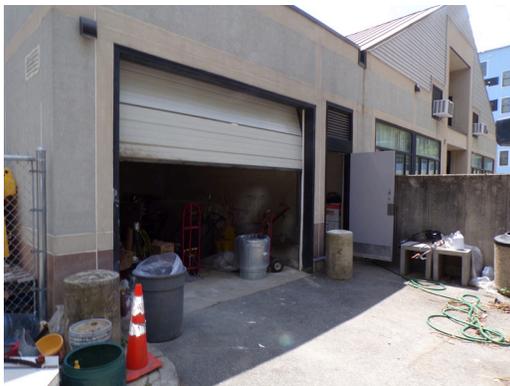
Community building - maintenance storage and shop overhead door

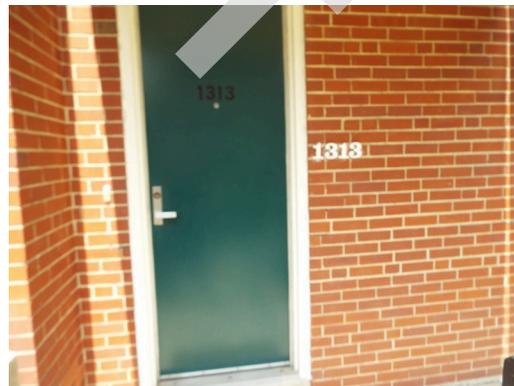
Building 13 - typical main ingress/egress door

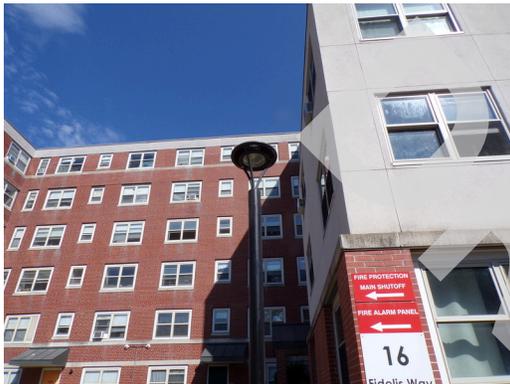
Building 4 - parking lot pole light

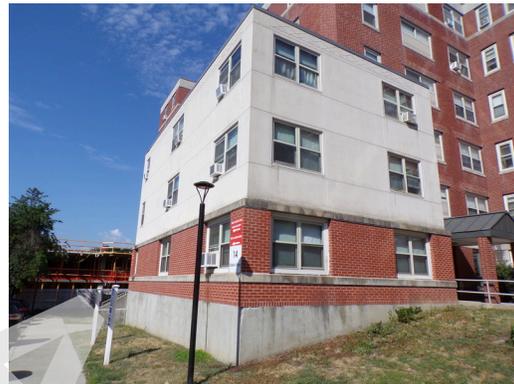
Building 4 - façade

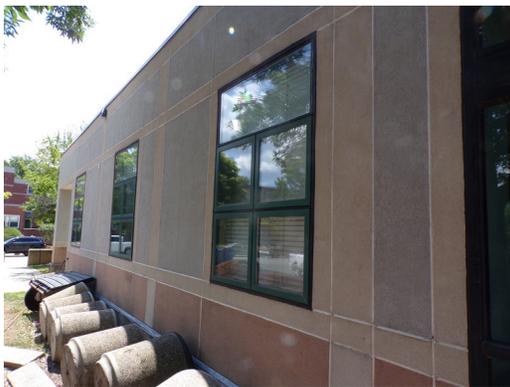
Community building - Exterior Insulation and Finishing (EIFS)

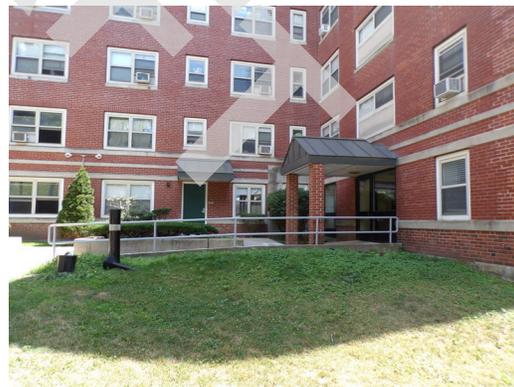
Building 5 - main ingress/egress

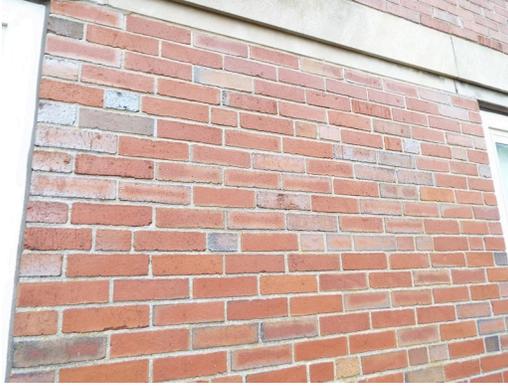
Building 8 - masonry condition

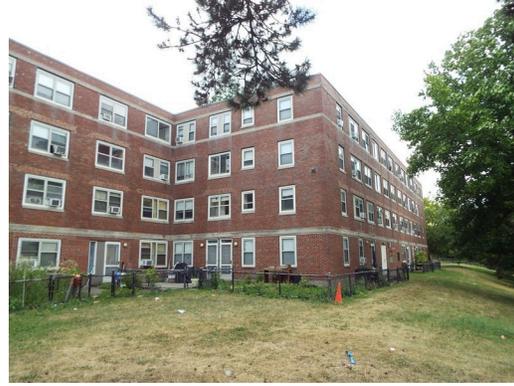
Building 8 - façade

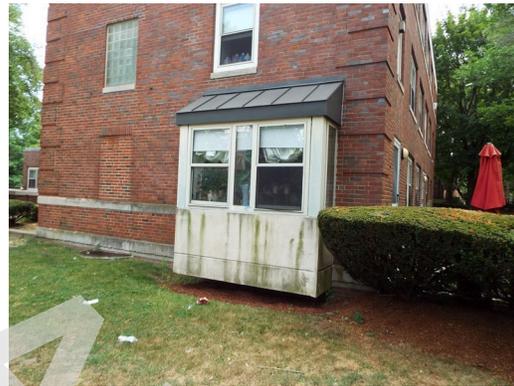
Building 11 - power wash siding (Non-Critical Repair)

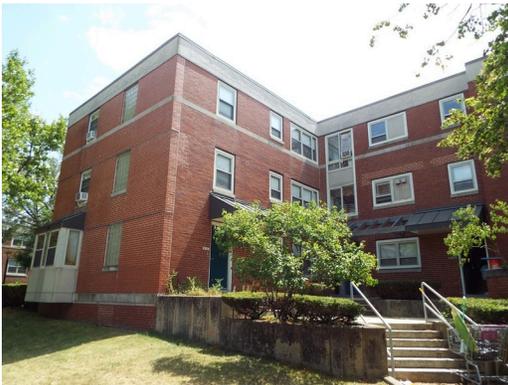
Building 13 - power wash retaining wall (Non-Critical Repair)

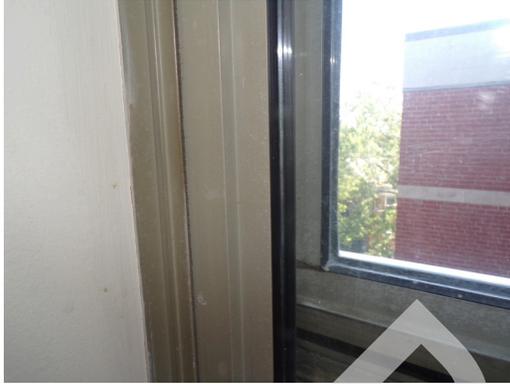
Building 4 - hallway window

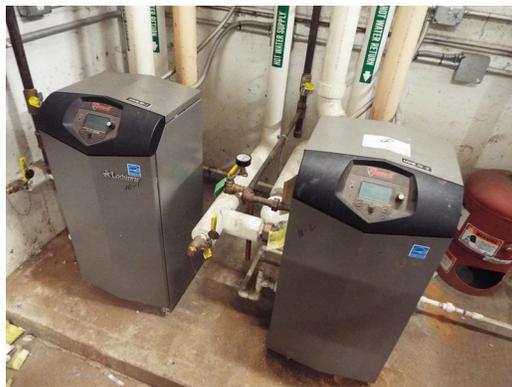
Building 11 - hot water storage tank corrosion  
(Non-Critical Repair)

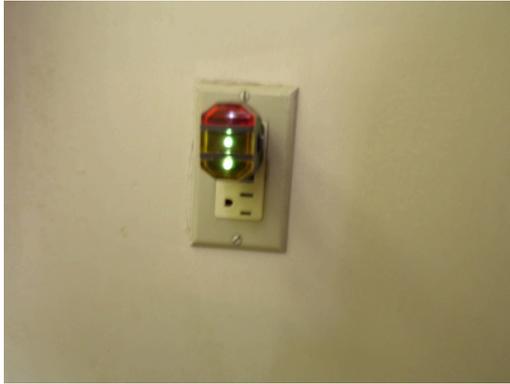
Building 4 - unit 414 - 3-bed/2-bath - TH - UFAS - bathroom GFCI

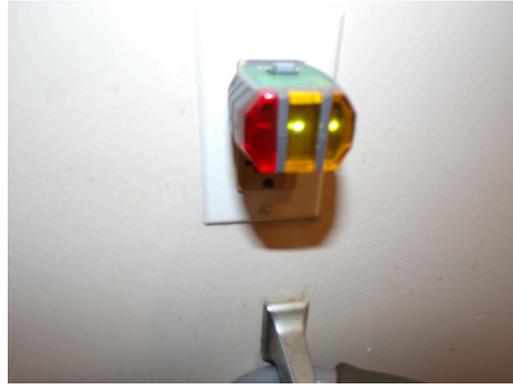
Building 4 - unit 412 - 3-bed/1.5-bath - UFAS - bathroom GFCI

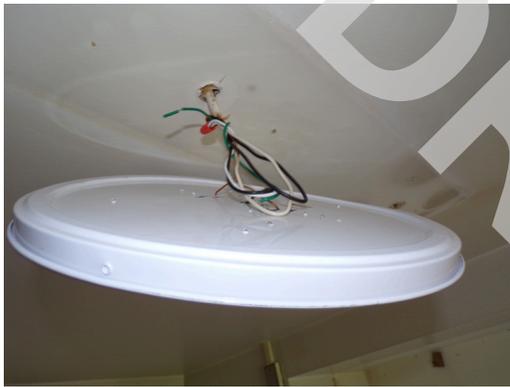
Building 4 - unit 451 - 2-bed/1-bath - wiring

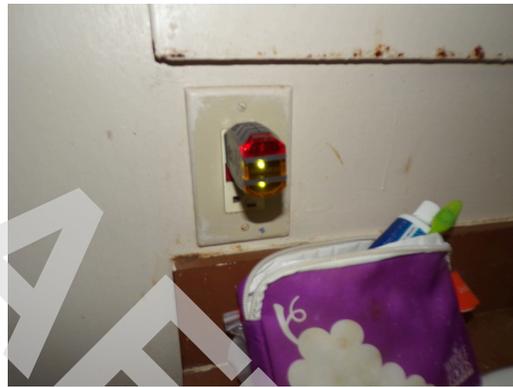
Building 4 - unit 431 - 2-bed/1-bath - bathroom GFCI

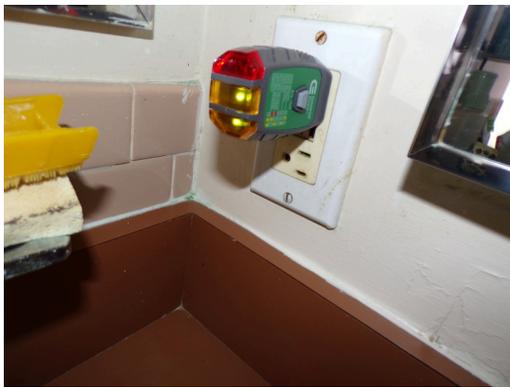
Building 7 - unit 731 - 2-bed/1-bath - UFAS - bathroom GFCI

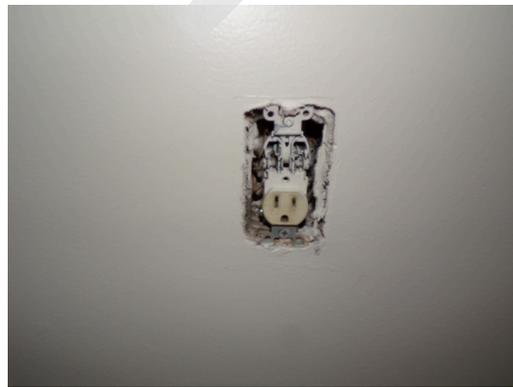
Building 7 - unit 733 - 1-bed/1-bath - UFAS - wiring

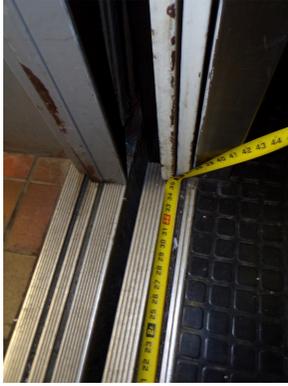
Building 7 - doorway floorspace (Critical Repair)

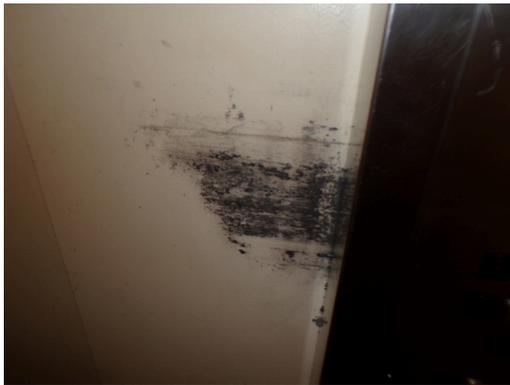
Building 7 - elevator cab door rubbing (Non-Critical Repair)

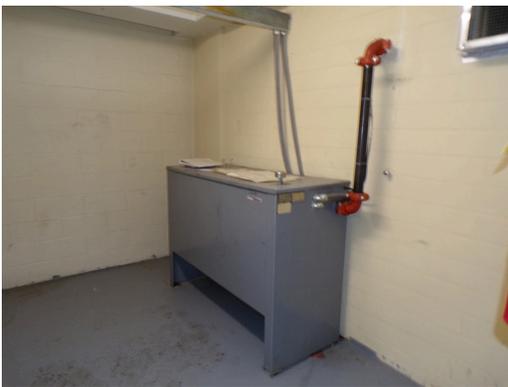
Based on the observed condition and age of the equipment, it is expected that modernization of the elevators may be necessary during the evaluation term. An opinion of cost for this work is included in the Tables. The equipment is located in the elevator room in the basement.

Building 7 - elevator motor (Non-Critical Repair)

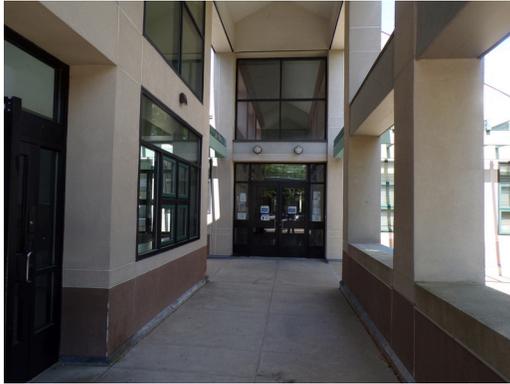
Community building - office - main entry breezeway

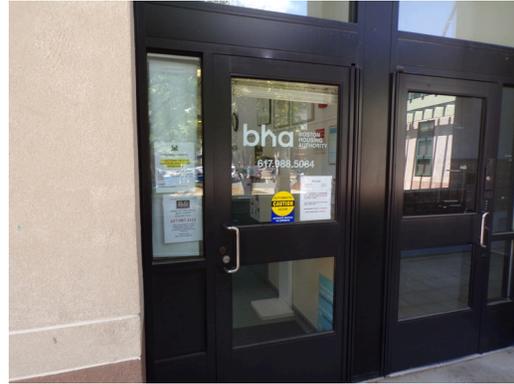
Community building - office - main ingress/egress door

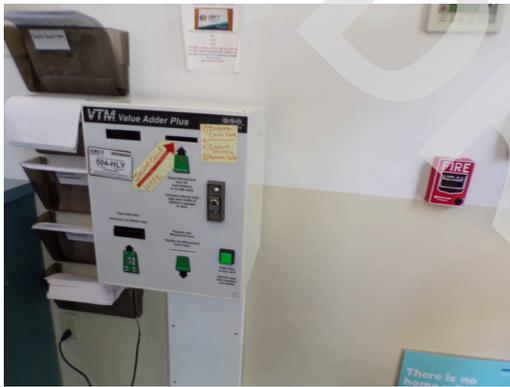
Community building - office - laundry room card loader and fire pull station

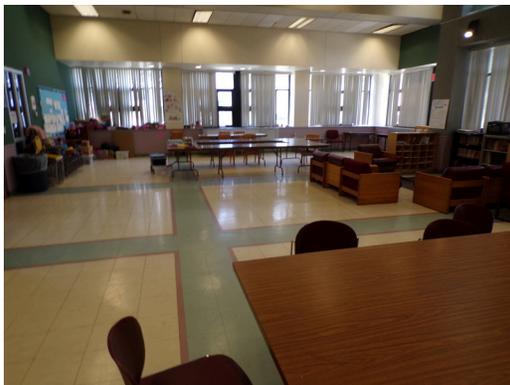
Community building - community room

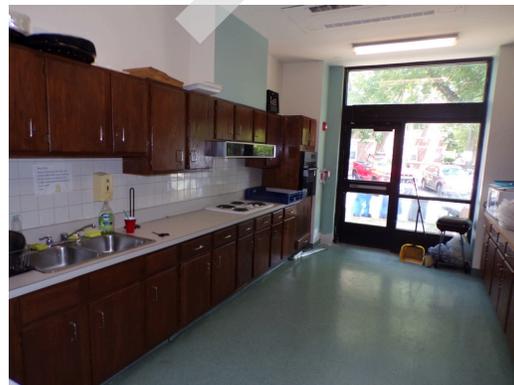
Community building - kitchen

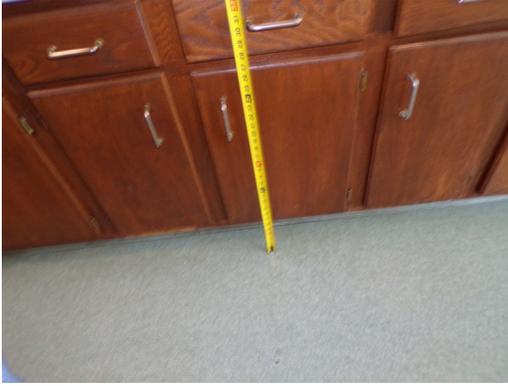
Community building - kitchen cabinets

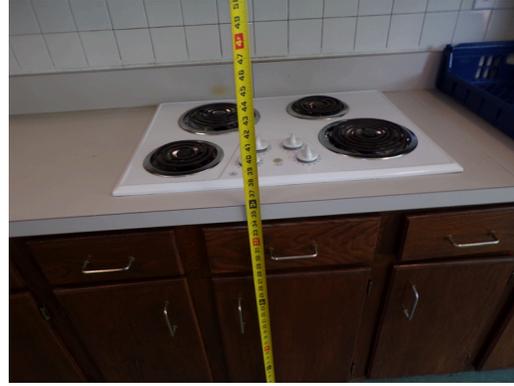
Community building - kitchen range

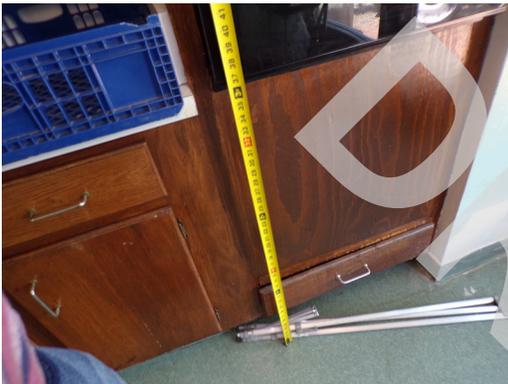
Community building - kitchen oven

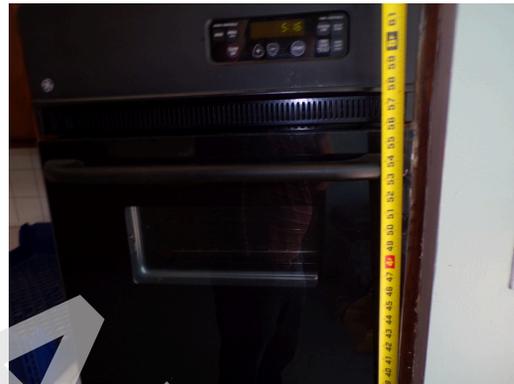
Community building - kitchen oven
