## HUD CAPITAL NEEDS ASSESSMENT

Commonwealth Family  
35 Fidelis Way  
Brighton, Massachusetts 02135

AEI Project No. 463346  
Site Inspection Date: July 20 and 21, 2022

Boston Housing Authority  
52 Chauncy Street  
Boston, Massachusetts 02111

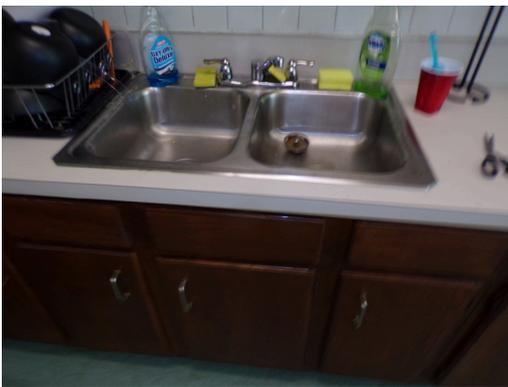
Community building - kitchen sink

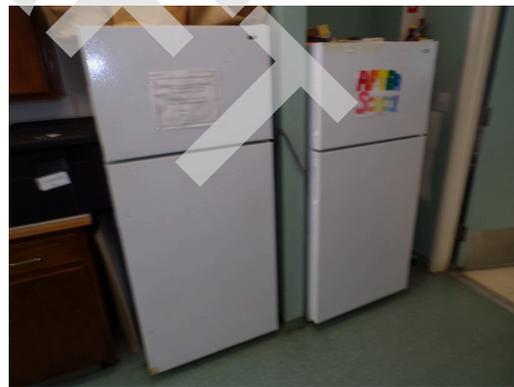
Community building - refrigerators

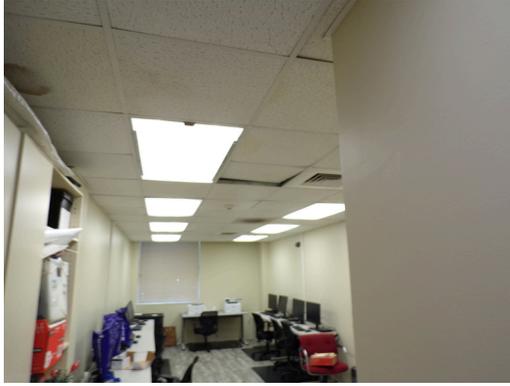
Community building - computer room

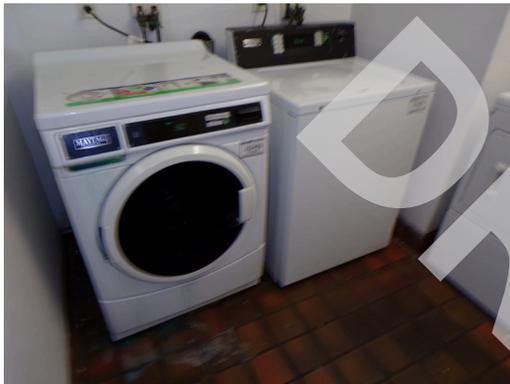
Building 5 - laundry room washers

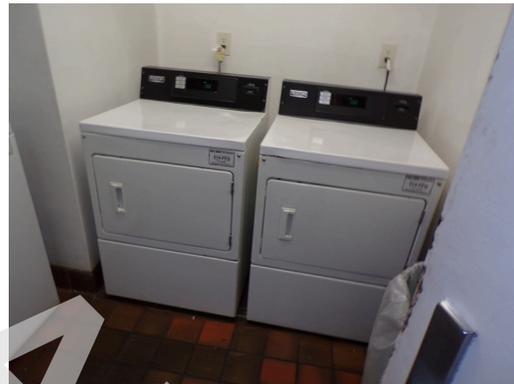
Building 5 - laundry room dryers

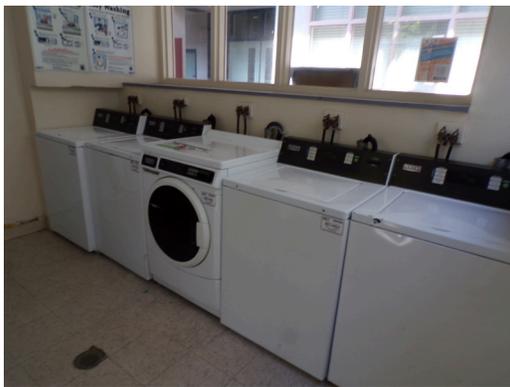
Community building - laundry room washers

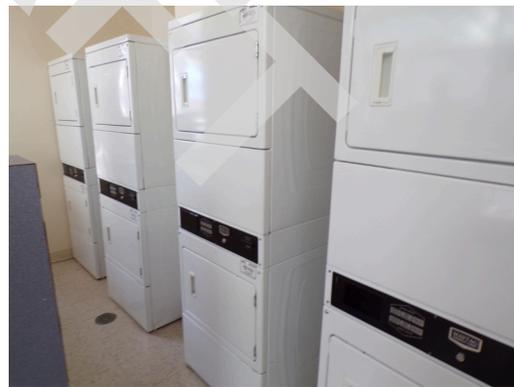
Community building - laundry room dryers

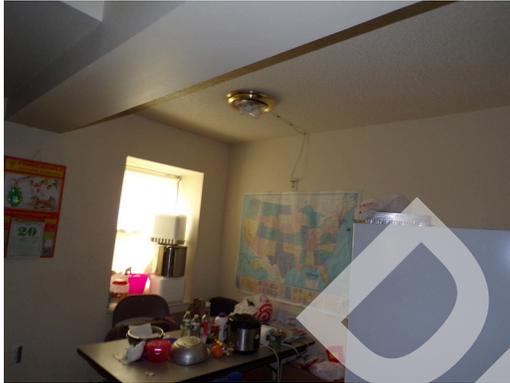
Building 4 - unit 414 - 3-bed/2-bath - TH - UFAS - dining room light missing cover (Non-Critical Repair)

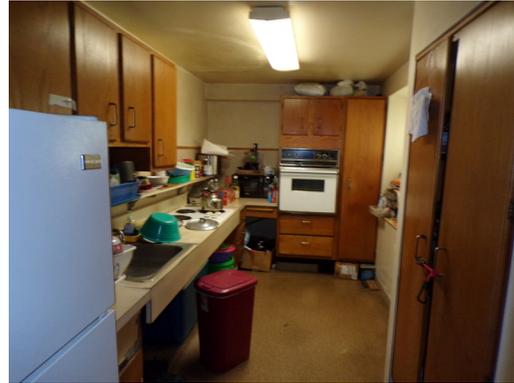
Building 4 - unit 414 - 3-bed/2-bath - TH - UFAS - kitchen

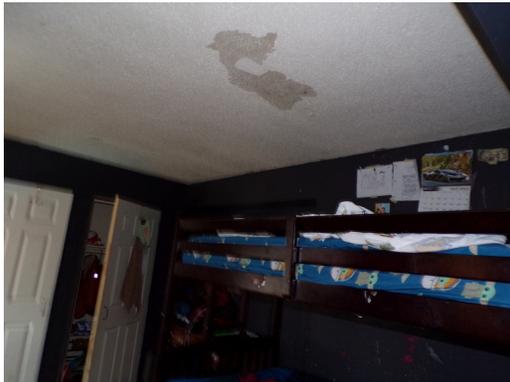
Building 4 - unit 418 - 3-bed/1.5-bath - TH - bedroom ceiling damage (Non-Critical Repair)

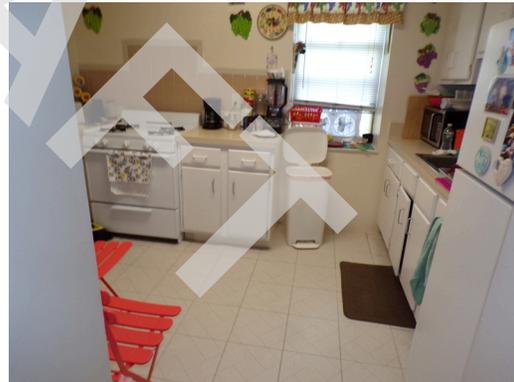
Building 4 - unit 433 - 1-bed/1-bath - kitchen

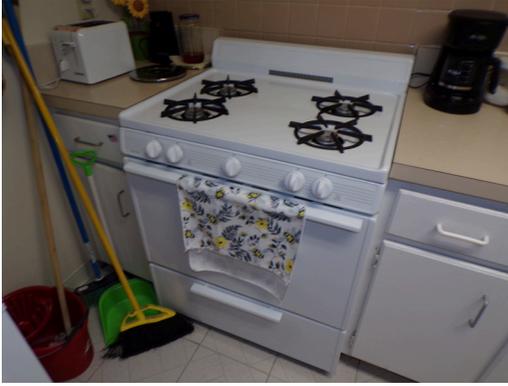
Building 4 - unit 433 - 1-bed/1-bath - kitchen range

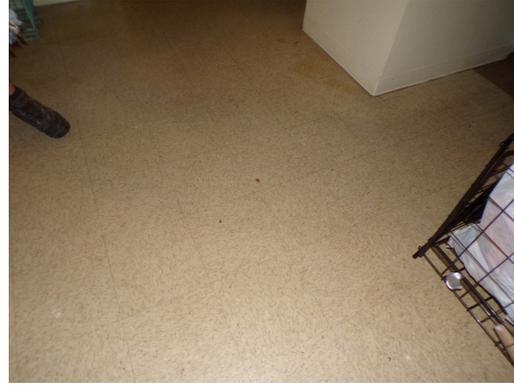
Building 4 - unit 454 - 2-bed/1-bath - vinyl tile floor

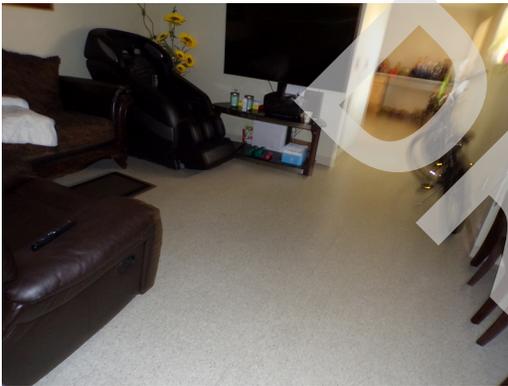
Building 4 - unit 437 - 4-bed/1.5-bath - UFAS - vinyl tile floor

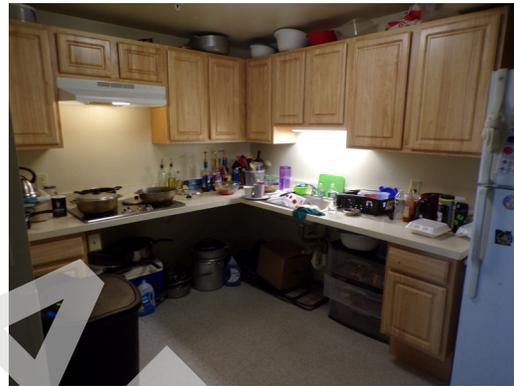
Building 4 - unit 437 - 4-bed/1.5-bath - UFAS - kitchen

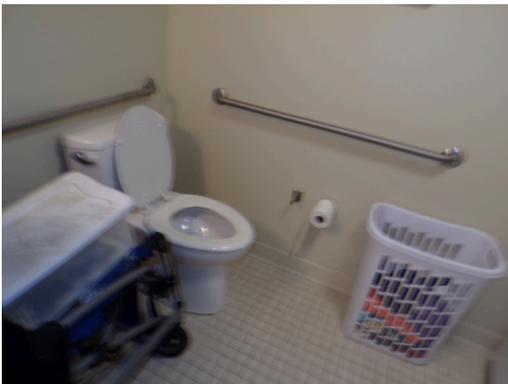
Building 4 - unit 437 - 4-bed/1.5-bath - UFAS - half bath toilet

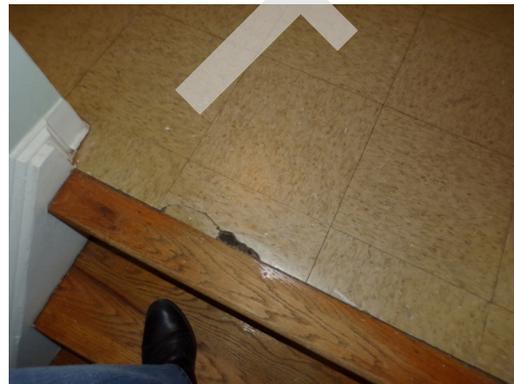
Building 4 - unit 416 - 3-bed/1.5-bath - TH - vinyl tile damage by stairs (Non-Critical Repair)

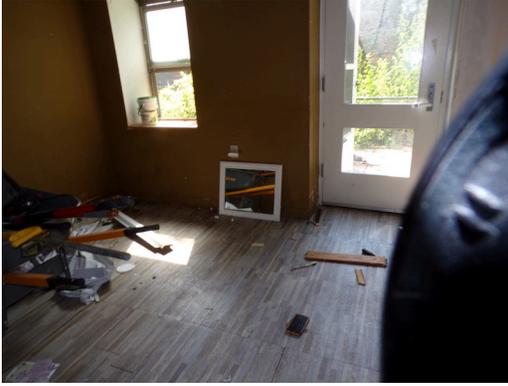
Building 5 - unit 514 - 3-bed/1-bath - TH -  
living room area

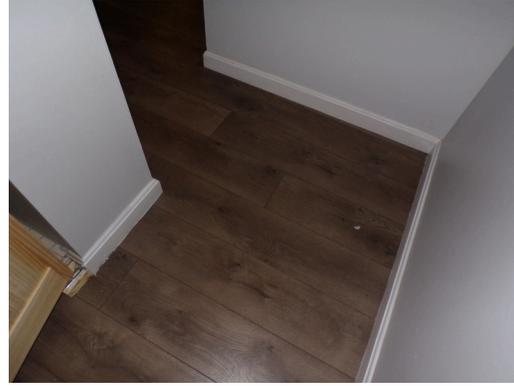
Building 5 - unit 517 - 3-bed/1.5-bath - TH -  
plank floor tile

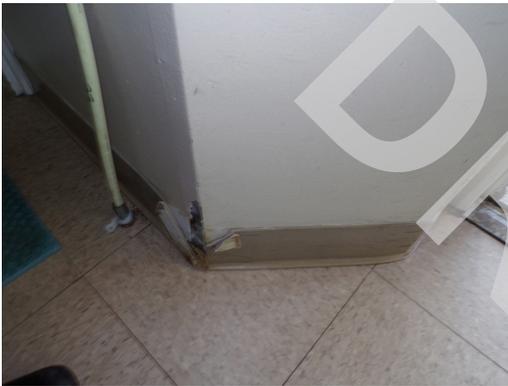
Building 8 - unit 822 - 2-bed/1.5-bath - TH -  
wall damage by main ingress/egress  
(Non-Critical Repair)

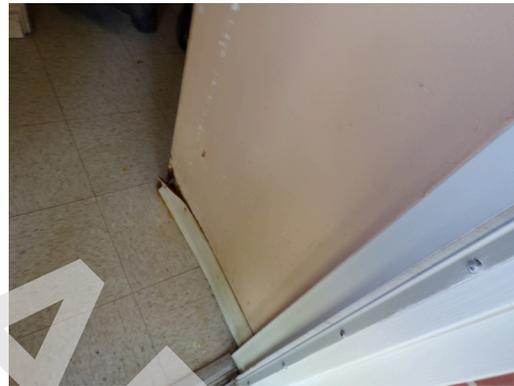
Building 8 - unit 822 - 2-bed/1.5-bath - TH -  
wall damage near main ingress/egress  
(Non-Critical Repair)

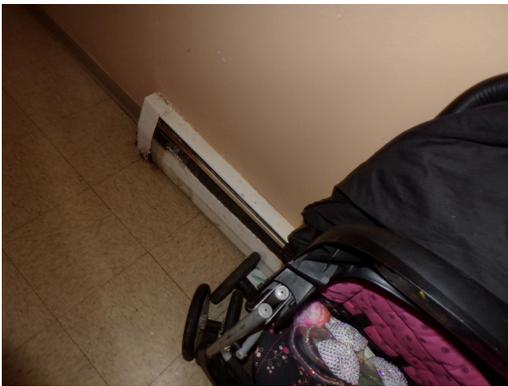
Building 8 - unit 822 - 2-bed/1.5-bath - TH -  
base board heater

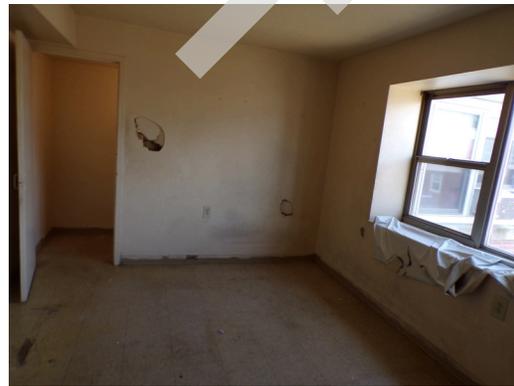
Building 10 - unit 1014 - 3-bed/1.5-bath - TH  
- wall damage (Non-Critical Repair)

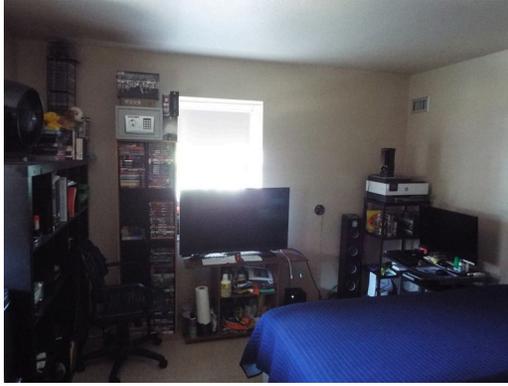
Building 13 - unit 1313 - 4-bed/2-bath - TH -  
bedroom

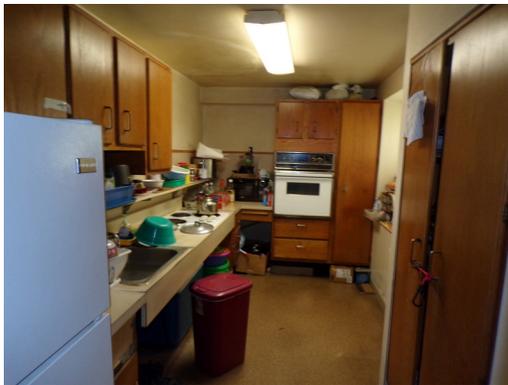
Building 4 - unit 414 - 3-bed/2-bath - TH -  
UFAS - kitchen

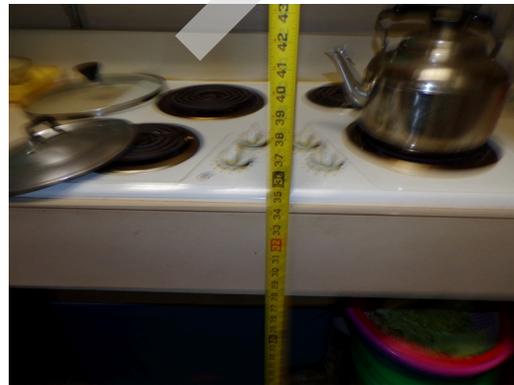
Building 4 - unit 414 - 3-bed/2-bath - TH -  
UFAS - range front end controls

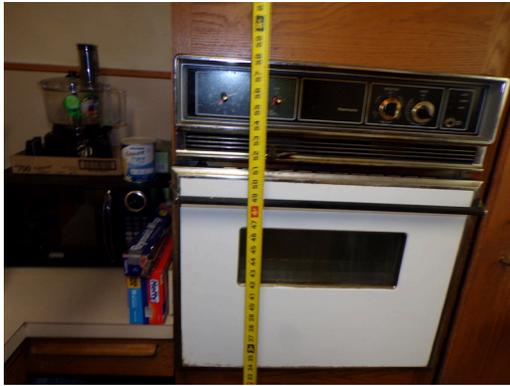
Building 4 - unit 414 - 3-bed/2-bath - TH - UFAS - oven

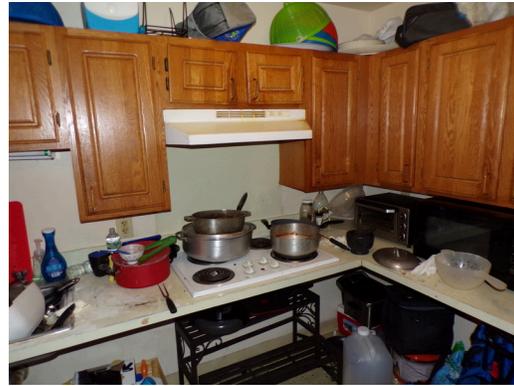
Building 4 - unit 412 - 3-bed/1.5-bath - UFAS - kitchen range hood missing front end controls (Critical Repair)

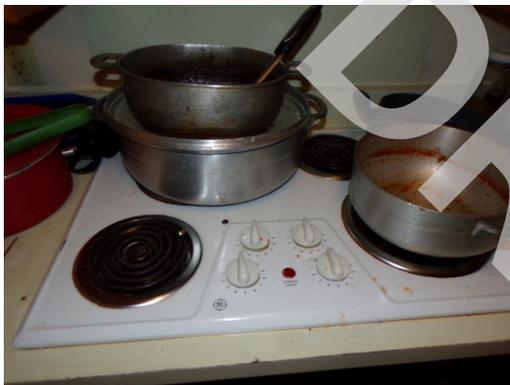
Building 4 - unit 412 - 3-bed/1.5-bath - UFAS - range front end controls

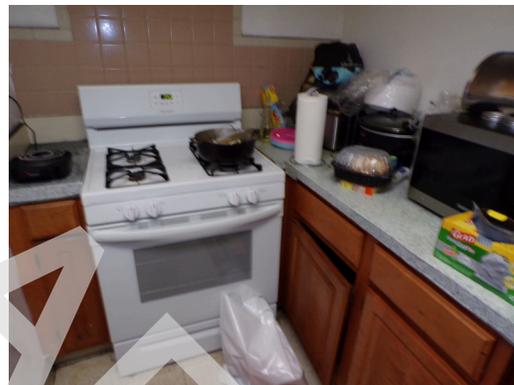
Building 4 - unit 418 - 3-bed/1.5-bath - TH - kitchen range

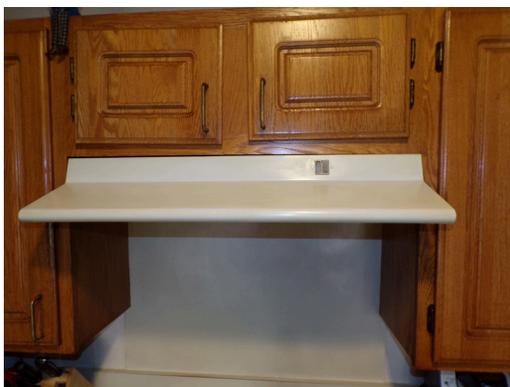
Building 4 - unit 422 - 3-bed/1.5-bath - UFAS - kitchen range hood missing front end controls (Critical Repair)

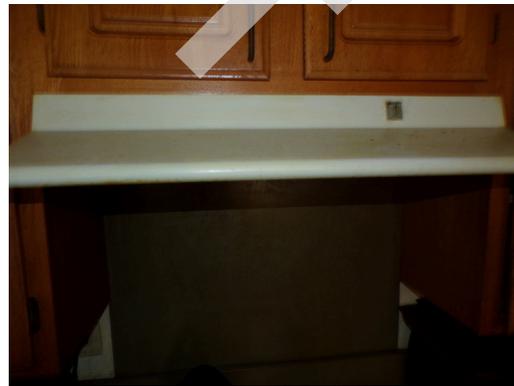
Building 4 - unit 427 - 3-bed/1.5-bath - UFAS - kitchen range hood missing front end controls (Critical Repair)

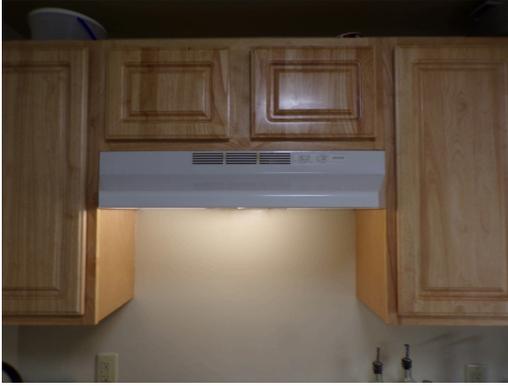
Building 4 - unit 437 - 4-bed/1.5-bath - UFAS  
- kitchen range hood missing front end  
controls (Critical Repair)

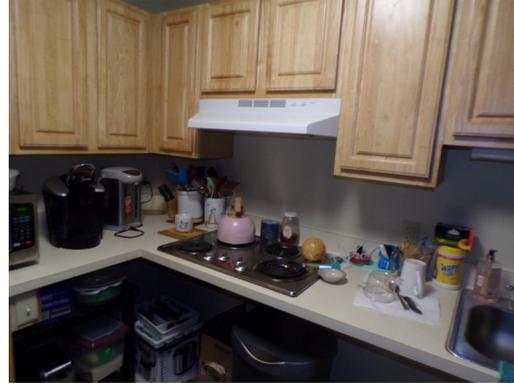
Building 4 - unit 417 - 3-bed/1.5-bath - UFAS  
- kitchen range hood missing front end  
controls (Critical Repair)

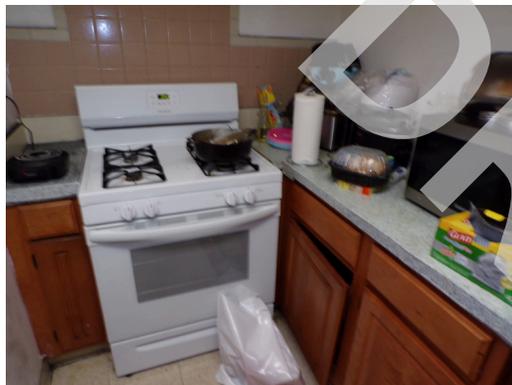
Building 4 - unit 418 - 3-bed/1.5-bath - TH - kitchen range

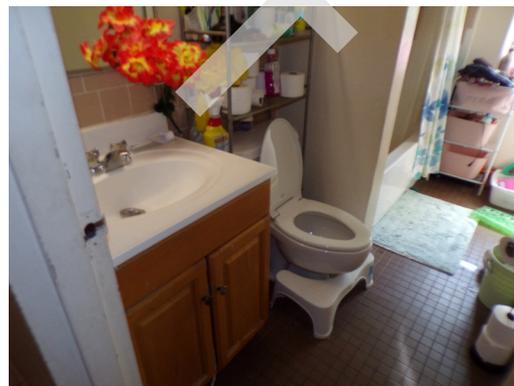
Building 5 - unit 513 - 3-bed/1.5-bath - TH - bathroom

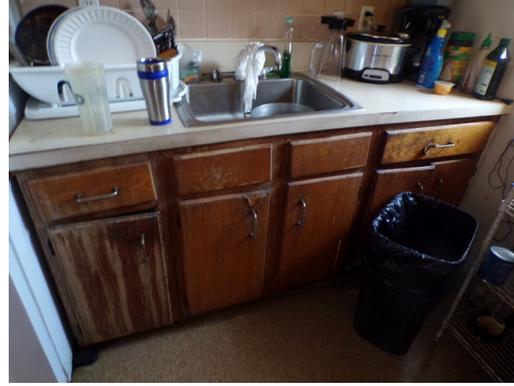
Building 5 - unit 533 - 1-bed/1-bath - kitchen cabinets replacement (Non-Critical Repair)

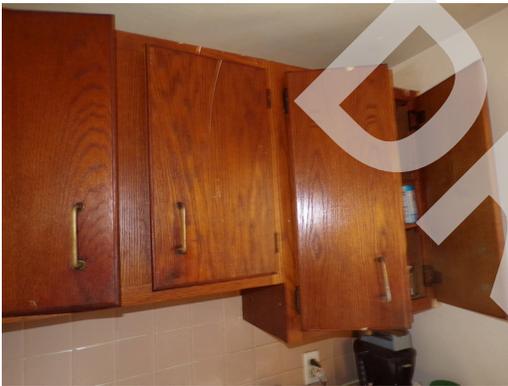
Building 5 - unit 533 - 1-bed/1-bath - kitchen cabinets replacement (Non-Critical Repair)

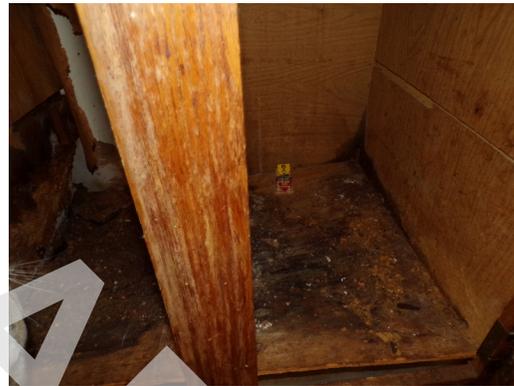
Building 5 - unit 533 - 1-bed/1-bath - kitchen cabinets replacement (Non-Critical Repair)

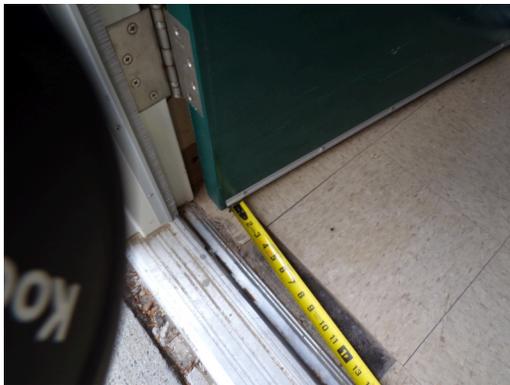
Building 4 - unit 414 - 3-bed/2-bath - TH -  
UFAS - main ingress/egress doorway  
floorspace

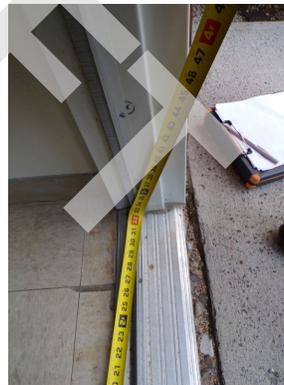
Building 4 - unit 414 - 3-bed/2-bath - TH -  
UFAS - main ingress/egress doorway  
floorspace

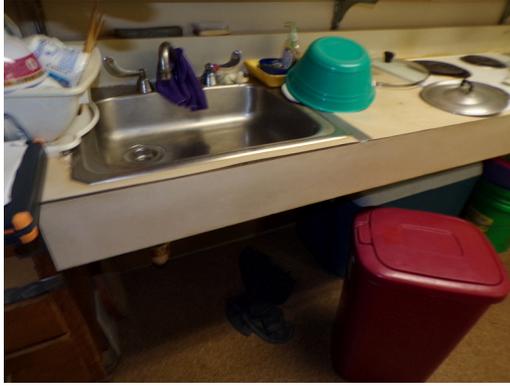
Building 4 - unit 414 - 3-bed/2-bath - TH - UFAS - kitchen sink

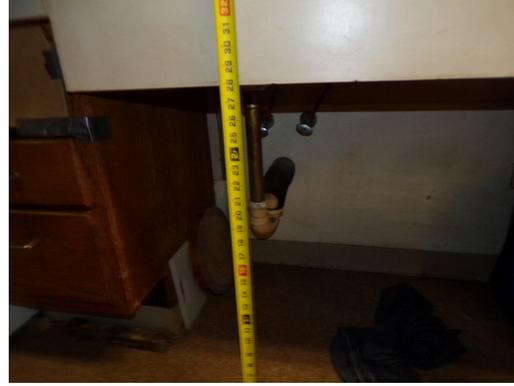
Building 4 - unit 414 - 3-bed/2-bath - TH - UFAS - kitchen sink pipes missing scald and abrasion protection (Critical Repair)

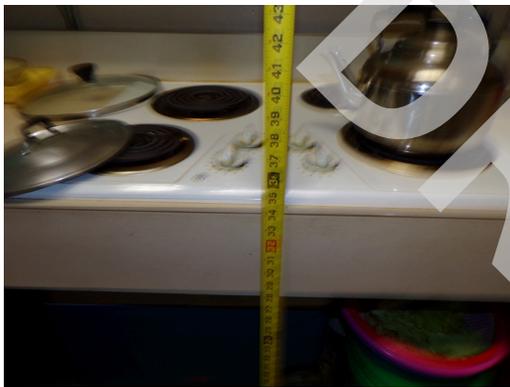
Building 4 - unit 414 - 3-bed/2-bath - TH - UFAS - range front end controls

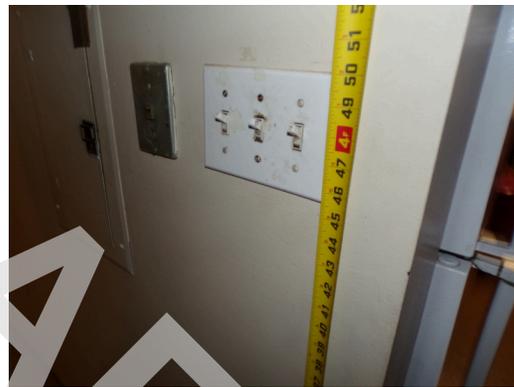
Building 4 - unit 414 - 3-bed/2-bath - TH - UFAS - light switch

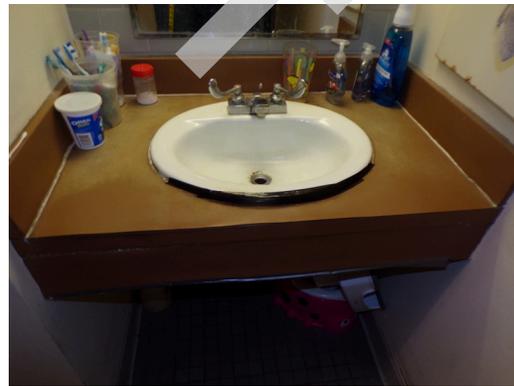
Building 4 - unit 414 - 3-bed/2-bath - TH - UFAS - bathroom sink

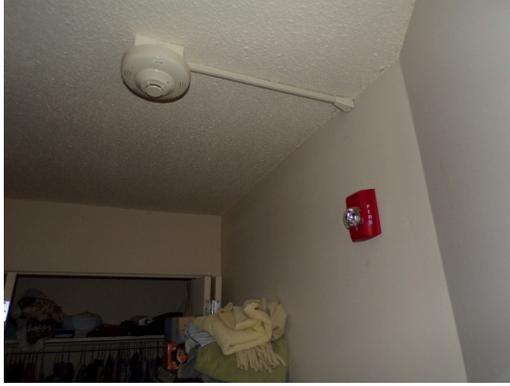
Building 4 - unit 414 - 3-bed/2-bath - TH - UFAS - smoke detector and fire strobe light

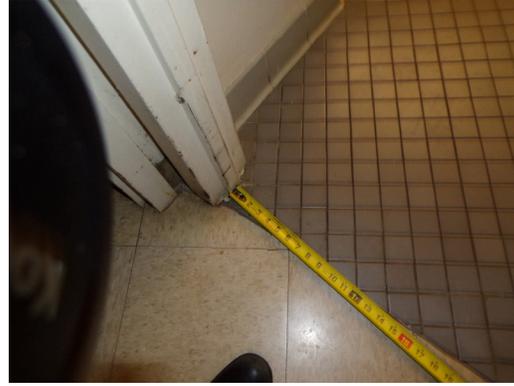
Building 4 - unit 414 - 3-bed/2-bath - TH - UFAS - bathroom doorway floorspace

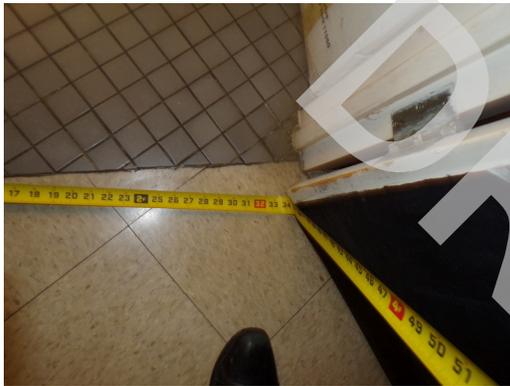
Building 4 - unit 414 - 3-bed/2-bath - TH - UFAS - bathroom doorway floorspace

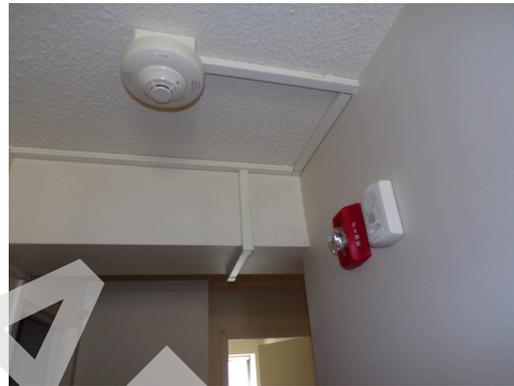
Building 4 - unit 414 - 3-bed/2-bath - TH - UFAS - smoke detector, fire strobe and audio alarm

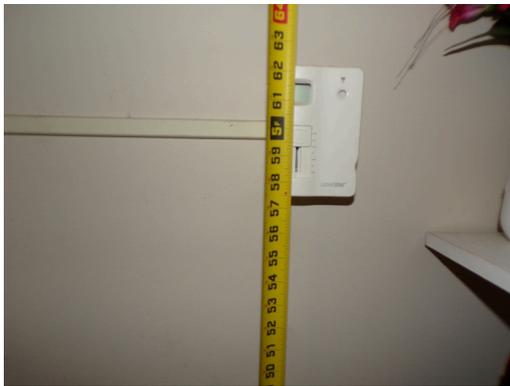
Building 4 - unit 414 - 3-bed/2-bath - TH - UFAS - lower thermostat (Critical Repair)

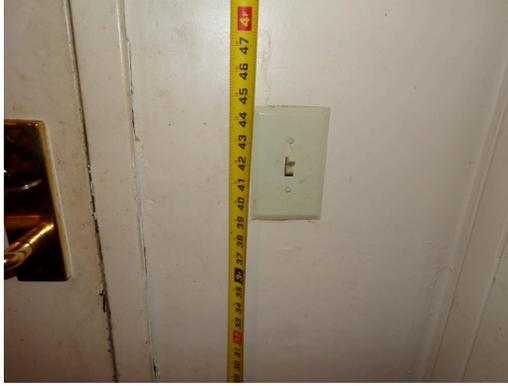
Building 4 - unit 412 - 3-bed/1.5-bath - UFAS  
- light switch

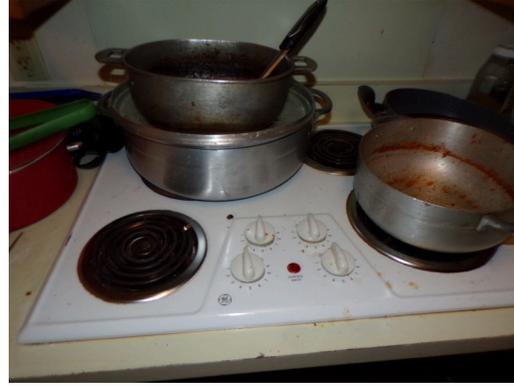
Building 4 - unit 412 - 3-bed/1.5-bath - UFAS  
- range front end controls

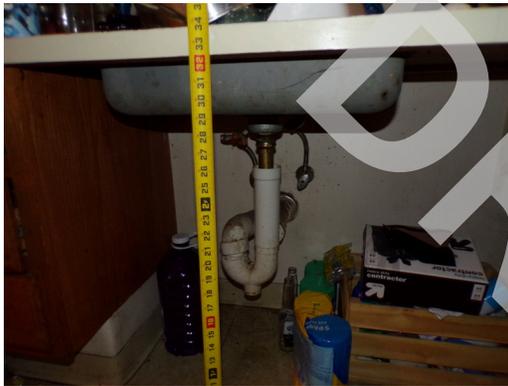
Building 4 - unit 412 - 3-bed/1.5-bath - UFAS  
- kitchen sink

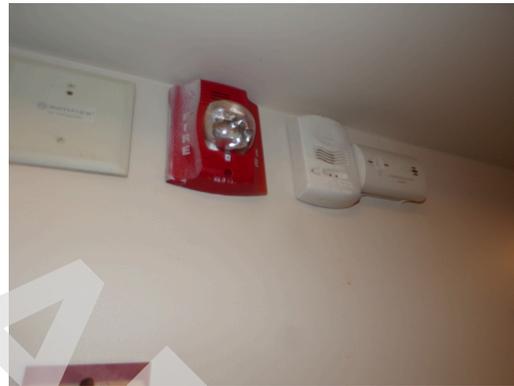
Building 4 - unit 412 - 3-bed/1.5-bath - UFAS  
- fire alarm strobe light and audio alarm

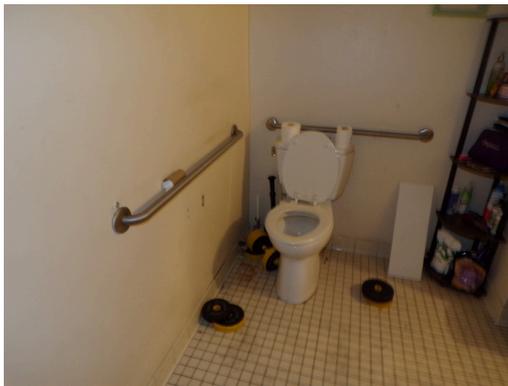
Building 4 - unit 412 - 3-bed/1.5-bath - UFAS  
- bathroom toilet

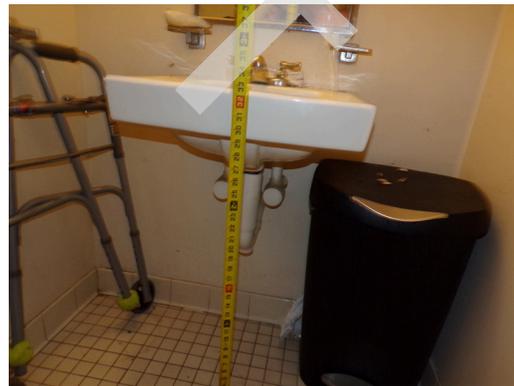
Building 4 - unit 412 - 3-bed/1.5-bath - UFAS  
- bathroom sink

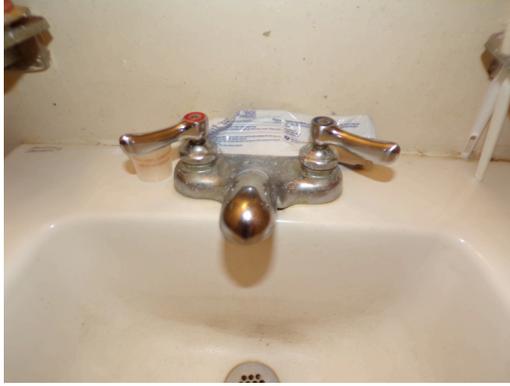
Building 4 - unit 412 - 3-bed/1.5-bath - UFAS  
- bathroom sink levered hardware

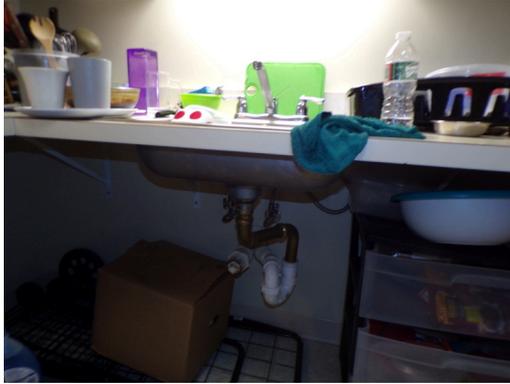
Building 4 - unit 432 - 4-bed/1.5-bath - UFAS  
- kitchen sink missing partial scald and  
abrasion protection (Critical Repair)

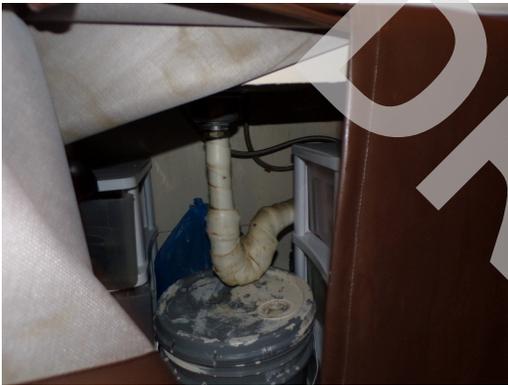
Building 5 - unit 515 - 3-bed/1.5-bath - TH - UFAS - kitchen sink missing scald and abrasion protection (Critical Repair)

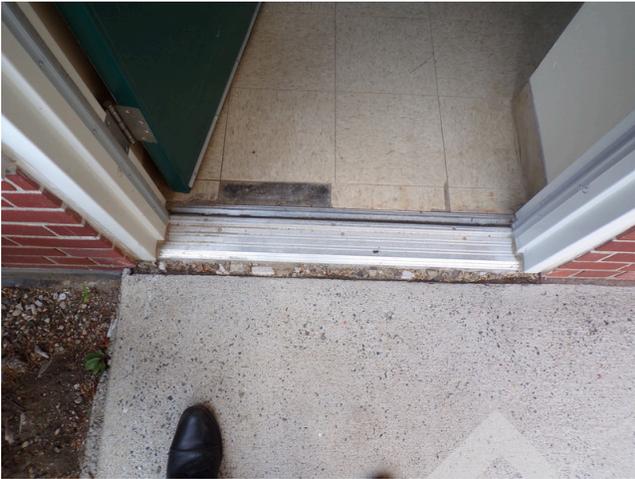
1. Building 4 - unit 414 - 3-bed/2-bath - TH - UFAS - main ingress/egress threshold

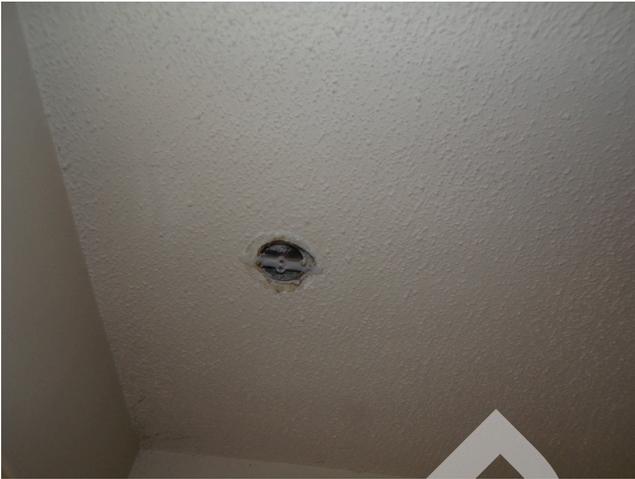
5. Building 4 - unit 414 - 3-bed/2-bath - TH - UFAS - living room missing light (Non-Critical Repair)

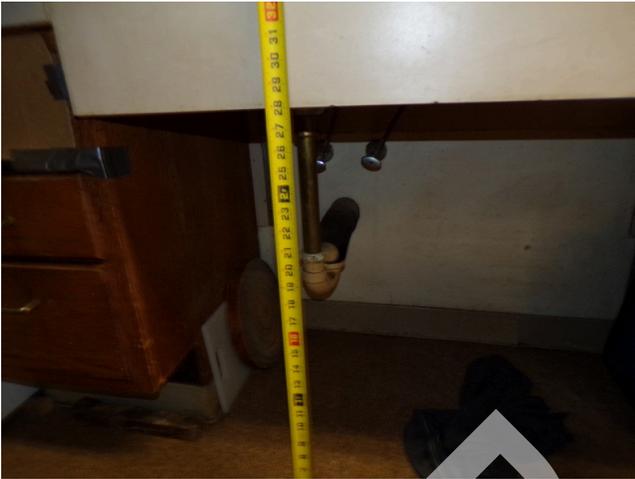
9. Building 4 - unit 414 - 3-bed/2-bath - TH - UFAS - kitchen sink pipes missing scald and abrasion protection (Critical Repair)

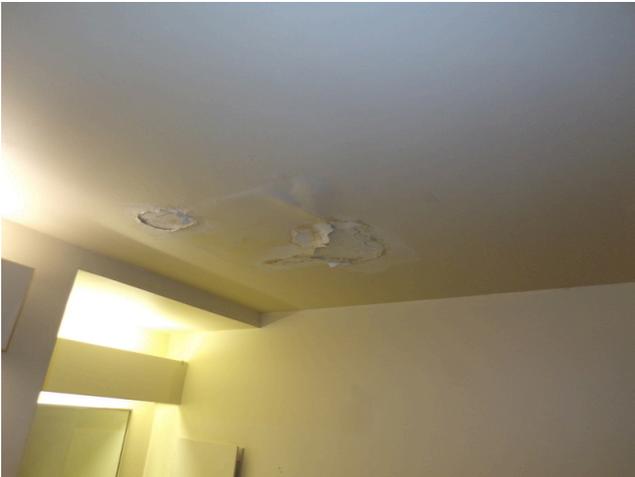
15. Building 4 - unit 414 - 3-bed/2-bath - TH - UFAS  
- first floor ceiling damage (Non-Critical Repair)

Drywall	Repair Damaged Ceiling (Non-Critical Repair)	Dwelling units 414, 418, 415, 437, 513, 563, 533, 1203 and 1216	Repair	9	Each	\$ 500.00	\$ 4,500.00	The select dwelling units ceilings were observed damaged with some areas of missing drywall. In order to prevent further damage, the repair of the ceilings is recommended.
Drywall	Repair Damaged Drywall (Non-Critical Repair)	Dwelling units 454, 444, 515,822, 909, 1014, 1110, 1202 and 1216	Repair	9	Each	\$ 500.00	\$ 4,500.00	The drywall in select dwelling units were observed damaged. In order to prevent further damage, the repair of the drywall is recommended.
Unit Entry Door, Exterior, solid wood/metal clad	Apartment Entry Doors (Non-Critical Repair)	Throughout property	Repair	25	Each	\$ 600.00	\$ 15,000.00	AEI observed select exterior dwelling units doors damaged and/or scratched. Repairing the damaged door and repainting is recommended.
Tenant buzzer / intercom /secured entry system	Intercom System (Non-Critical Repair)	Buildings 4, 5 and 7	Level 1 Alteration	278	Each	\$ 300.00	\$ 83,400.00	AEI observed the intercom system throughout the building past the estimated useful life (EUL). Replacing the intercom system is recommended.

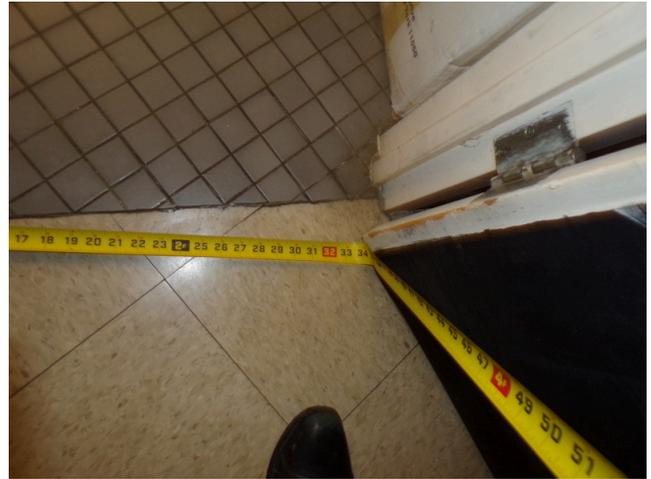
25. Building 4 - unit 414 - 3-bed/2-bath - TH - UFAS  
- bathroom doorway floorspace

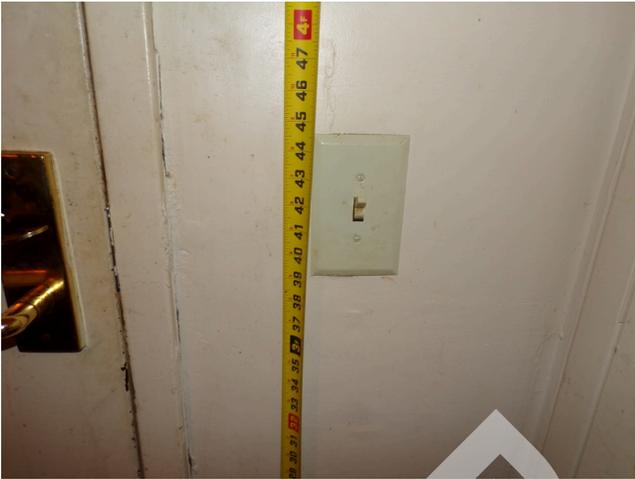
32. Building 4 - unit 412 - 3-bed/1.5-bath - UFAS -  
main ingress/egress doorway floorspace

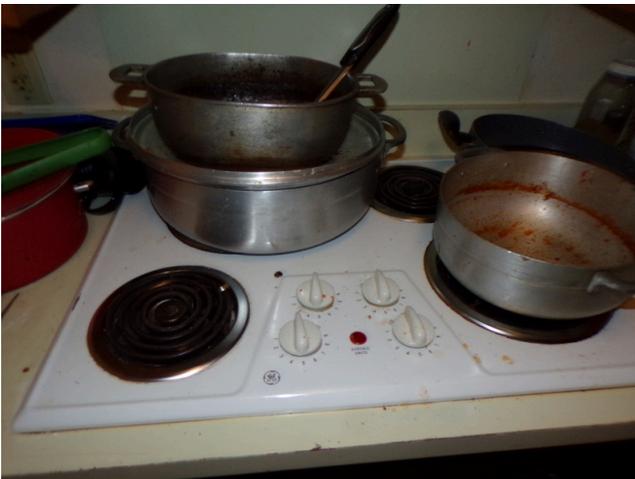
34. Building 4 - unit 412 - 3-bed/1.5-bath - UFAS - kitchen range hood missing front end controls (Critical Repair)

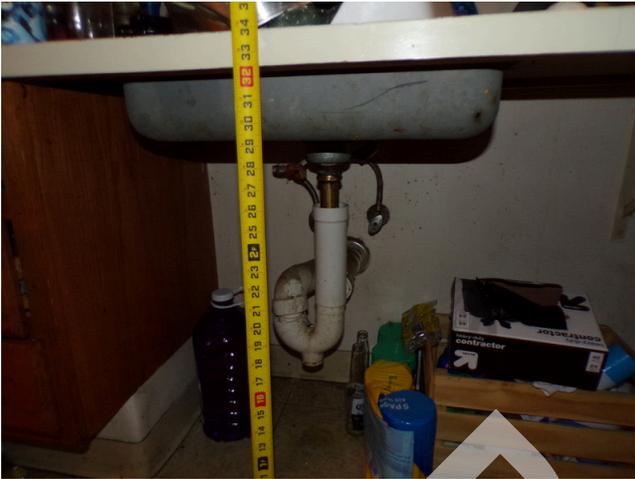
36. Building 4 - unit 412 - 3-bed/1.5-bath - UFAS - kitchen sink hardware missing lever handles (Critical Repair)

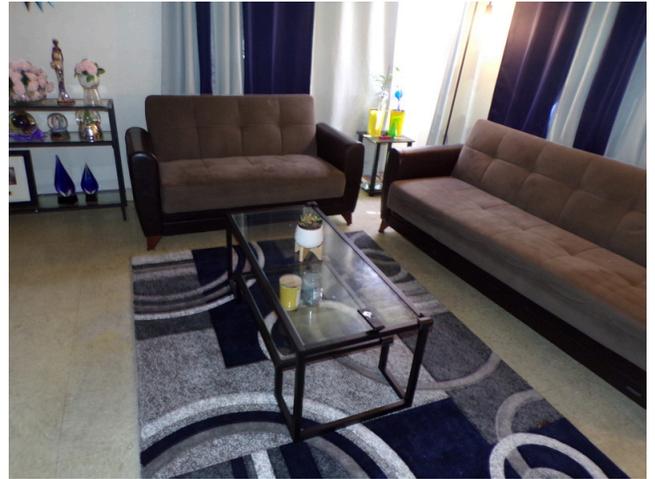
37. Building 4 - unit 412 - 3-bed/1.5-bath - UFAS - kitchen sink

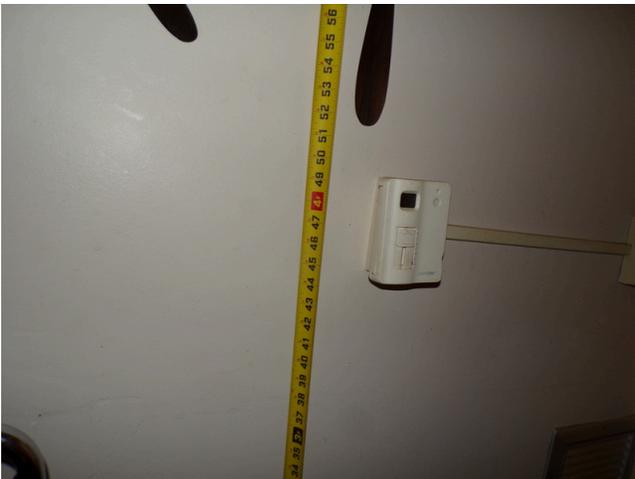
38. Building 4 - unit 412 - 3-bed/1.5-bath - UFAS - living room

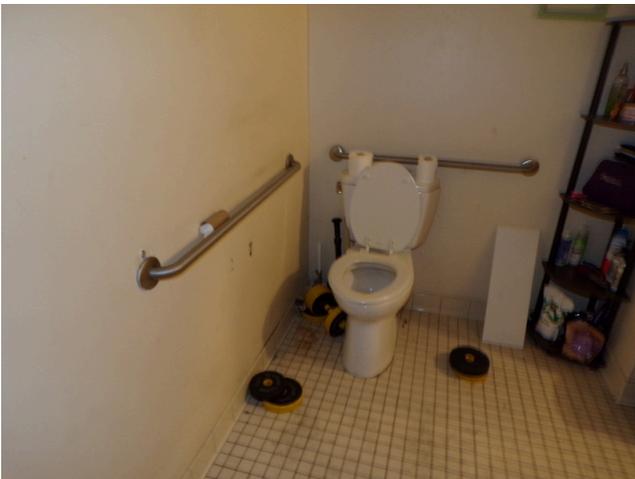
42. Building 4 - unit 412 - 3-bed/1.5-bath - UFAS - bathroom

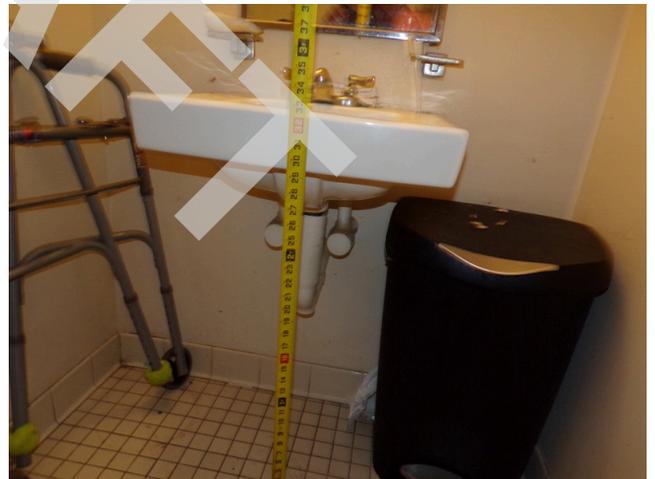
43. Building 4 - unit 412 - 3-bed/1.5-bath - UFAS - bathroom toilet

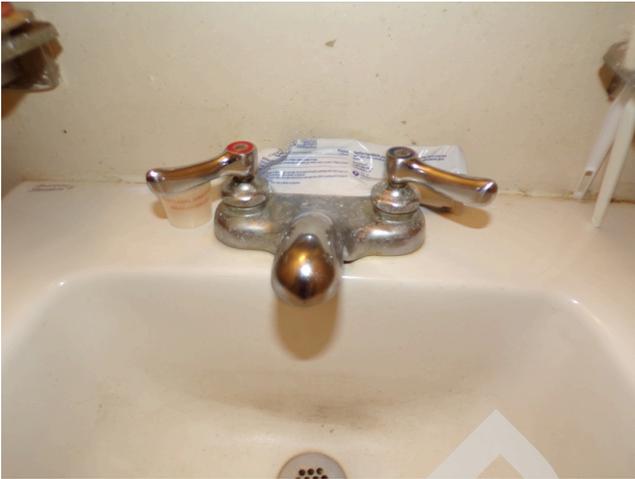
44. Building 4 - unit 412 - 3-bed/1.5-bath - UFAS - bathroom sink

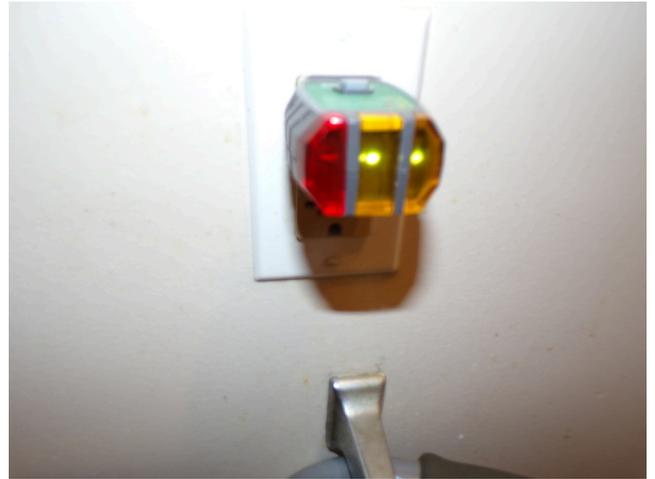
45. Building 4 - unit 412 - 3-bed/1.5-bath - UFAS -  
bathroom sink levered hardware

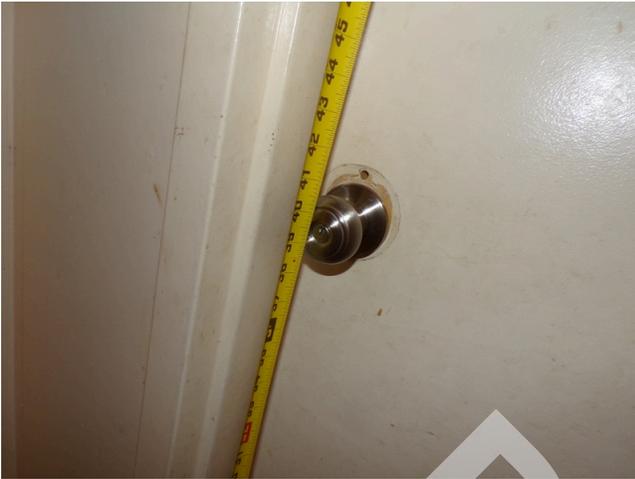
48. Building 4 - unit 412 - 3-bed/1.5-bath - UFAS -  
levered door hardware

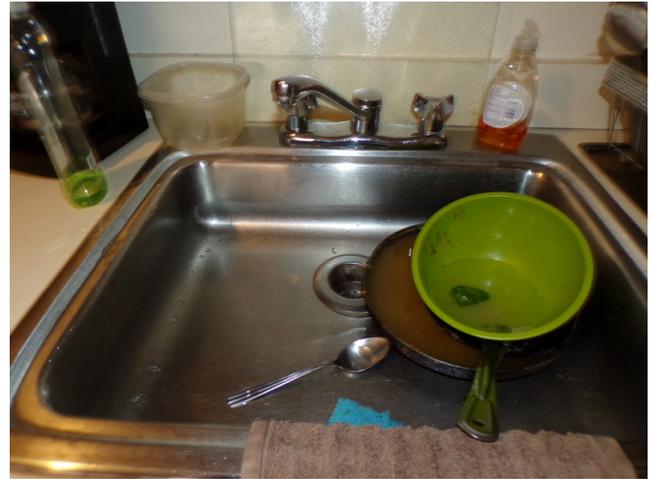
65. Building 4 - unit 422 - 3-bed/1.5-bath - UFAS - kitchen

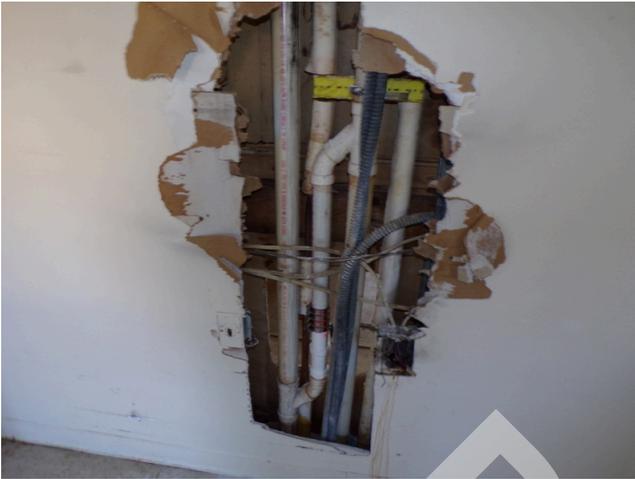
96. Building 4 - unit 444 - 2-bed/1-bath - bathroom missing vanity (Non-Critical Repair)

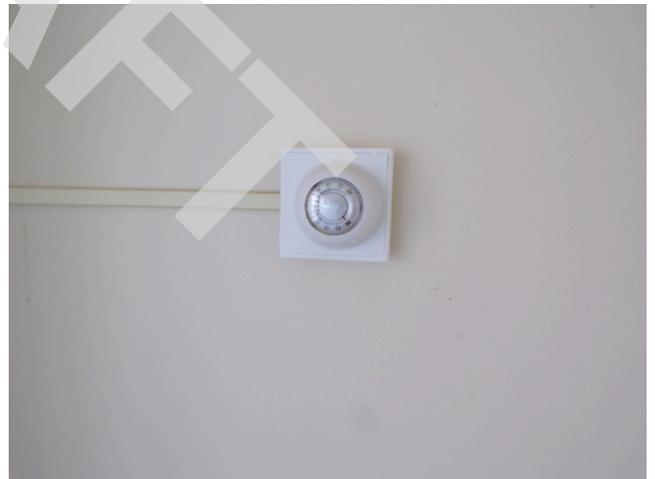
99. Building 4 - unit 444 - 2-bed/1-bath - heat

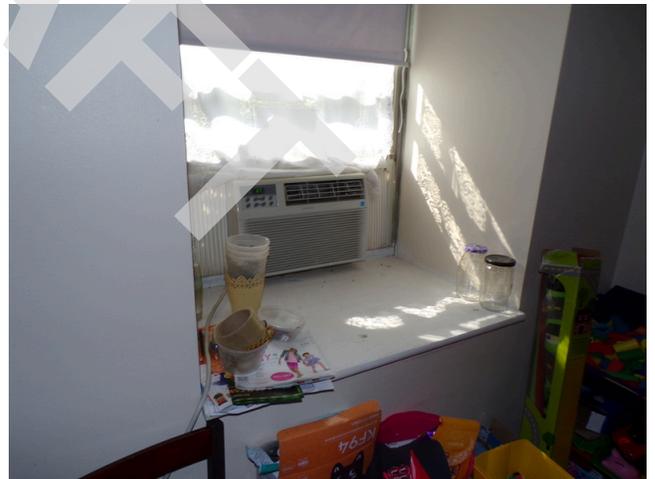
116. Building 4 - unit 415 - 3-bed/2-bath - TH - UFAS - thru-window air conditioner

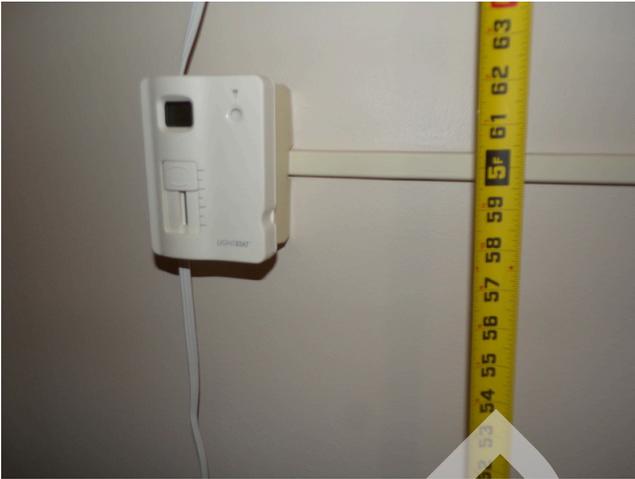
117. Building 4 - unit 415 - 3-bed/2-bath - TH - UFAS - thermostat to high (Critical Repair)

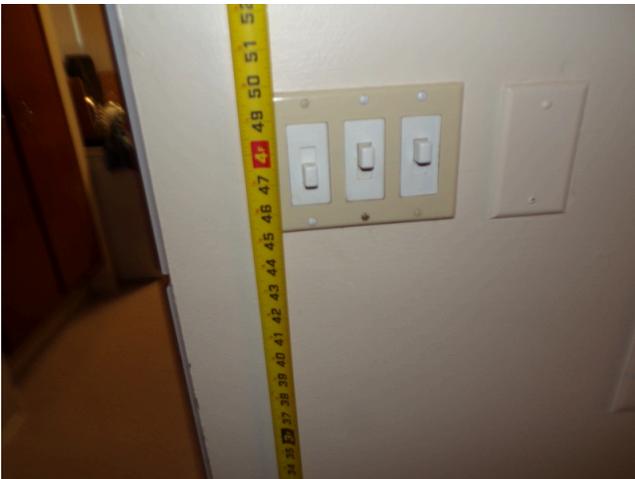
119. Building 4 - unit 415 - 3-bed/2-bath - TH - UFAS - light switch

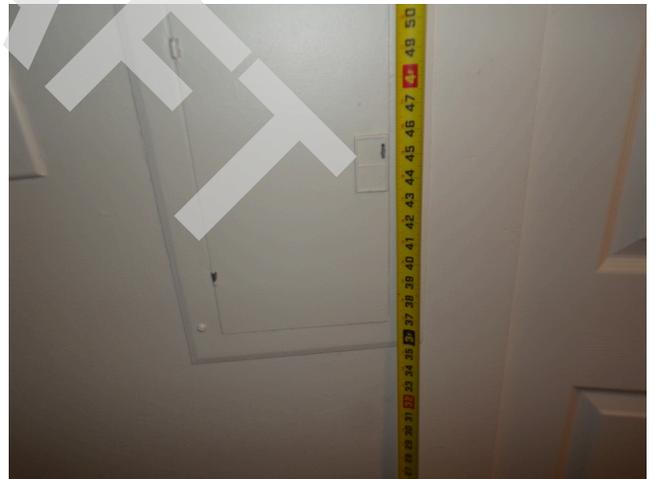
120. Building 4 - unit 415 - 3-bed/2-bath - TH - UFAS - circuit breaker box

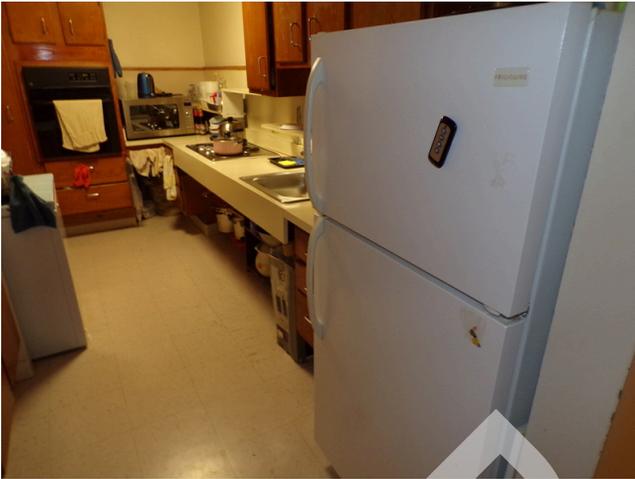
121. Building 4 - unit 415 - 3-bed/2-bath - TH - UFAS - kitchen

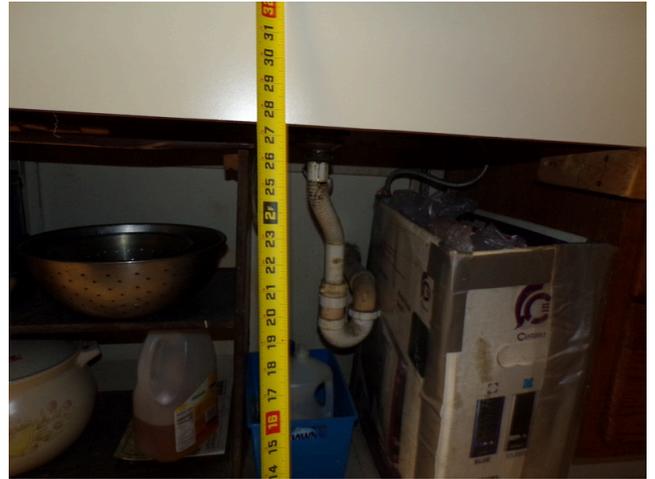
122. Building 4 - unit 415 - 3-bed/2-bath - TH - UFAS - kitchen sink missing scald and abrasion protection (Critical Repair)

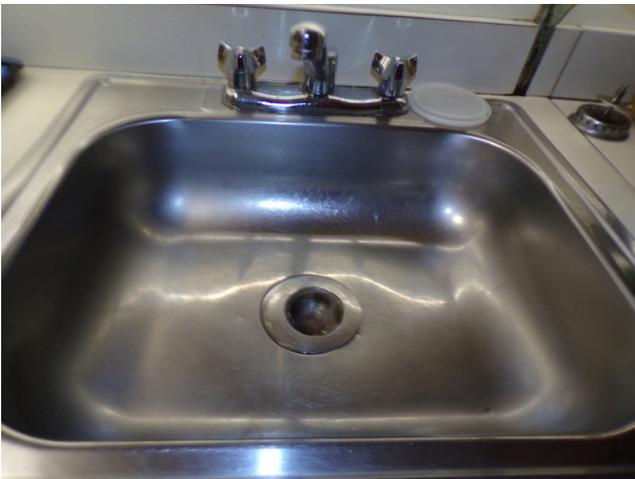
123. Building 4 - unit 415 - 3-bed/2-bath - TH - UFAS - kitchen sink missing levered hardware (Critical Repair)

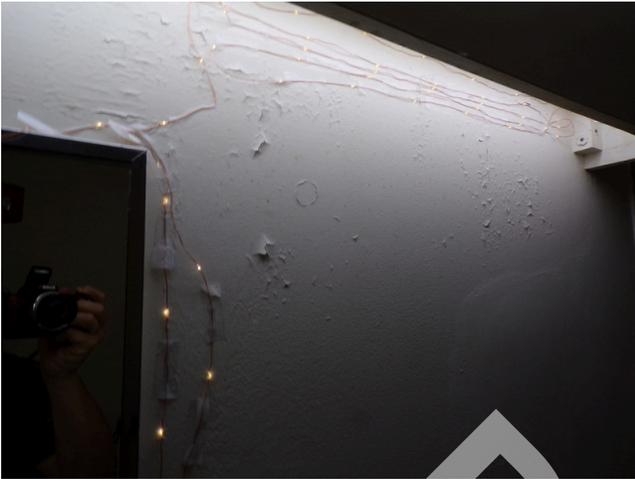
125. Building 4 - unit 415 - 3-bed/2-bath - TH - UFAS - bathroom peeling paint (Non-Critical Repair)

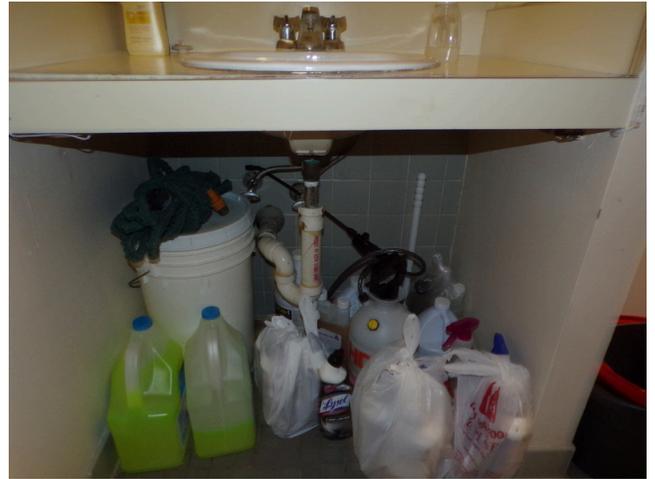
130. Building 4 - unit 415 - 3-bed/2-bath - TH - UFAS - bathroom sink missing scald and abrasion protection (Critical Repair)

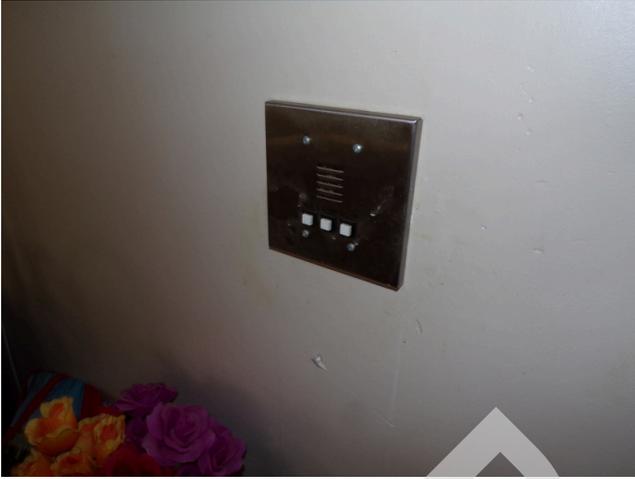
133. Building 4 - unit 427 - 3-bed/1.5-bath - UFAS - call box (Non-Critical Repair)

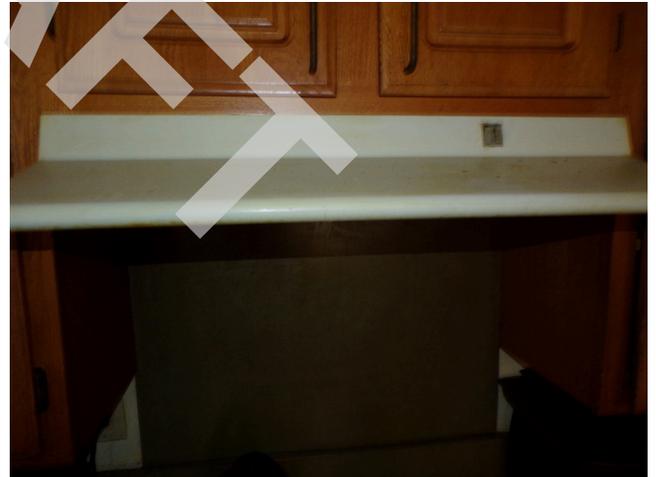
136. Building 4 - unit 427 - 3-bed/1.5-bath - UFAS - kitchen range hood missing front end controls (Critical Repair)
