## HUD CAPITAL NEEDS ASSESSMENT

Commonwealth Family  
35 Fidelis Way  
Brighton, Massachusetts 02135

AEI Project No. 463346  
Site Inspection Date: July 20 and 21, 2022

Boston Housing Authority  
52 Chauncy Street  
Boston, Massachusetts 02111

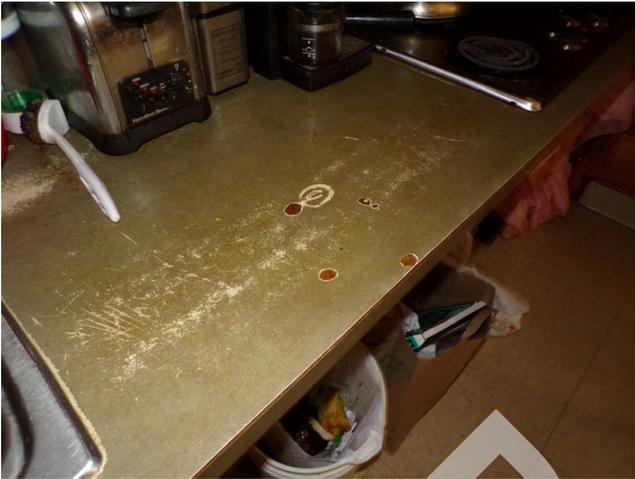
137. Building 4 - unit 427 - 3-bed/1.5-bath - UFAS - kitchen countertop damage (Non-Critical Repair)

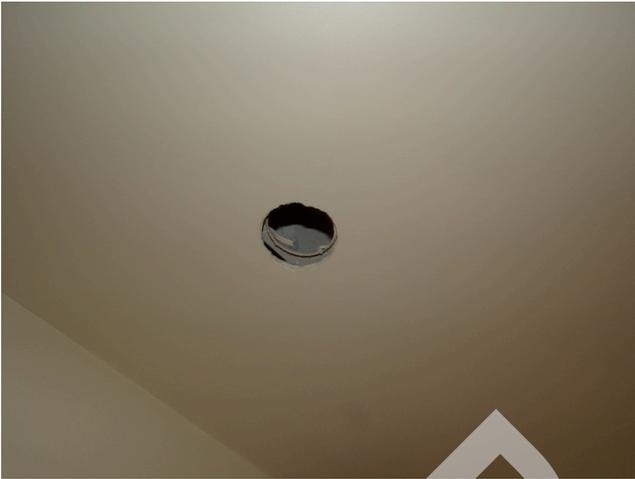
141. Building 4 - unit 437 - 4-bed/1.5-bath - UFAS - hole in ceiling (Non-Critical Repair)

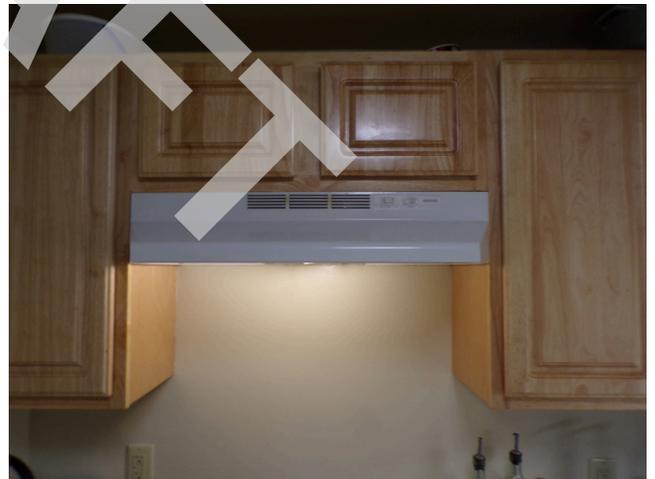
144. Building 4 - unit 437 - 4-bed/1.5-bath - UFAS - kitchen range hood missing front end controls (Critical Repair)

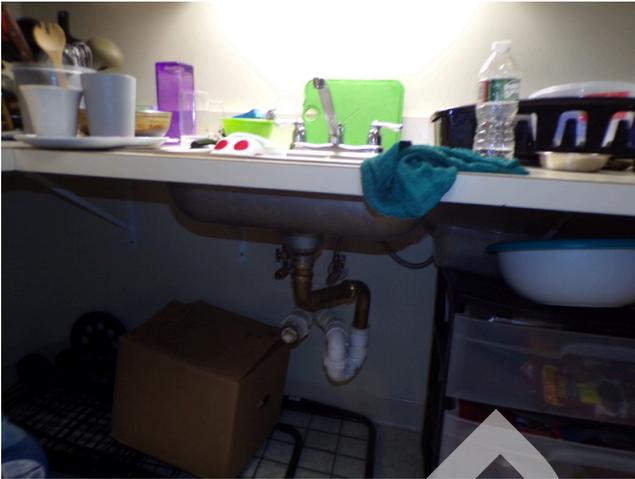
145. Building 4 - unit 437 - 4-bed/1.5-bath - UFAS - kitchen sink missing scald and abrasion protection (Critical Repair)

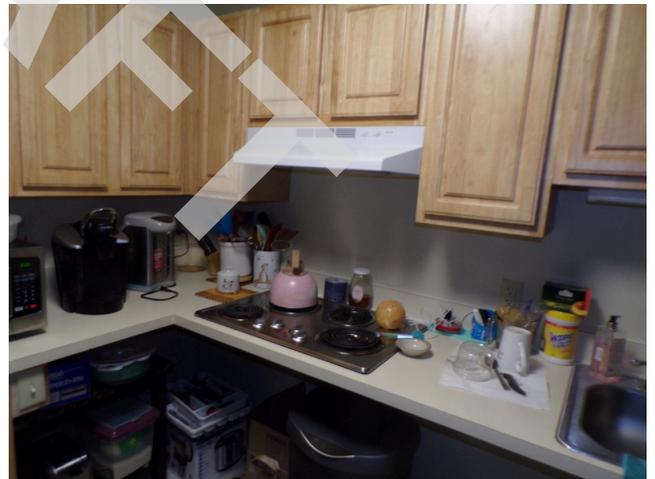
152. Building 4 - unit 417 - 3-bed/1.5-bath - UFAS - kitchen range hood missing front end controls (Critical Repair)

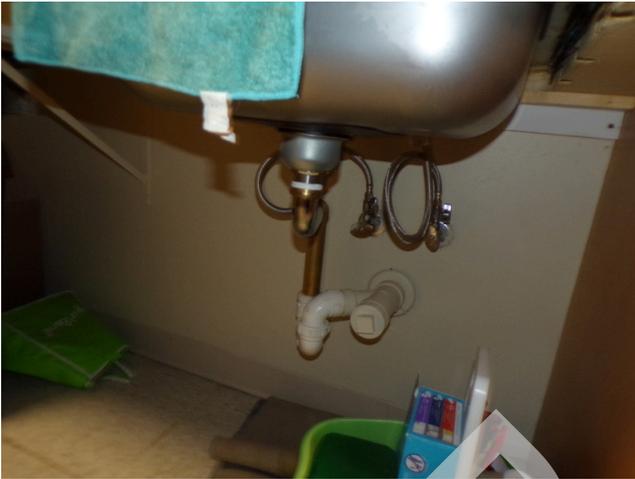
153. Building 4 - unit 417 - 3-bed/1.5-bath - UFAS - kitchen sink missing scald and abrasion protection (Critical Repair)

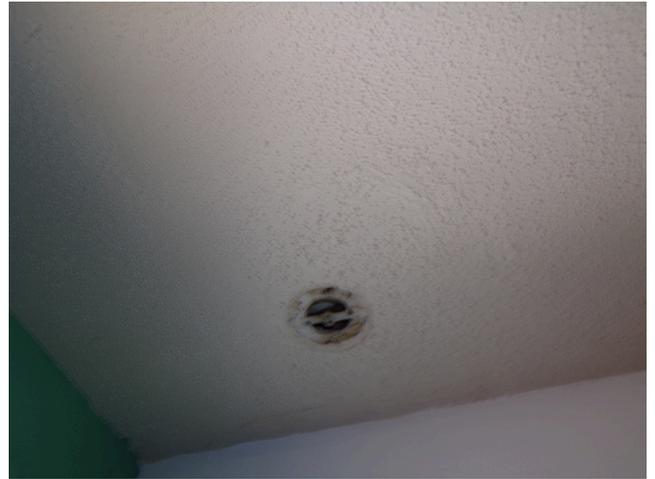
169. Building 5 - unit 513 - 3-bed/1.5-bath - TH - bathroom

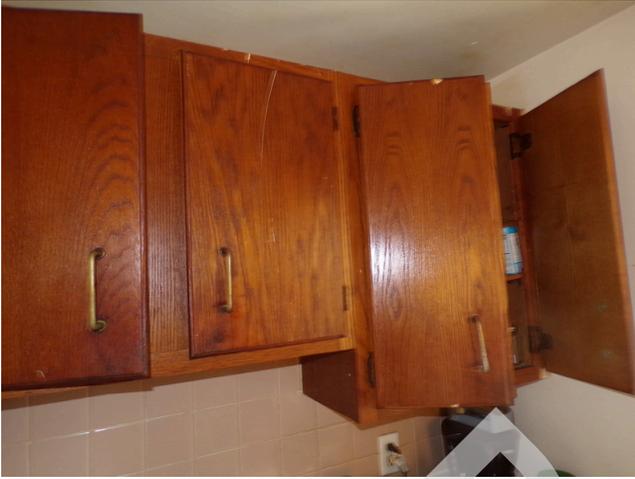
176. Building 5 - unit 533 - 1-bed/1-bath - kitchen cabinets replacement (Non-Critical Repair)

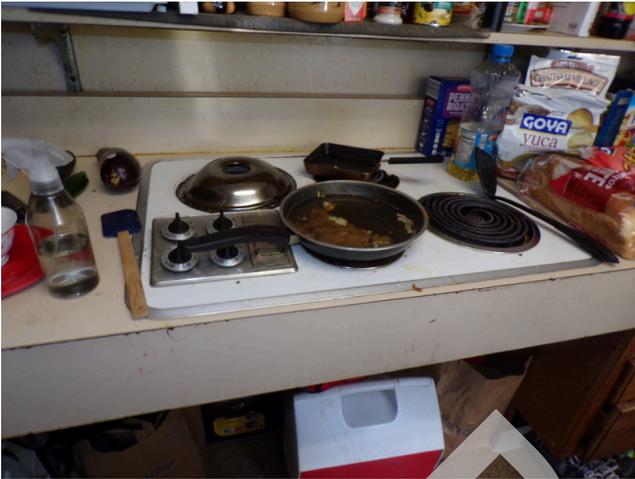
184. Building 5 - unit 515 - 3-bed/1.5-bath - TH - UFAS - kitchen

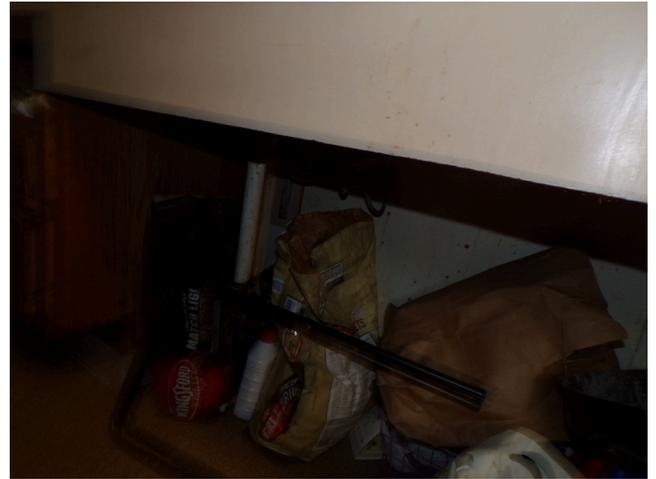
185. Building 5 - unit 515 - 3-bed/1.5-bath - TH - UFAS - kitchen range

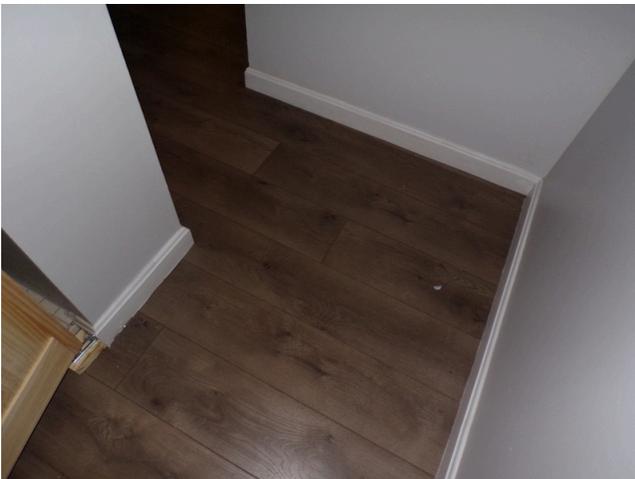
194. Building 5 - unit 517 - 3-bed/1.5-bath - TH - bedroom vinyl floor tile

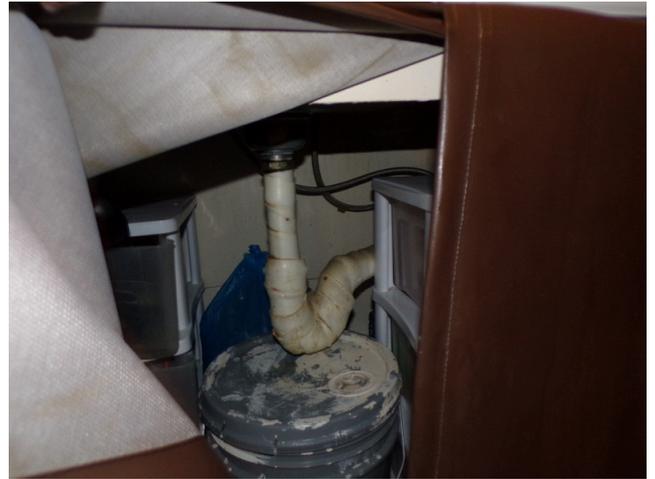
197. Building 7 - unit 735 - 2-bed/1-bath - UFAS - kitchen

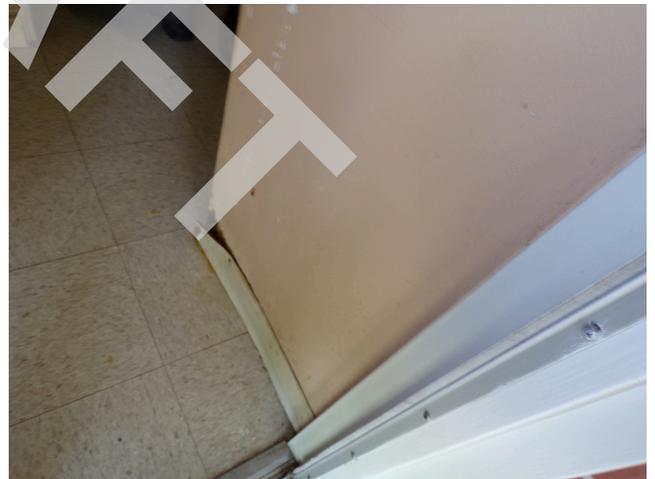
235. Building 8 - unit 822 - 2-bed/1.5-bath - TH - wall damage by main ingress/egress (Non-Critical Repair)

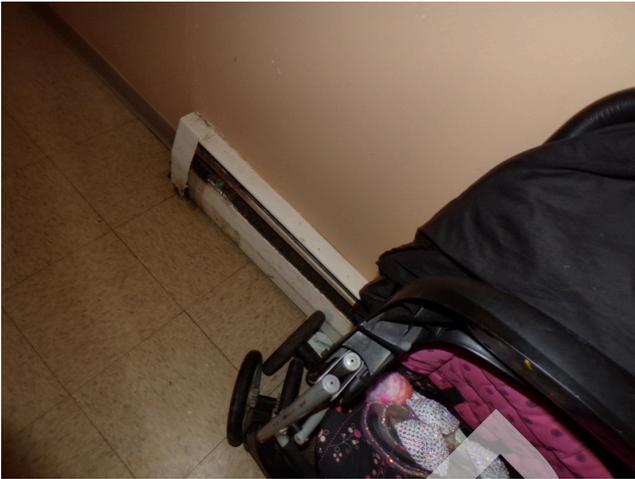
236. Building 8 - unit 822 - 2-bed/1.5-bath - TH - wall damage near main ingress/egress (Non-Critical Repair)

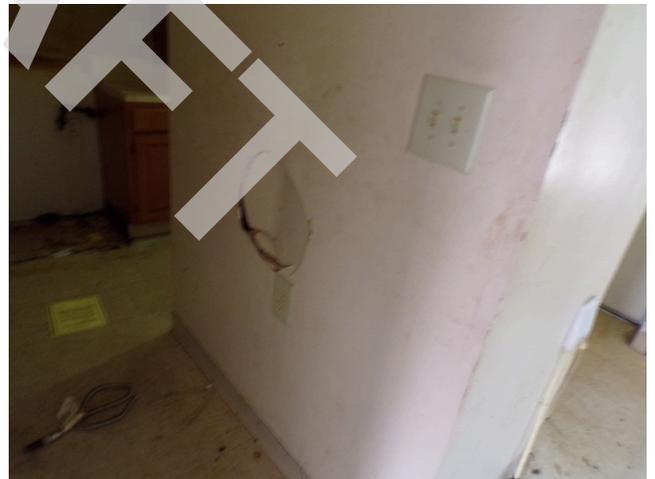
247. Building 10 - unit 1014 - 3-bed/1.5-bath - TH - missing light cover (Non-Critical Repair)

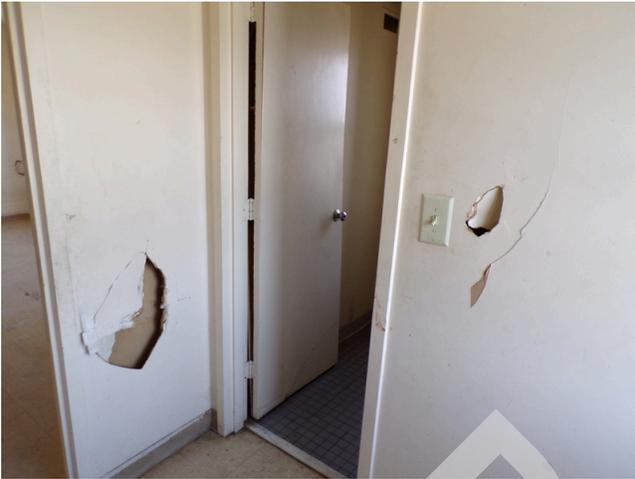
248. Building 10 - unit 1014 - 3-bed/1.5-bath - TH - wall damage (Non-Critical Repair)

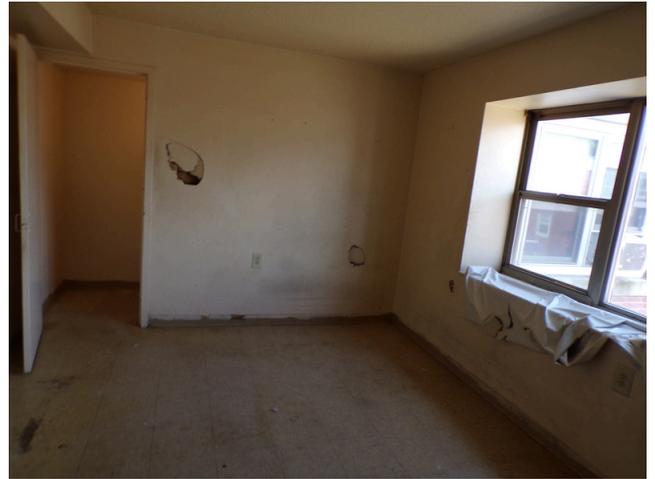
249. Building 10 - unit 1014 - 3-bed/1.5-bath - TH - wall damage (Non-Critical Repair)

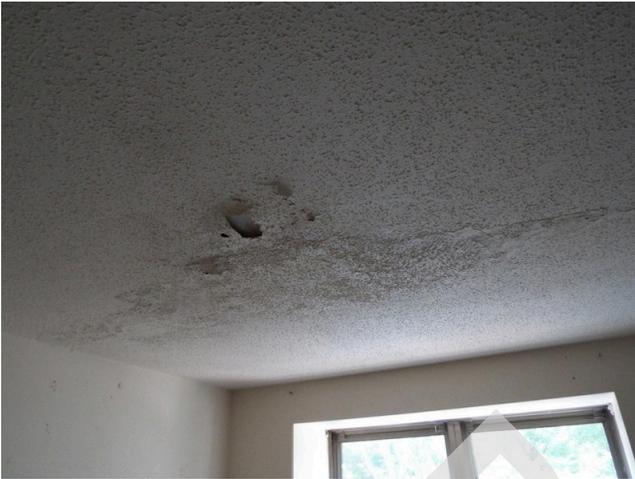
264. Building 12 - unit 1203 - 3-bed/1.5-bath - TH - kitchen ceiling damage (Non-Critical Repair)

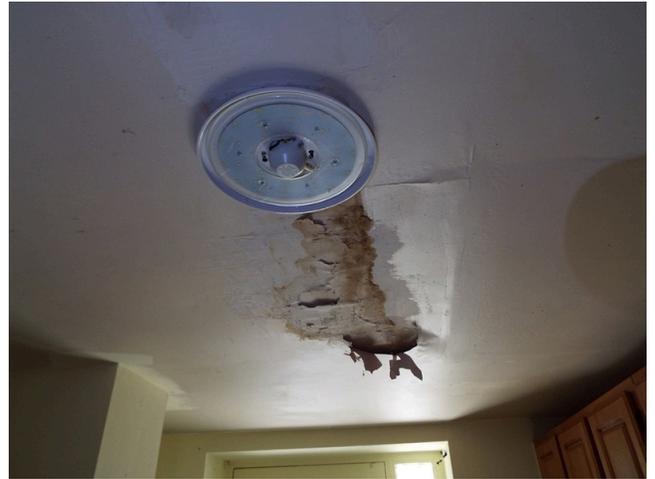
265. Building 12 - unit 1216 - 4-bed/2-bath - TH - bedroom ceiling damage (Non-Critical Repair)

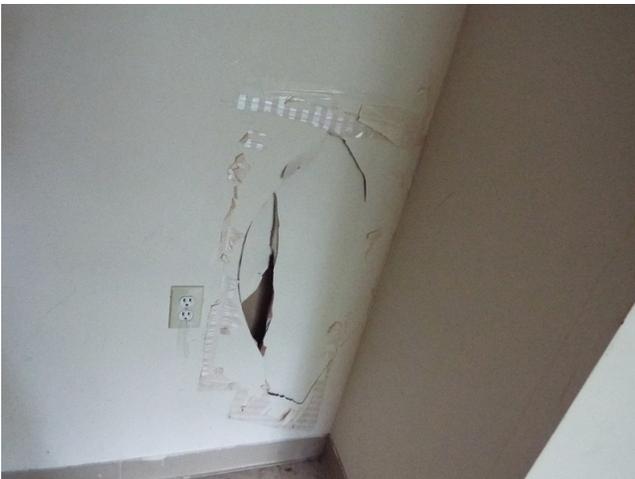
266. Building 12 - unit 1216 - 4-bed/2-bath - TH - kitchen ceiling damage (Non-Critical Repair)

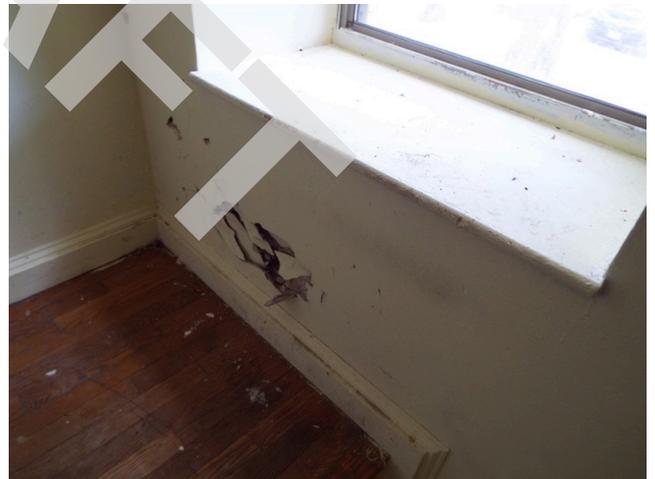
267. Building 12 - unit 1216 - 4-bed/2-bath - TH - bedroom wall damage (Non-Critical Repair)

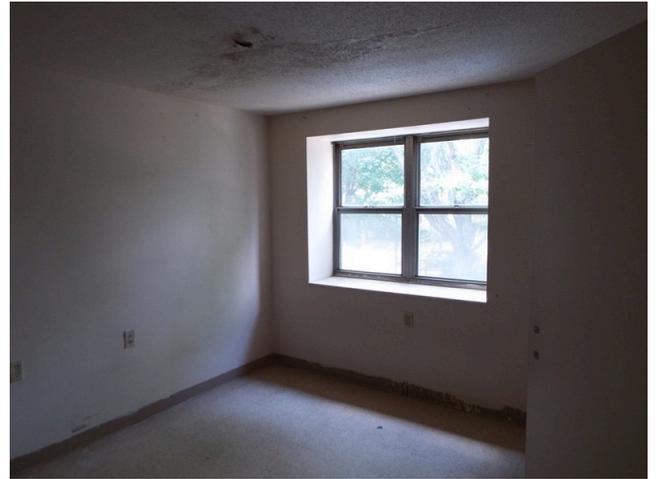
269. Building 12 - unit 1216 - 4-bed/2-bath - TH - kitchen ceiling damage (Non-Critical Repair)

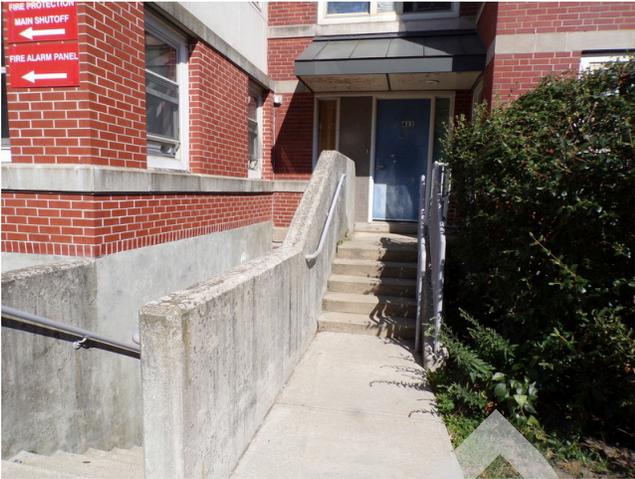
5. Building 4 - exterior concrete stairs

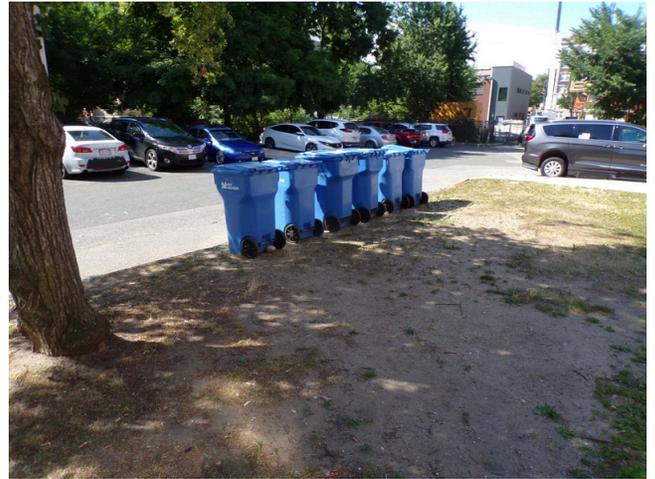
6. Building 4 - bare ground (Non-Critical Repair)

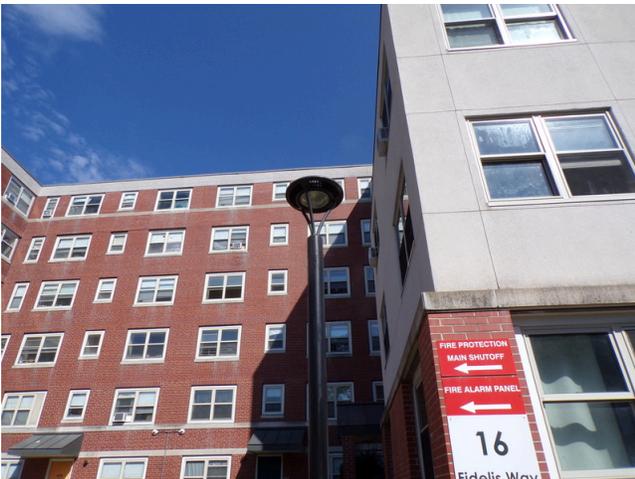
7. Building 4 - parking lot pole light

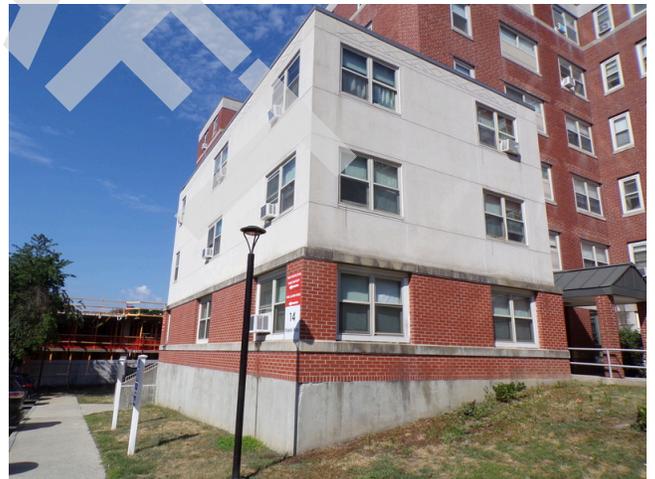
8. Building 4 - façade

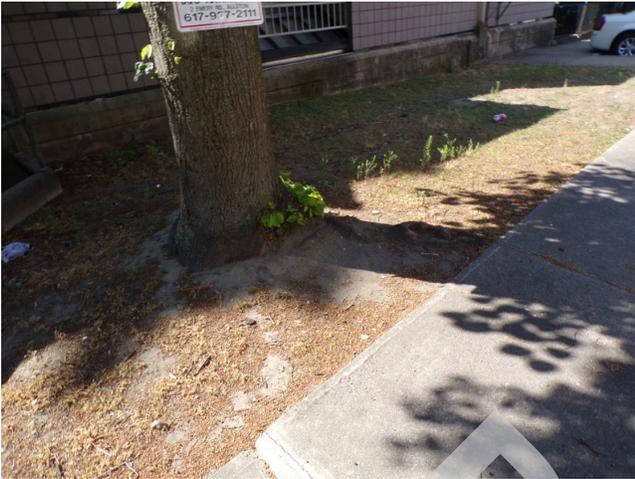
9. Building 4 - bare ground (Non-Critical Repair)

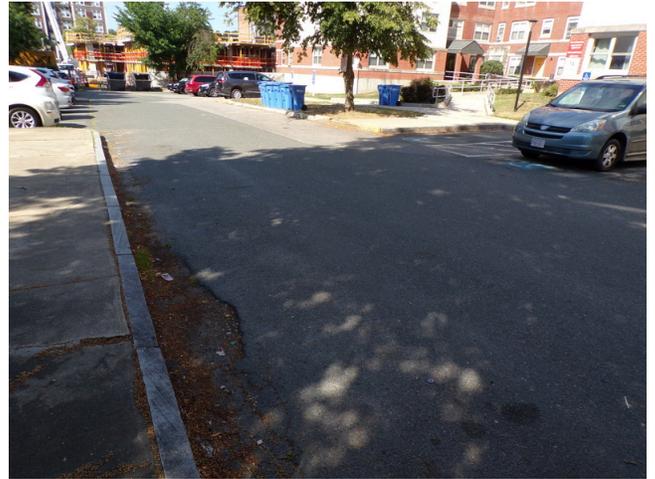
10. Building 4 - asphalt condition (Non-Critical Repair)

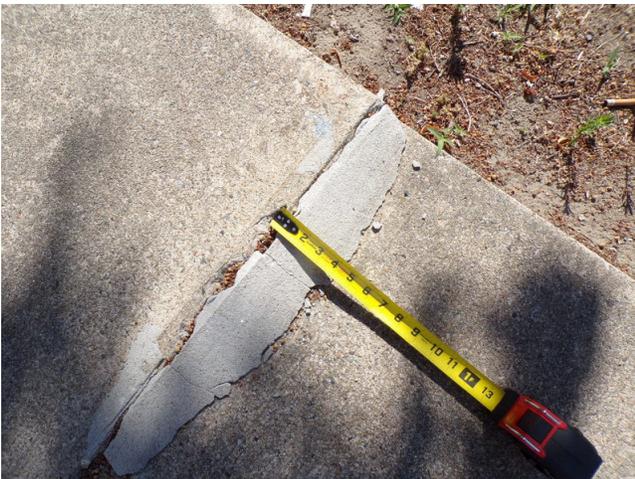
11. Building 4 - sidewalk trip hazard (Critical Repair)

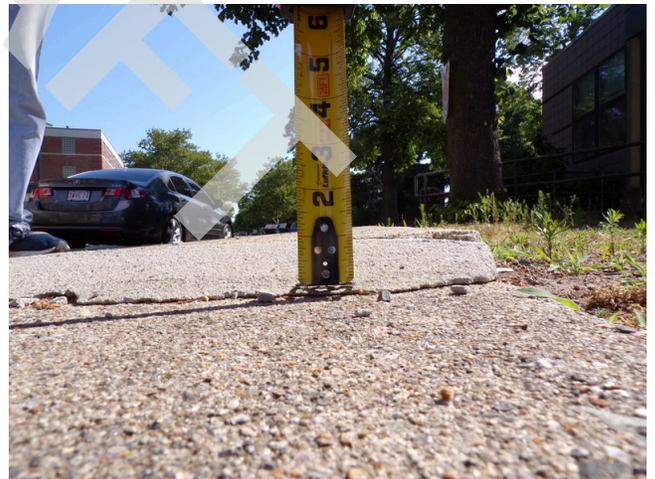
12. Building 4 - sidewalk trip hazard (Critical Repair)

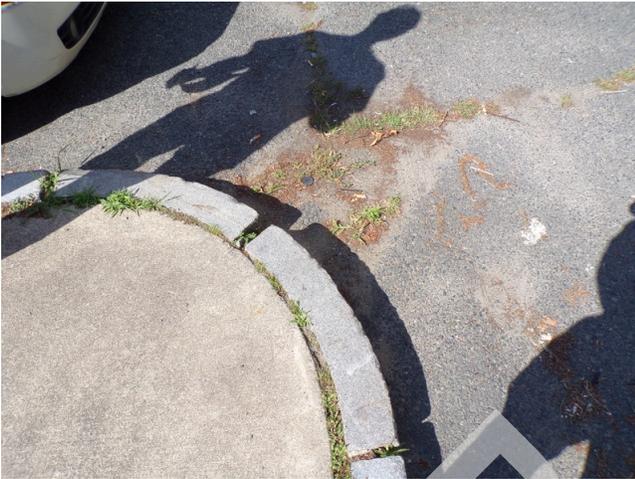
13. Building 4 - curb damage trip hazard (Critical Repair))

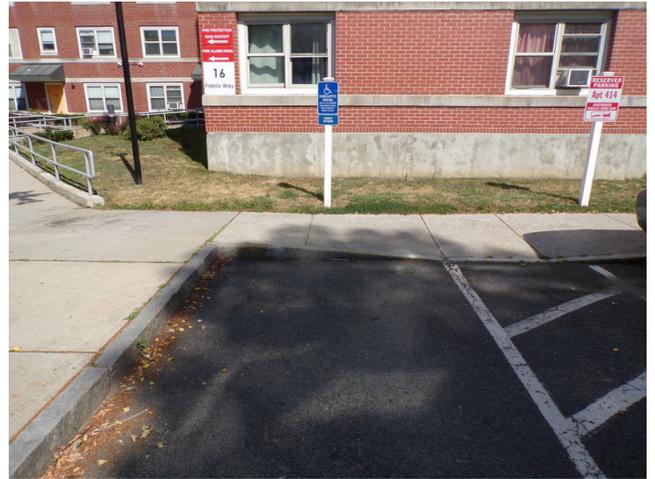
14. Building 4 - handicap parking

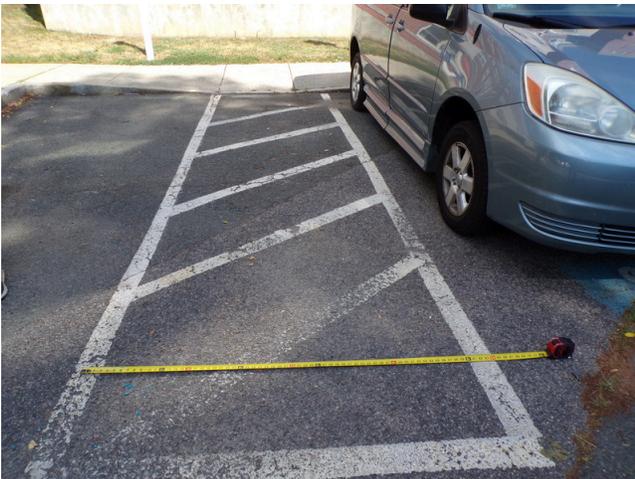
15. Building 4 - handicap parking

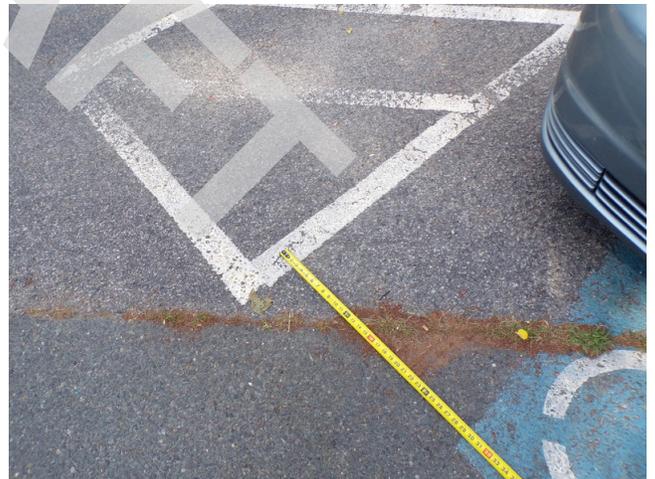
16. Building 4 - handicap parking

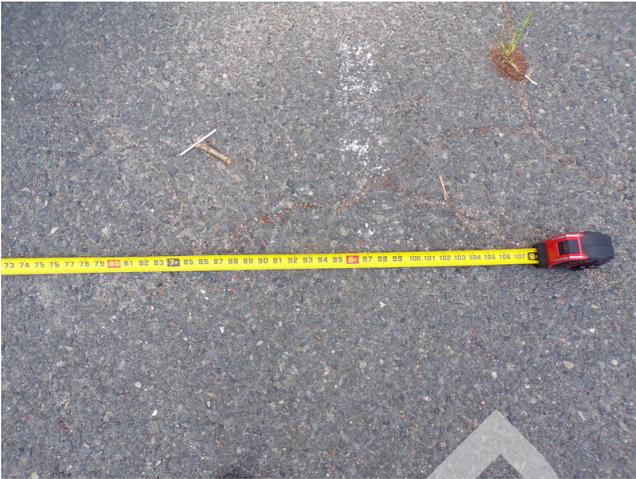
17. Building 4 - handicap parking

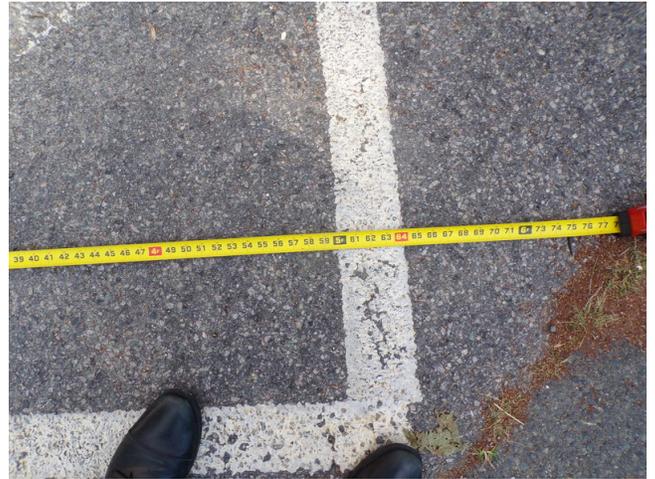
18. Building 4 - handicap parking

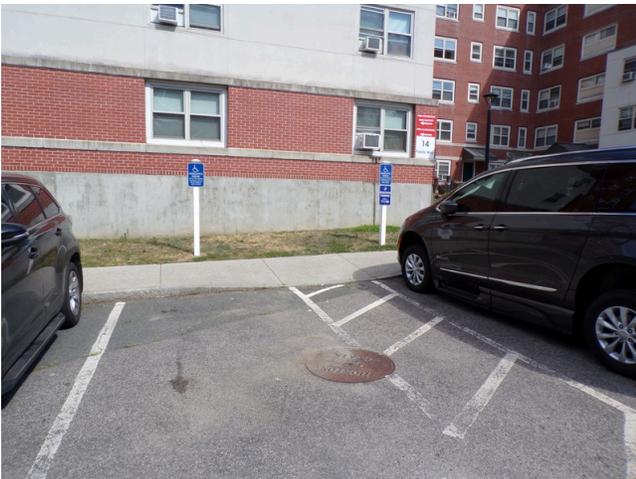
19. Building 4 - handicap parking

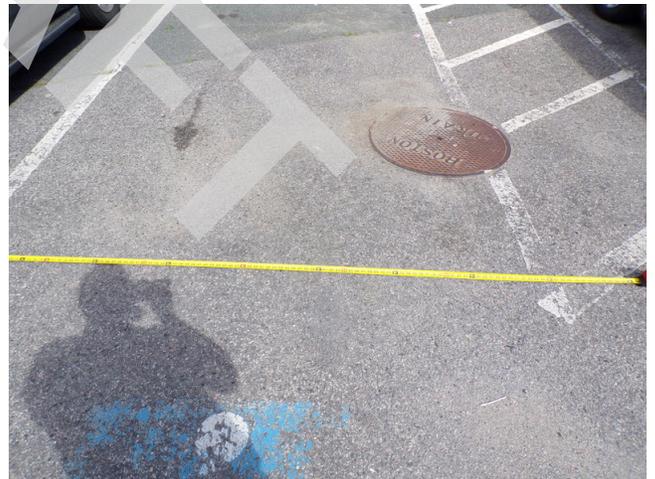
20. Building 4 - handicap parking

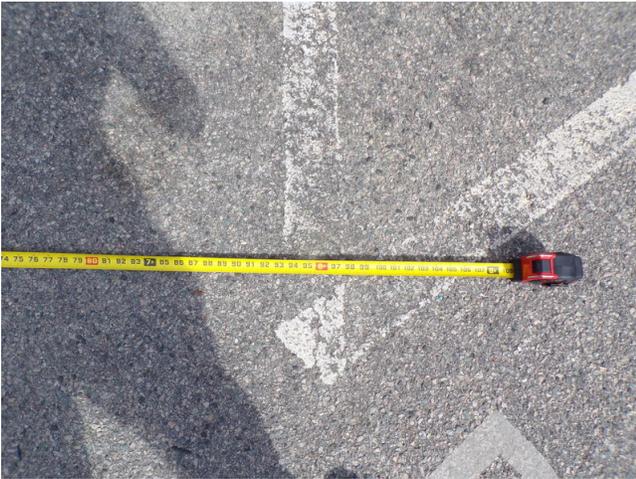
21. Building 4 - handicap parking

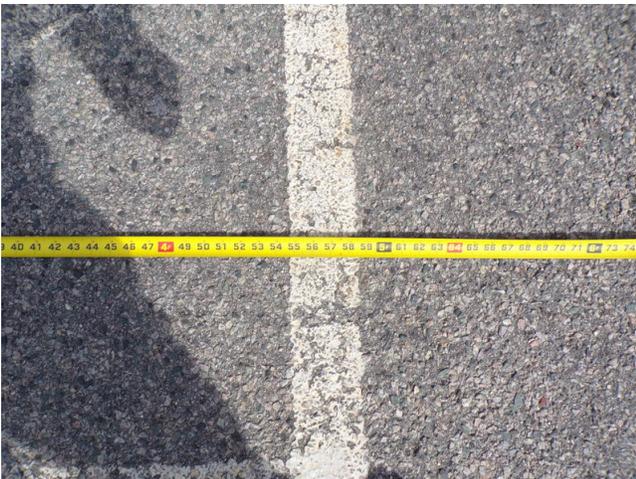
23. Building 4 - handicap parking

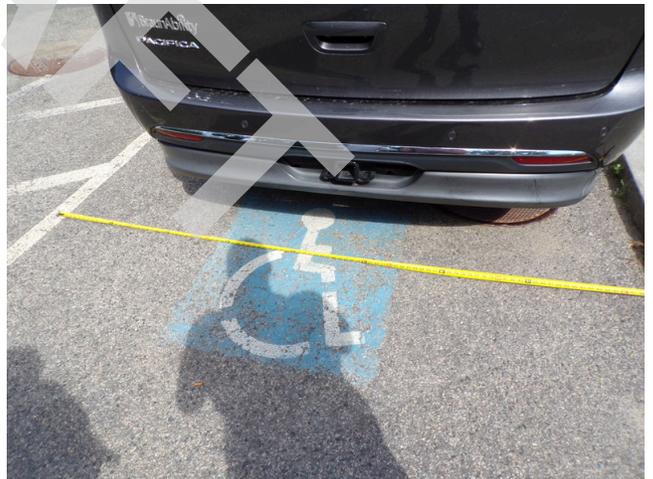
24. Building 4 - handicap parking

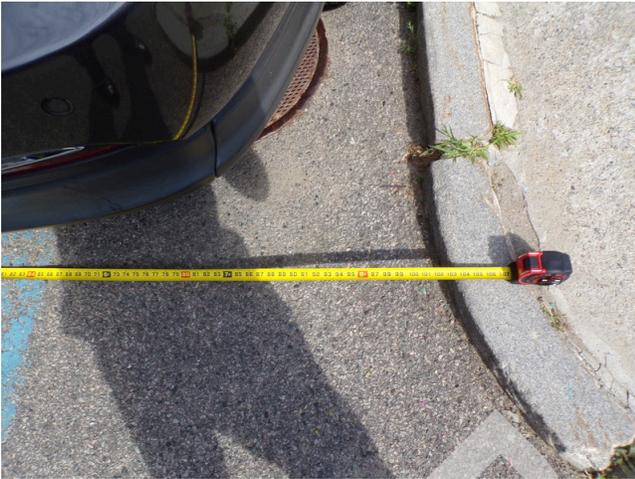
25. Building 4 - handicap parking

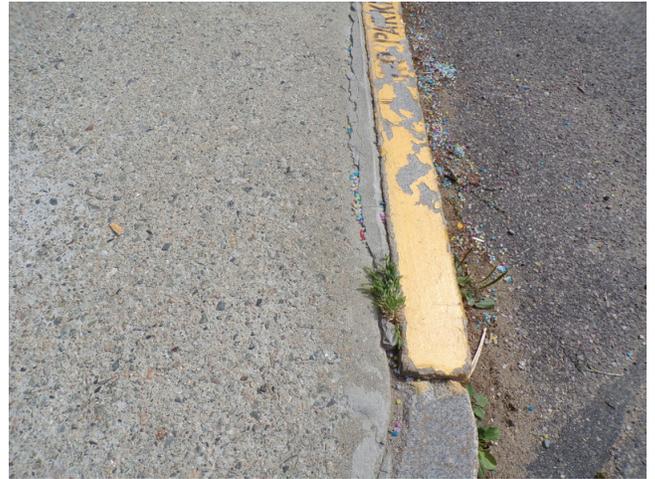
26. Building 4 - trip hazard (Critical Repair)

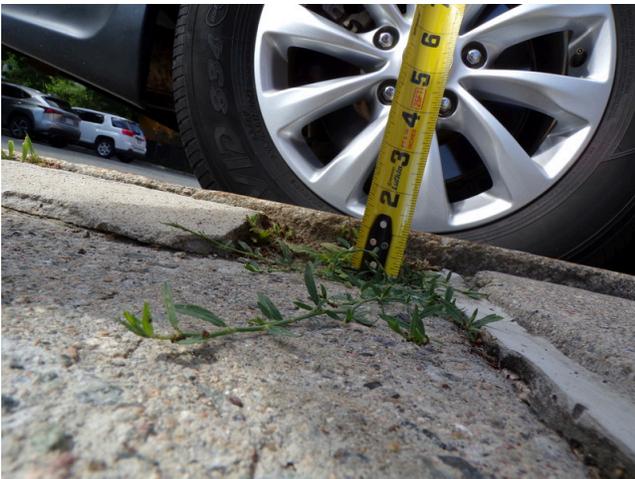
27. Building 4 - trip hazard (Critical Repair)

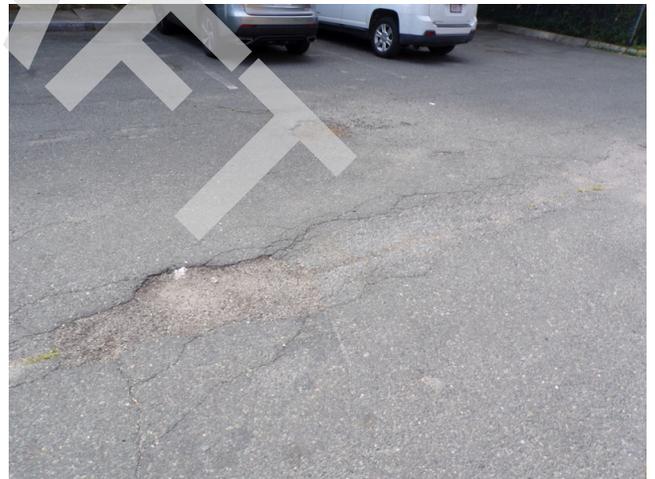
28. Building 4 - parking lot condition (Non-Critical Repair)

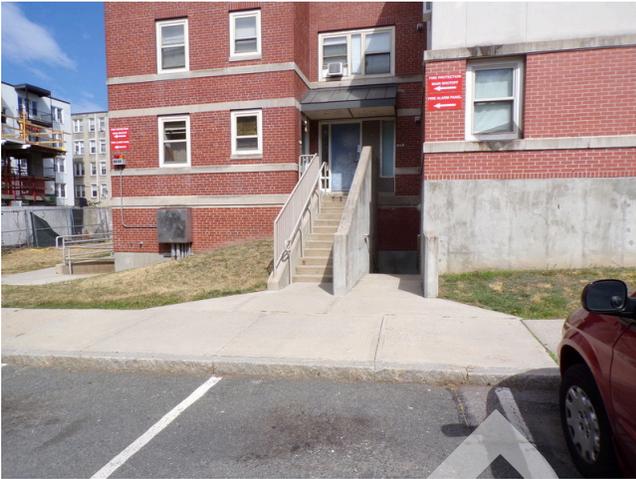
29. Building 4 - exterior concrete stairs

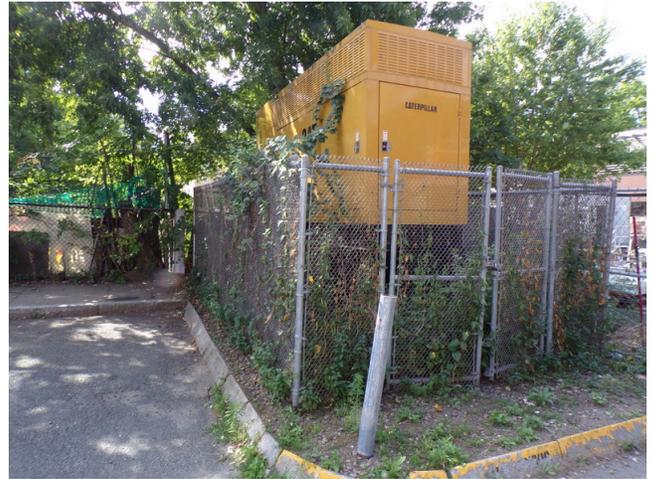
30. Building 4 - emergency generator

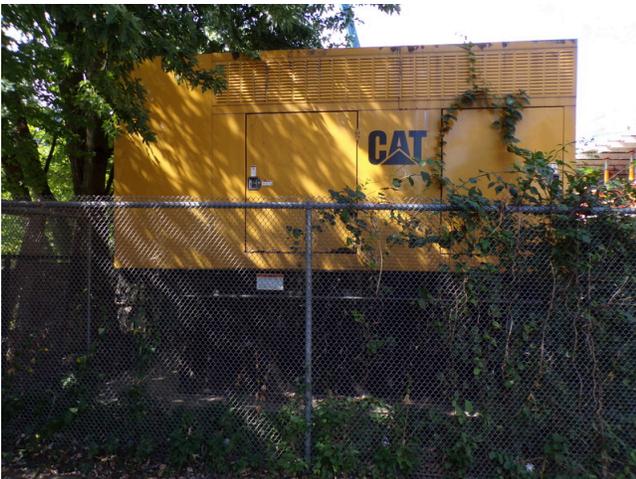
31. Building 4 - emergency generator

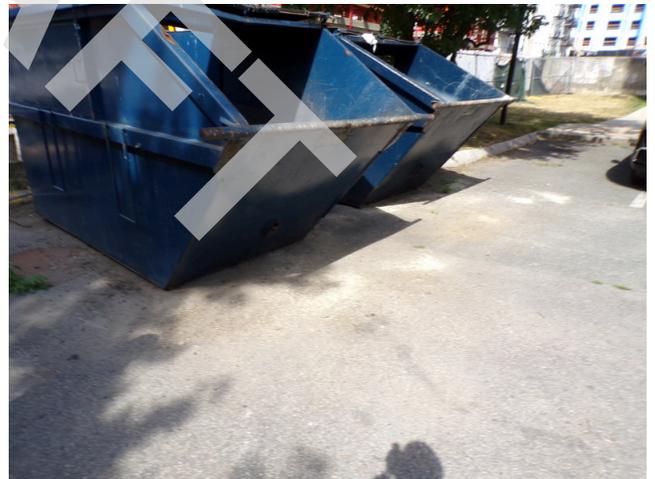
32. Building 4 - dumpsters missing concrete pad  
(Non-Critical Repair)

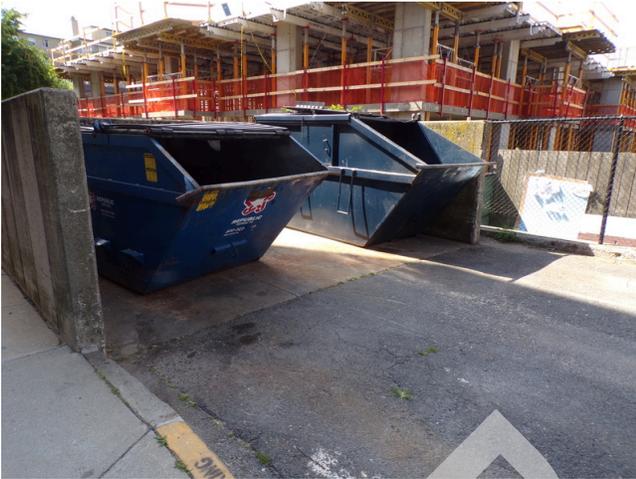
33. Building 4 - dumpsters

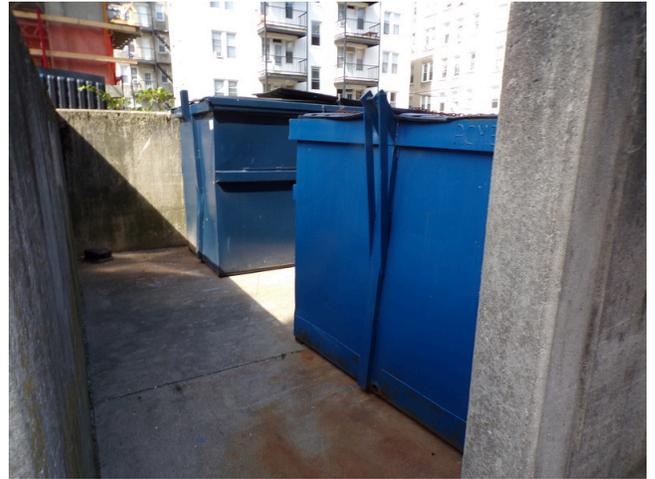
34. Building 4 - dumpsters concrete enclosure

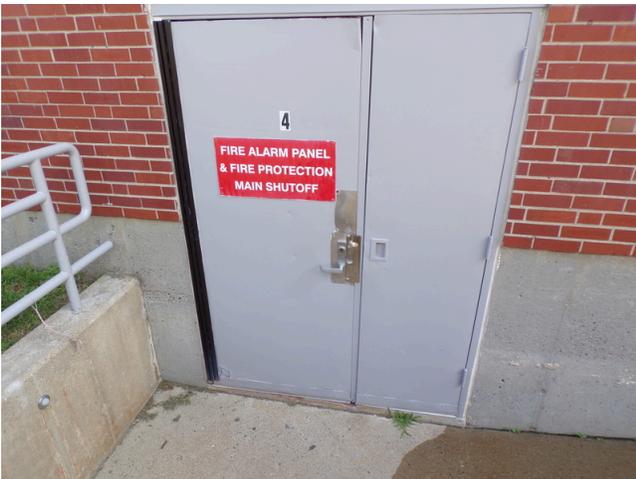
35. Building 4 - basement ingress/egress

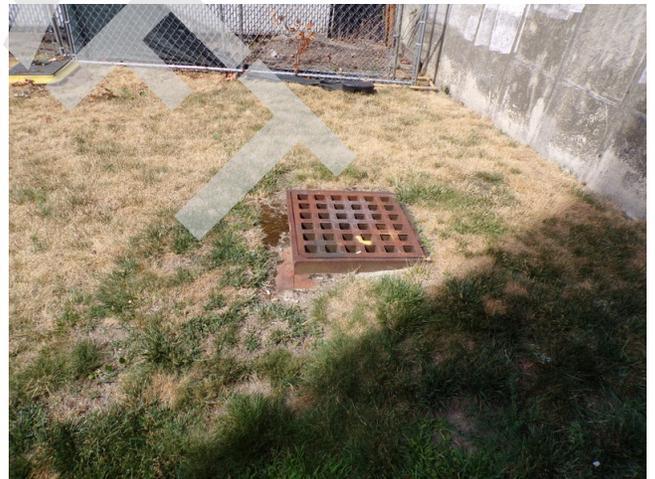
36. Building 4 - property drainage

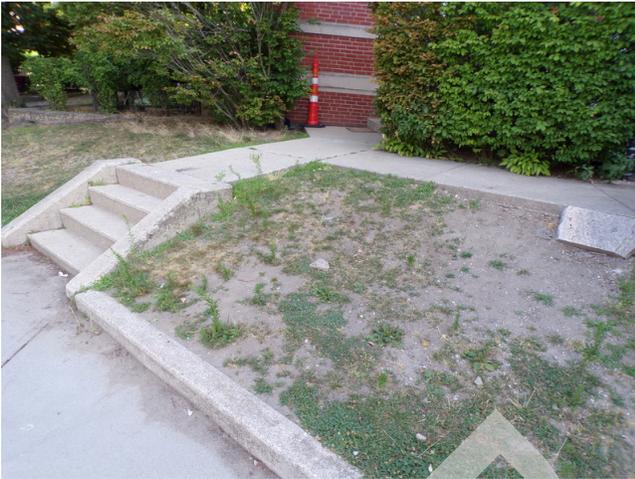
37. Building 4 - bare ground (Non-Critical Repair)

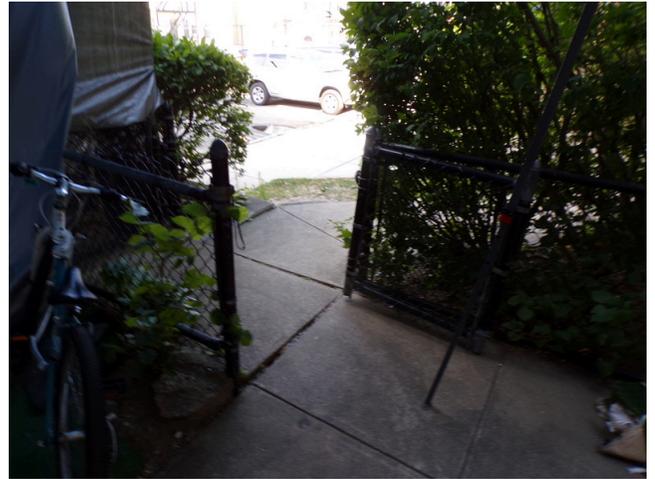
38. Building 4 - chain link fence

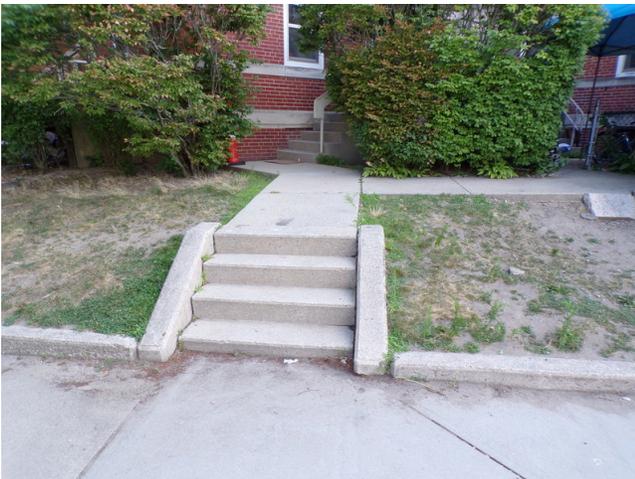
39. Building 4 - concrete stairs missing railing (Critical Repair)

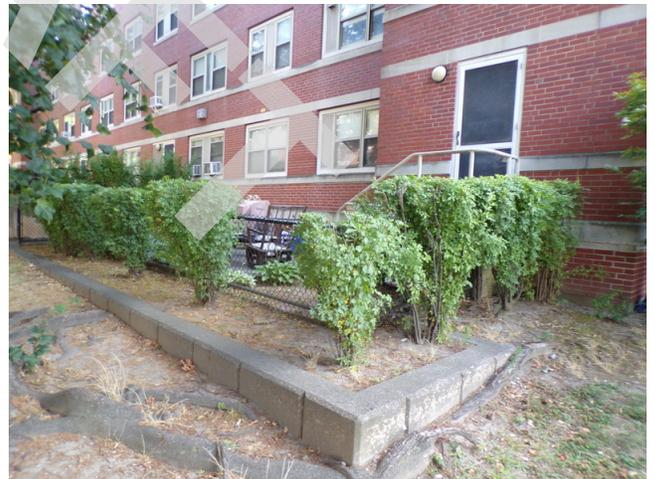
40. Building 4 - north elevation bare ground (Non-Critical Repair)

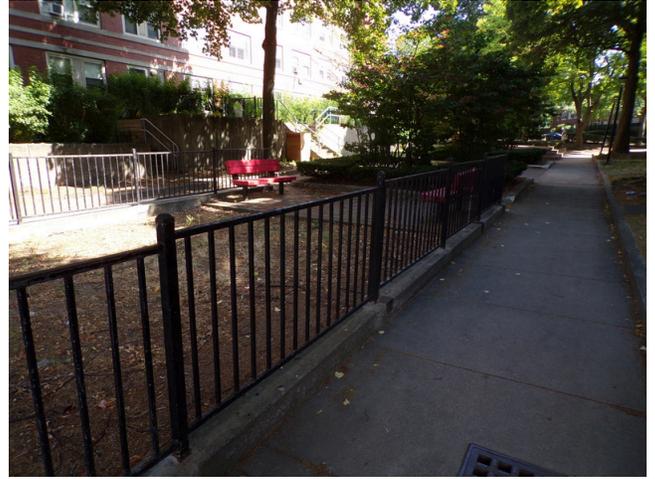
42. Building 4 - park iron fence

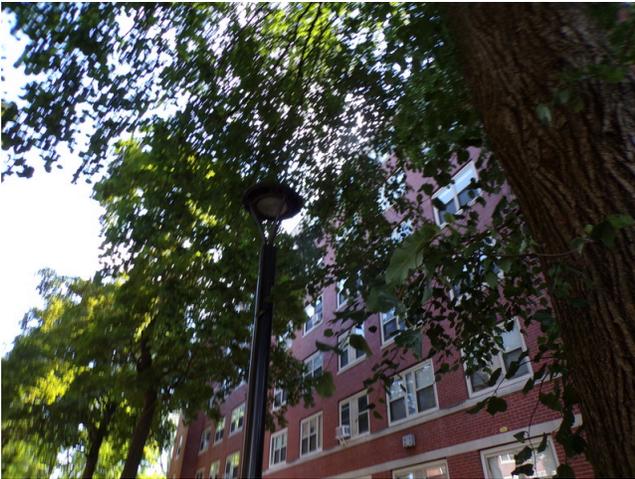
43. Building 4 - park pole lighting

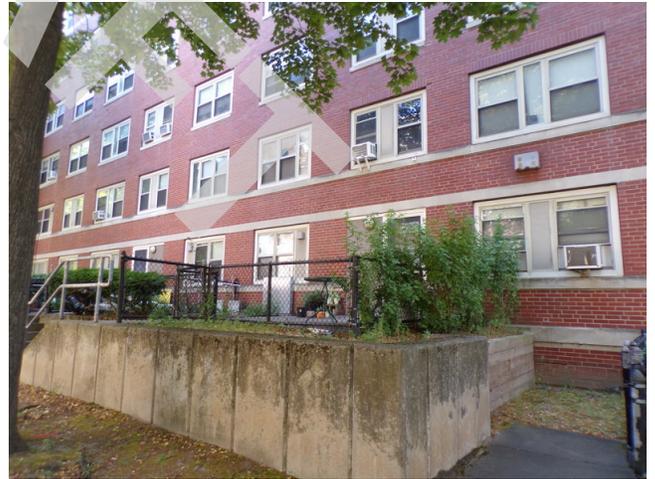
44. Building 4 - retention wall power washing (Non-Critical Repair)

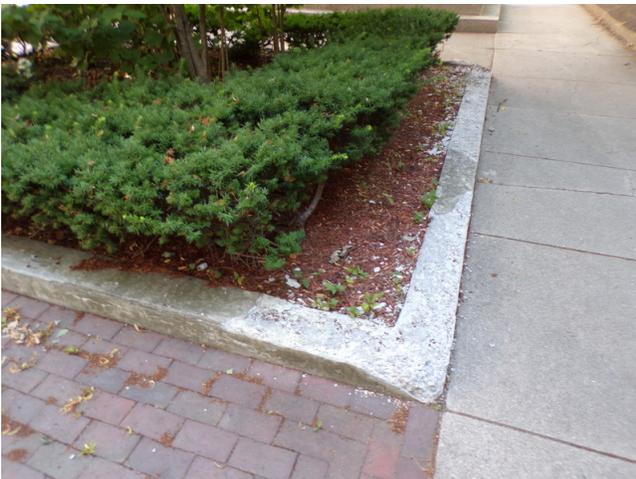
46. Building 4 - curb damage (Non-Critical Repair)

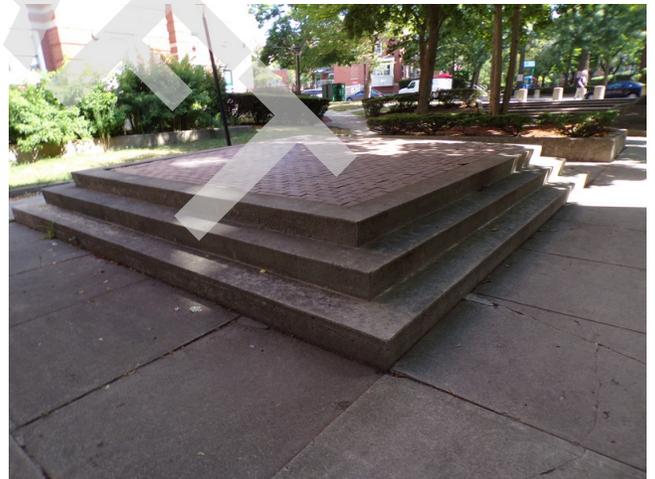
47. Building 4 - curb damage (Non-Critical Repair)

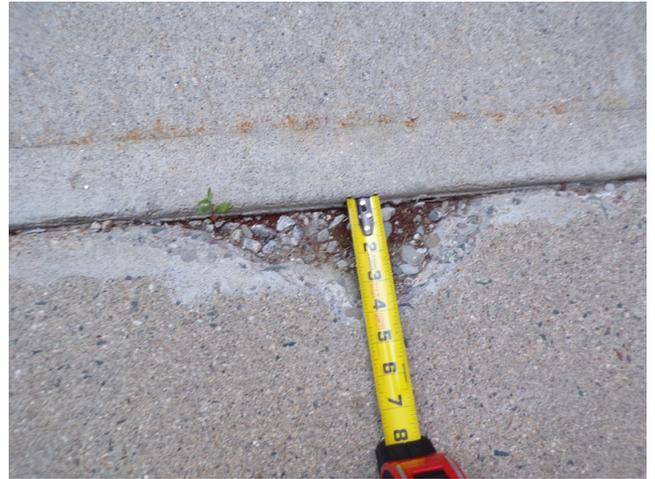
49. Building 4 - concrete trip hazard (Critical Repair)

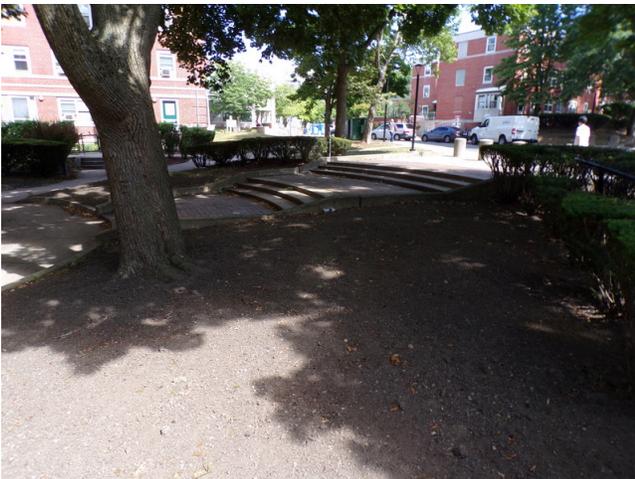
50. Building 4 - concrete trip hazard (Critical Repair)

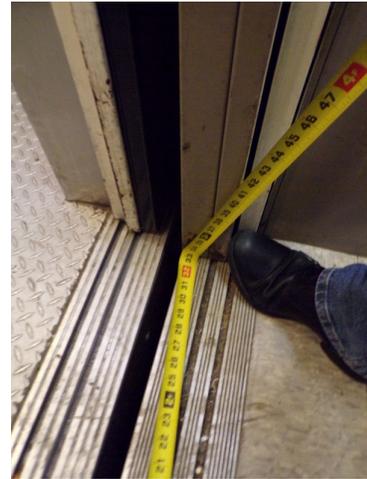
73. Building 4 - elevator ingress/egress floor space (Critical Repair)

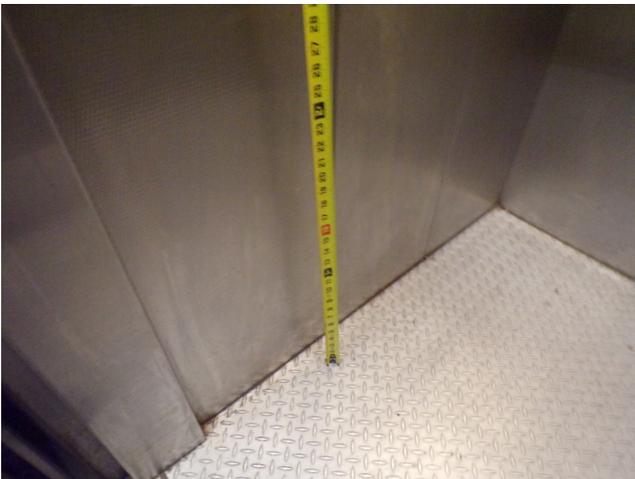
74. Building 4 - elevator floor space (Critical Repair)

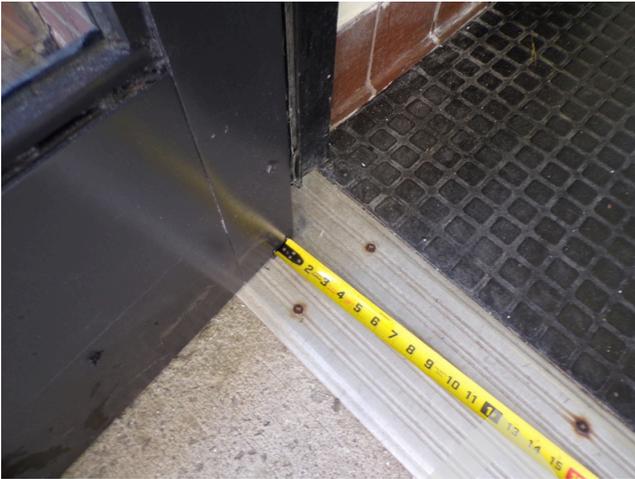
84. Building 4 - main ingress/egress door hardware

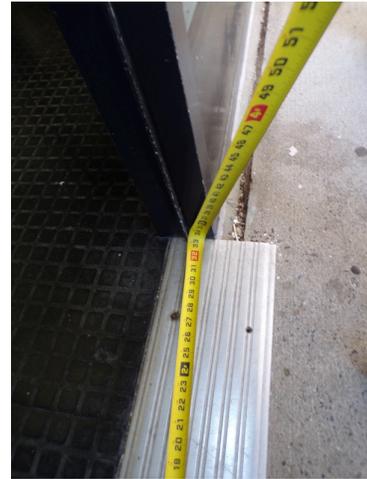
85. Building 4 - main ingress/egress doorway  
floorspace and threshold

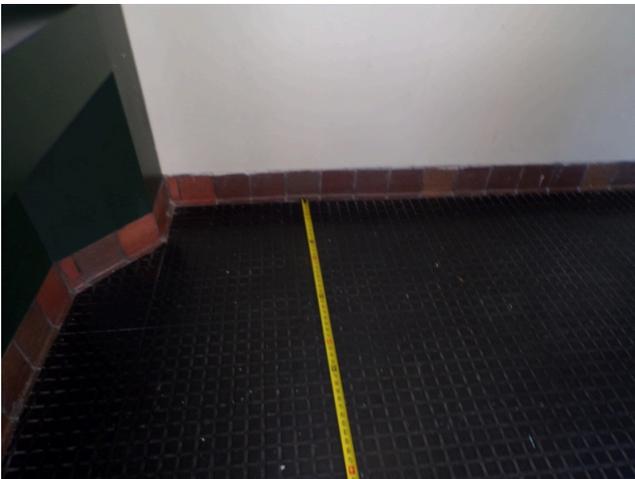
86. Building 4 - main ingress/egress doorway  
floorspace and threshold

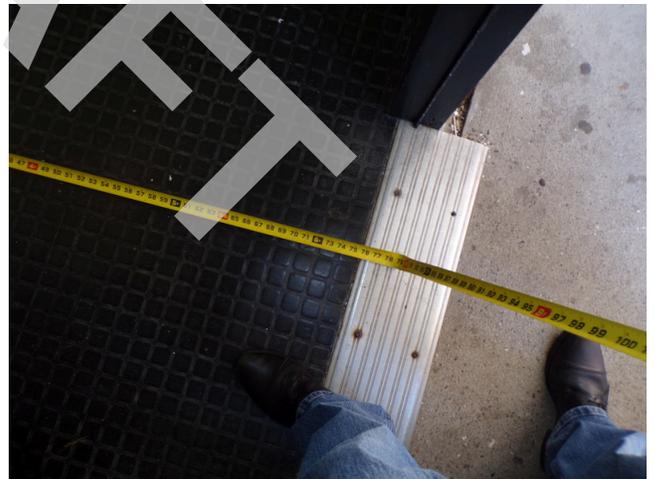
87. Building 4 - main ingress/egress floorspace

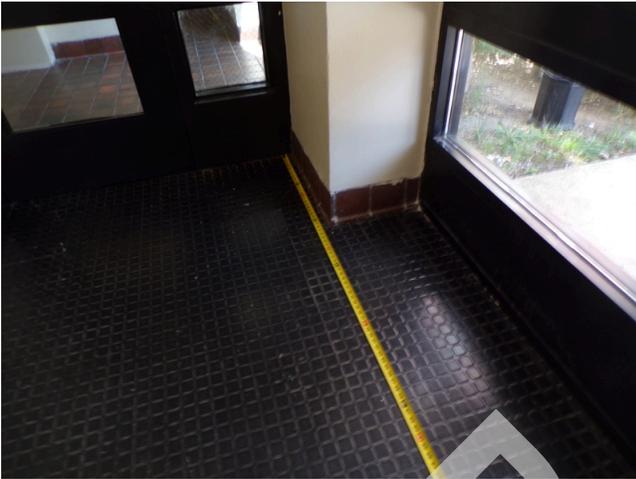
88. Building 4 - main ingress/egress floorspace

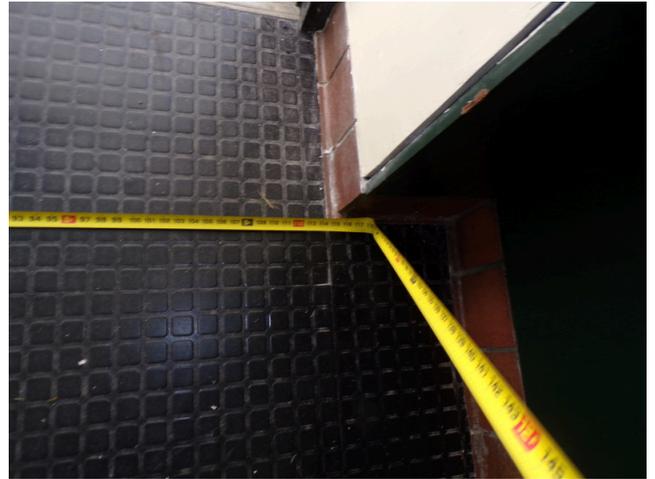
89. Building 4 - main ingress/egress floorspace
