## HUD CAPITAL NEEDS ASSESSMENT

Commonwealth Family  
35 Fidelis Way  
Brighton, Massachusetts 02135

AEI Project No. 463346  
Site Inspection Date: July 20 and 21, 2022

Boston Housing Authority  
52 Chauncy Street  
Boston, Massachusetts 02111

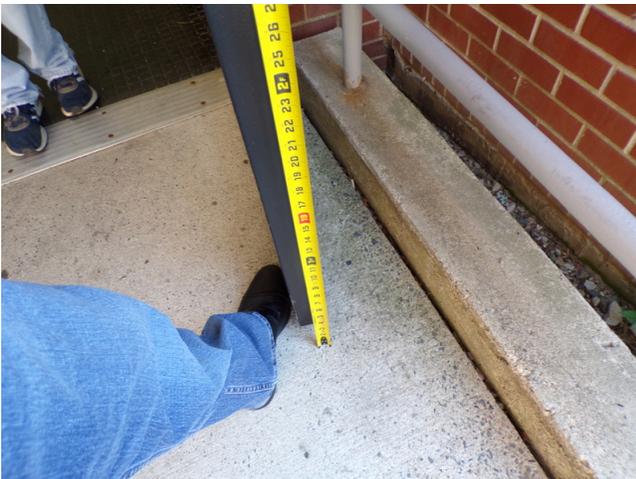
90. Building 4 - main ingress/egress floorspace

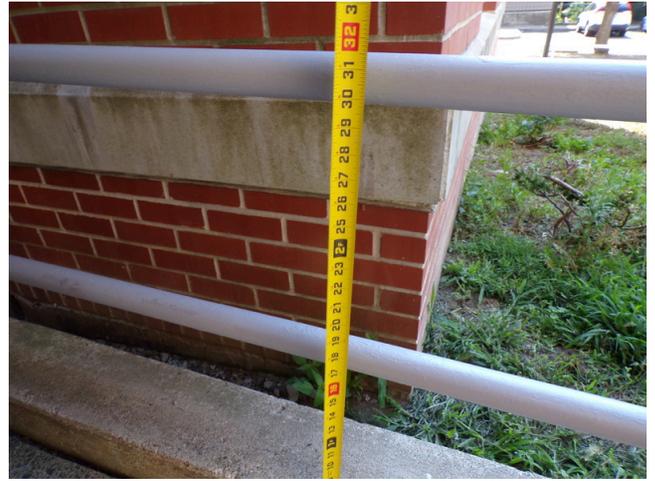
93. Building 4 - main ingress/ egress hardware

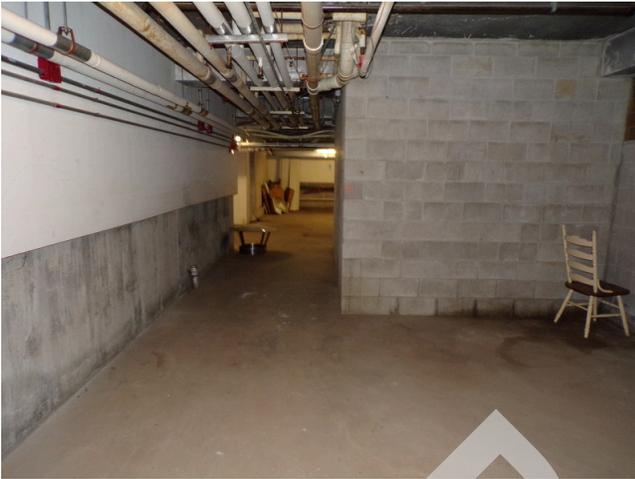
119. Building 4 - stairs damage (Critical Repair)

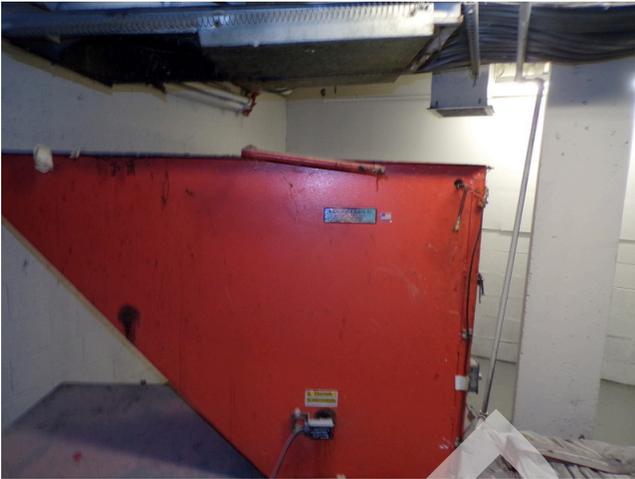
125. Building 4 - trash compactor not in use

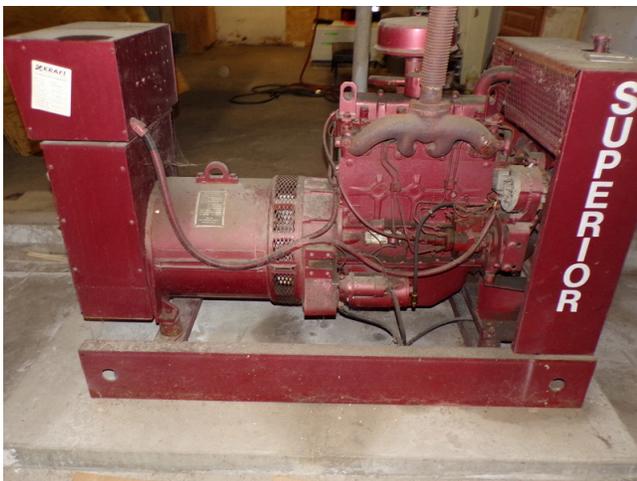
143. Building 4 - fire pump emergency generator not operational (Critical Repair)

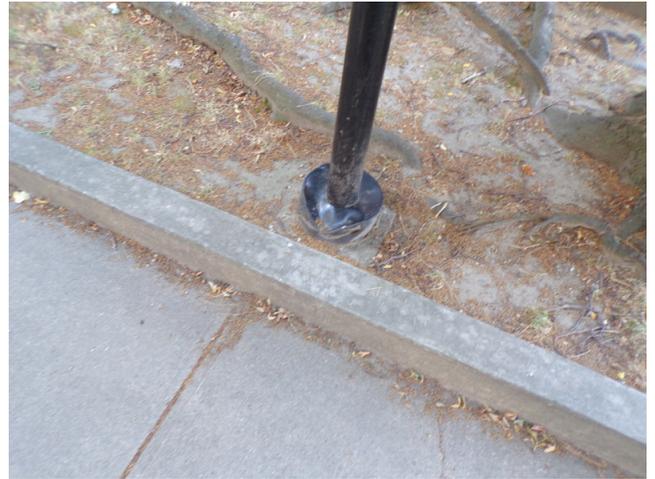
145. Building 4 - damaged fence (Non-Critical Repair)

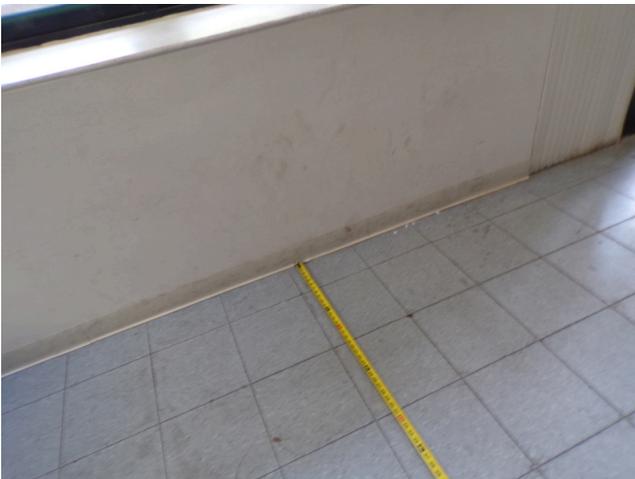
166. Community building - mailroom for townhouses  
- mailboxes

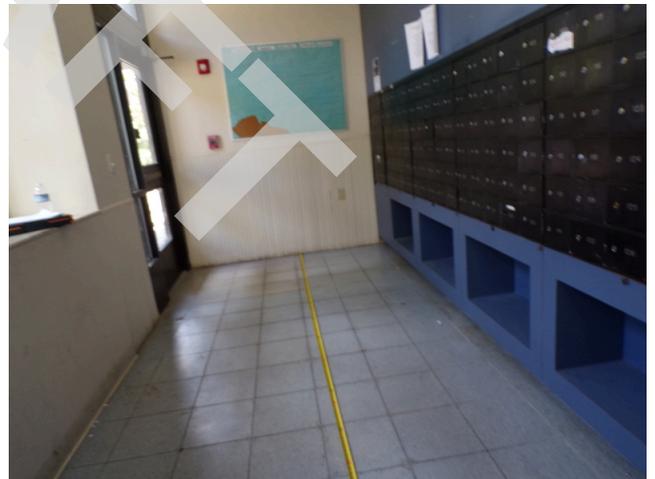
167. Community building - mailroom for townhouses  
- floorspace

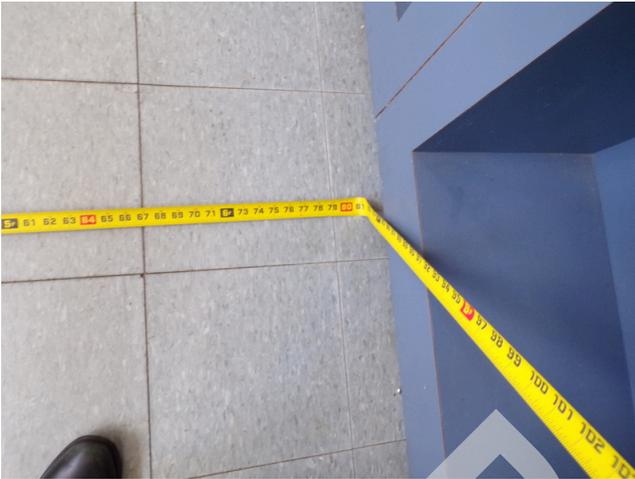
168. Community building - mailroom for townhouses  
- floorspace

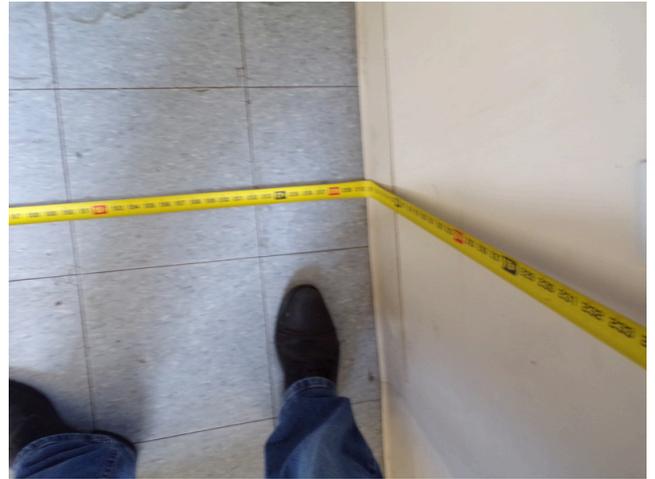
169. Community building - mailroom for townhouses  
- floorspace

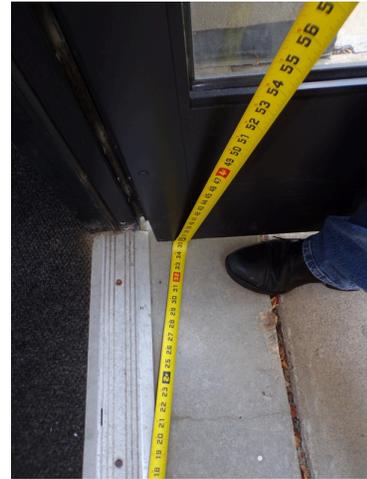
173. Community building - main ingress/egress doorway floorspace

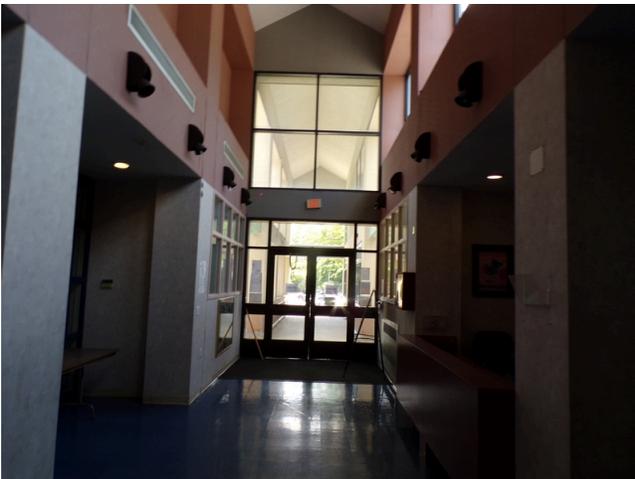
174. Community building - main ingress/egress doorway floorspace

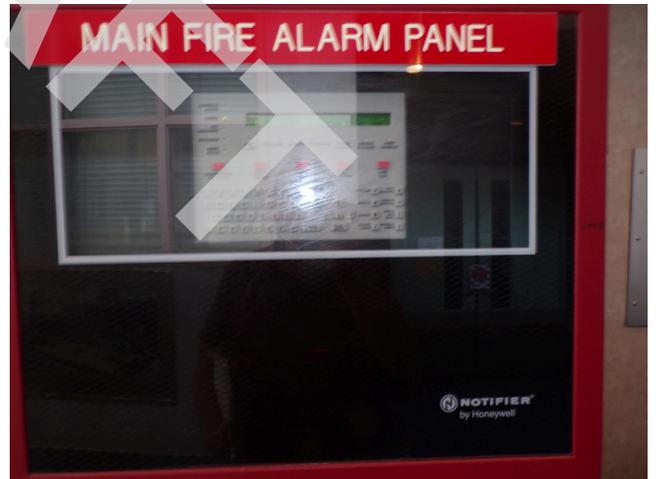
175. Community building - main ingress/egress

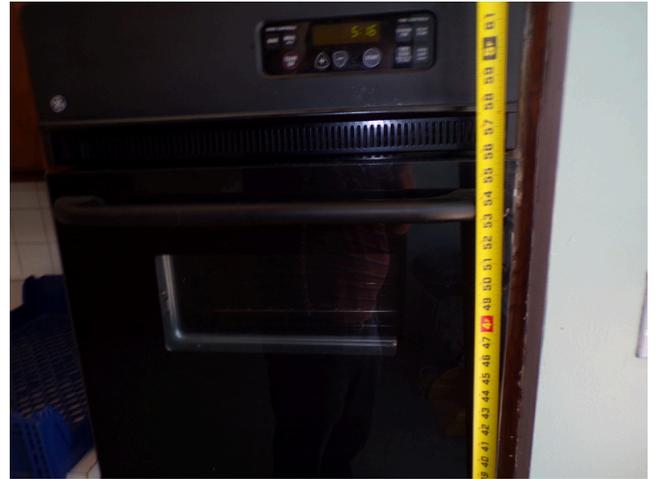
181. Community building - kitchen oven

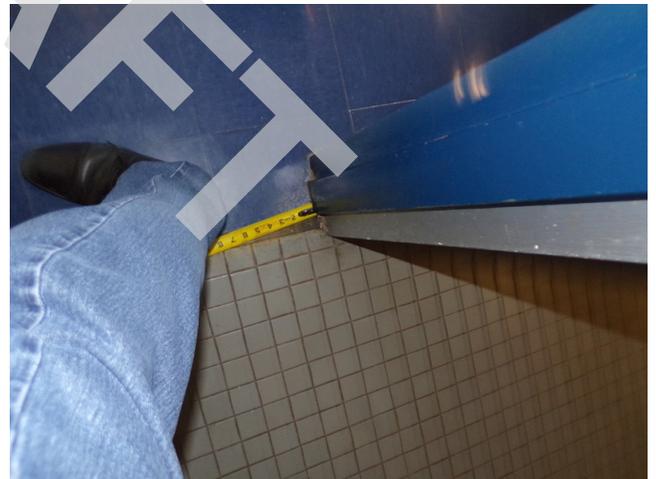
187. Community building - women's restroom

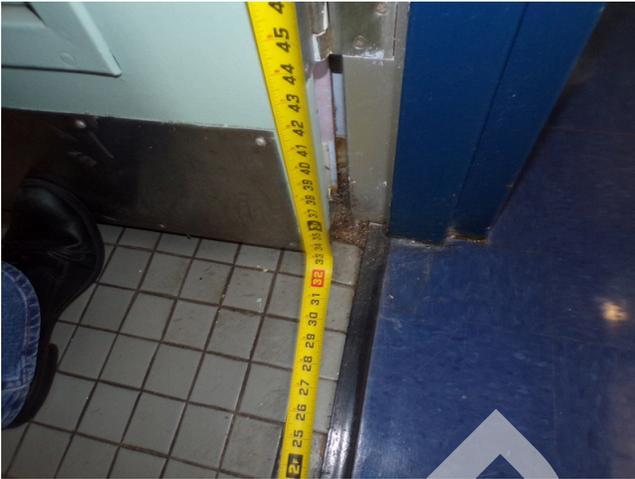
188. Community building - women's restroom

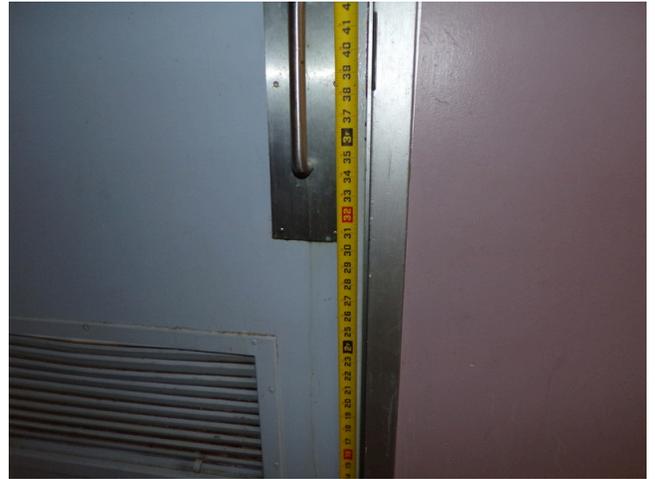
189. Community building - women's restroom

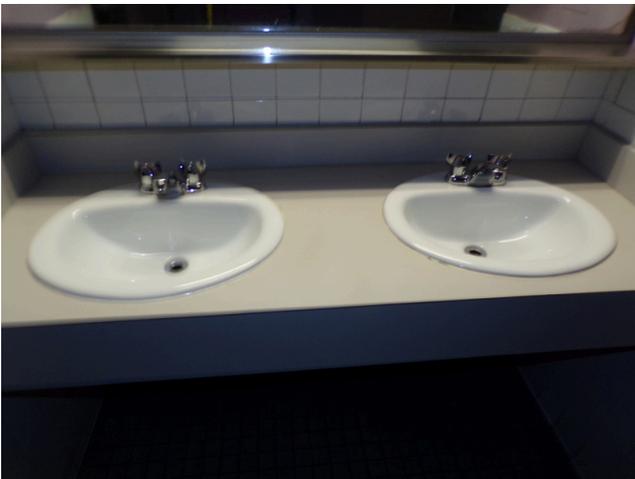
190. Community building - women's restroom

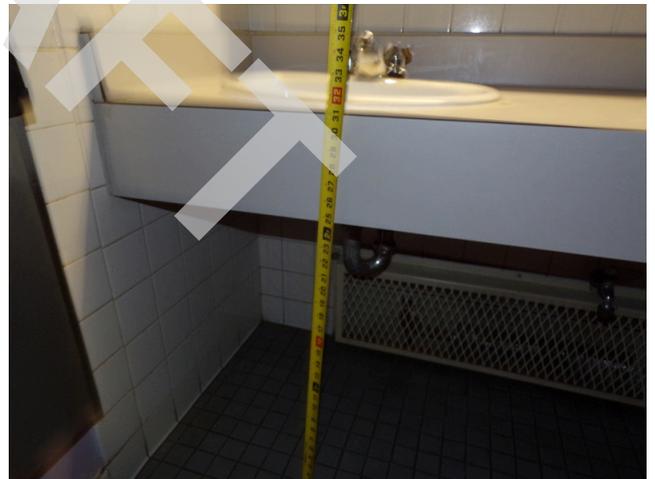
191. Community building - women's restroom dual sinks

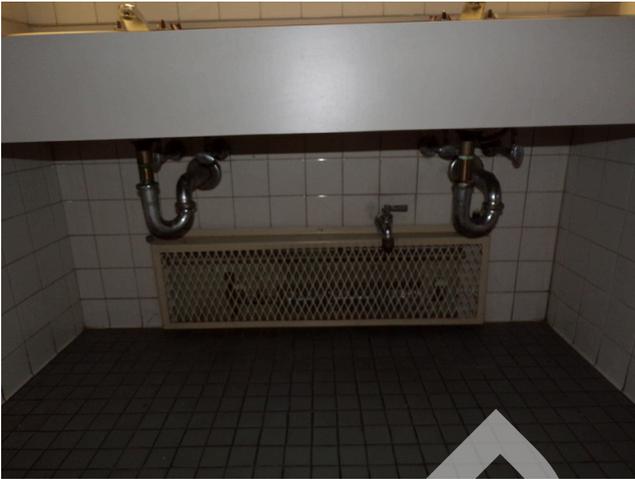
192. Community building - women's restroom sink countertop

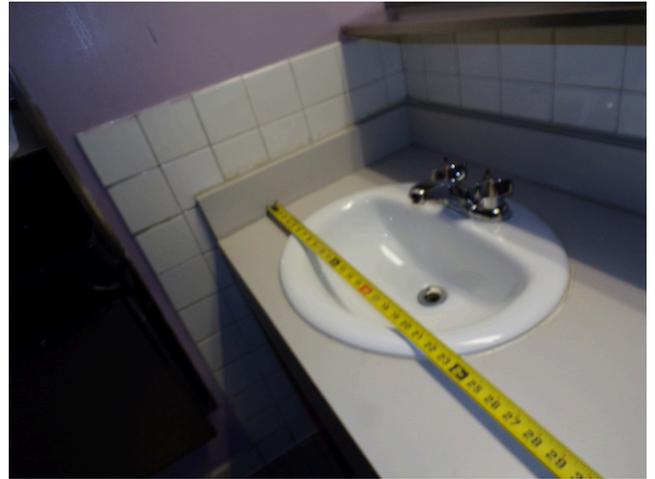
193. Community building - women's restroom sinks missing scald and abrasion protection (Critical Repair)

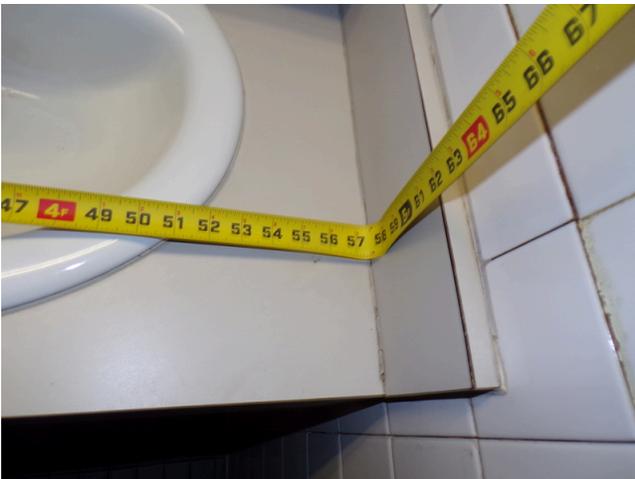
194. Community building - women's restroom sink countertop space

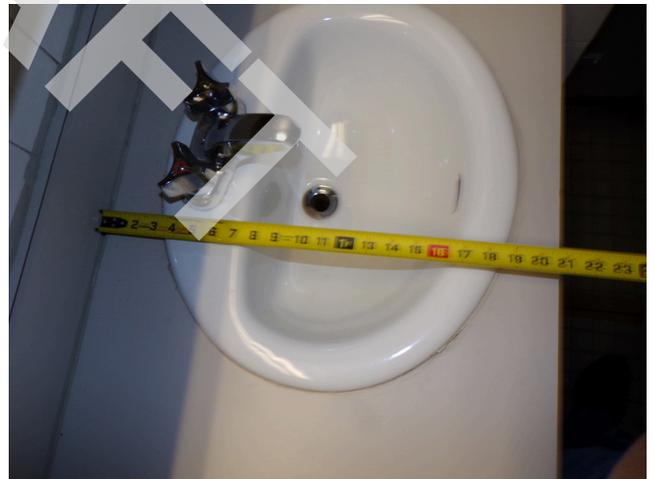
195. Community building - women's restroom sink countertop space

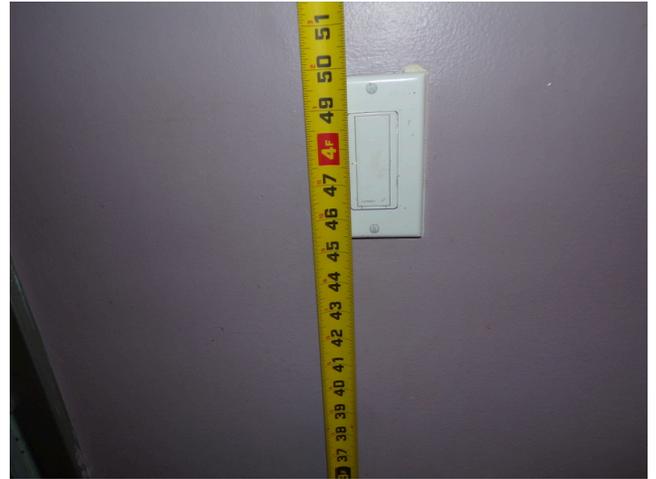
197. Community building - women's restroom light switch

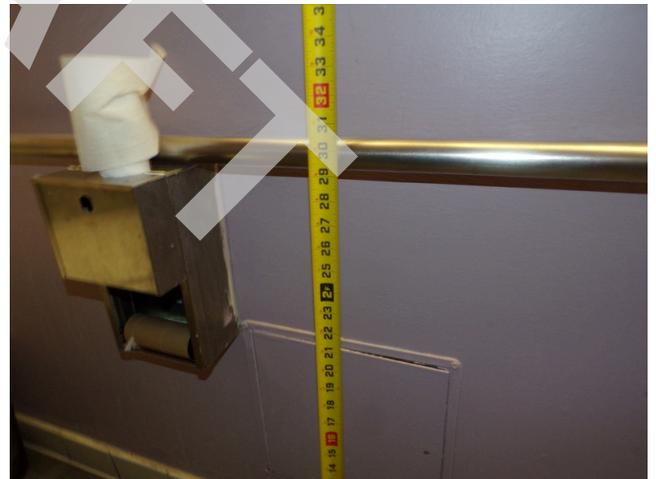
199. Community building - women's restroom toilet

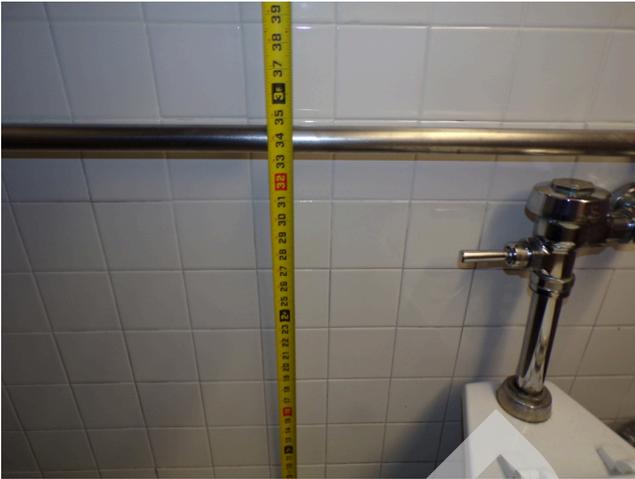
200. Community building - women's restroom toilet grab bar

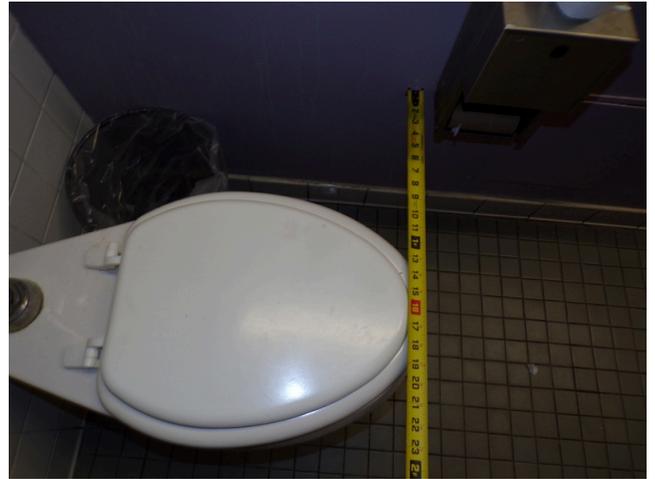
201. Community building - women's restroom toilet grab bar

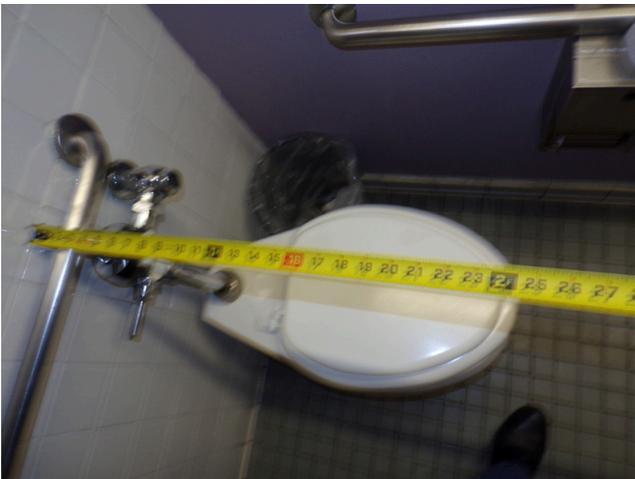
202. Community building - women's restroom toilet space

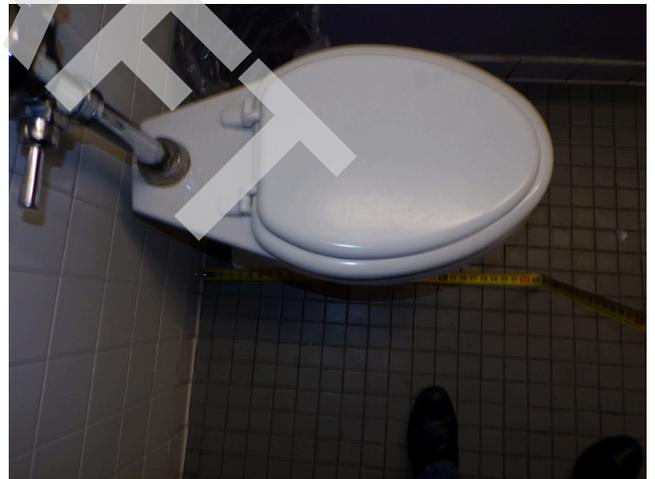
203. Community building - women's restroom toilet space

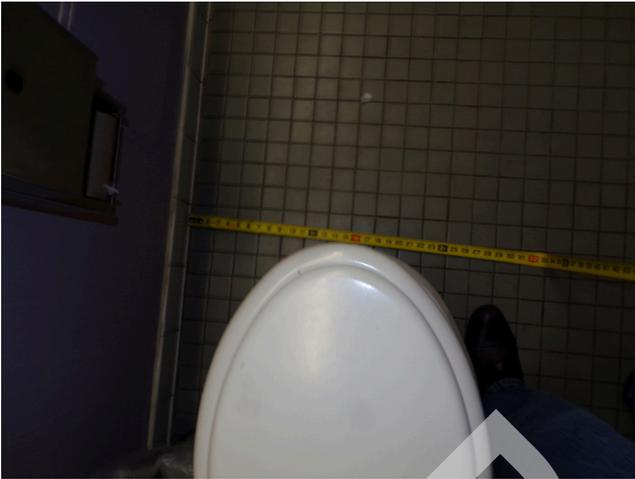
204. Community building - women's restroom toilet floorspace

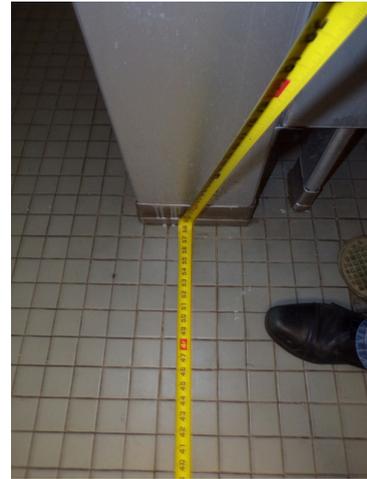
205. Community building - women's restroom toilet floorspace

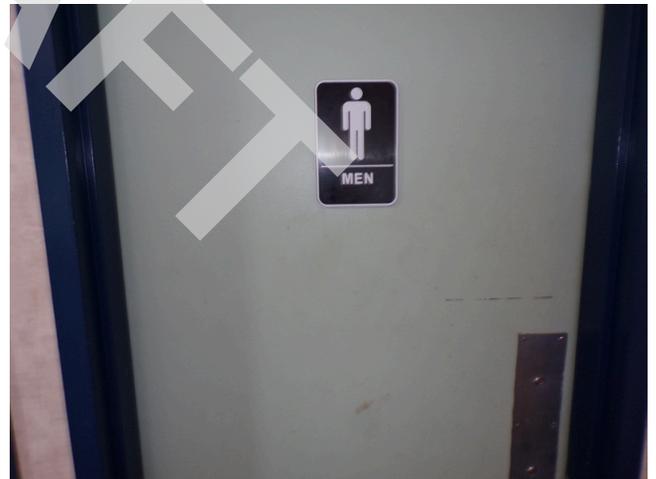
208. Community building - men's restroom signage (Critical Repair)

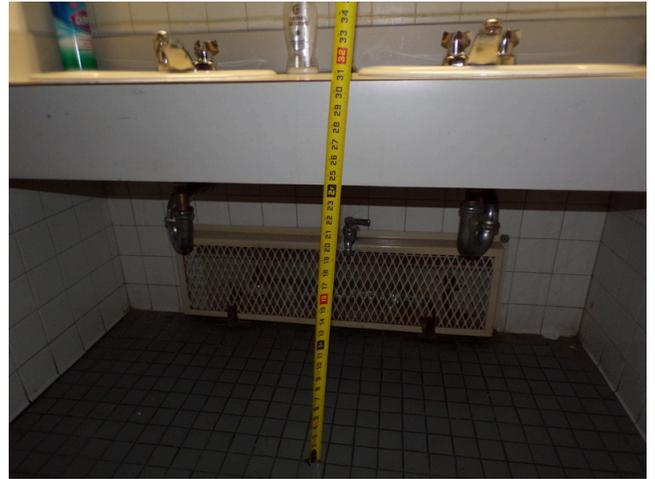
210. Community building - men's restroom missing scald and abrasion protection and levered sink hardware (Critical Repair)

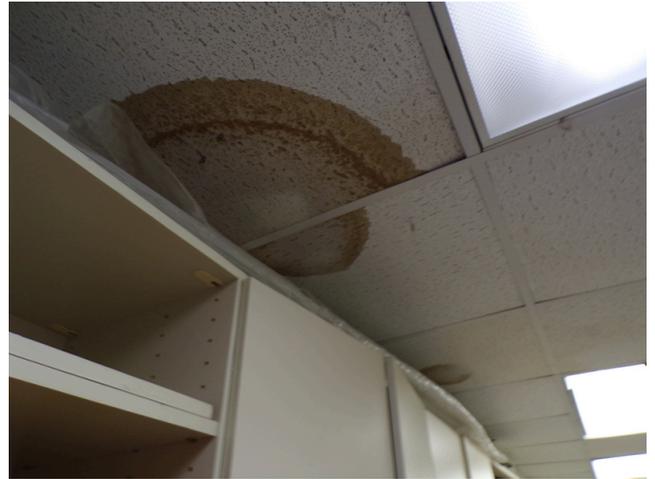
218. Community building - computer room stained acoustical ceiling tile (Non-Critical Repair)

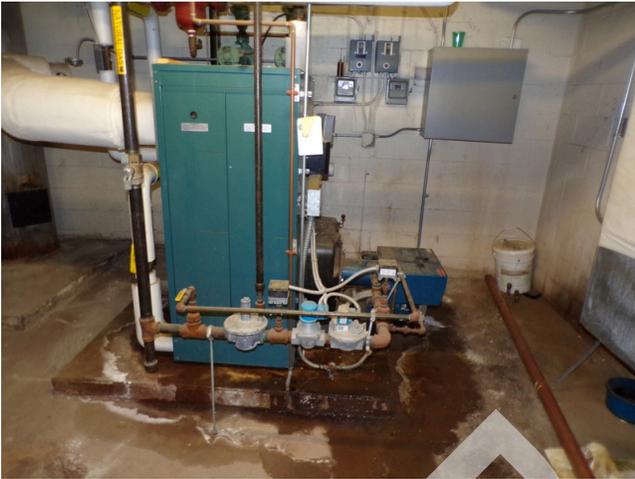
233. Community building - boiler, leak (Critical Repair)

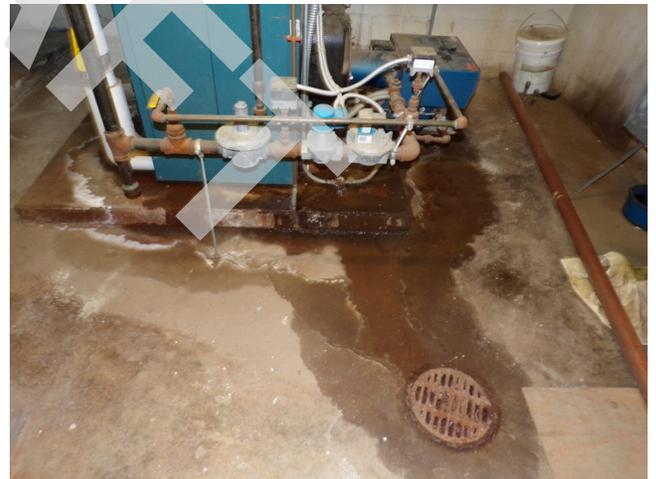
236. Community building - boiler leaking (Critical Repair)

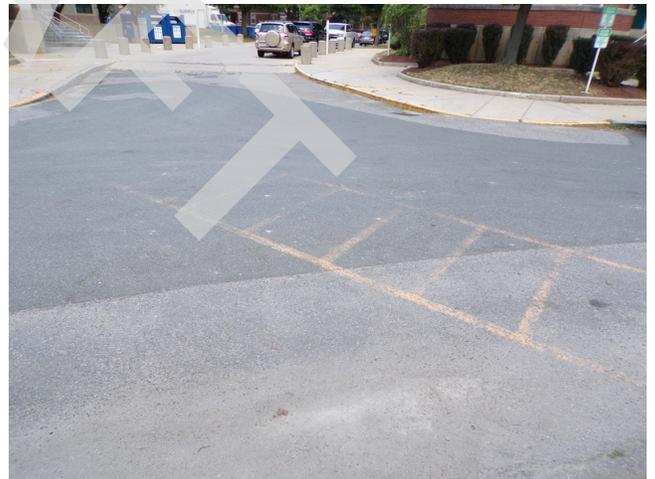
244. Building 5 - hash marks (Critical Repair)

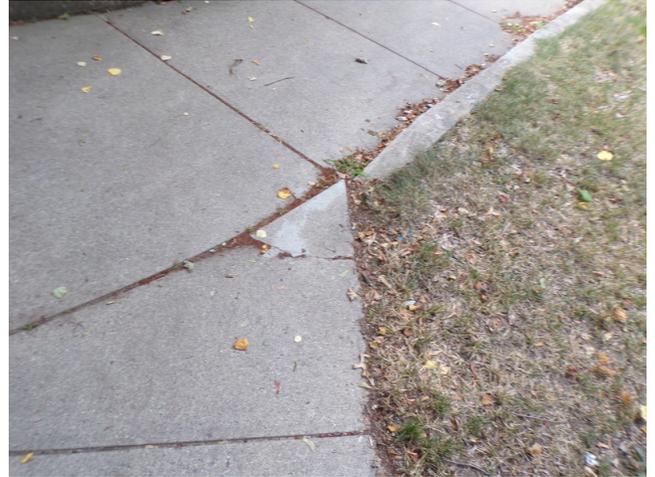
246. Building 5 - sidewalk trip hazard (Critical Repair)

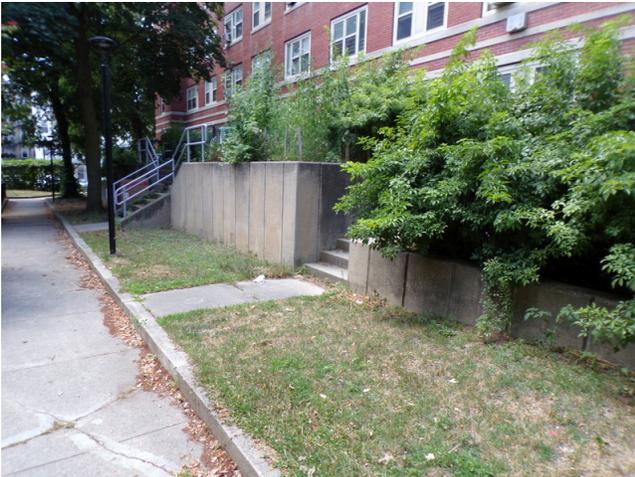
247. Building 5 - overgrown vegetation and retaining wall (Non-Critical Repair)

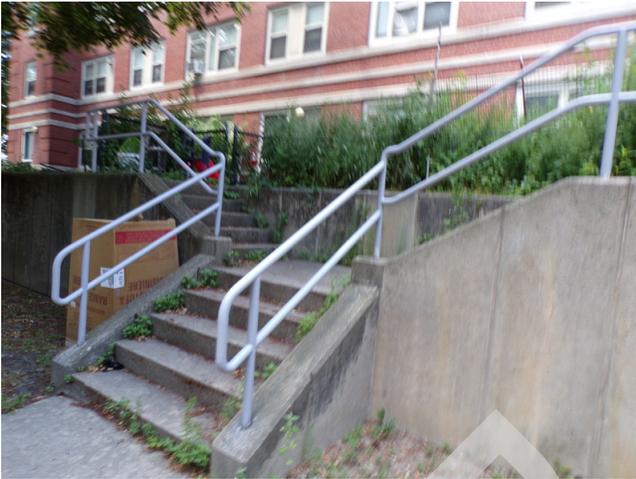
248. Building 5 - overgrown vegetation and chain link fence damage (Non-Critical Repair)

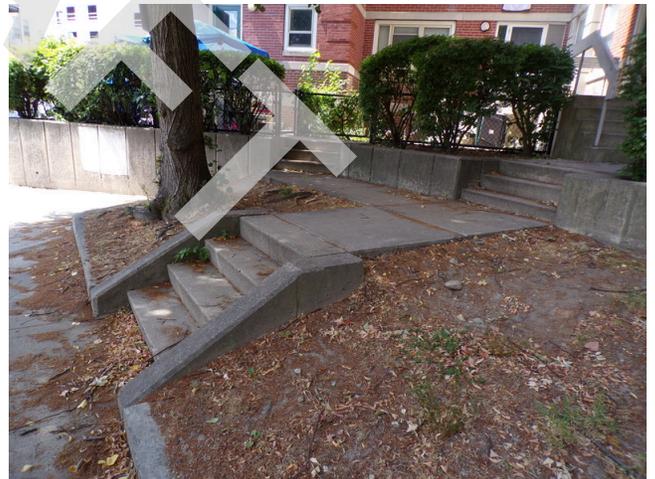
251. Building 5 - power wash retaining wall (Non-Critical Repair)

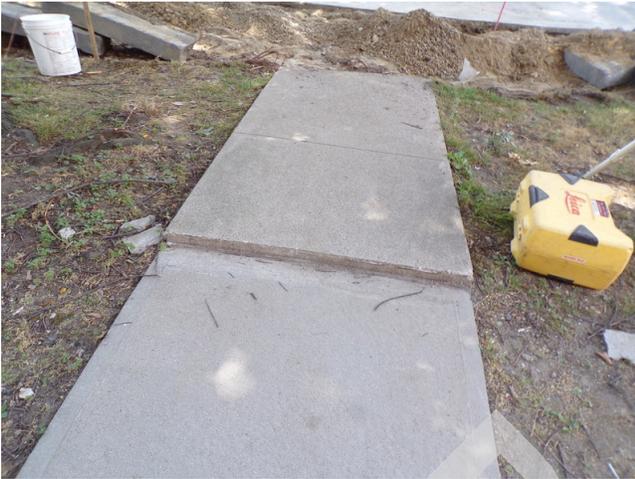
256. Building 5 - sidewalk trip hazard (Critical Repair)

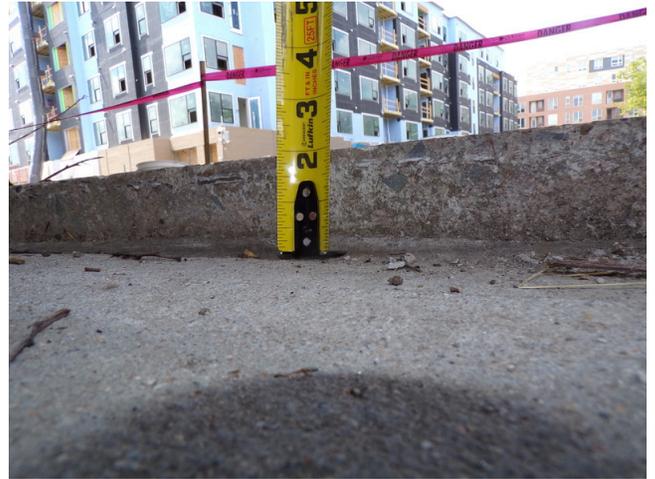
257. Building 5 - sidewalk trip hazard (Critical Repair)

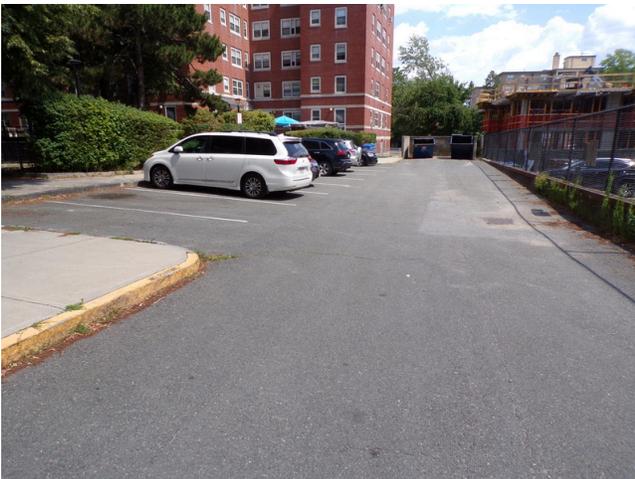
270. Building 5 - parking lot (Non-Critical Repair)

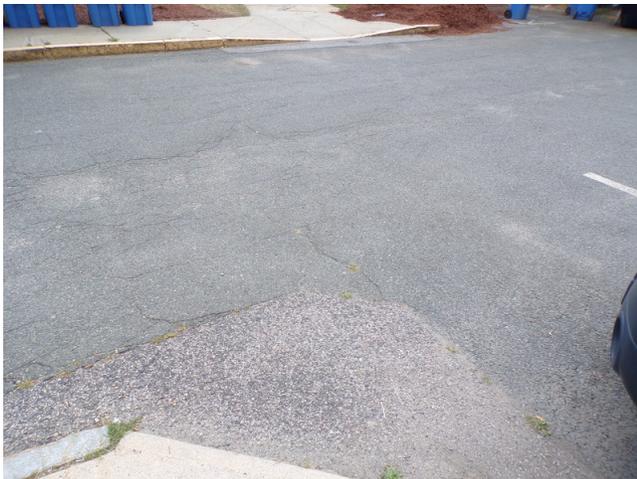
286. Building 7 - parking lot (Non-Critical Repair)

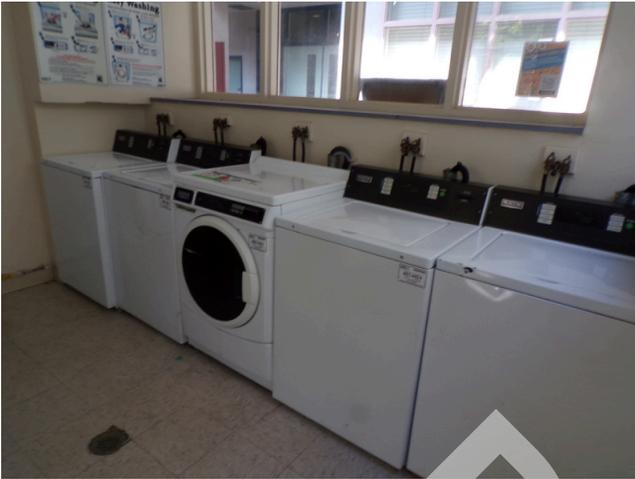
289. Community building - laundry room washers

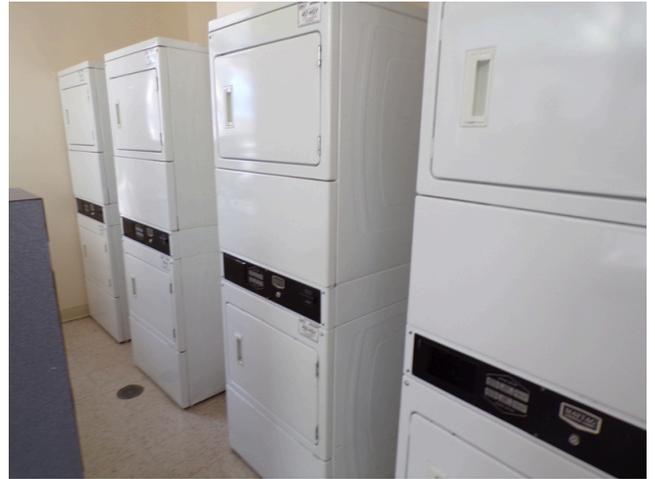
290. Community building - laundry room dryers

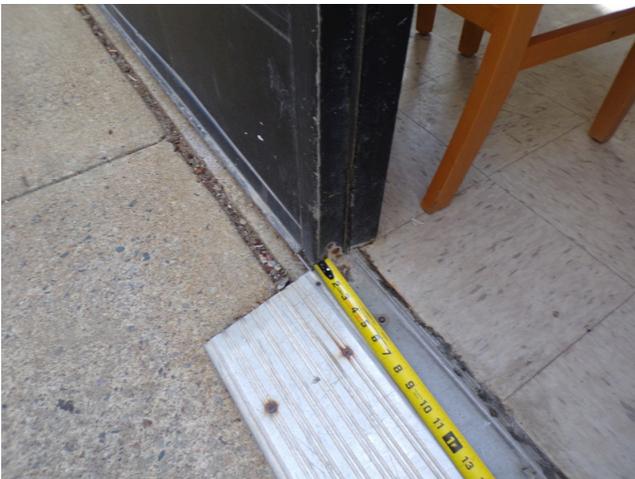
291. Community building - laundry room threshold and doorway floor space

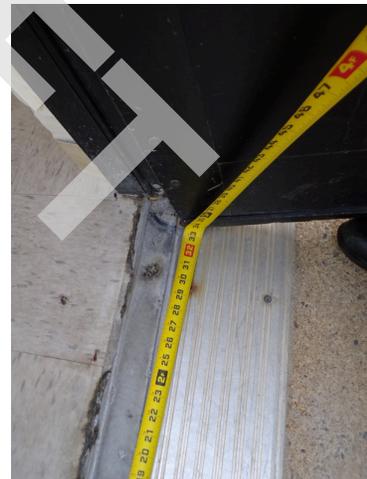
292. Community building - laundry room threshold and doorway floor space

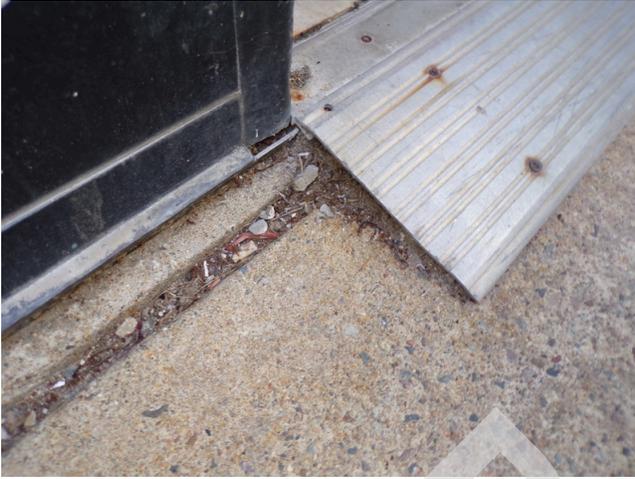
293. Community building - threshold trip hazard  
(Critical Repair)

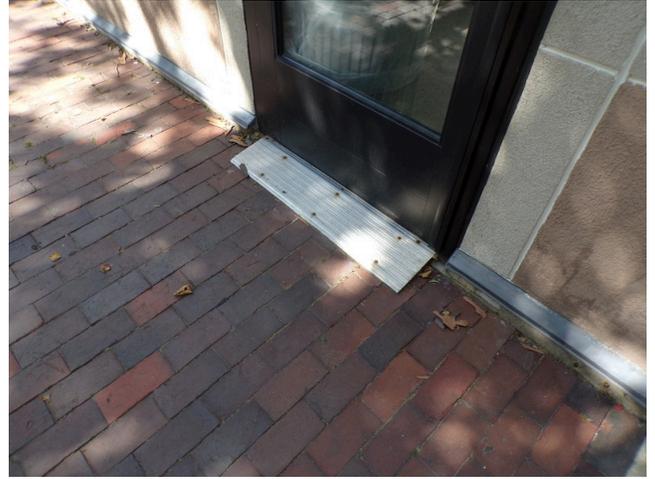
294. Community building - threshold trip hazard  
(Critical Repair)

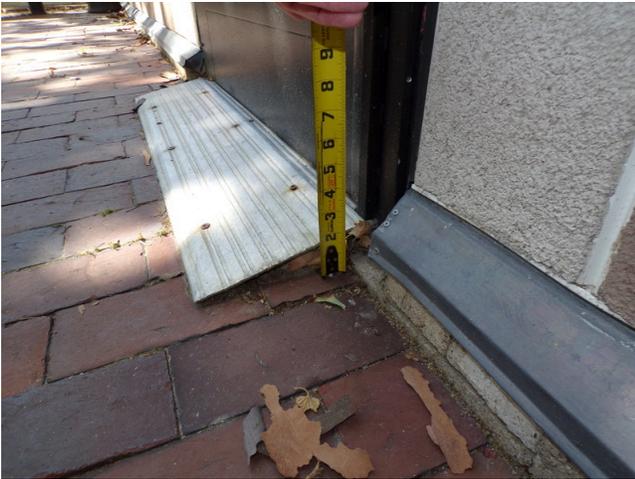
295. Community building - threshold trip hazard  
(Critical Repair)

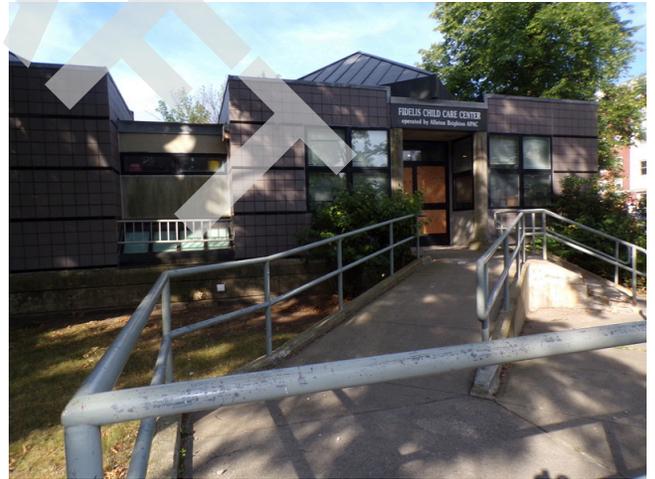
296. Child care center - to be demolished

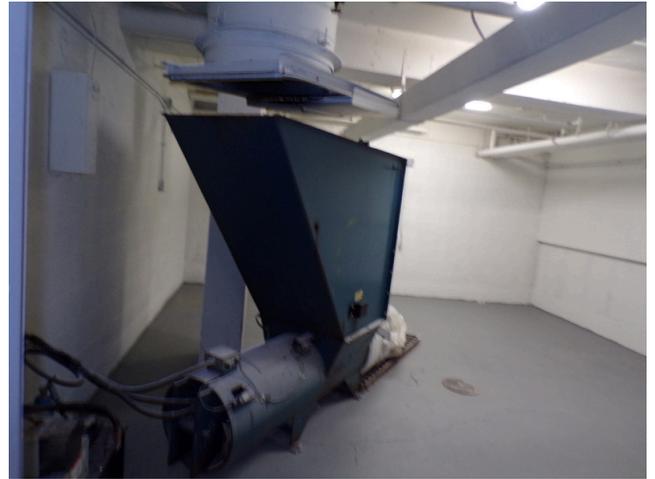
298. Building 7 - trash compactor not in use

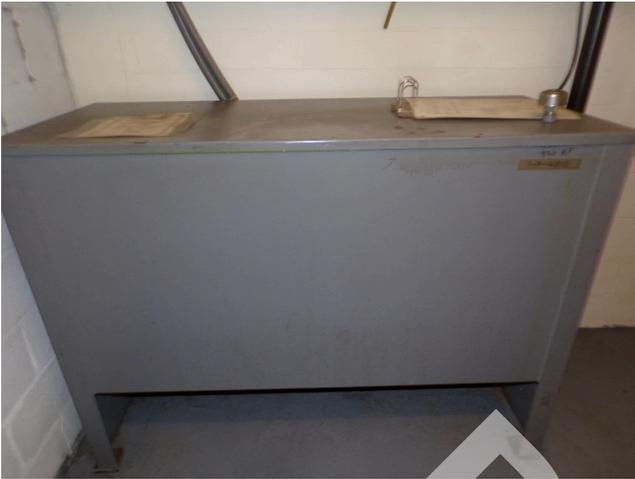
301. Building 7 - elevator motor (Non-Critical Repair)

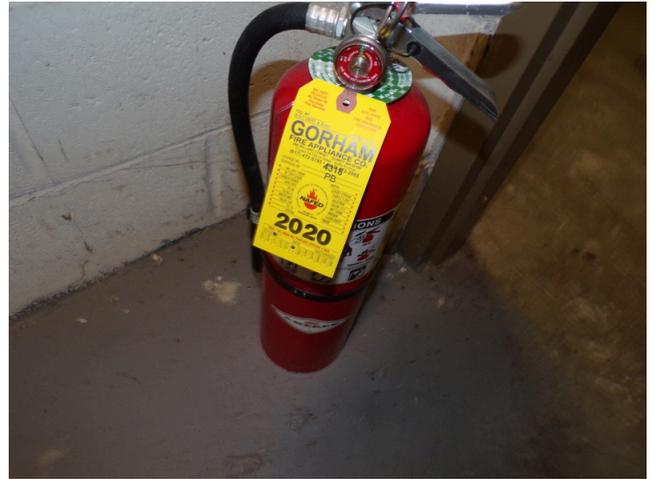
302. Building 7 - elevator room fire extinguisher expired (Non-Critical Repair)

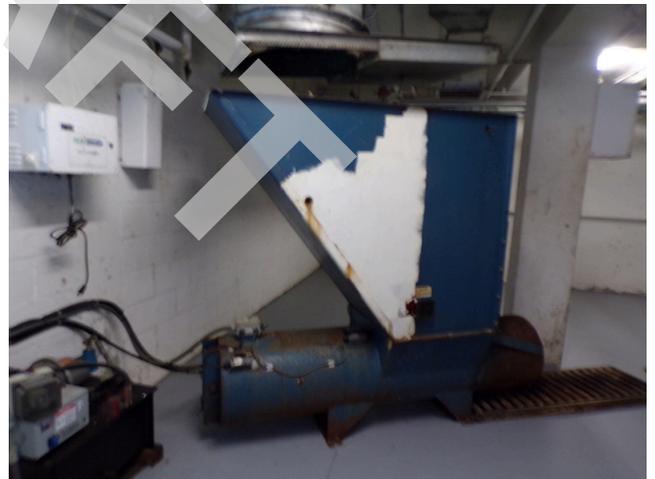
304. Building 7 - trash compactor not in use

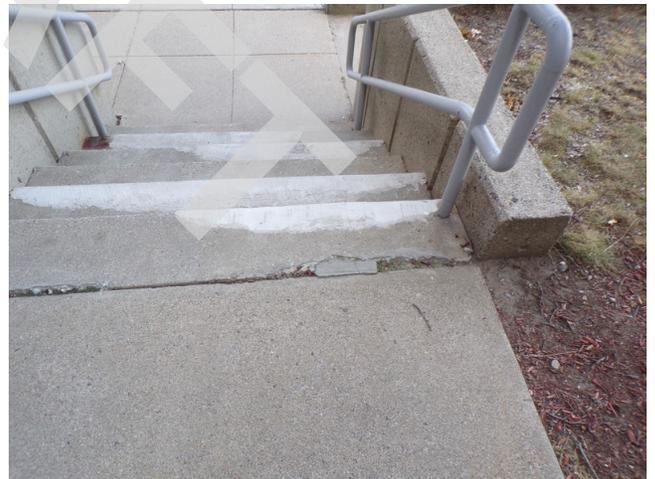
312. Building 7 - stairs trip hazard (Critical Repair)

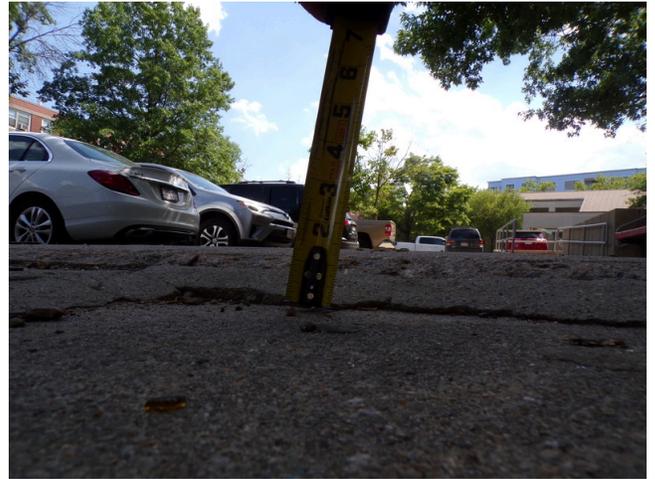
314. Building 7 - sidewalk trip hazard (Critical Repair)

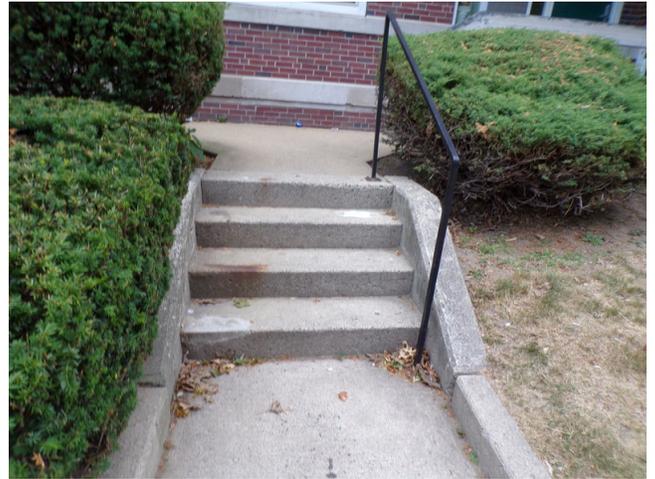
318. Building 7 - stairs missing railing (Critical Repair)

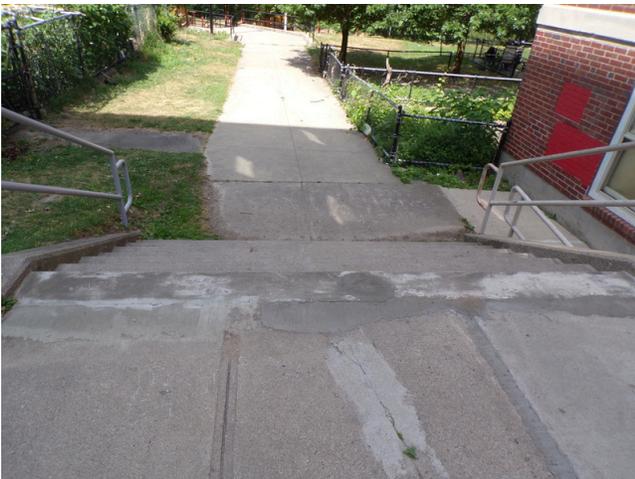
319. Building 7 - Stairs for overlook park trip hazard (Critical Repair)

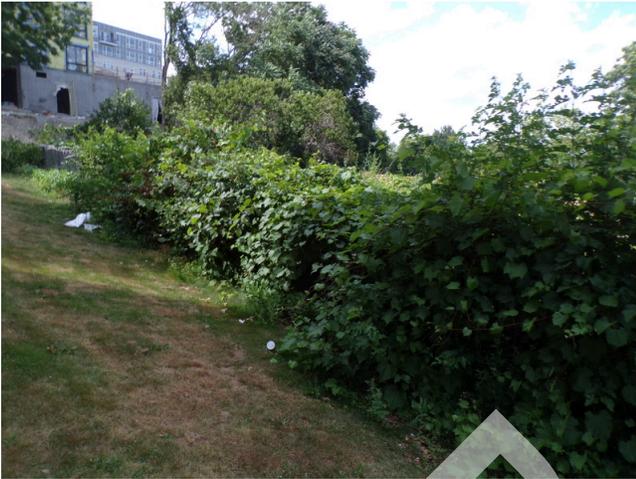
321. Building 7 - overgrown vegetation

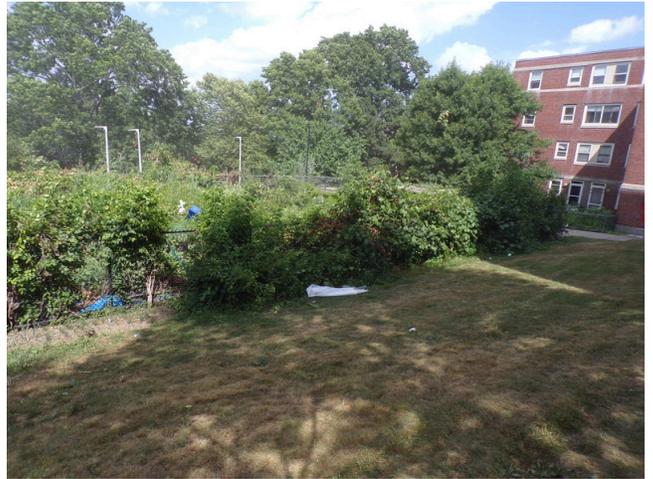
322. Building 7 - overgrown vegetation

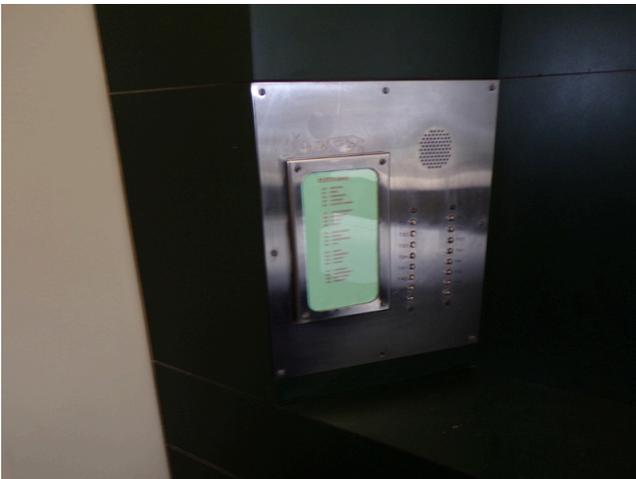
323. Building 7 - call box (Non-Critical Repair)

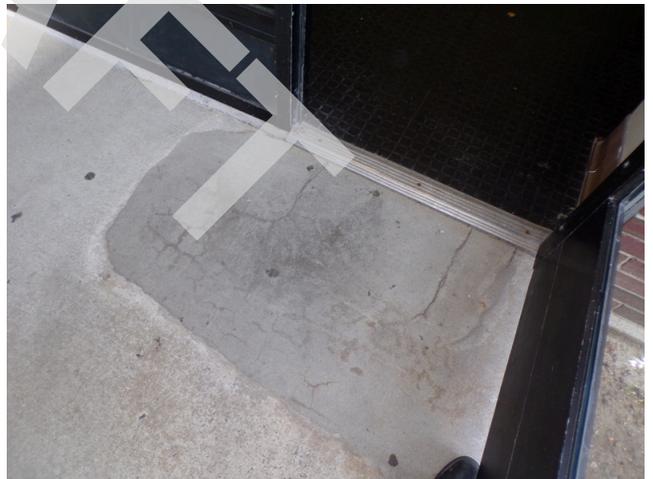
324. Building 7 - concrete ramp trip hazard (Critical Repair)

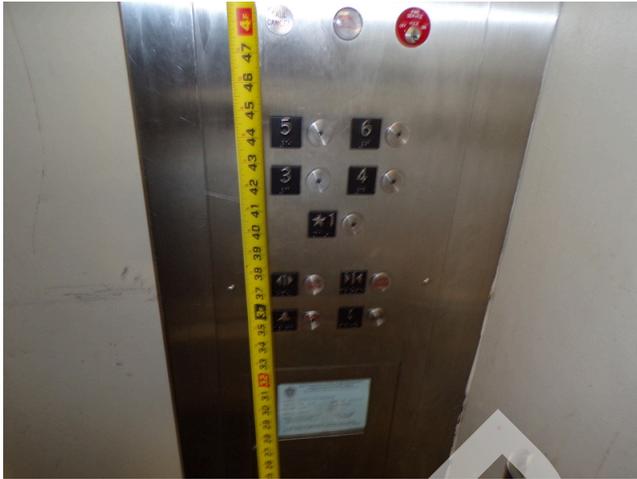
329. Building 7 - elevator cab controls

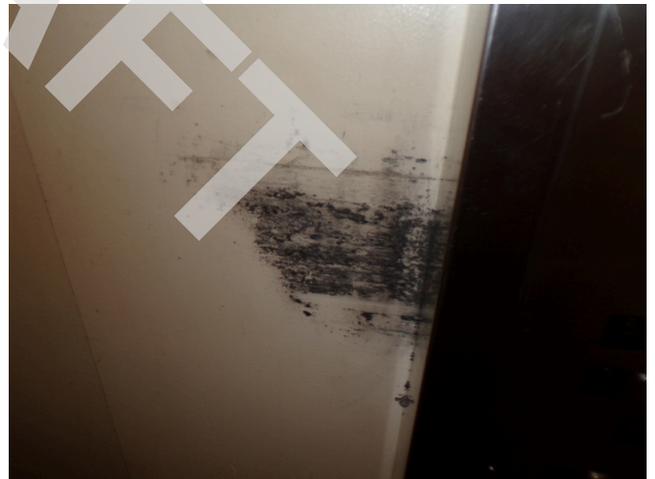
336. Building 7 - elevator cab door rubbing (Non-Critical Repair)

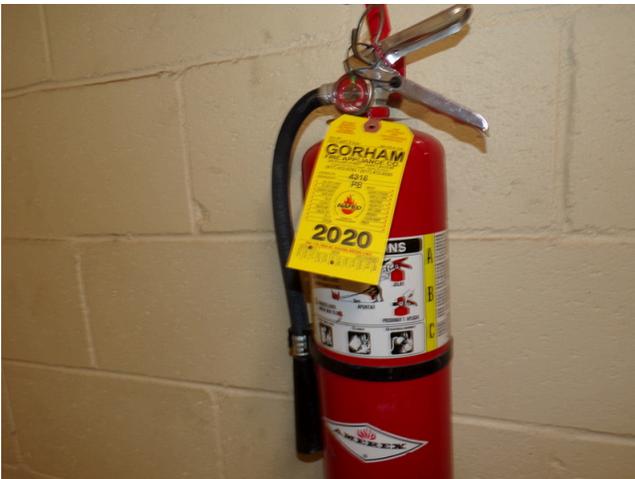
343. Building 7 - elevator room fire extinguisher expired (Non-Critical Repair)

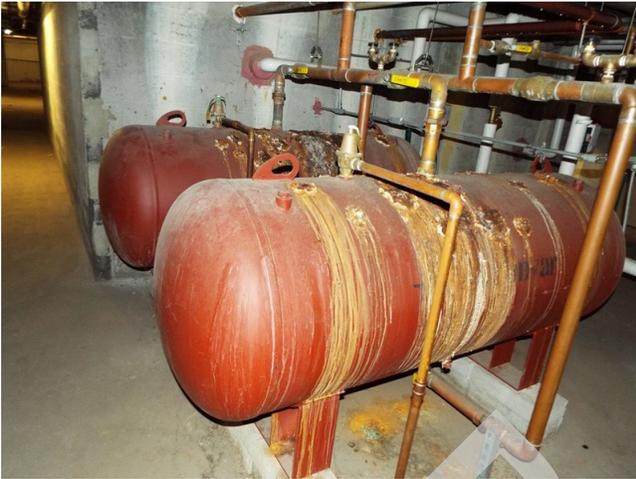
369. Building 11 - hot water storage tank corrosion  
(Non-Critical Repair)

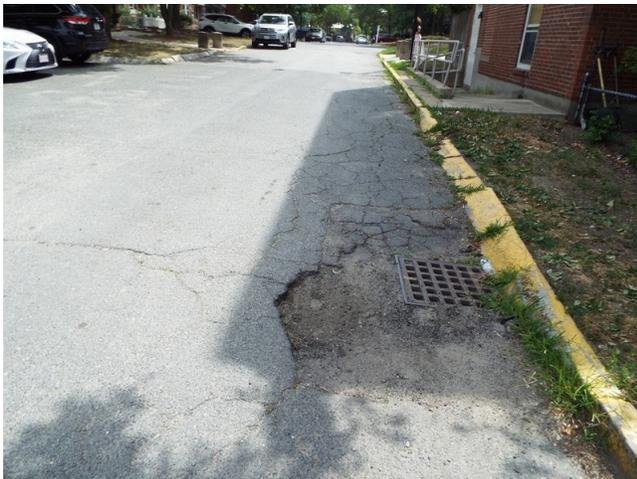
387. Building 8 - asphalt condition (Non-Critical Repair)

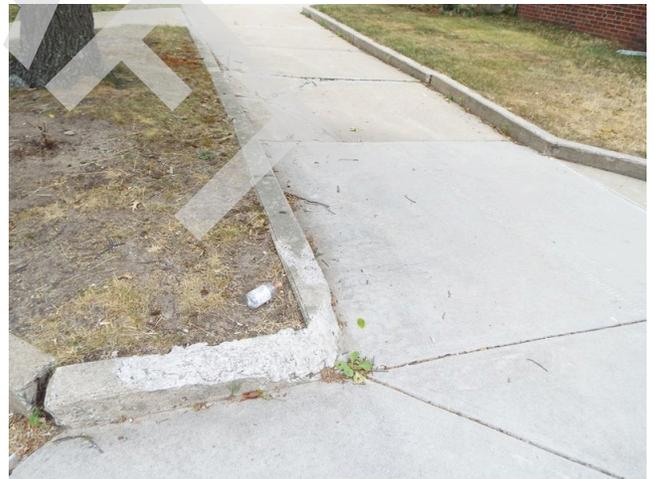
388. Building 8 - curb damage (Non-Critical Repair)

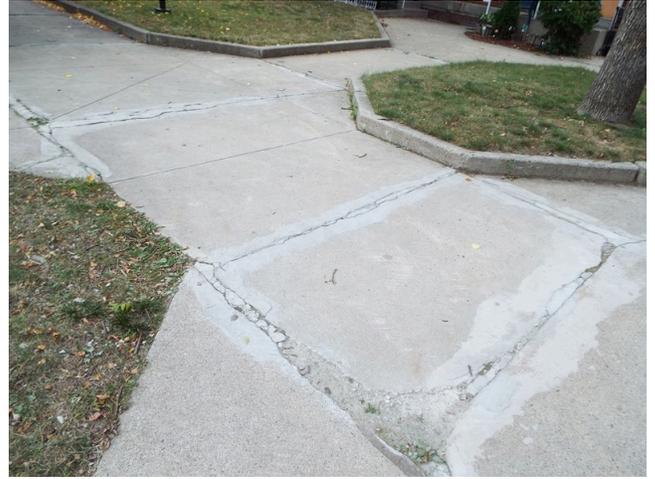
390. Building 8 - sidewalk trip hazard (Critical Repair)
