## HUD CAPITAL NEEDS ASSESSMENT

Commonwealth Family  
35 Fidelis Way  
Brighton, Massachusetts 02135

AEI Project No. 463346  
Site Inspection Date: July 20 and 21, 2022

Boston Housing Authority  
52 Chauncy Street  
Boston, Massachusetts 02111

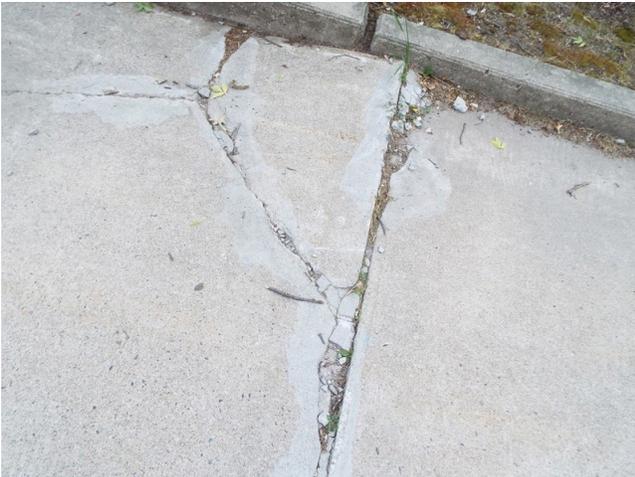
391. Building 8 - sidewalk trip hazard (Critical Repair)

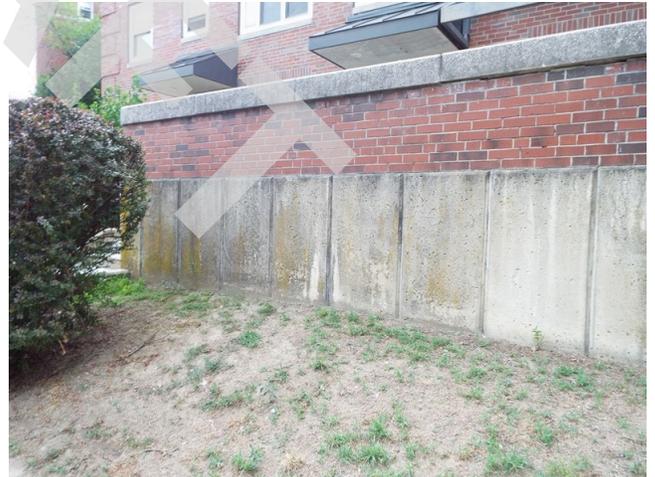
392. Building 8 - power wash foundation (Non-Critical Repair)

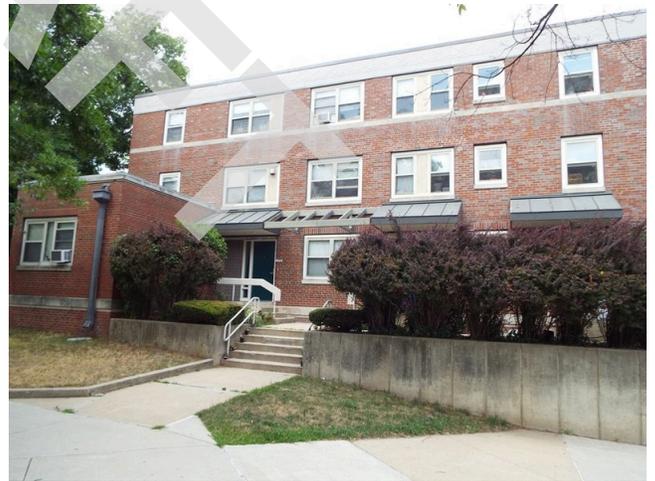
396. Building 8 - power wash retaining wall (Non-Critical Repair)

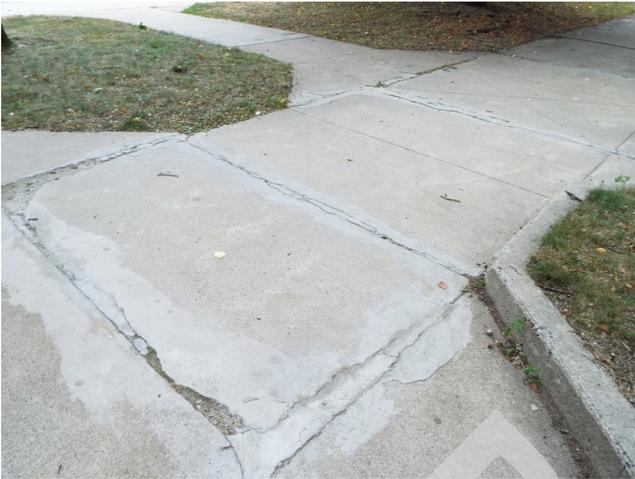
397. Building 8 - sidewalk trip hazard (Critical Repair)

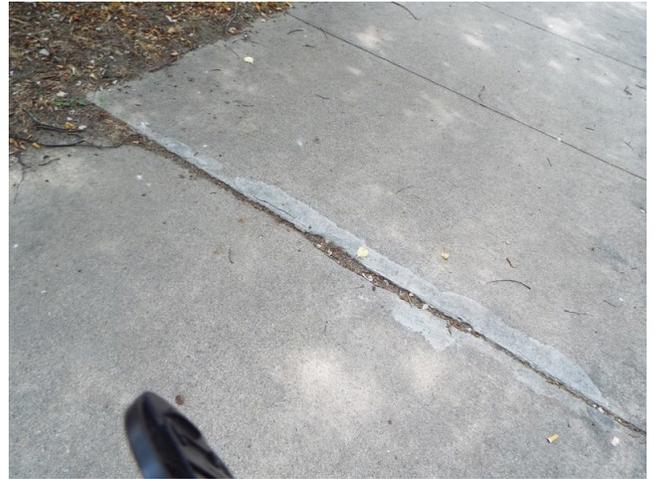
398. Building 8 - sidewalk trip hazard (Critical Repair)

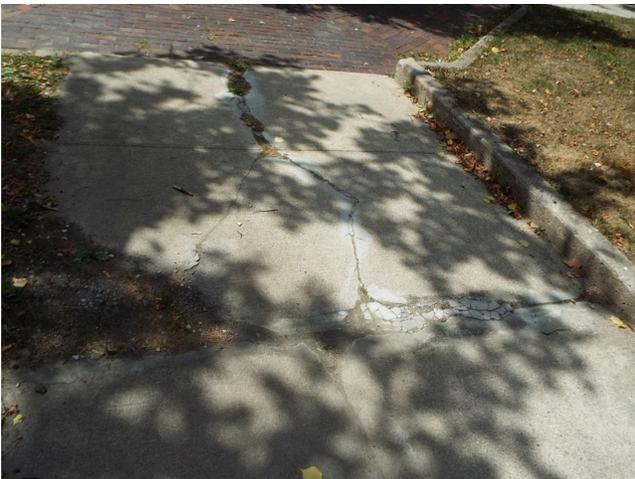
399. Building 8 - sidewalk trip hazard (Critical Repair)

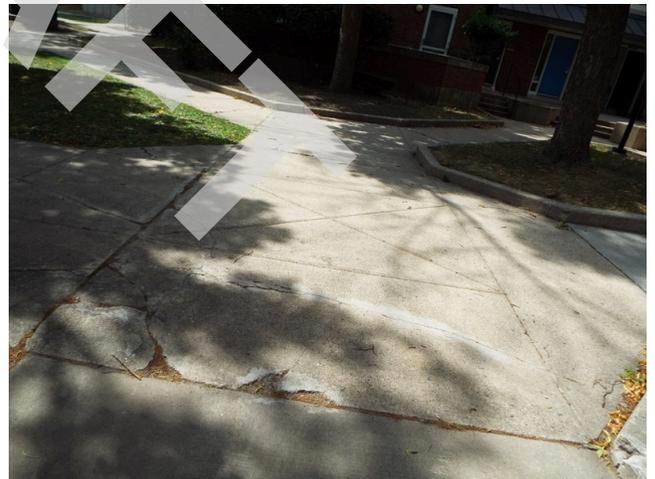
400. Building 8 - sidewalk trip hazard (Critical Repair)

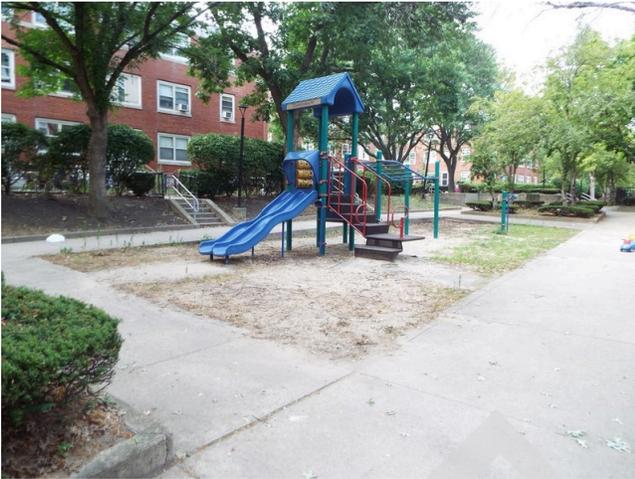
401. Building 8 - playground with bare ground (Non-Critical Repair)

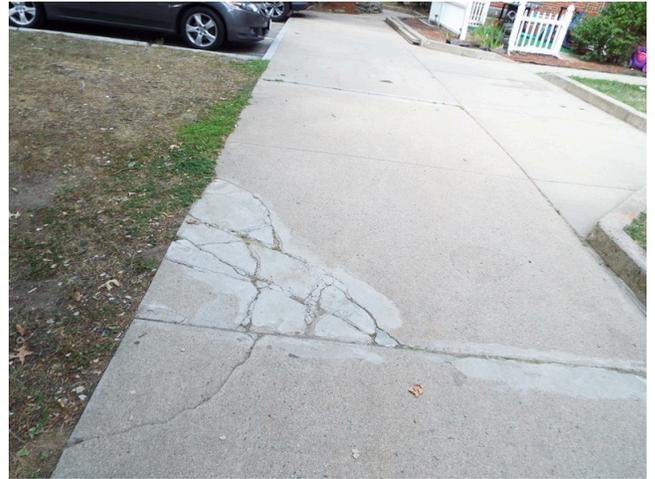
402. Building 9 - sidewalk trip hazard (Critical Repair)

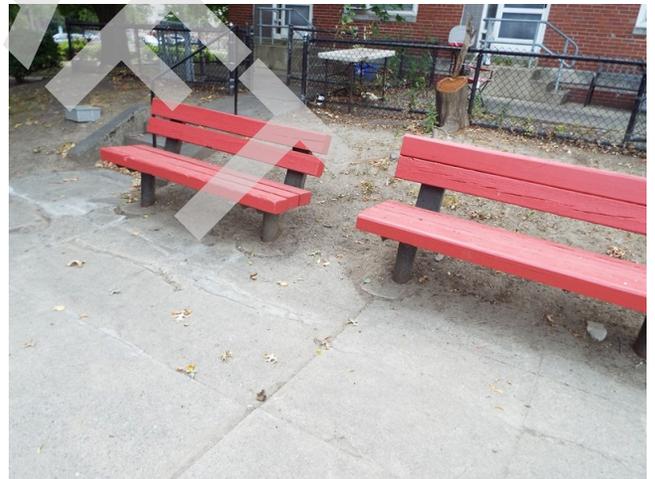
404. Building 9 - sidewalk trip hazard (Critical Repair)

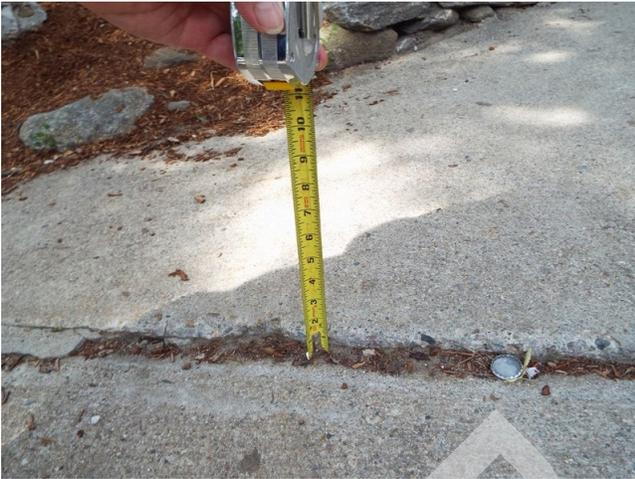
405. Building 9 - sidewalk trip hazard (Critical Repair)

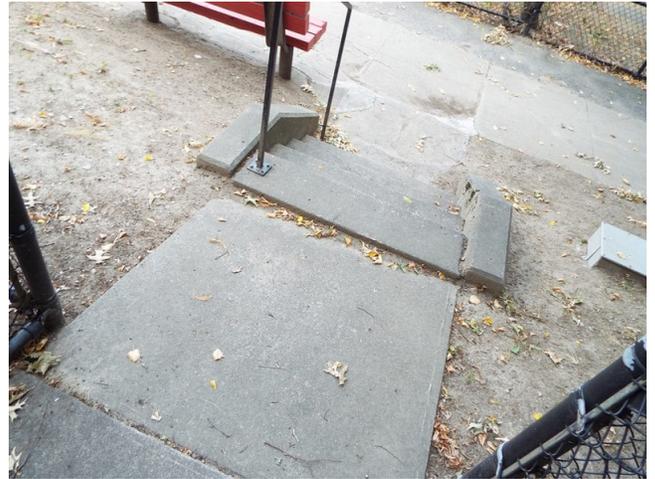
406. Building 9 - sidewalk trip hazard (Critical Repair)

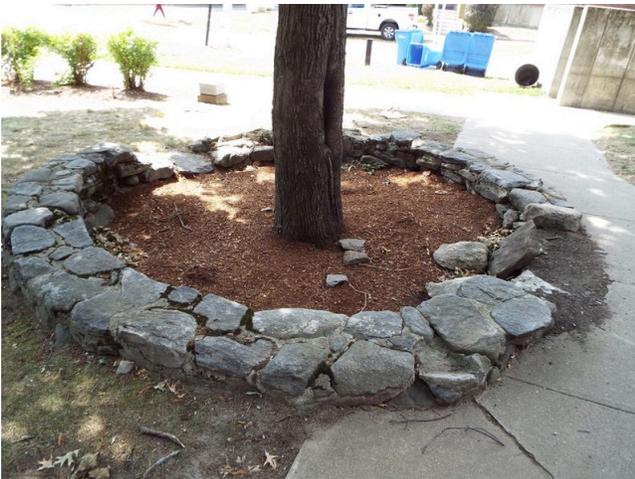
407. Building 9 - stone planter wall (Non-Critical Repair)

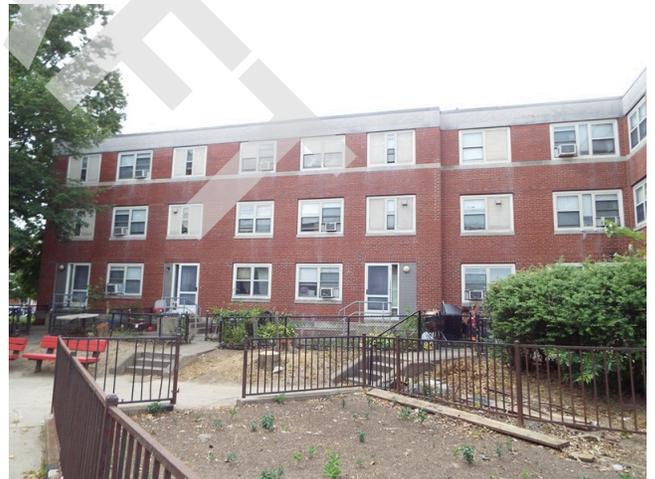
408. Building 9 - stairs missing railings (Critical Repair)

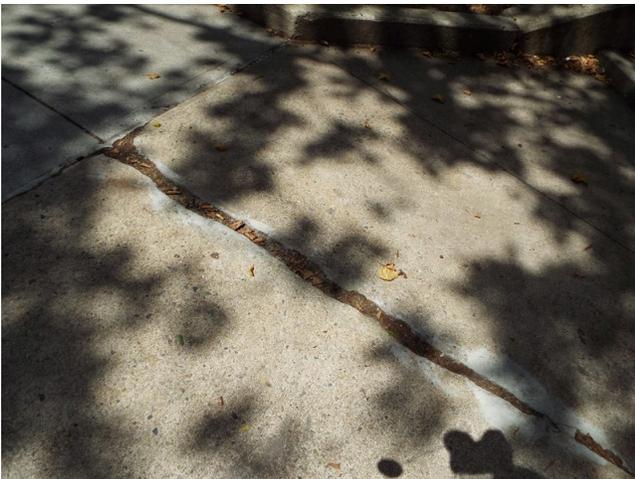
410. Building 9 - sidewalk trip hazard (Critical Repair)

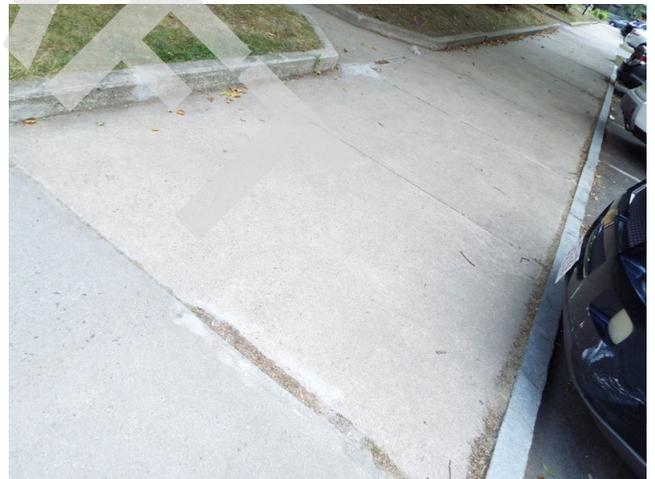
411. Building 9 - sidewalk trip hazard (Critical Repair)

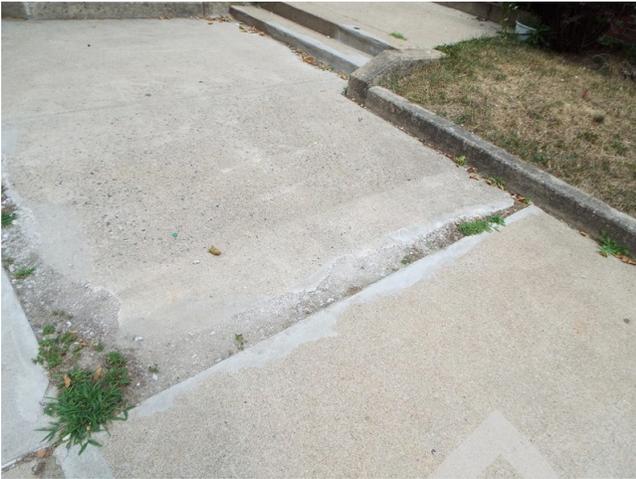
412. Building 9 - sidewalk trip hazard (Critical Repair)

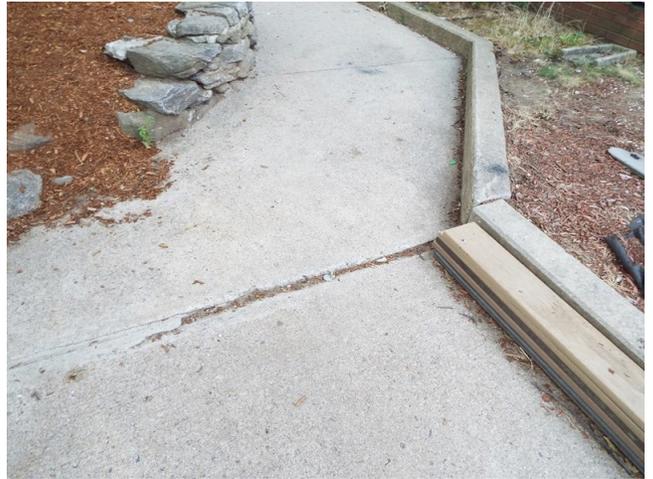
413. Building 9 - sidewalk trip hazard (Critical Repair)

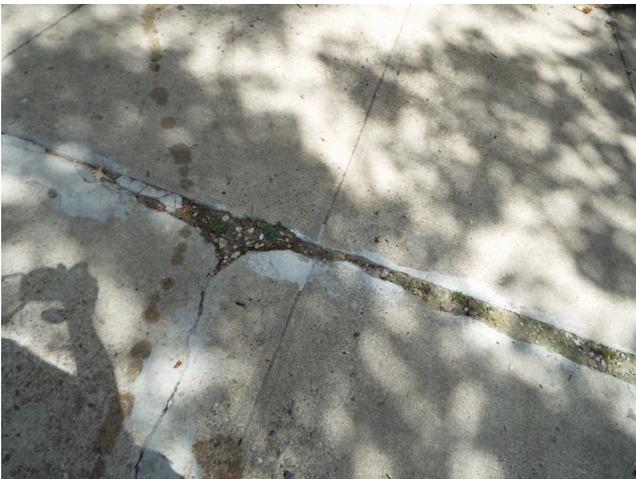
414. Building 9 - sidewalk trip hazard (Critical Repair)

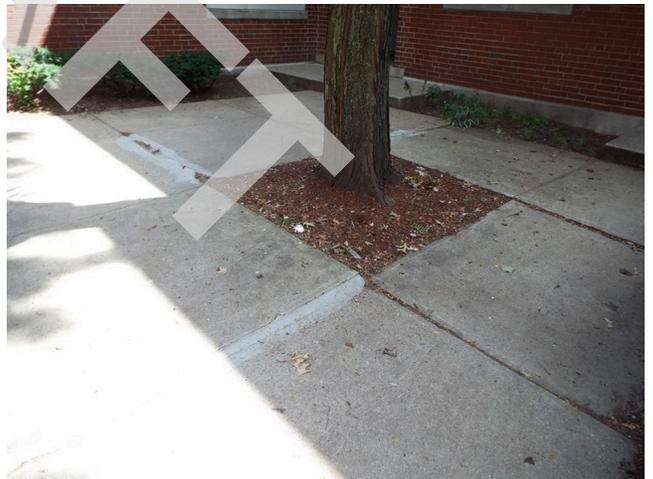
415. Building 9 - sidewalk trip hazard (Critical Repair)

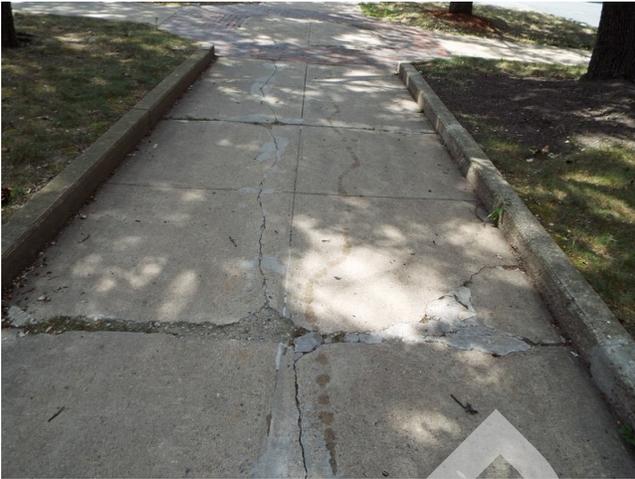
416. Building 9 - sidewalk trip hazard (Critical Repair)

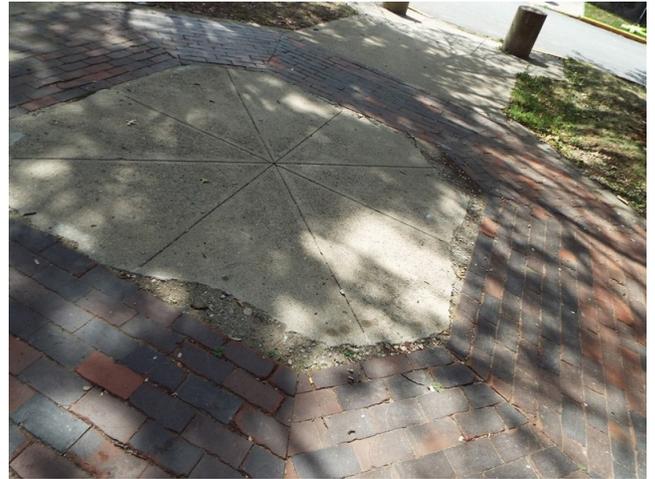
417. Building 9 - sidewalk trip hazard (Critical Repair)

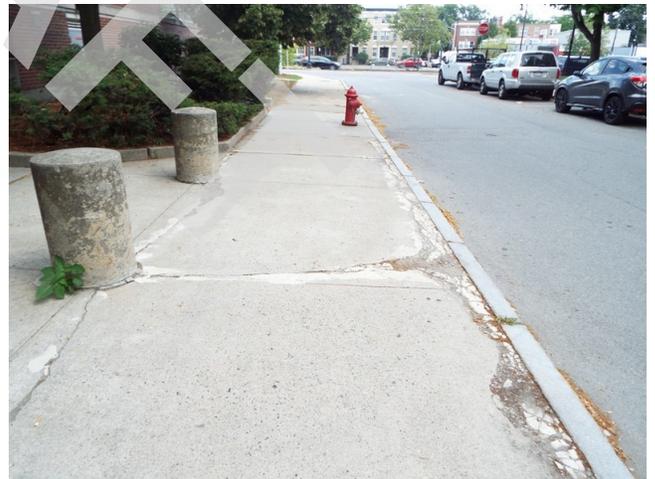
419. Building 9 - parking lot condition (Non-Critical Repair)

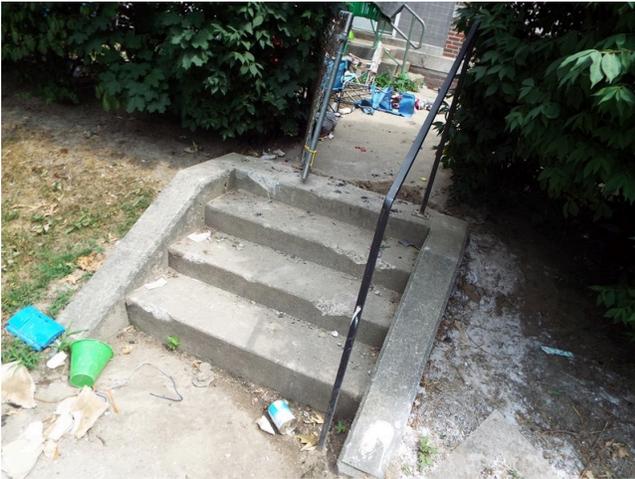
420. Building 10 - sidewalk trip hazard (Critical Repair)

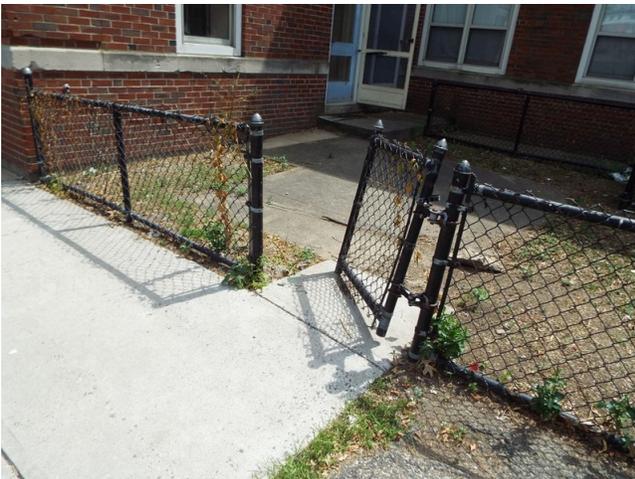
422. Building 10 - sidewalk trip hazard (Critical Repair)

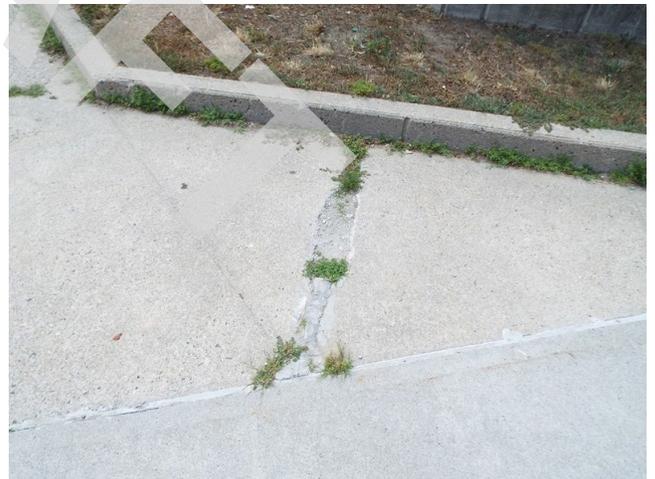
427. Building 10 - concrete curb damage

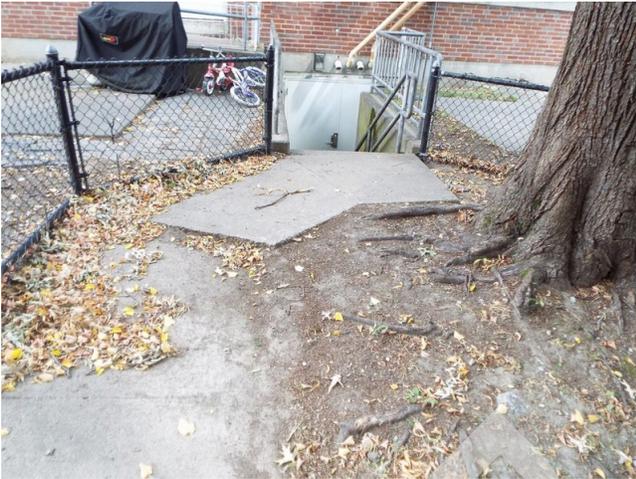
428. Building 10 - sidewalk trip hazard (Critical Repair)

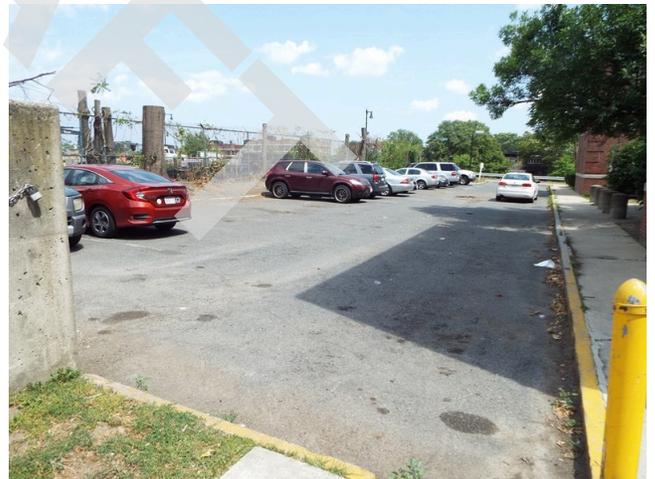
431. Building 10 and 11 - asphalt condition north elevation (Non-Critical Repair)

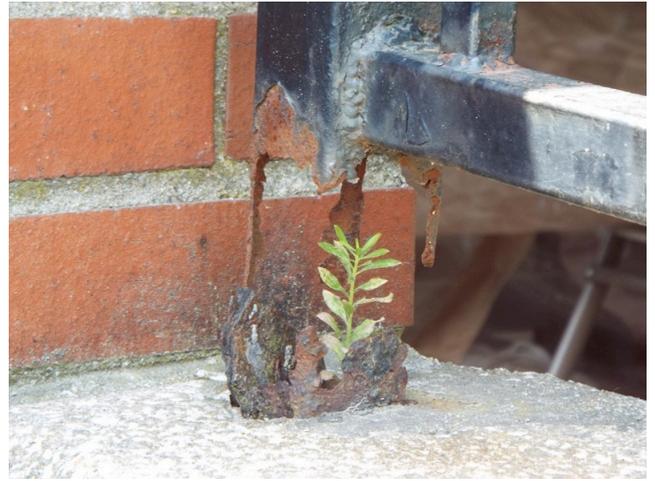
441. Building 11 - retaining wall damage by fence  
(Non-Critical Repair)

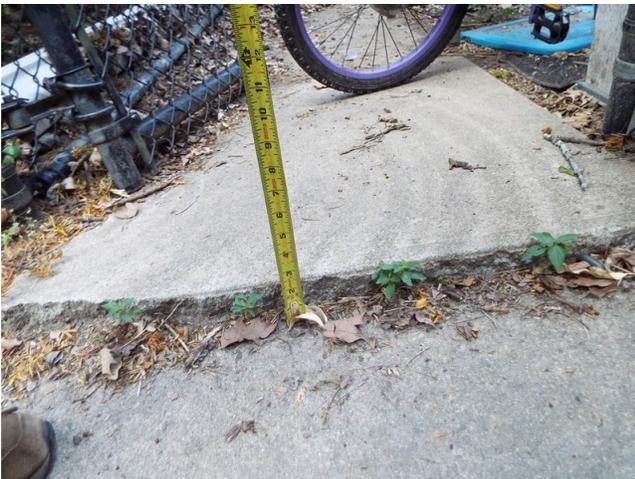
446. Building 12 - sidewalk trip hazard (Critical Repair)

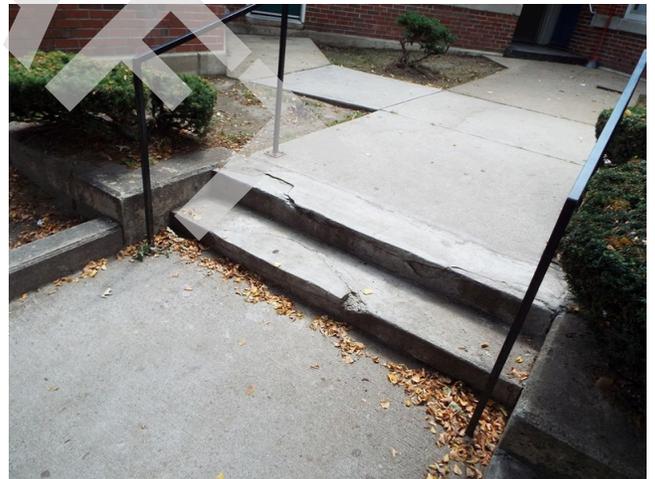
447. Building 12 - sidewalk trip hazard (Critical Repair)

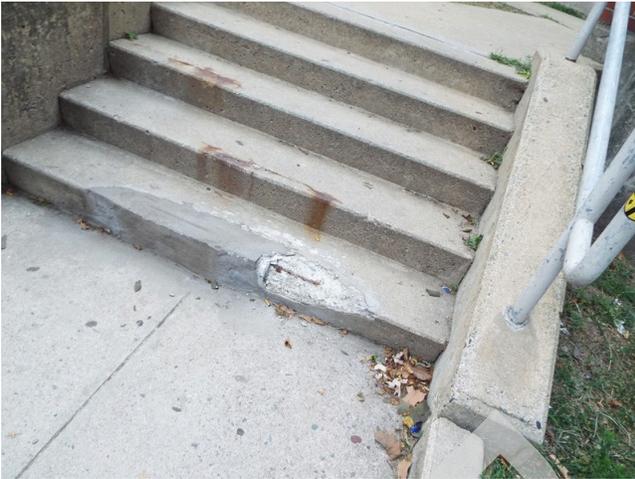
448. Building 12 - concrete steps trip hazard (Critical Repair)

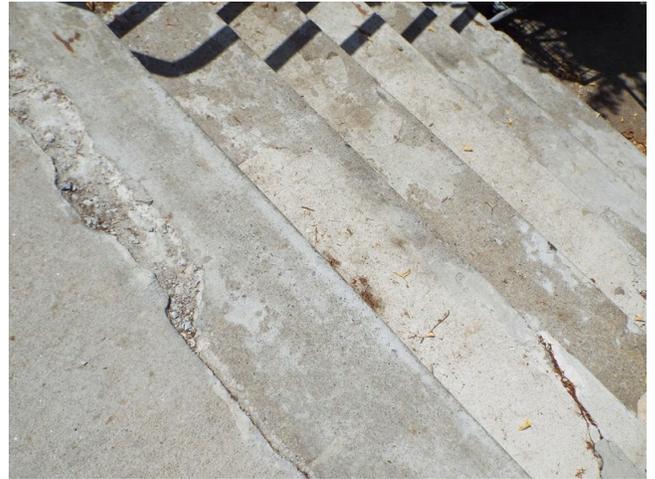
465. Building 13 - concrete stair trip hazard and missing railing (Critical Repair)

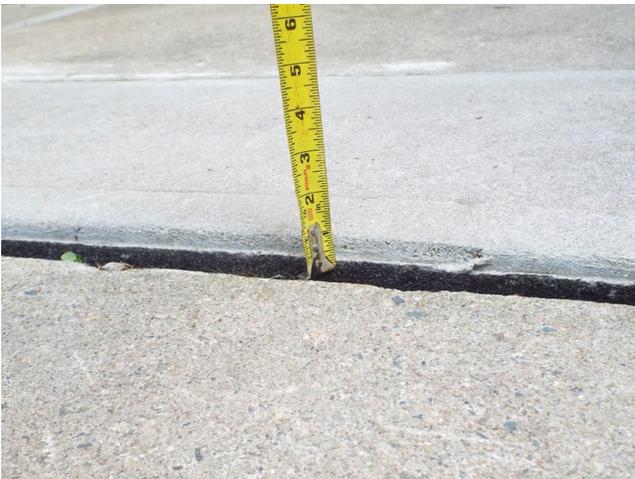
466. Building 13 - concrete stairs trip hazard (Critical Repair)

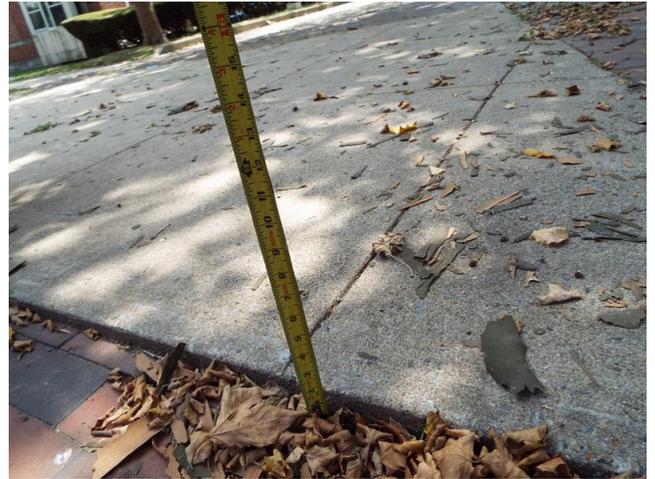
469. Building 13 - sidewalk trip hazard (Critical Repair)

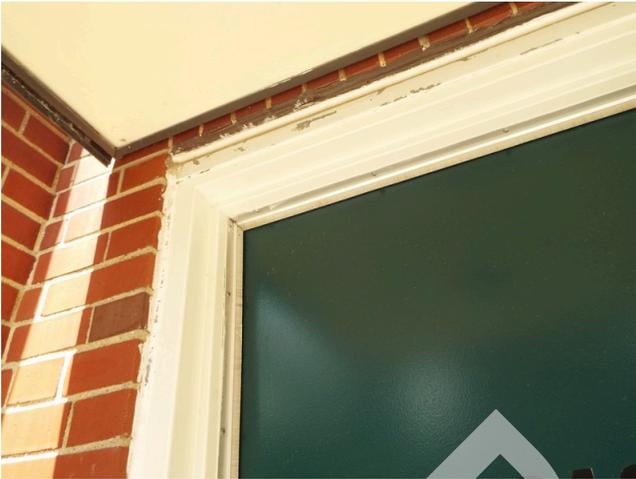
472. Building 13 - typical patio door

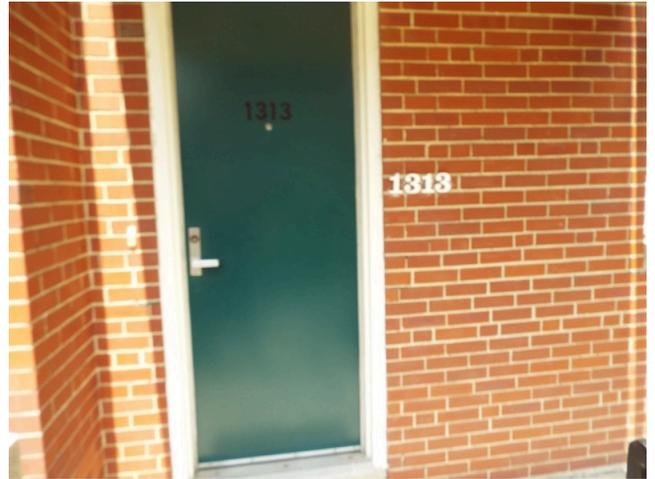
473. Building 13 - typical main ingress/egress door frame

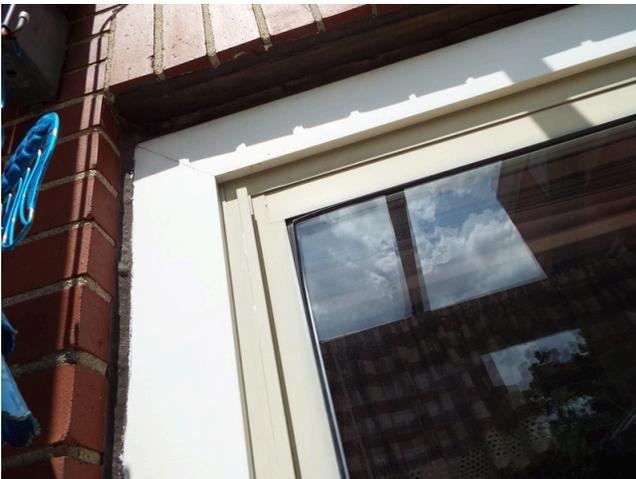
474. Building 13 - typical main ingress/egress door

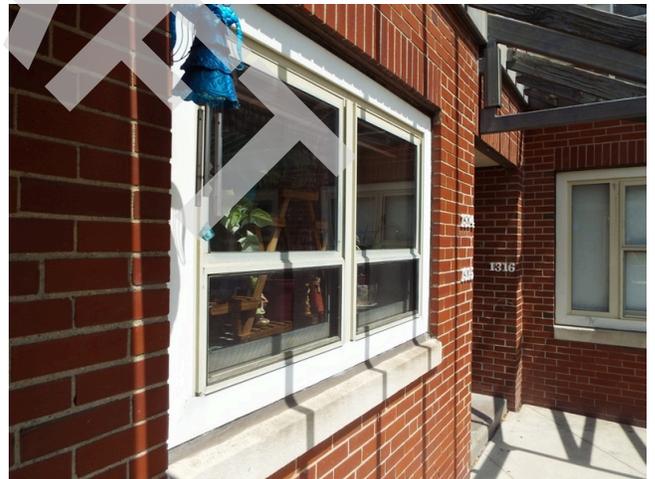
475. Building 13 - typical window frame

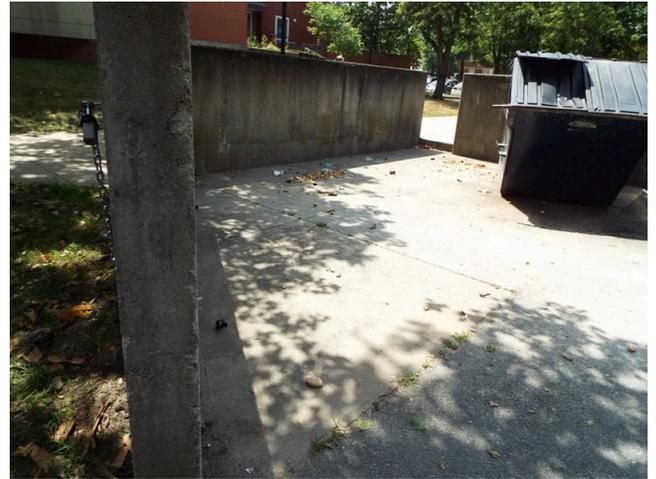
489. Building 13 - dumpsters

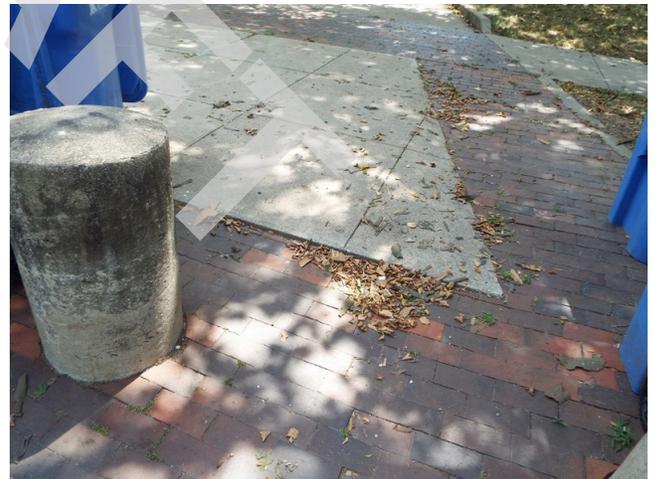
491. Building 13 - damaged concrete sidewalk and paving trip hazard (Critical Repair)

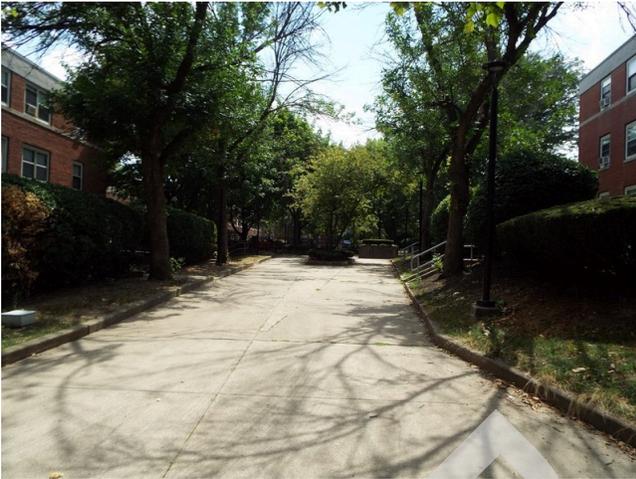
492. Building 13 - sidewalk trip hazard (Critical Repair)

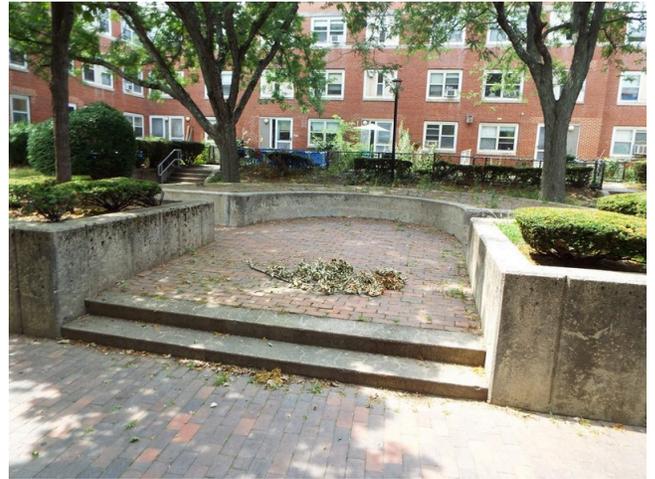
493. Building 13 - concrete paving

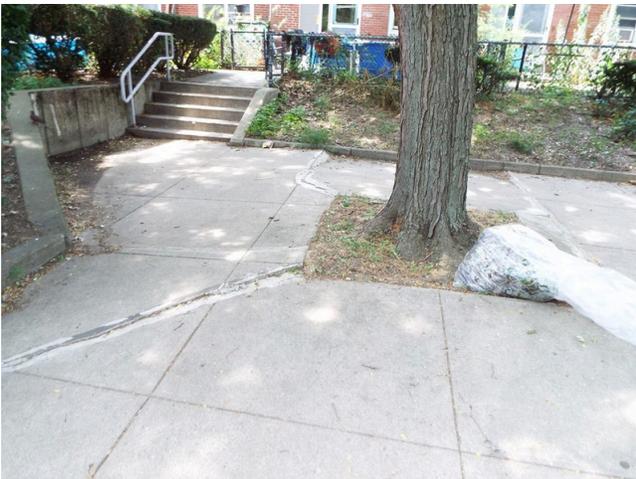
494. Building 13 - plaza area no ADA access (Critical Repair)

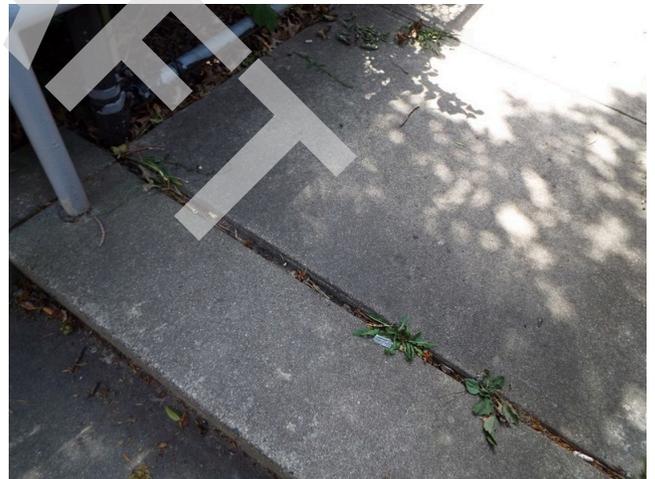
495. Building 13 - plaza area no ADA access (Critical Repair)

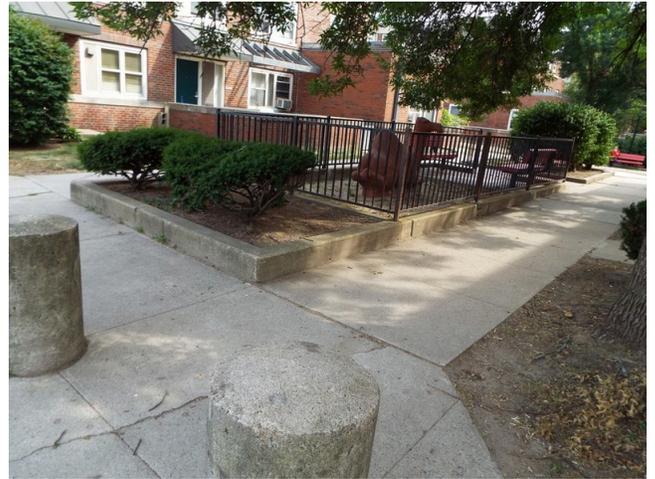
501. Building 10 and 11 - plaza access concrete stairs trip hazard (Critical Repair)
