HUD CAPITAL NEEDS ASSESSMENT

ML King
280 Martin Luther King Boulevard
Boston, Massachusetts 02119

AEI Project No. 463348
Site Inspection Date: June 28, 2022

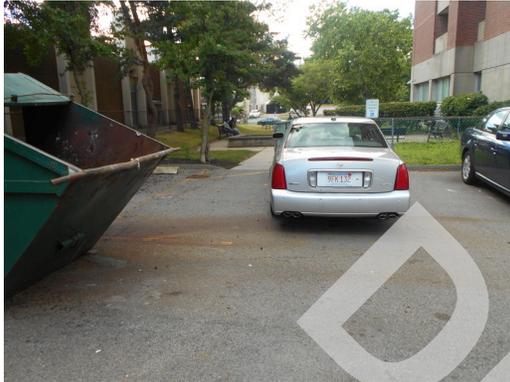
Items	Description	Action	Condition
Total Number of Parking Spaces	16 spaces in open lots	NA	Not applicable
Number of ADA Spaces	1	IM	Poor

Handicap parking space, faded lines
(Non-Critical Repair)

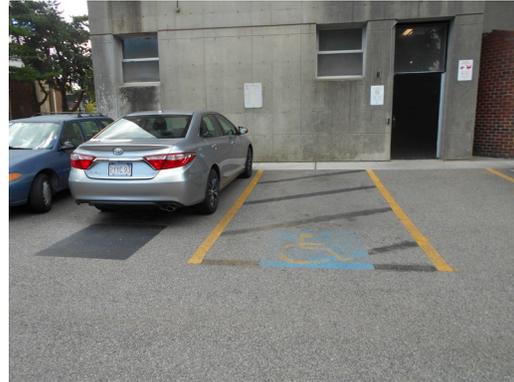
Handicap parking space marking in access aisle by removed handicap parking space
(Critical Repair)

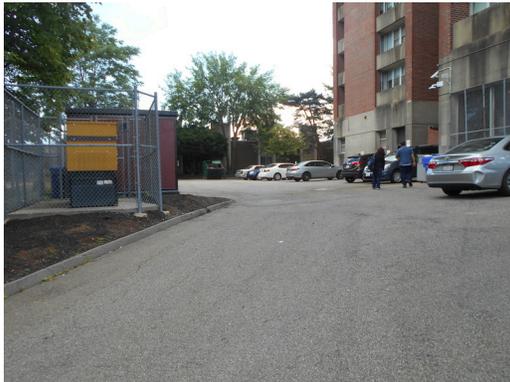
Items	Description	Action	Condition
Asphalt Pavement	Asphalt pavement is provided for on-site parking and drive lanes	RR	Good
Concrete Pavement	Not applicable	RR	Good
Curbing	Concrete	RR	Good
Seal Coating	Worn and considered at the end of its useful life	IM/RR	Fair
Striping	Painted parking striping faded and worn	IM/RR	Fair

Asphalt parking lot

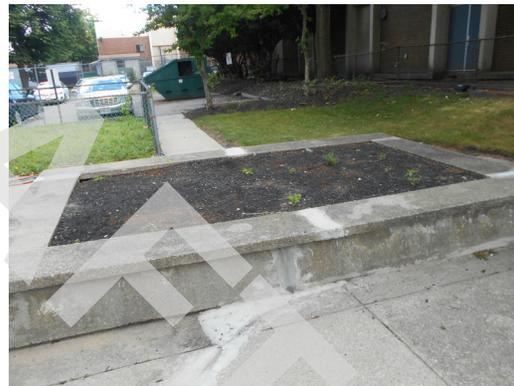
Concrete patio

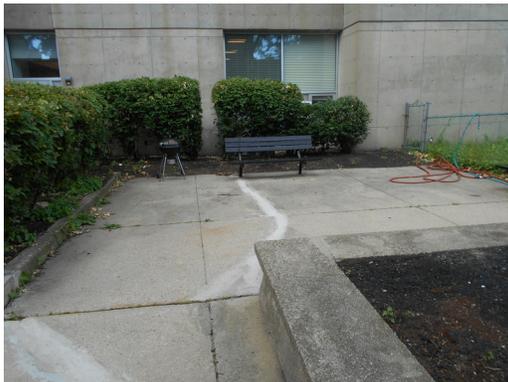
Concrete patio

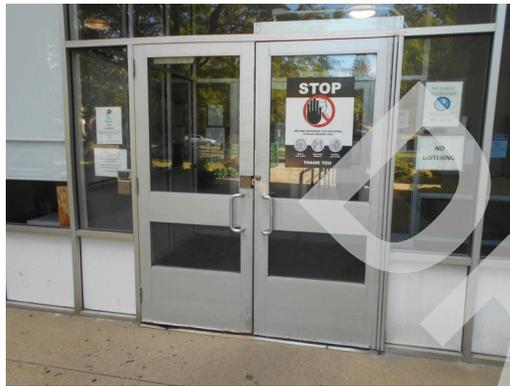
Building Entrance

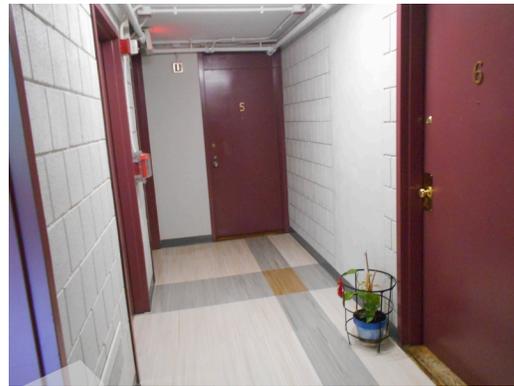
Typical resident floor hallway

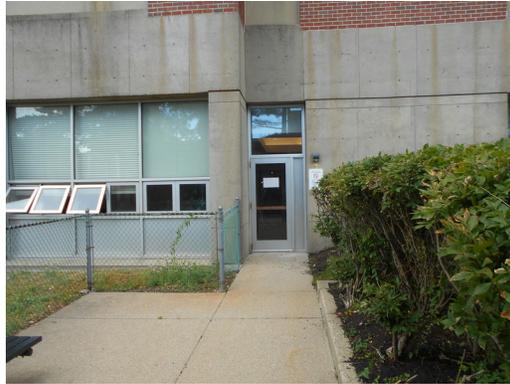
Building entrance to community room

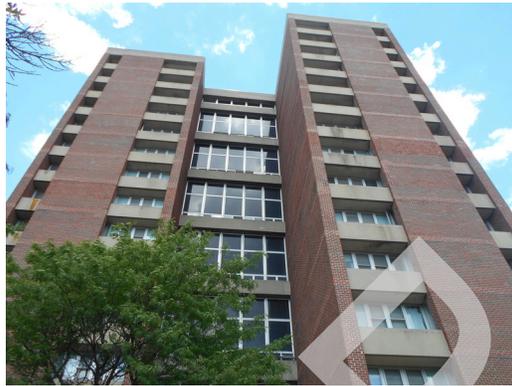
Front façade

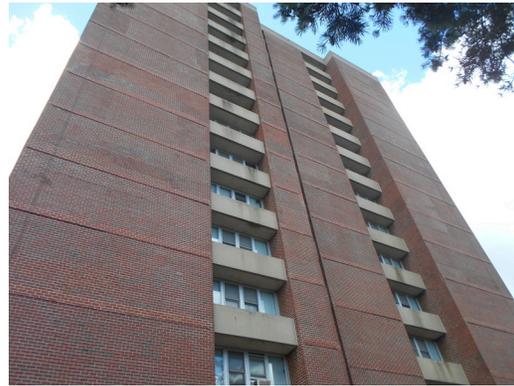
Side façade

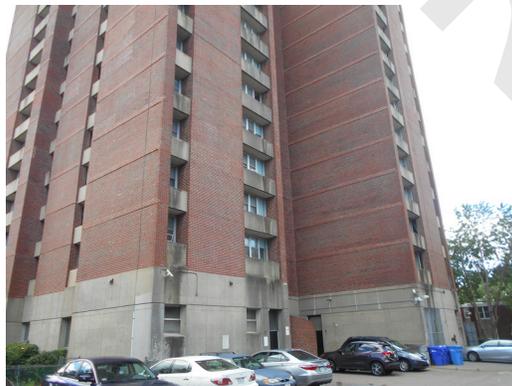
Rear façade

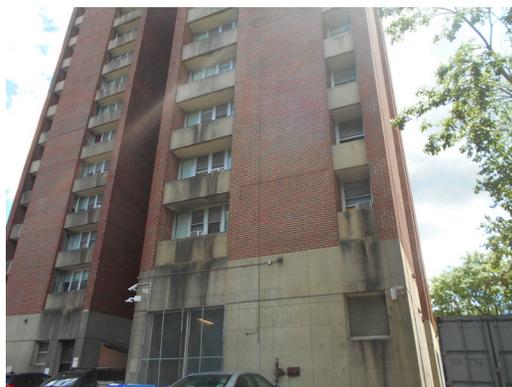
Rear façade

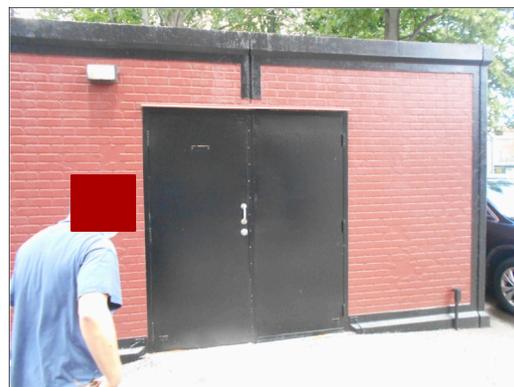
Exterior maintenance shed

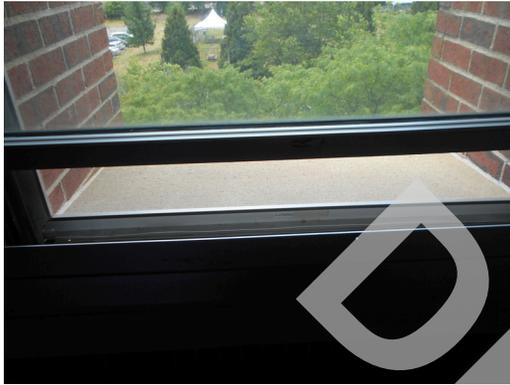
1br/1ba, Unit 25 - Typical window

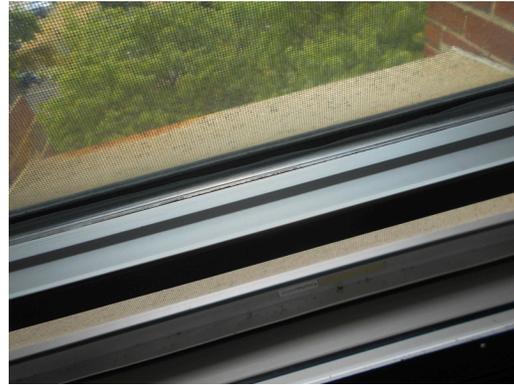
1br/1ba, Unit 25 - Typical window

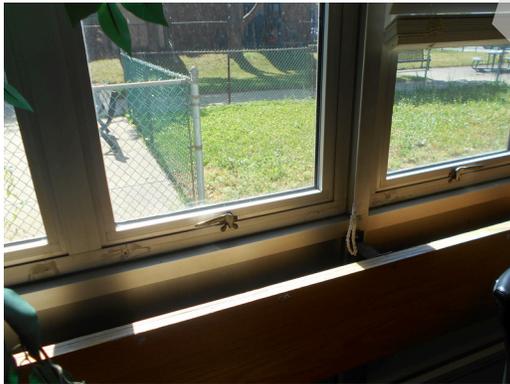
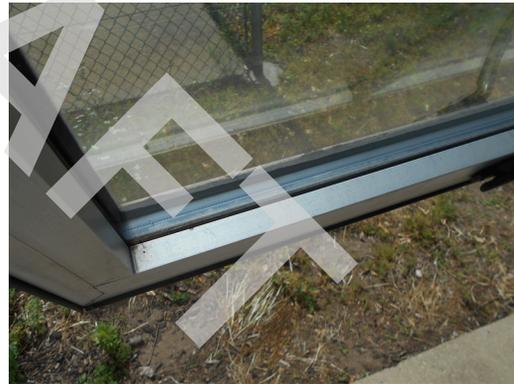
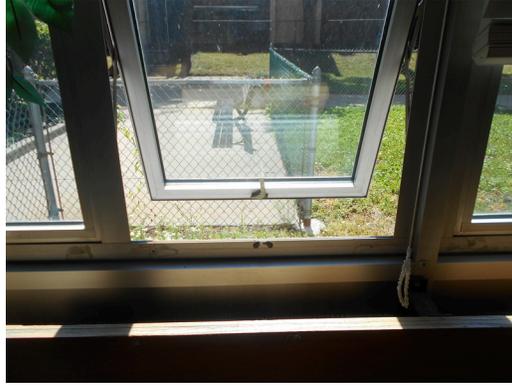
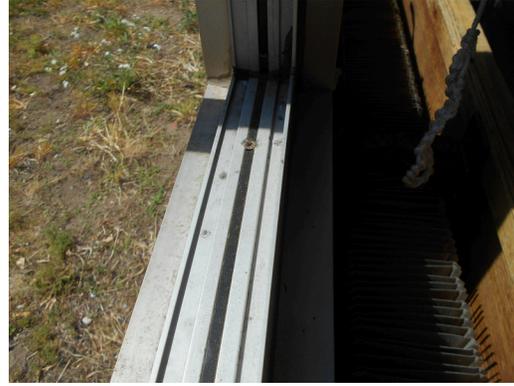
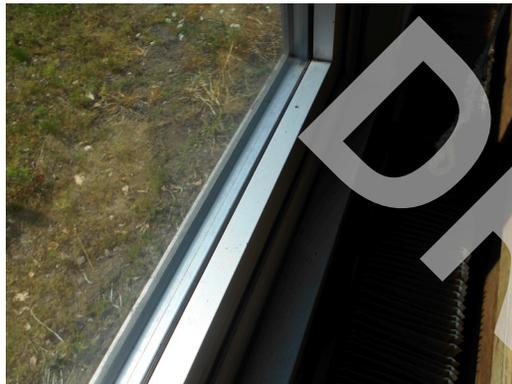
Community room aluminum window

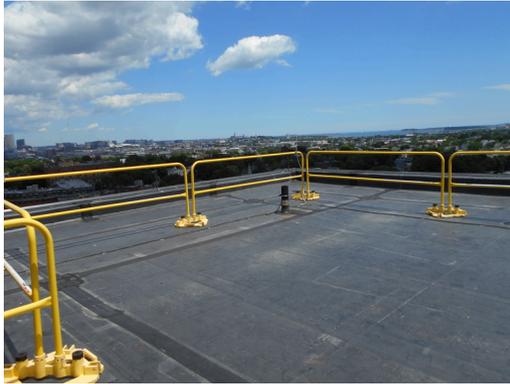
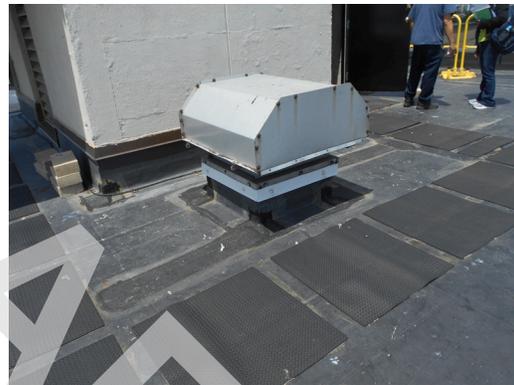
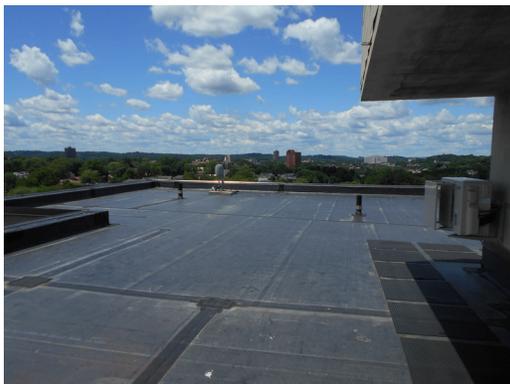
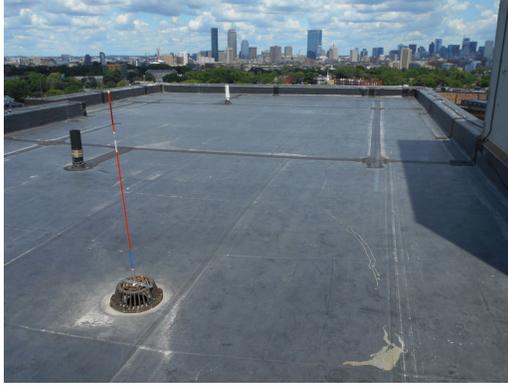
EPDM Roof

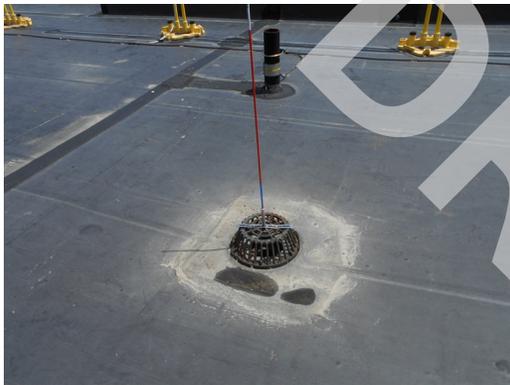
EPDM Roof area drain

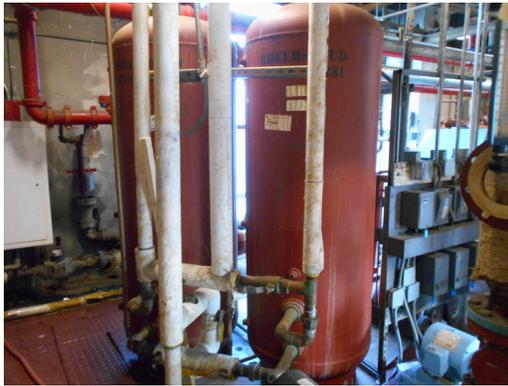
257-gal Water storage tanks

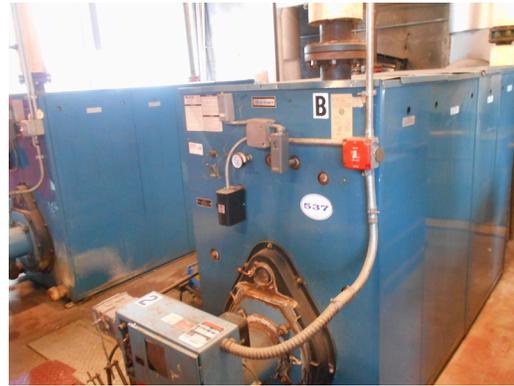
Steam boilers

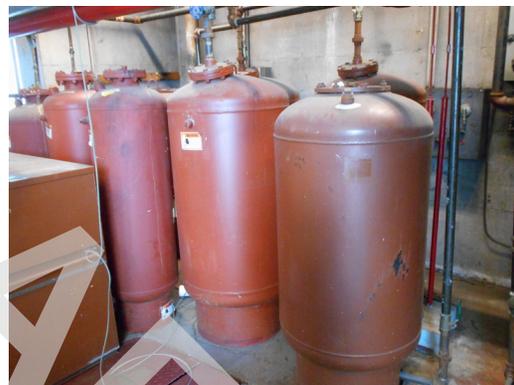
Backup hot water heaters

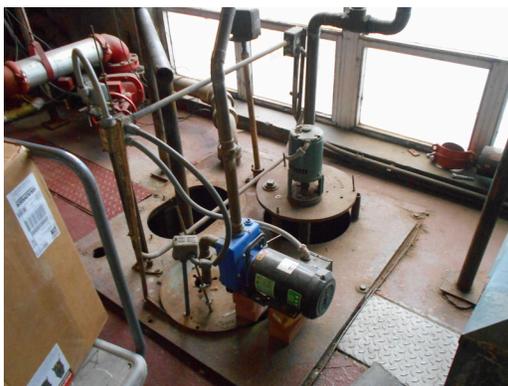
Sump pump

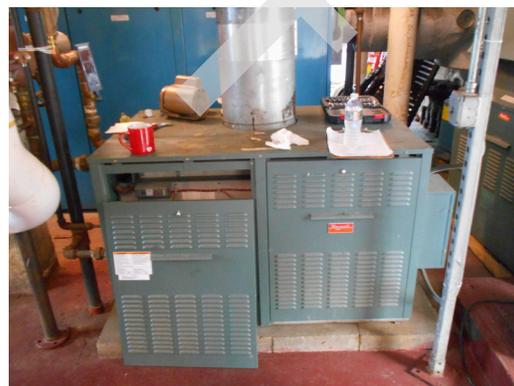
Hot water boiler

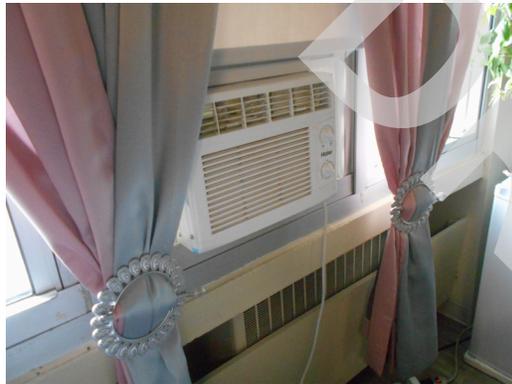
1br/1ba, Unit 32 - Typical individual A/C unit

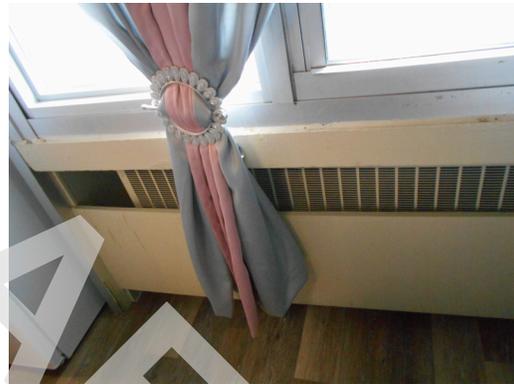
1br/1ba, Unit 32 - Living area radiator

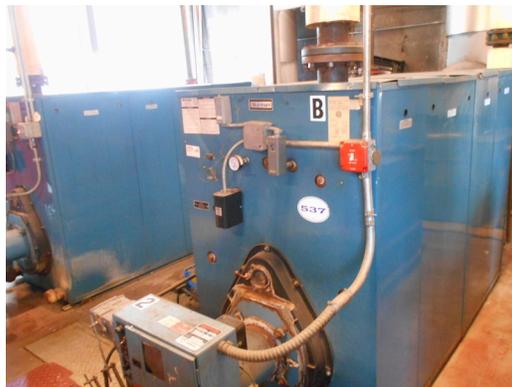
Steam boilers

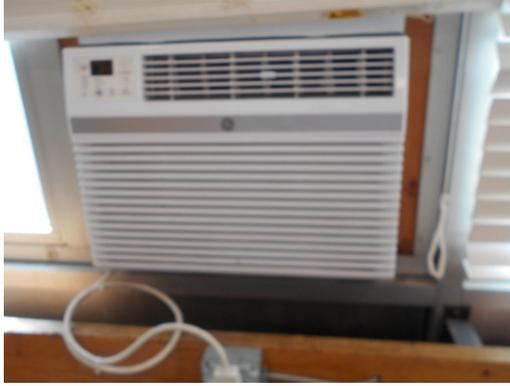
Community room A/C

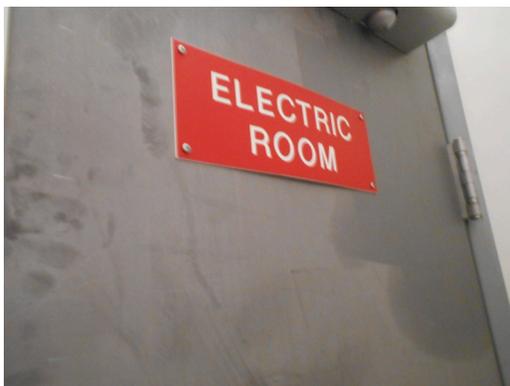
Electrical room

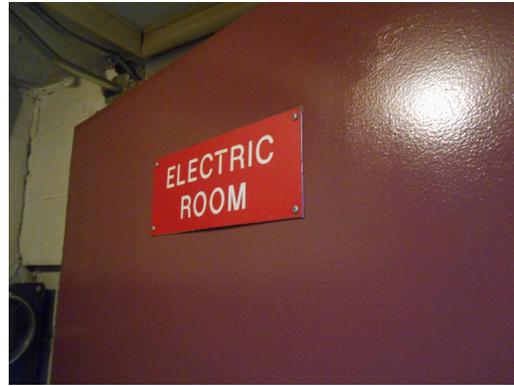
Typical electrical room

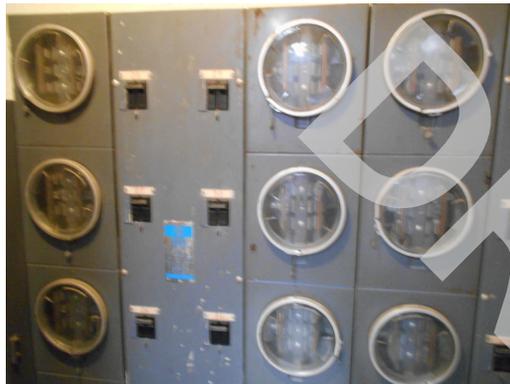
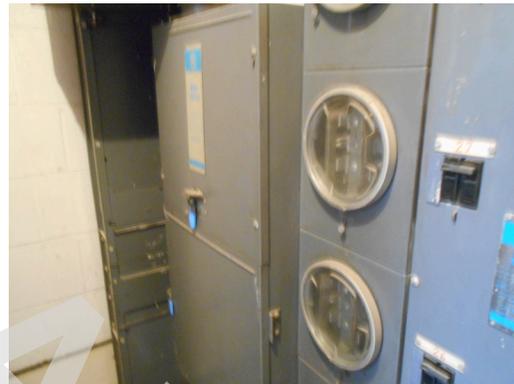
Typical tenant breakers

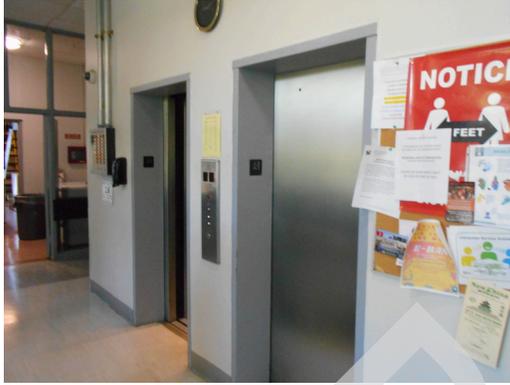
Based on the observed condition and age of the equipment, it is expected that modernization of the elevators may be necessary during the evaluation term. An opinion of cost for this work is included in the Tables.

As part of the site inspection, the inspector attended a tenant meeting where problems with the elevators were described. The issues described involved the elevator stopping despite being repaired multiple times. (Non-Critical Repair)

Building elevators

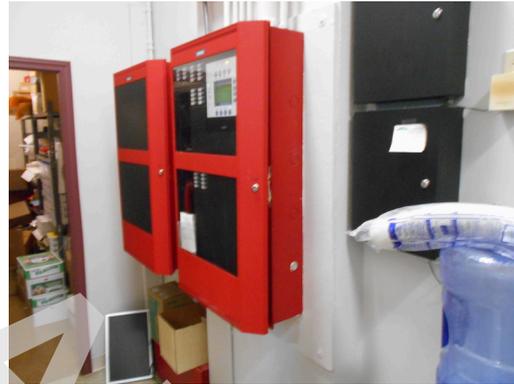
Fire alarm panel, inspected 4/26/2022

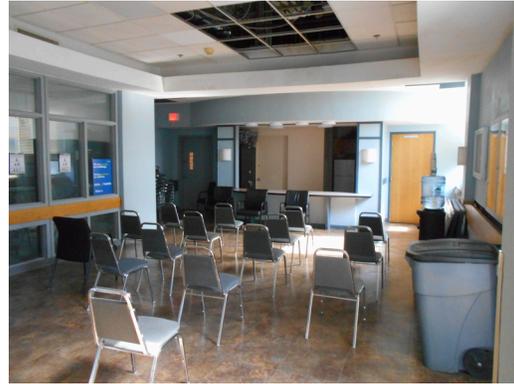
Building community room, ceiling tiles were replaced later in the day

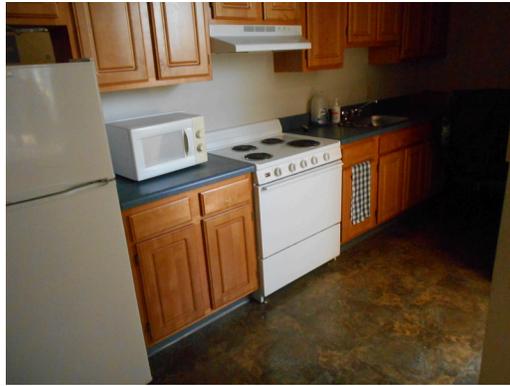
Community room kitchen, no roll under sink
(Critical Repair)

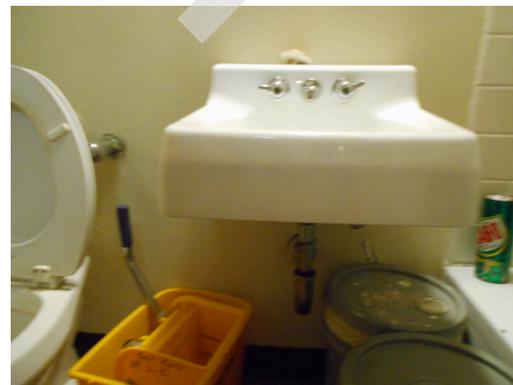
0br/1ba, Unit 7 - Bathroom sink, no scald abrasion protection

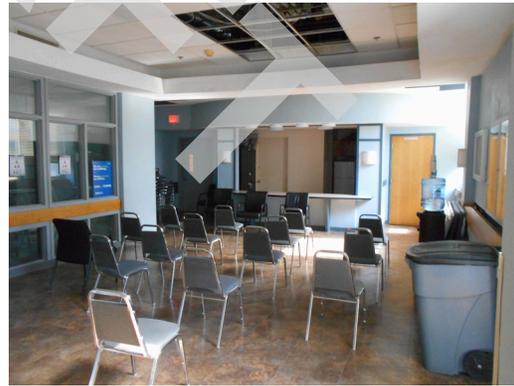
Building community room, ceiling tiles were replaced later in the day

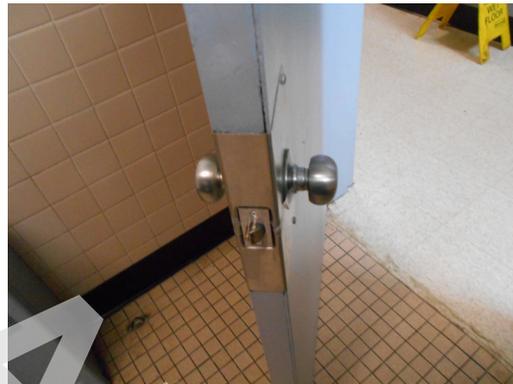
1.	Are common area public restrooms located on an accessible route?	✓			
2.	Are pull handles push/pull or lever type?		✓		Automatic opener provided at restroom entrance. Knob hardware located at public restroom entrances. Automatic door opener doesn't work without first twisting the knob hardware. (Critical Repair)

Public restrooms, knob hardware (Critical Repair)

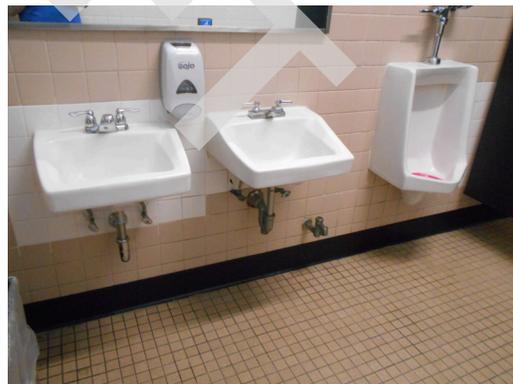
Men's public restroom, no scald abrasion protection at sinks (Critical Repair)

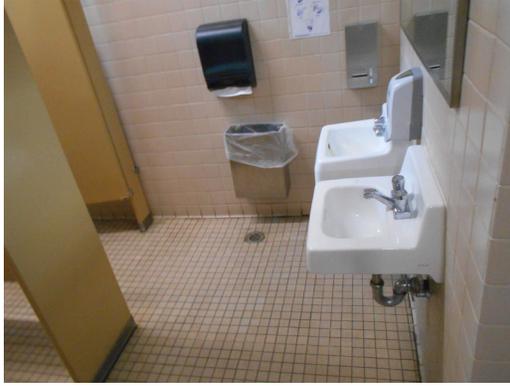
Women's public restroom, sink, no scald abrasion protection (Critical Repair)

Cabinets & vanities	UFAS Community Kitchen Cabinet Modifications (Critical Repair)	Community room kitchen	Repair	1	Each	\$ 5,000.00	\$ 5,000.00	The community room kitchen was observed without a roll-under forward approach sink with scald and abrasion protection, lower cabinets mounted at maximum height of 34-inches above the finished floor (AFF) upper cabinets mounted at maximum height of 48-inches (AFF). In order to comply with the Uniformed Federal Accessibility Standards (UFAS), the installation of a roll-under forward approach sink with scald and abrasion protection, lower cabinets mounted at maximum height of 34-inches above the finished floor AFF upper cabinets mounted at maximum height of 48-inches AFF.
Common area bath accessories (towel bars, grab bars, toilet stalls, etc.)	Install Scald and Abrasion Sink Wrap (Critical Repair)	Public Restroom	Level 1 Alteration	4	Each	\$ 80.00	\$ 320.00	The public restrooms were observed without scald and abrasion protection at the roll under sinks. In order to comply with the Americans with Disabilities Act Accessibility Guidelines (ADAAG), the installation of scald and abrasion protection is required.

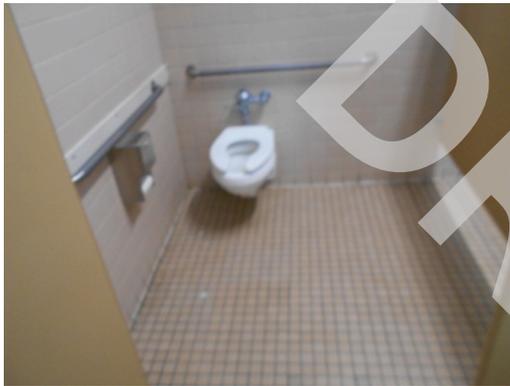
Women's public restroom, sink, no scald abrasion protection (Critical Repair)

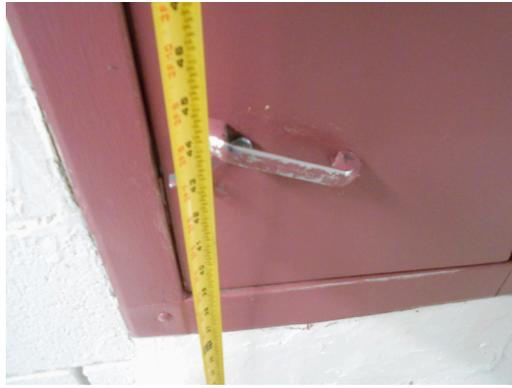
Typical trash chute door, controls at 44"

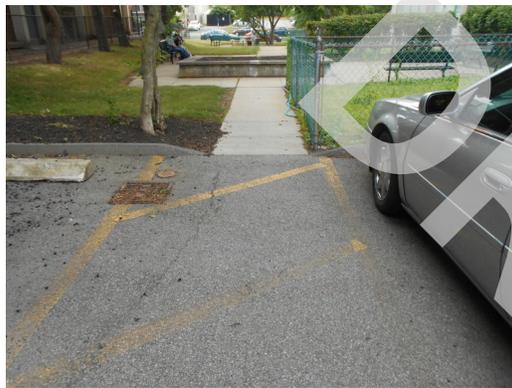
Handicap parking space, faded lines
(Non-Critical Repair)

CRITICAL REPAIRS								
Need Category	Component	Repair or Replacement Location	Classification of Work	Quantity	Unit of Measure	Unit Cost	Total	Comments
CRITICAL REPAIRS (ACCESSIBILITY)								
Striping and Marking	Reconfigure Handicapped Parking (Critical Repair)	Designated handicapped parking	Level 1 Alteration	1	Each	\$ 175.00	\$ 175.00	Based upon the fifteen (15) standard uncovered parking spaces available at the site, one (1) handicapped accessible parking spaces, inclusive of one (1) van accessible handicapped parking space are required by the Americans with Disabilities Act Accessibility Guidelines (ADAAG). The site currently features one (1) designated handicapped space; however the existing space was observed without vertical signs and is not van accessible. Additionally handicap space marking was observed in a access aisle near a building entrance. In order for the existing designated handicapped parking space to comply with ADAAG, the installation of vertical signs and conversion of the space to van accessible is required. Standard handicapped spaces require a 60" wide access aisles and vertical and horizontal identification. Van accessible handicapped spaces require a 96" wide access aisle, vertical signage identifying the space as van accessible, and horizontal identification. The designated handicapped parking spaces should be located at the closest accessible route to the building entrances and two (2) spaces may share a single access aisle.

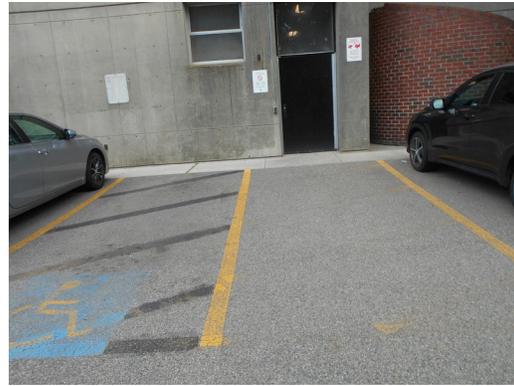
Handicap parking space marking in access aisle by removed handicap parking space (Critical Repair)

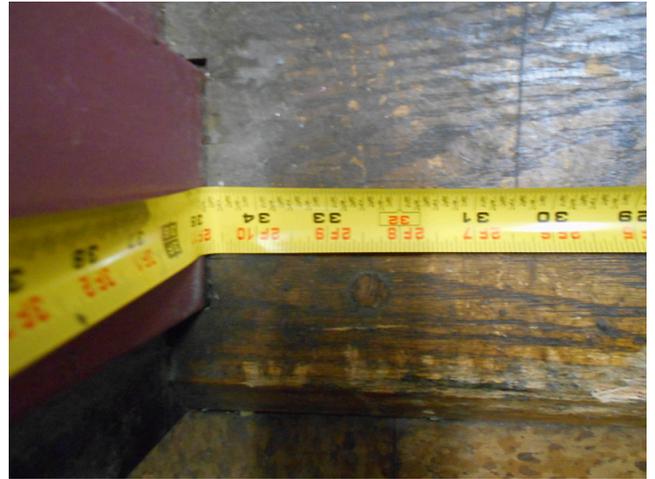
2. 0br/1ba, Unit 7 - Unit entrance door width, 35"

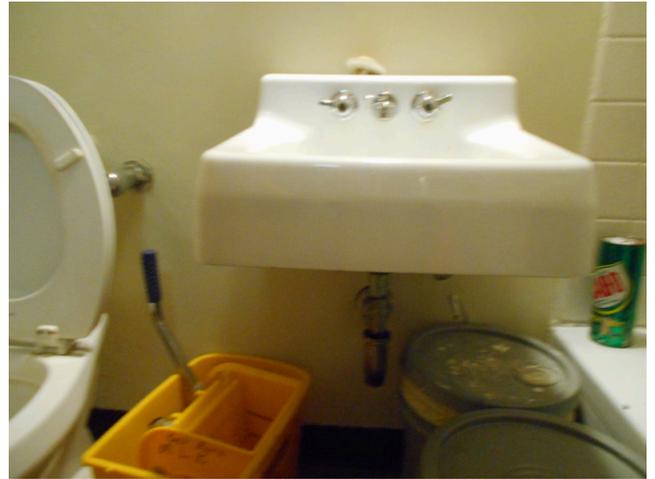
6. 0br/1ba, Unit 7 - Bathroom sink, no scald abrasion protection

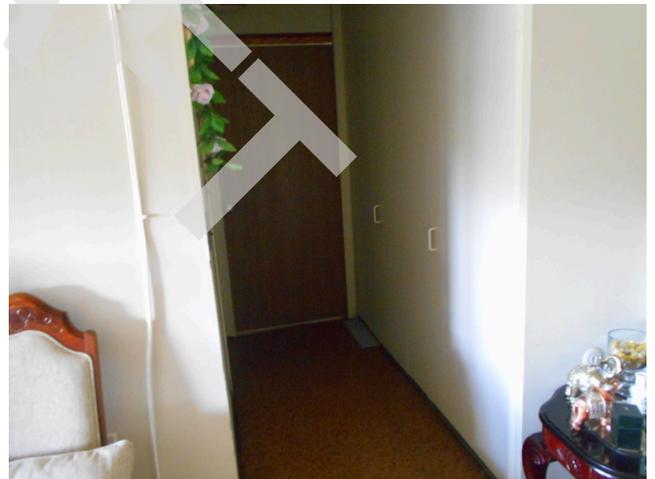
19. 1br/1ba, Unit 25 - Living area

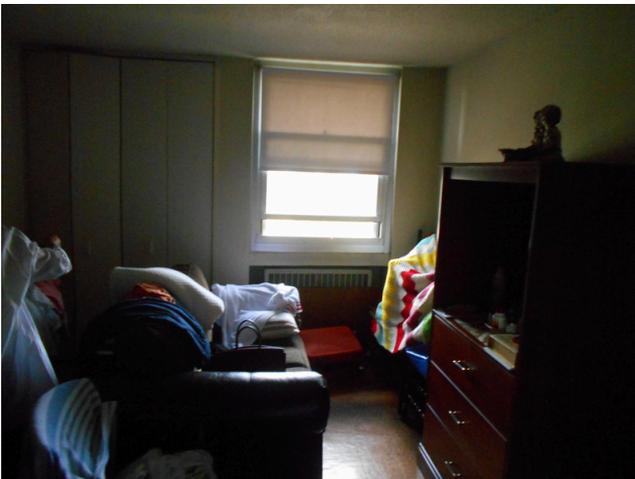
26. 1br/1ba, Unit 25 - Bedroom ceiling, no smoke detector (Critical Repair)

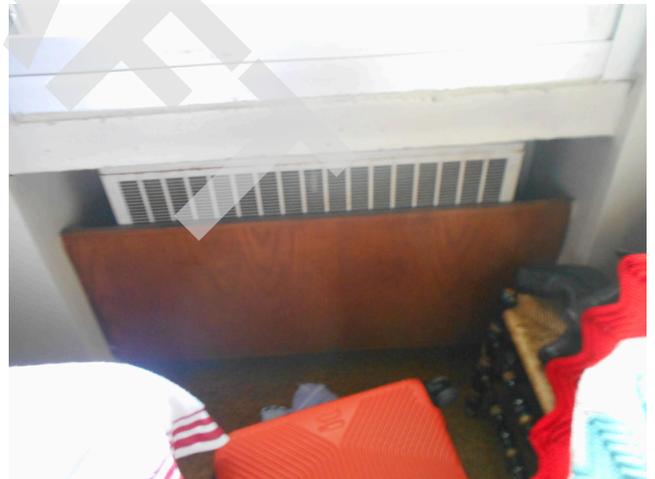
27. 1br/1ba, Unit 25 - Bedroom

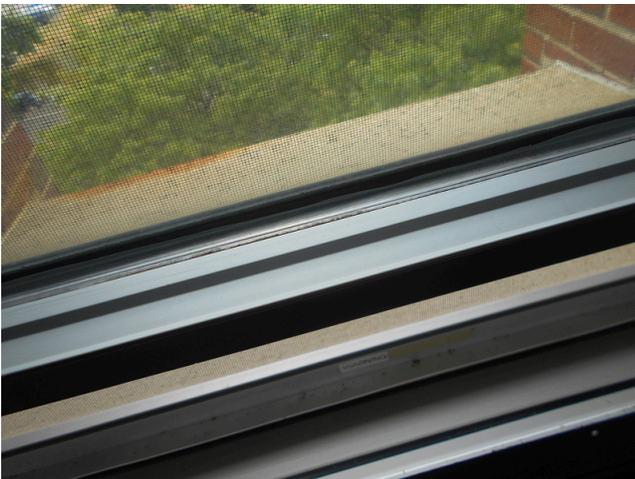
30. 1br/1ba, Unit 25 - Typical window

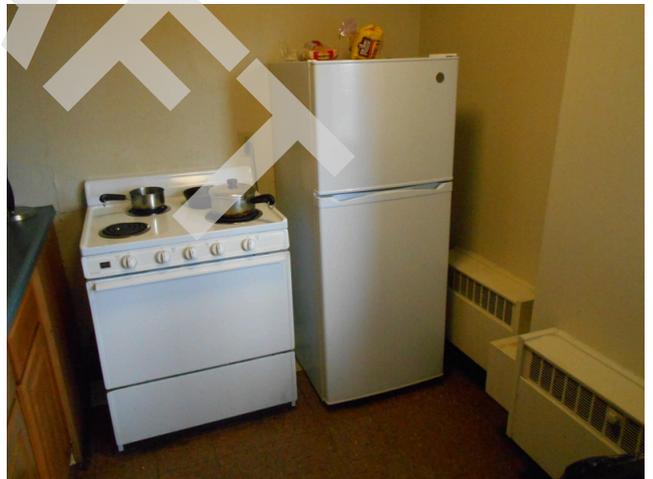
43. 1br/1ba, Unit 28 - Kitchen

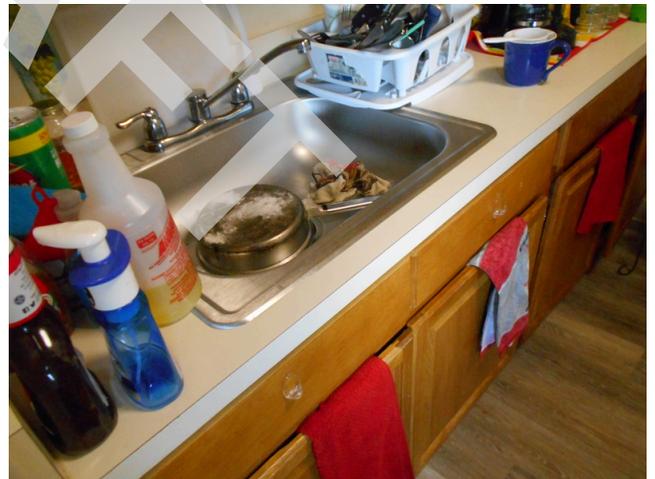
51. 1br/1ba, Unit 32 - Kitchen

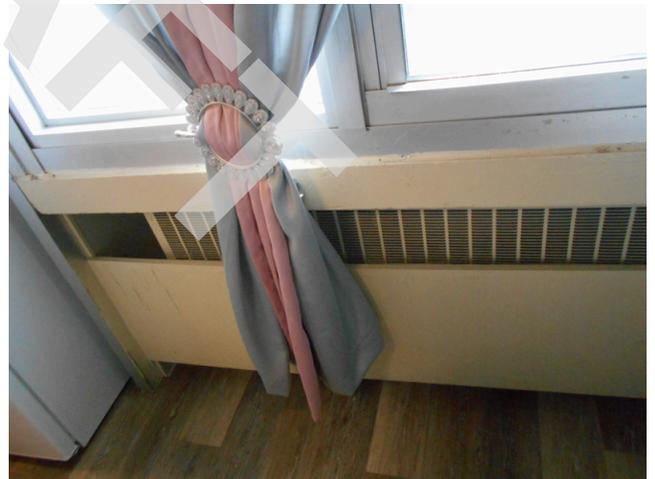
55. 1br/1ba, Unit 32 - Typical individual A/C unit

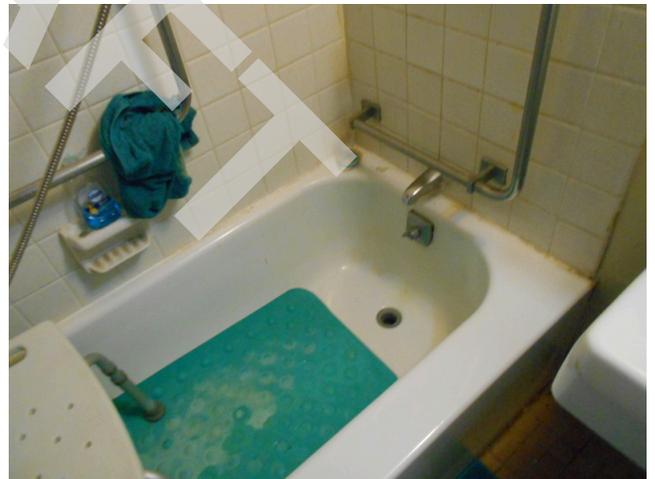
59. 0br/1ba, Unit 26 - Bathroom

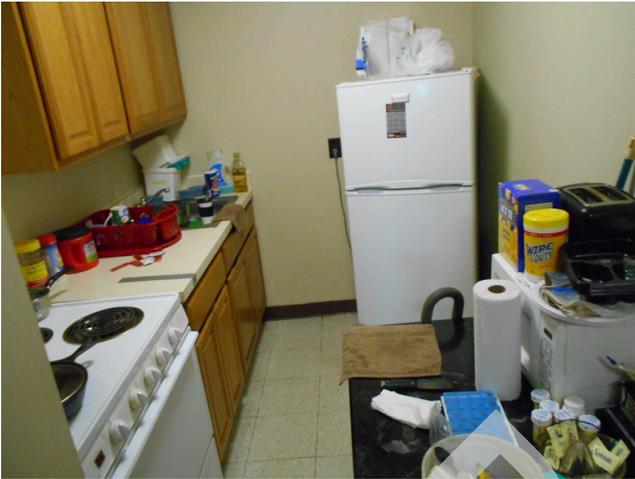
61. 0br/1ba, Unit 26 - Kitchen

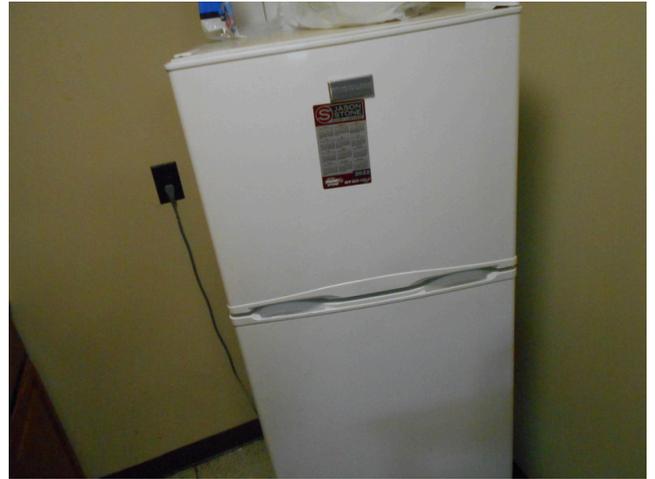
62. 0br/1ba, Unit 26 - Kitchen

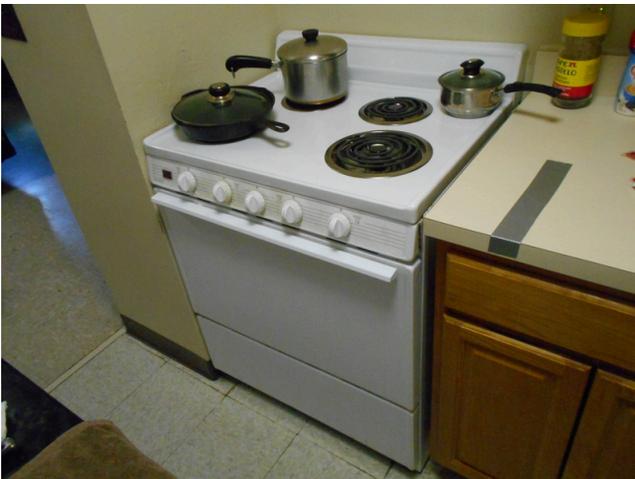
63. 0br/1ba, Unit 26 - Kitchen

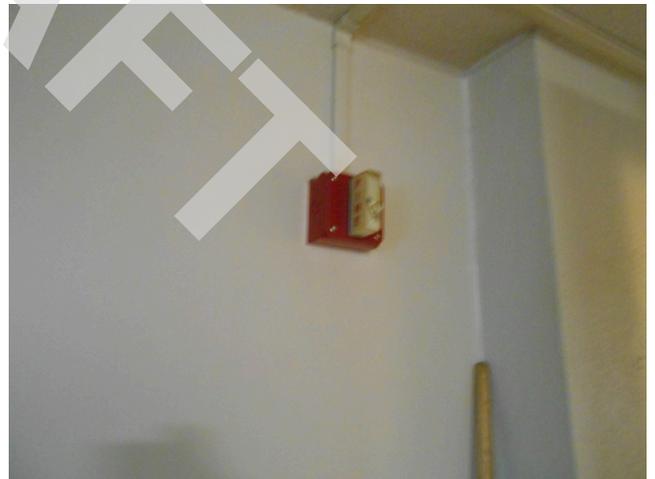
64. 0br/1ba, Unit 26 - Living area audio/visual
smoke detector

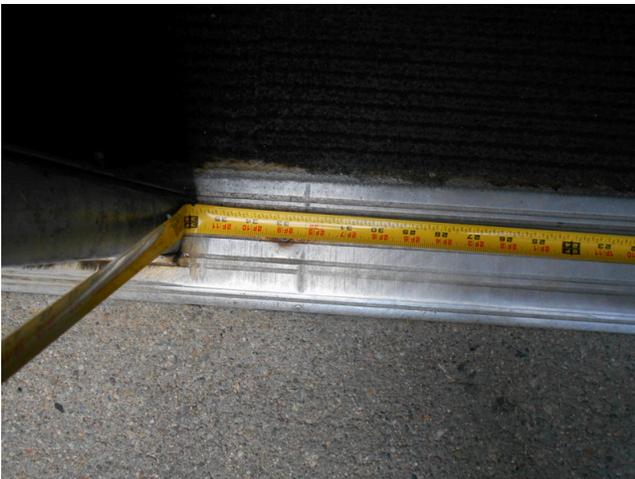
3. Building Entrance, door width, 36"

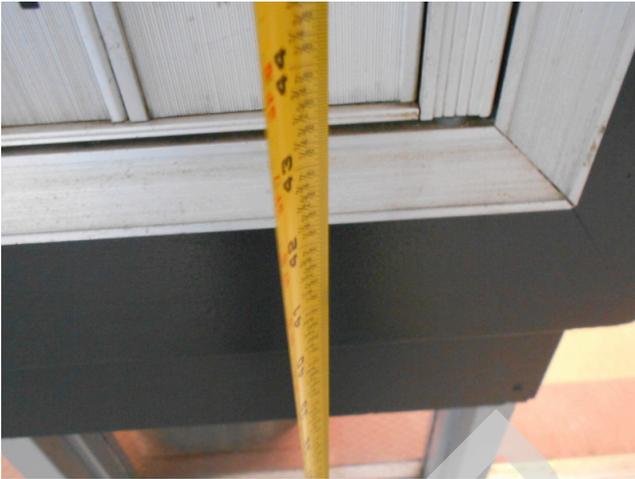
9. Tenant Mailboxes lower height, 44"

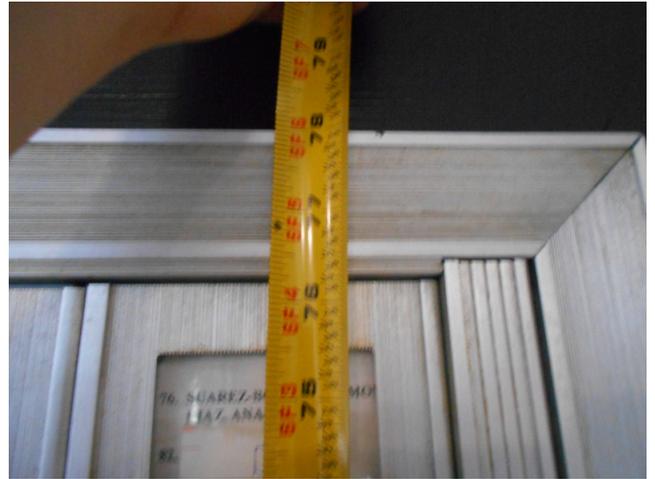
10. Tenant Mailboxes upper height, 76"

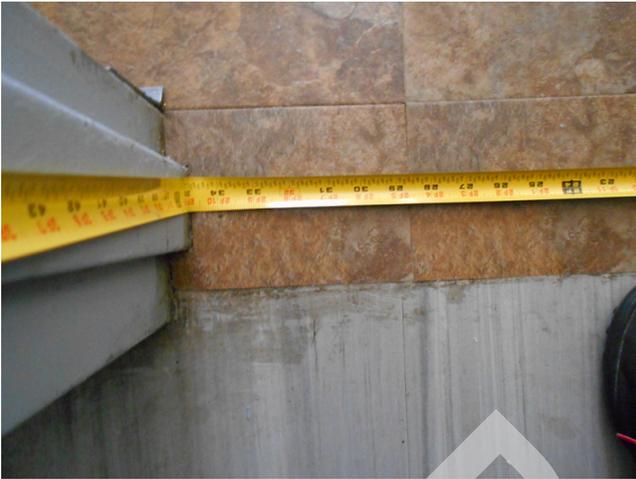
13. Community room entrance, 35"

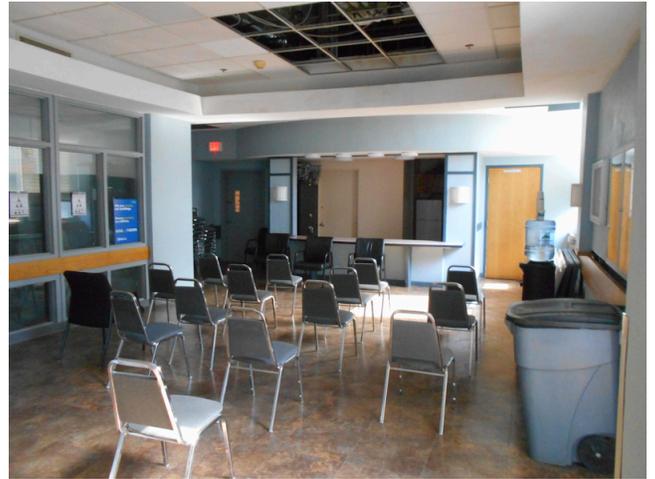
14. Building community room, ceiling tiles were replaced later in the day

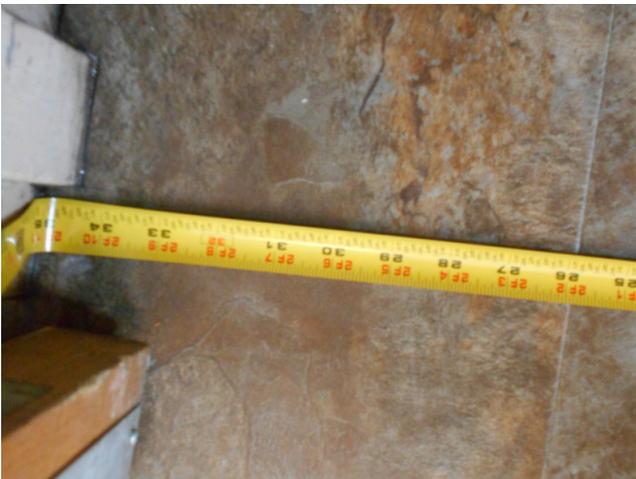
19. Community room kitchen entrance, 34"

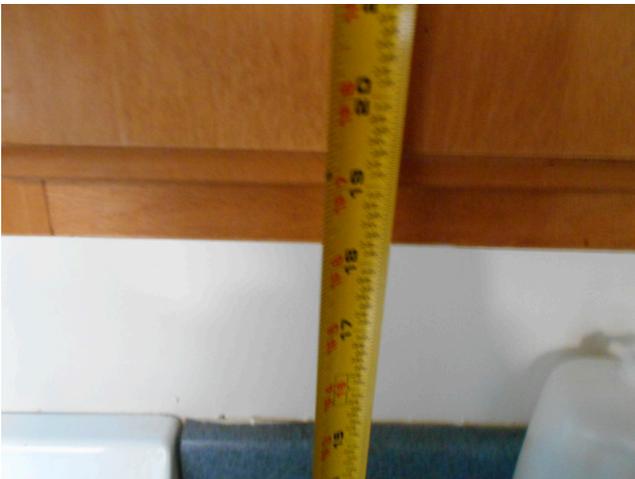
23. Community room kitchen cabinets, 54" AFF

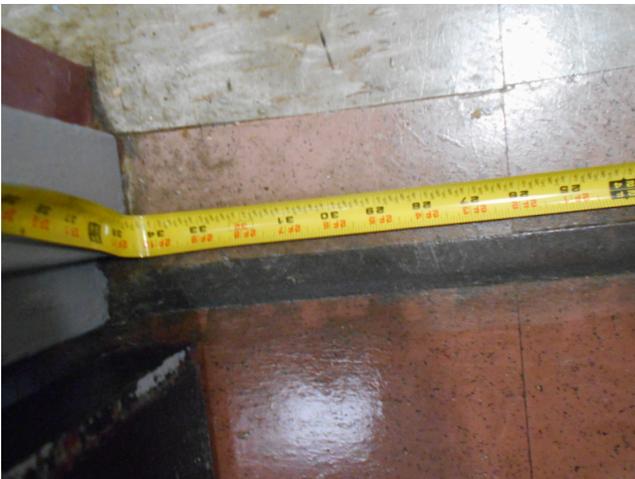
31. Leasing office entrance door width, 36"

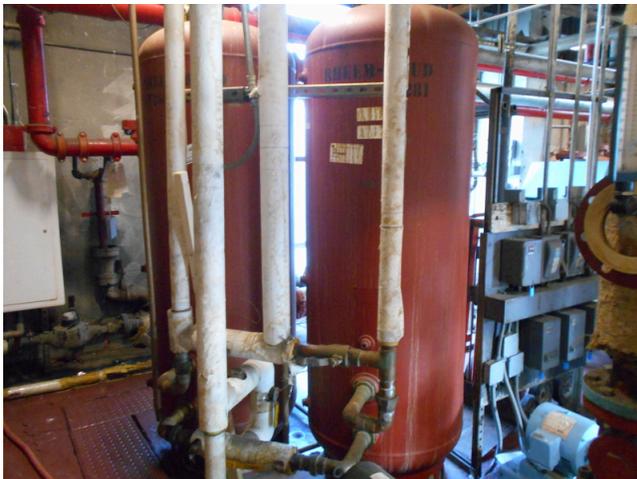
39. 257-gal Water storage tanks

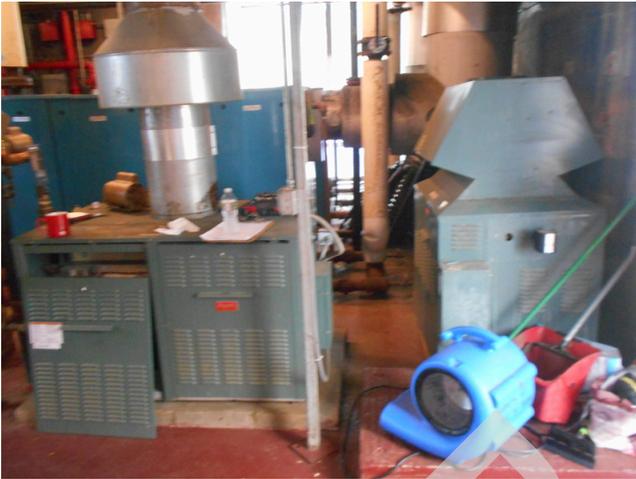
41. Hot water boiler and an inactive boiler

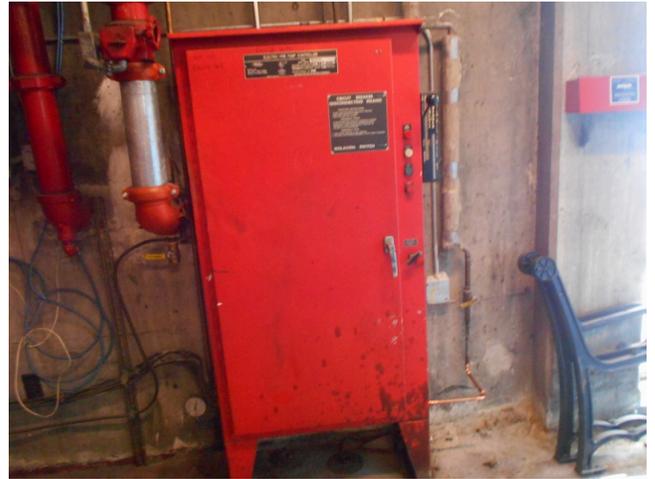
45. Fire sprinkler system, inspected 9/7/2021

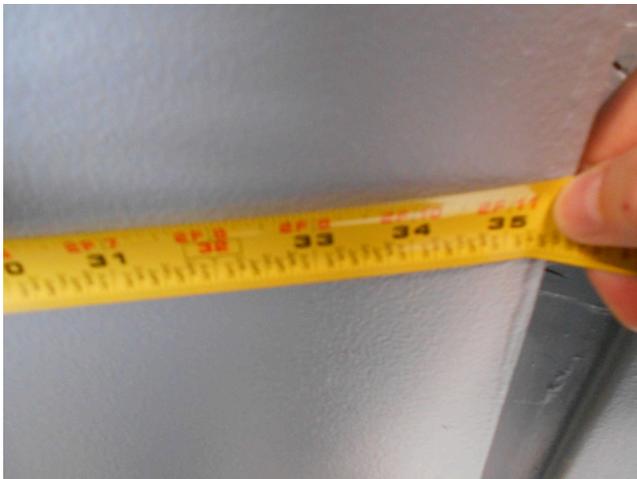
58. Public restrooms, knob hardware (Critical Repair)

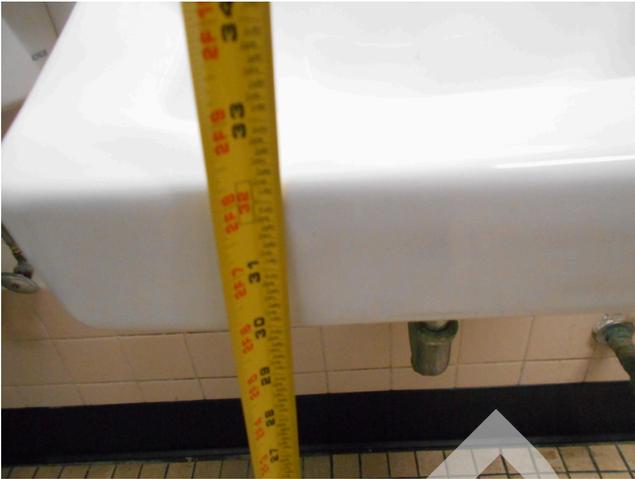
60. Men's public restroom, no scald abrasion protection at sinks (Critical Repair)

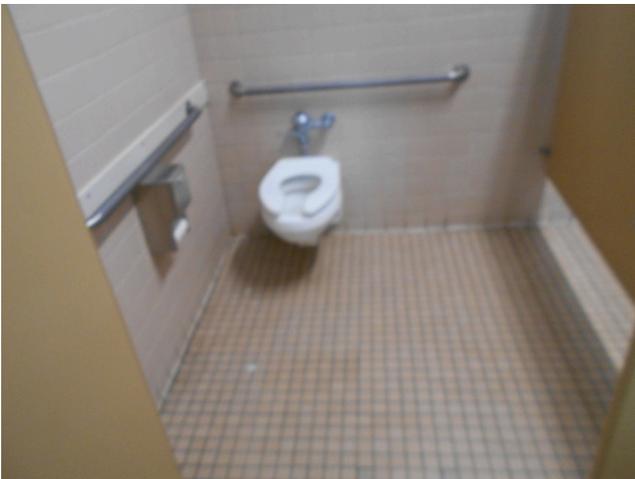
74. Women's public restroom, sink, no scald abrasion protection (Critical Repair)

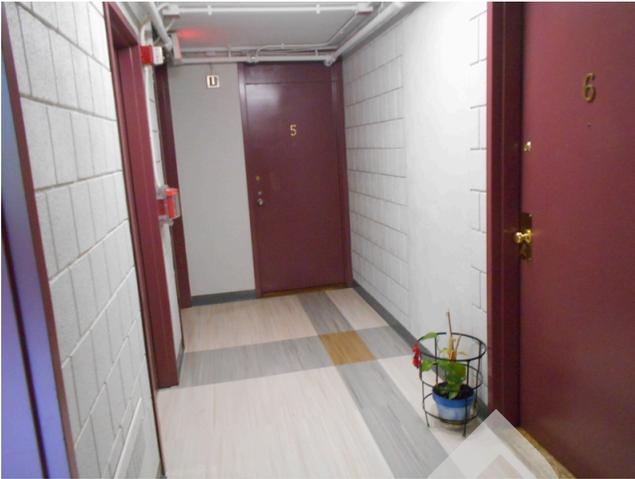
85. Typical resident floor hallway

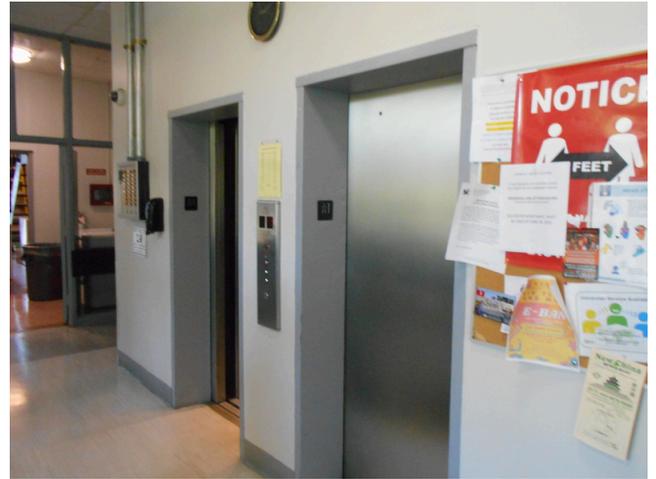
86. Building elevators

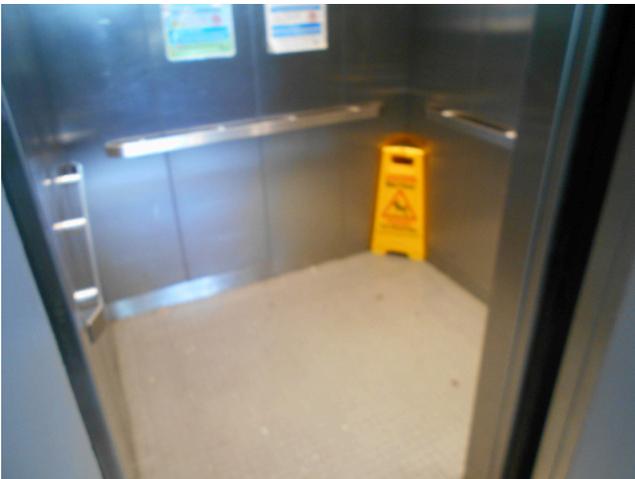
87. Elevator interior

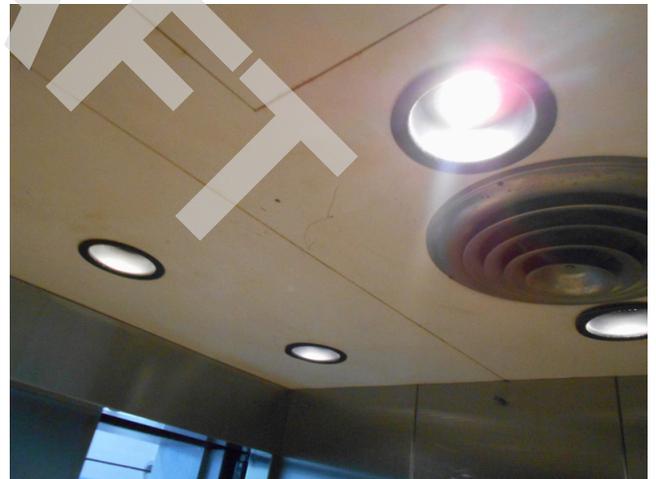
88. Elevator interior ceiling

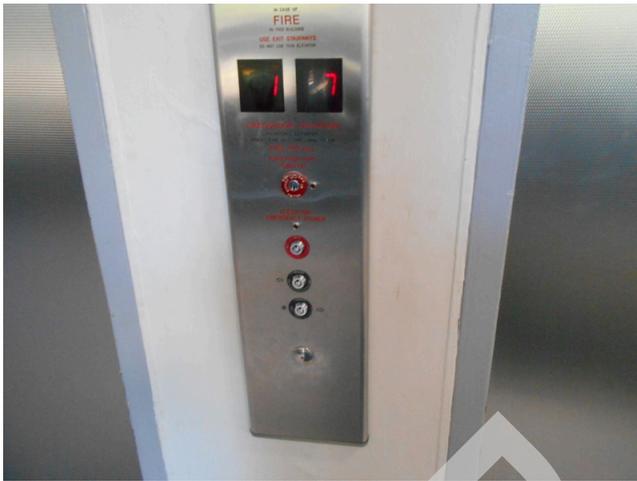
89. Elevator controls

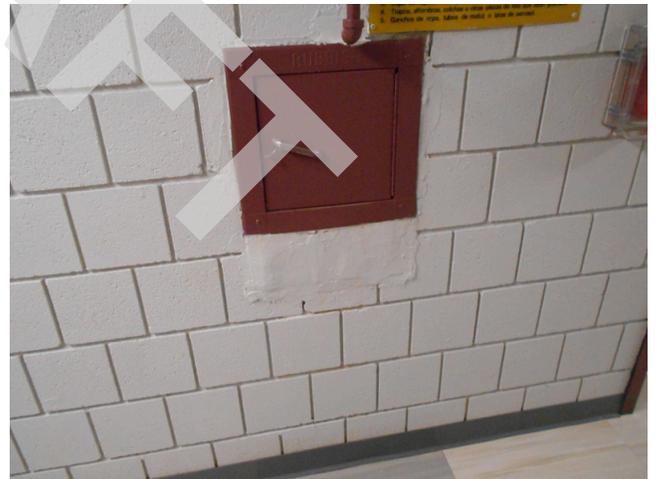
93. Typical trash chute door, controls at 44"

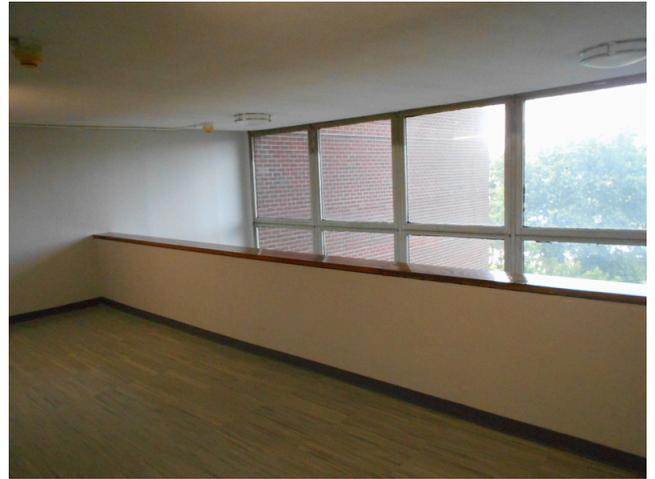
95. Typical hallway, overlooking lower floor

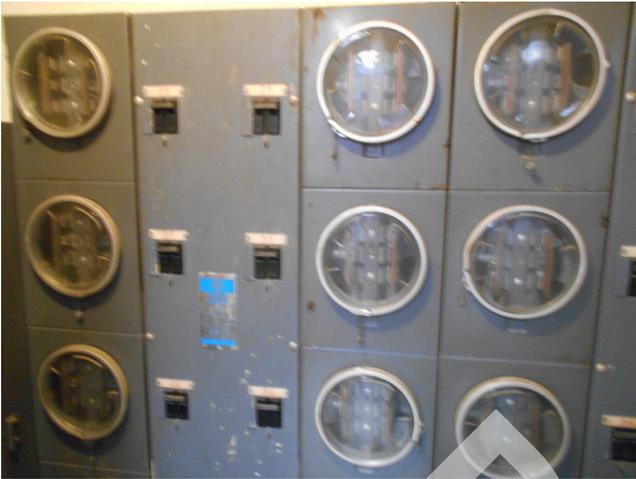
98. Typical tenant breakers
