HUD CAPITAL NEEDS ASSESSMENT

ML King
280 Martin Luther King Boulevard
Boston, Massachusetts 02119

AEI Project No. 463348
Site Inspection Date: June 28, 2022

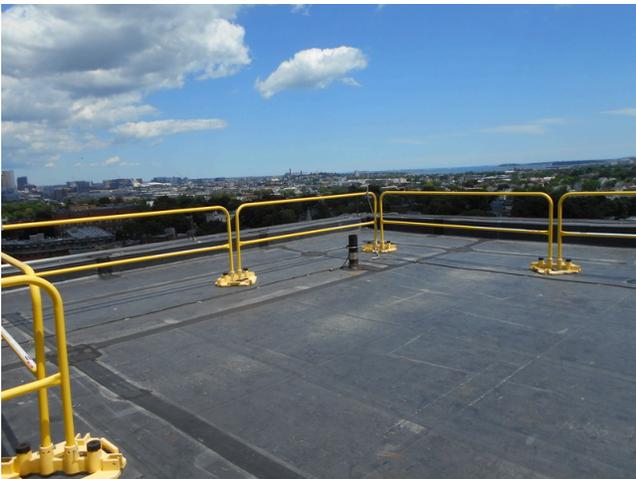
100. EPDM Roof

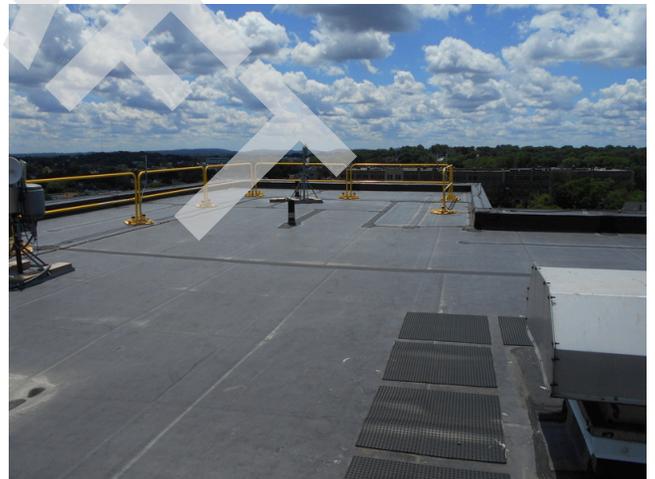
101. EPDM Roof area drain

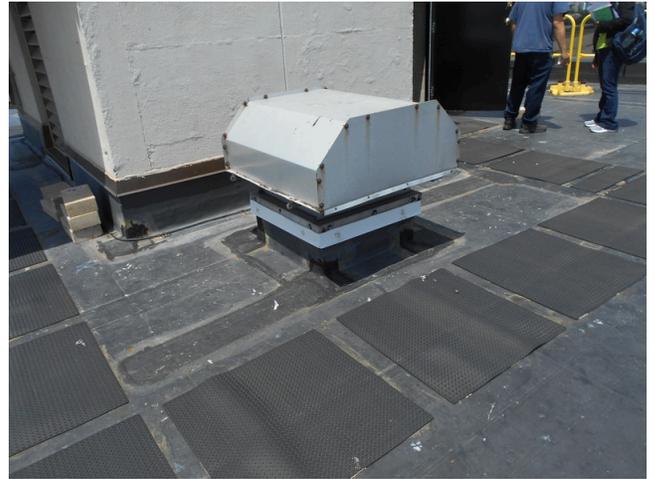
103. EPDM Roof

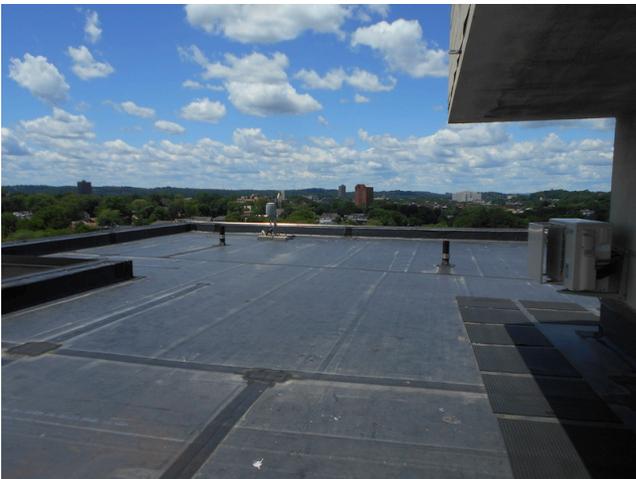
104. EPDM Roof

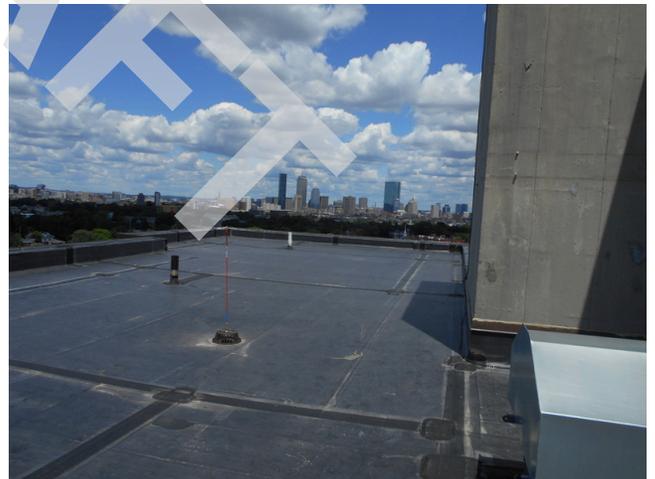
105. EPDM Roof

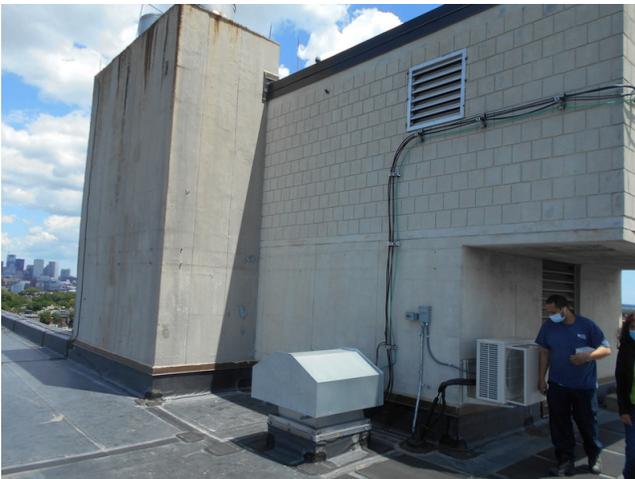
108. Elevator room

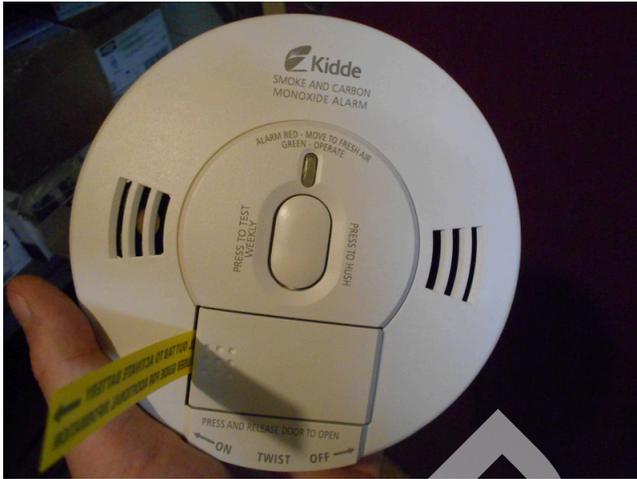
114. Typical tenant smoke and carbon monoxide alarm

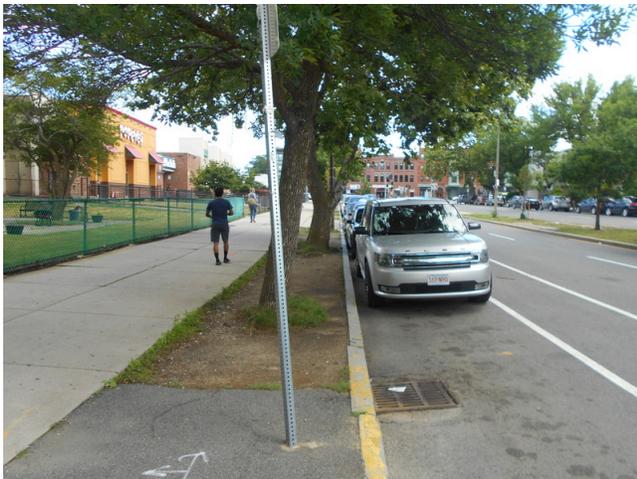
116. M.L.K. Boulevard

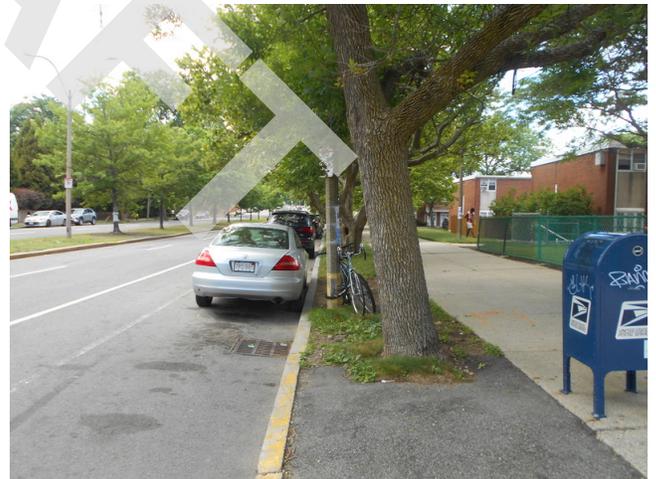
117. Building entrance from M.L.K. Boulevard

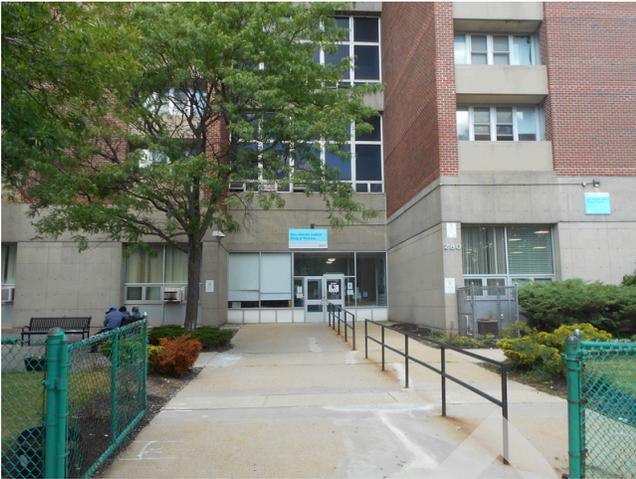
118. Front façade

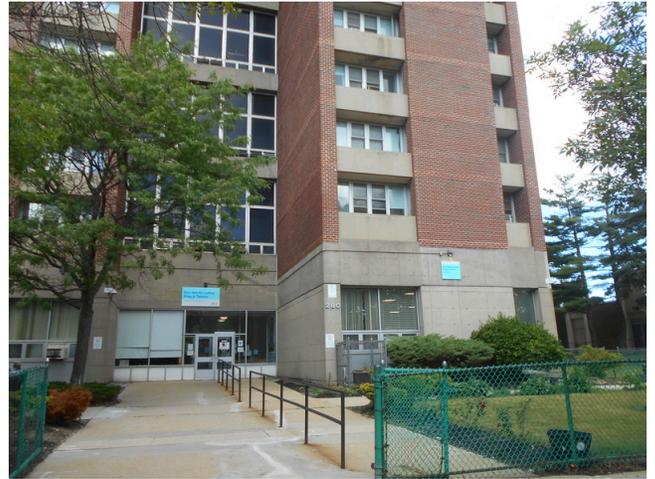
119. Front façade

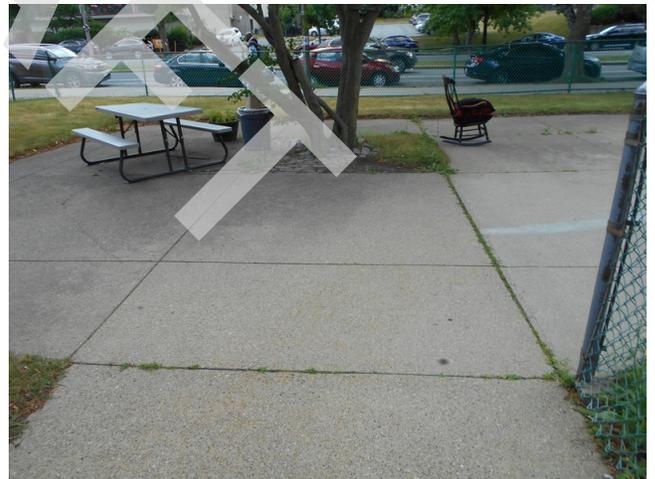
121. Concrete patio

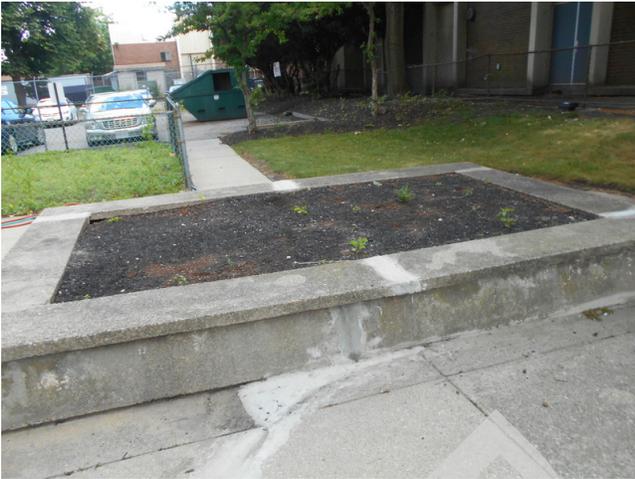
122. Concrete patio

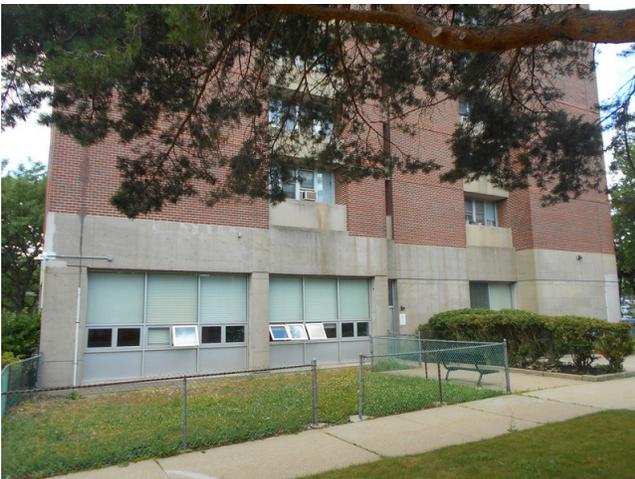
124. Side façade

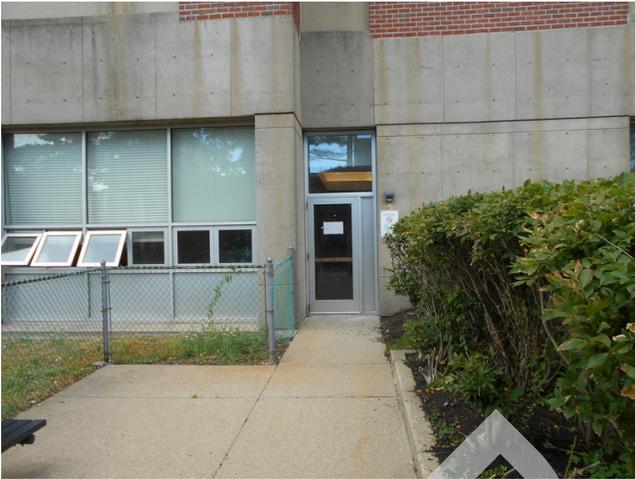
126. Exterior light

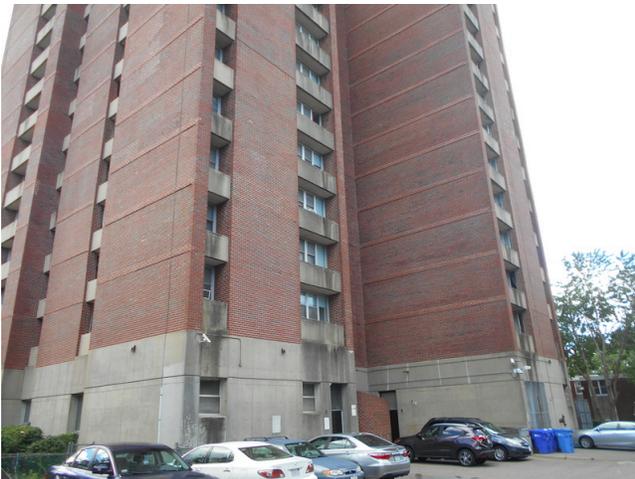
127. Rear façade

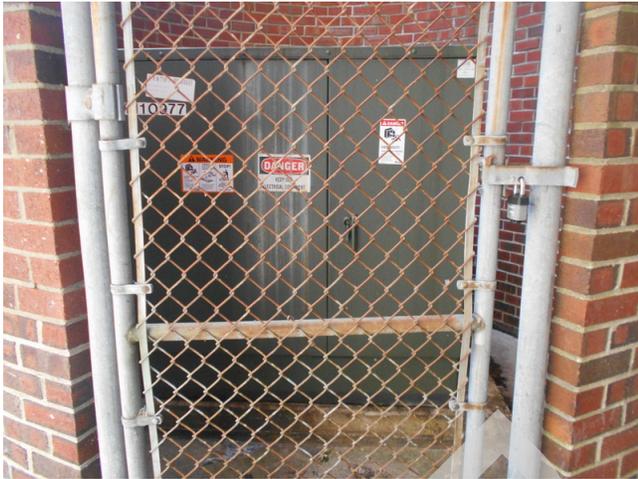
129. Electric transformer

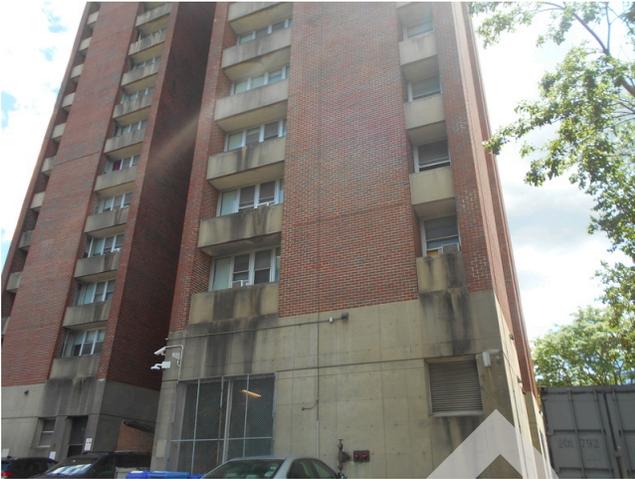
133. Rear façade

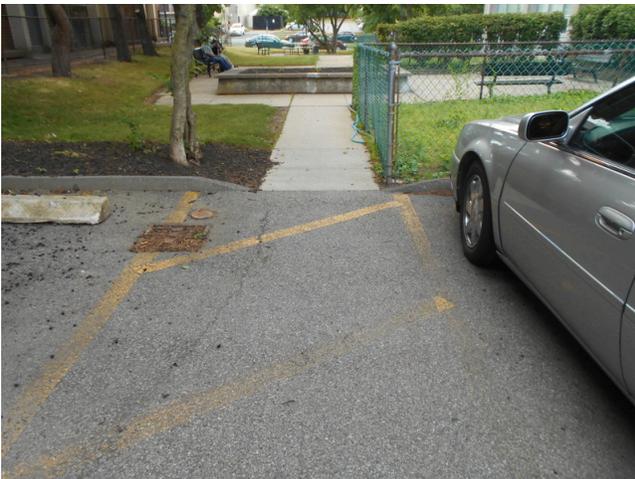
135. Handicap parking access aisle to sidewalk leading to building entrance

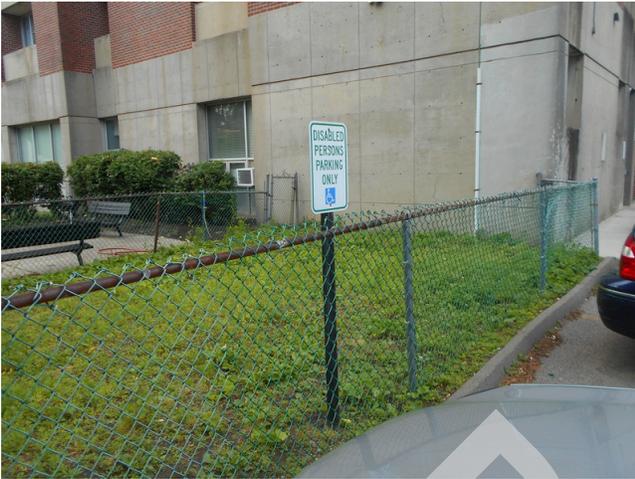
137. Handicap parking space signage

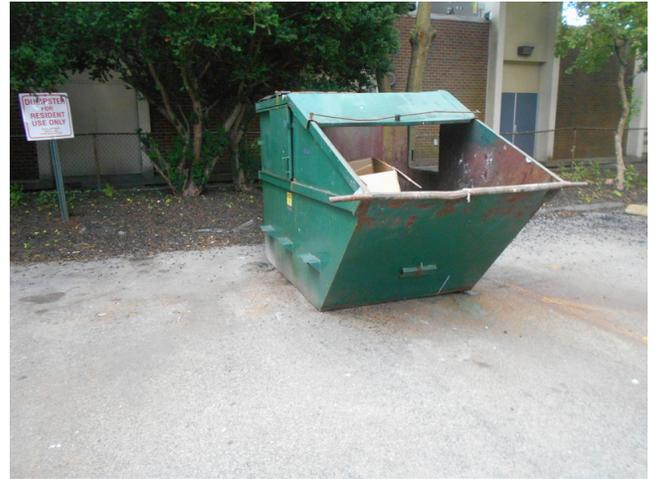
138. Refuse area

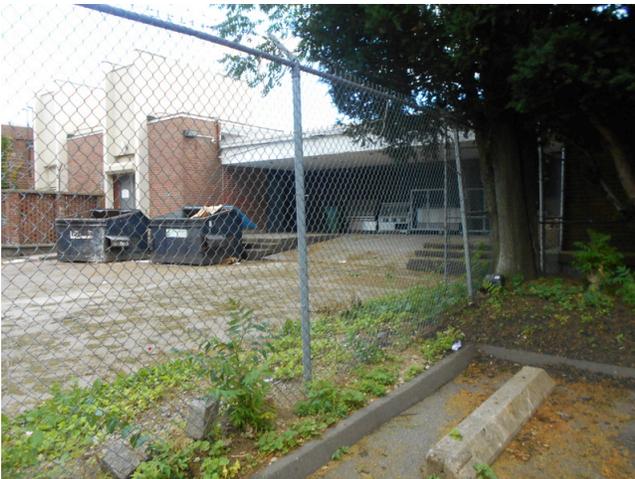
139. Chain link fencing

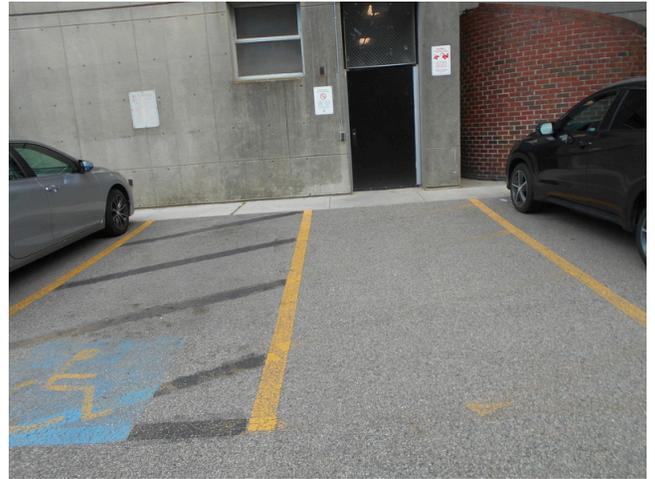
142. Potential handicap parking space leading to building rear entrance by public restrooms

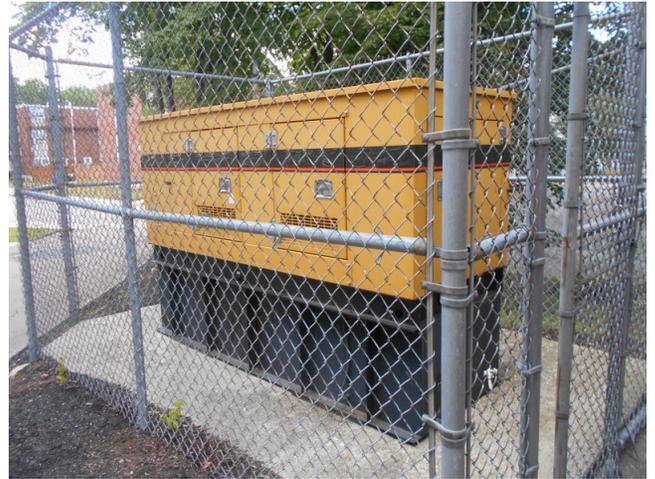
146. Emergency generator

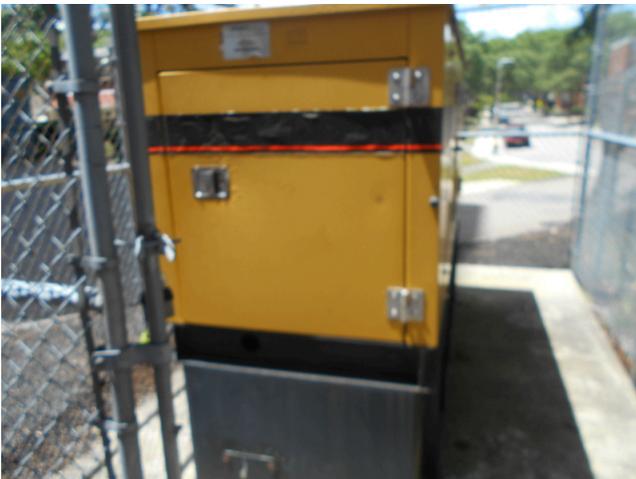
147. Emergency generator

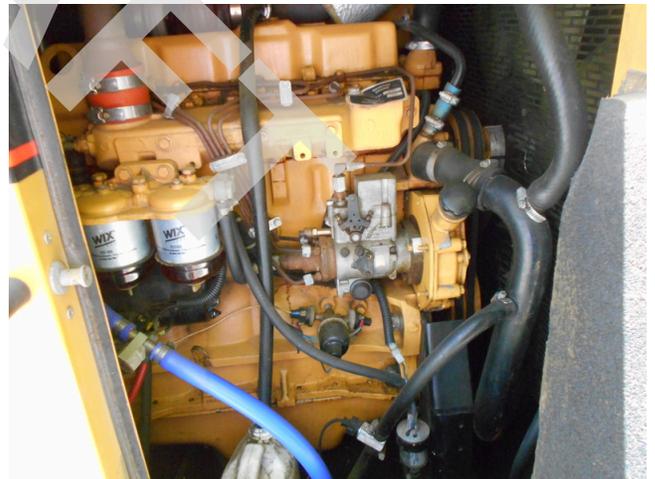
148. Emergency generator

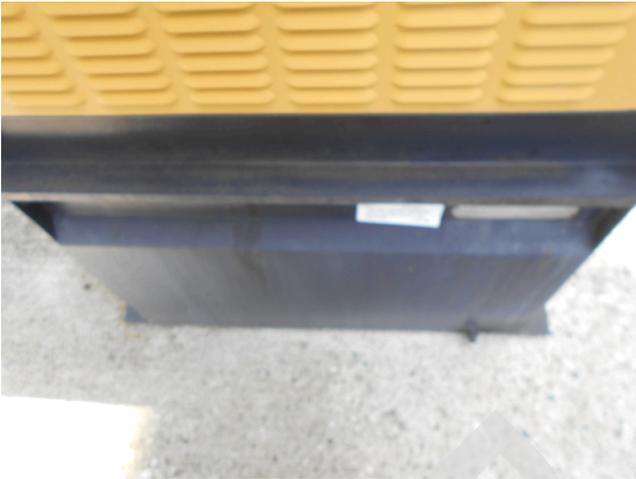
149. Emergency generator storage tank

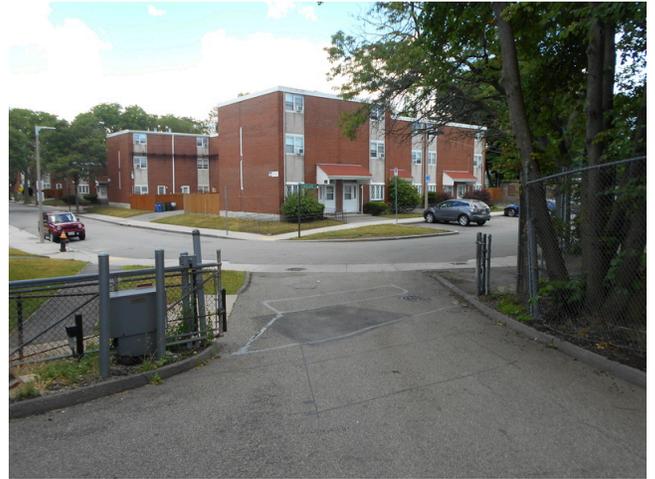
150. Site rear entrance from Charlame Street.

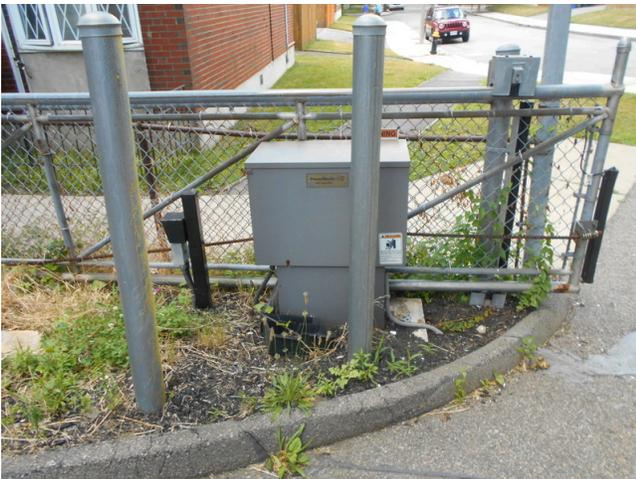
151. Rolling security gate at parking lot entrance
