HUD RAD CAPITAL NEEDS ASSESSMENT

Property Identification: Joseph Malone Apartments 11 Gordon Avenue Hyde Park, Massachusetts 02136

AEI Project No. 463343 Site Inspection Date: June 27, 2022 Prepared For: Boston Housing Authority 52 Chauncy Street Boston, Massachusetts 02111

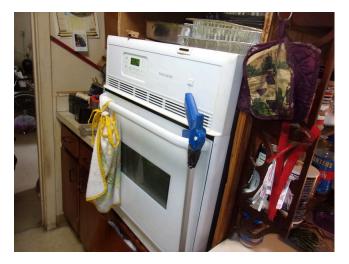
3. Unit 5A 1 Bedroom / 1 Bathroom H/C Kitchen Wall Oven

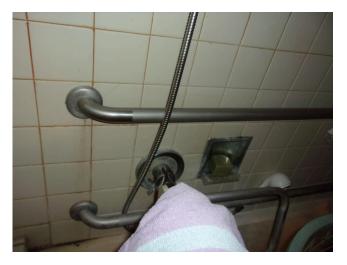
6. Unit 5A 1 Bedroom / 1 Bathroom H/C Shower Stall Grab Bars

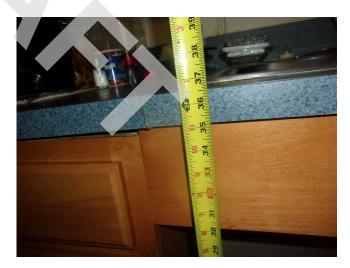
32. Unit 59B 1 Bedroom / 1 Bathroom H/C Sink Countertop Measurement From Finished Floor

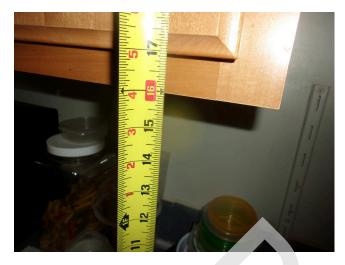
33. Unit 59B 1 Bedroom / 1 Bathroom H/C Upper Kitchen Cabinet Measurement From Countertop

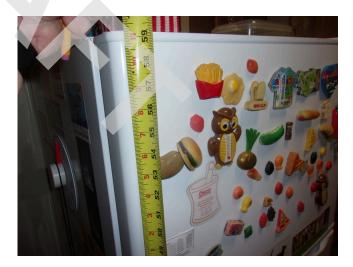
36. Unit 59B 1 Bedroom / 1 Bathroom H/C Freezer Measurement From Finished Floor

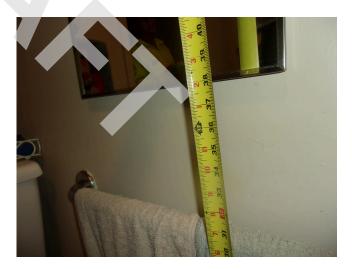
40. Unit 59B 1 Bedroom / 1 Bathroom H/C Bathroom Mirror Measurement From Finished Floor

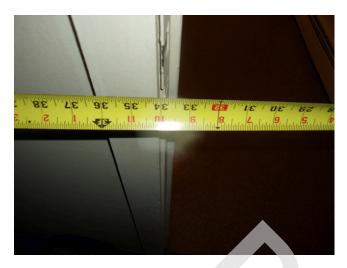
41. Unit 59B 1 Bedroom / 1 Bathroom H/C Clear Width Door Opening

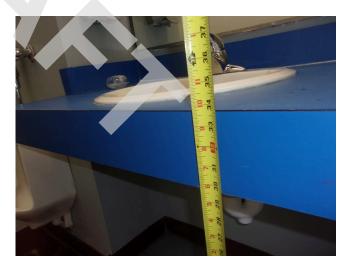
8. Community Building Restroom Countertop Measurement From Finished Floor

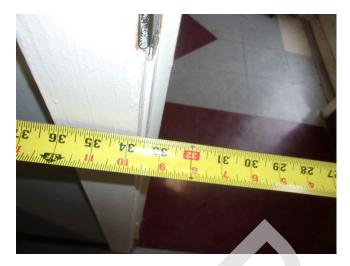
9. Community Building Restroom Clear Width Door Opening

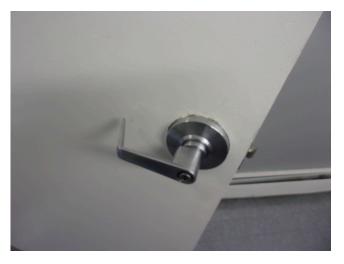
10. Community Building Restroom Levered Door Hardware

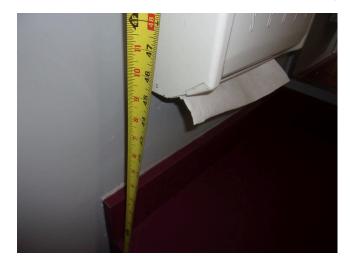
11. Community Building Restroom Paper Towel Measurement From Finished Floor

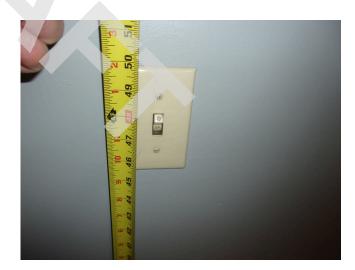
12. Community Building Restroom Light Switch Measurement From Finished Floor

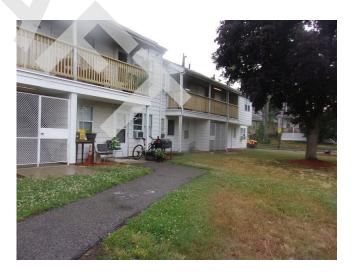
24. New Elevated Walkway Wood Railings

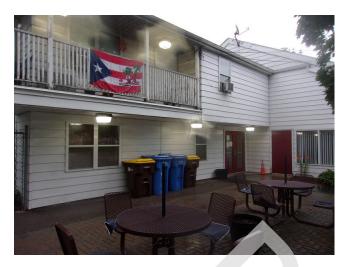
25. Old Elevated Walkway Wood Railings

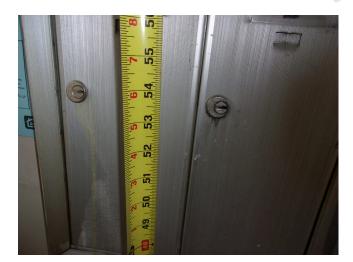
31. Mail Kiosk Measurement From Finished Floor

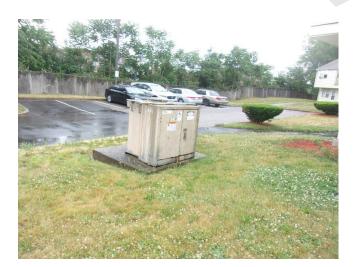
34. Fire Alarm Control Panel #2

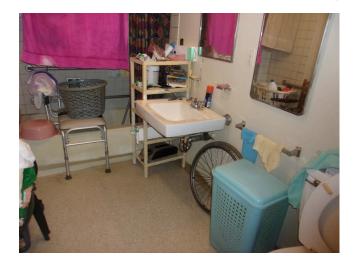
38. Dwelling Unit Bathroom

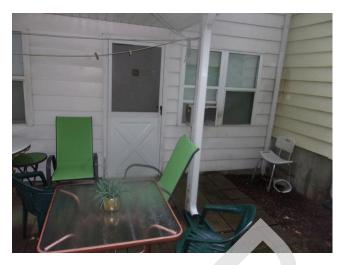
68. Brick Paver Patio Building 15

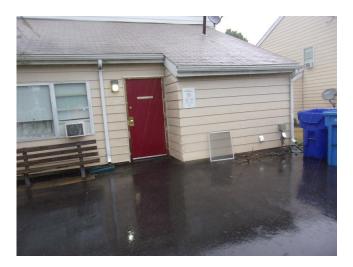
69. Dwelling Unit Rear Egress Door

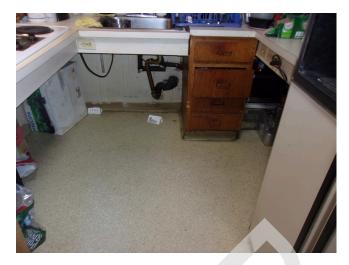
80. Kitchen Countertop Mounted Above the 34" Maximum From Finished Floor In The Designated Handicapped Unit
